# Biosolids Dryer Tilbury Essex

## Archaeological Watching Brief Report

**Client: Anglian Water**

**Biosolids Dryer, Tilbury, Essex**

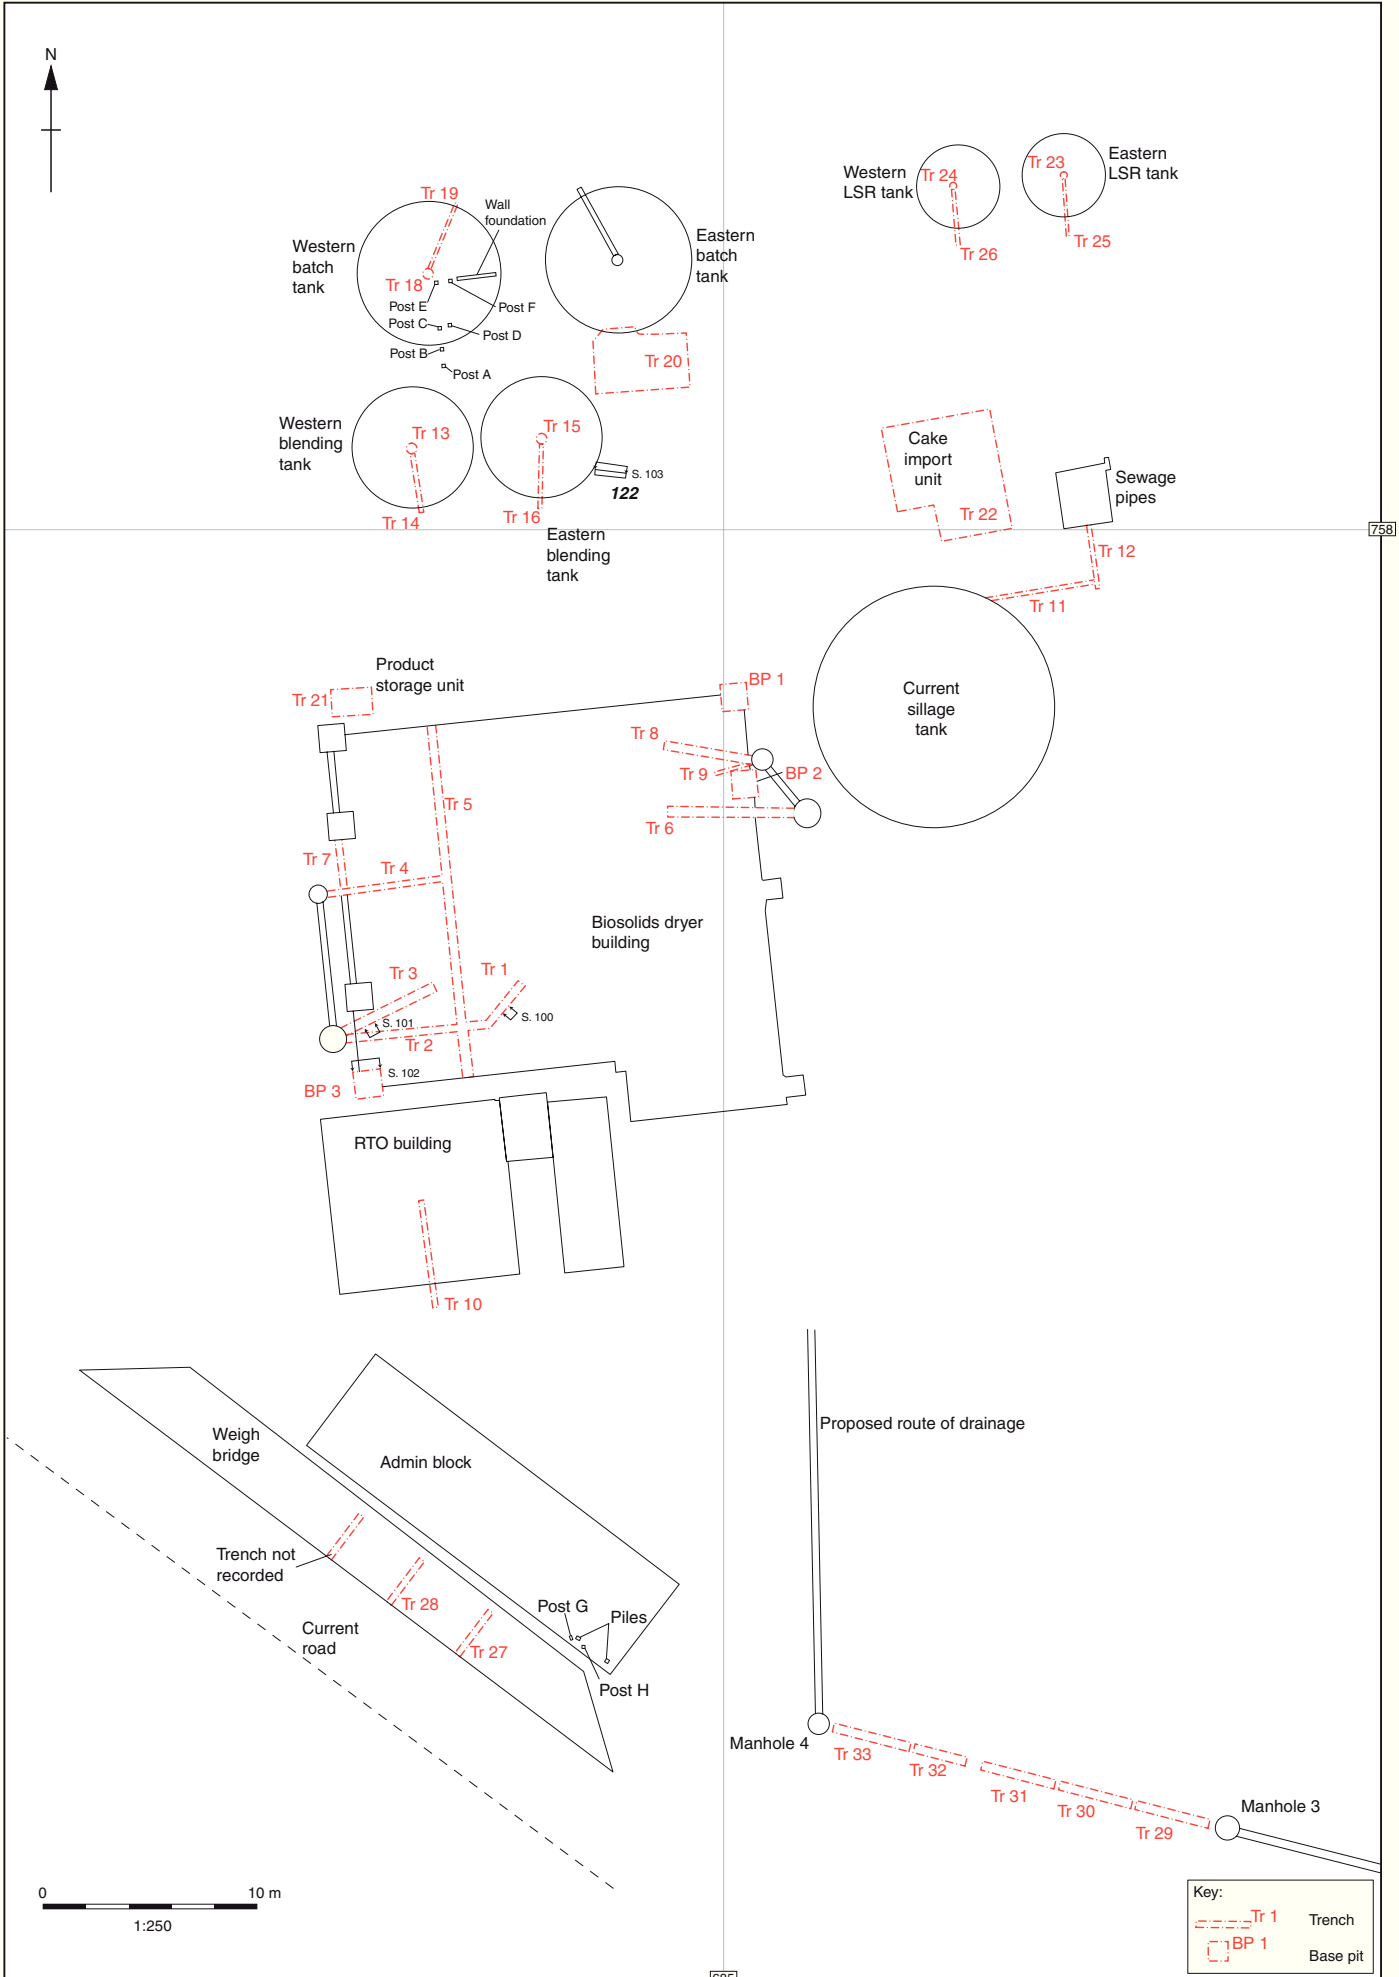
Figure 2: Site plan with Trench locations

- 3.2.1 This area is the location of the main Biosolids Dryer Building (Fig. 2) and occupied the central location within the site. However, the concrete working surface (blinding) had already been laid prior to the commencement of the watching brief and work had already begun on the excavation of gullies around the perimeter of the building and pile pits along the edge. This meant that the observation of any possible archaeological features in this area was limited to the proposed service trenches.

- 3.2.2 A series of service trenches were to be dug through the concrete blinding in order to lay drainage pipes (Trenches 1 to 9) although Trenches 5 and 7 were drainage channels running north to south along the length of the Dryer Building and contained no pipes. Trenches 5 and 7 were approximately 400 mm deep and about 1 m wide. Trench 7 was only dug into made ground and consequently did not expose the natural peat layer that may have lain beneath. Trench 5 was excavated down into the peat layer, however, no archaeological features were encountered.

- 3.2.3 The remaining trenches (1 to 4, 6 & 8 to 9) were excavated to accommodate drainpipes down to an average depth of about 1.5 m. Trenches 1 to 4 were excavated in the south-west area of the Dryer Building and were made up of a layer of peat (104, 108, 110, 117 & 118) overlying brown/grey alluvial clay deposits (105, 111 & 119) and at around 1.6 m blue/grey clay (112) could be seen. No significant archaeological features were seen in these trenches although within Trench 3 a cassy deposit (109) could be seen in the section (Fig. 4, Section 101). This has been interpreted as a dump of waste material, probably Victorian in date (Appendix 2). The remaining trenches (6, 8 & 9) were excavated at the north-eastern end of the Biosolids Dryer. In places the peat layer had disappeared due to ground reduction. Mainly the layers comprised dark grey/black peat overlying a mid to dark brown/grey alluvial layer. London clay was observed below 1.4 m. A series of service pipes and cables ran across the width of Trenches 6 & 8 making the sides of the trenches very unstable and subject to collapse. No archaeological features were visible within these trenches.

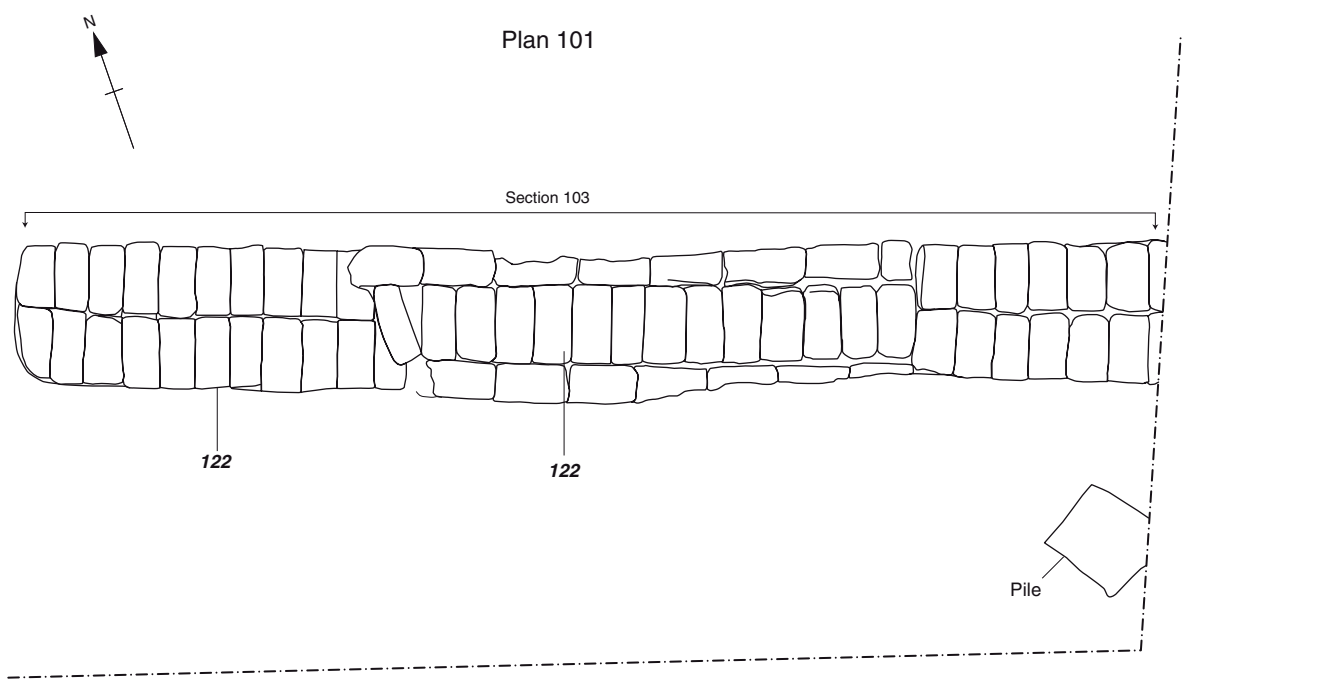
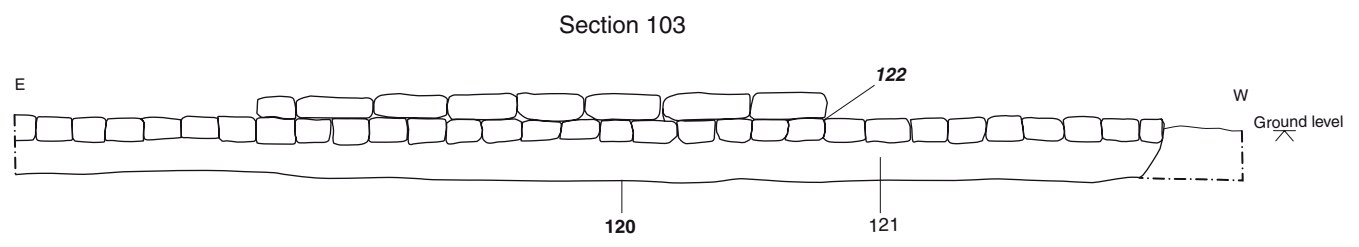
Figure 3: Plan 101, Section 103

- 3.4.2 During the reduction of the ground level around the area of the western Batch Tank partial remains of wall foundations (122) (Fig. 3, Plan 101 & Section 103) were uncovered running east-west. The foundations were 0.6 m wide and 4 m long. The depth of the foundations were 0.18 m, 0.13 m of which were below the top of the alluvium. The foundations were made up of large river pebbles with a lime mortar bond.

- 3.4.3 Immediately to the west of the wall foundation the remains of four wooden posts representing a fence line could be seen running at a right angle, north-south for approximately 7.7 m. Two more fence posts running for 3.8 m could be seen one metre away running parallel to the first set of posts representing a second fence line. These fences were associated with the foundations in that they would have most likely formed some type of enclosure. Directly to the east of the eastern Blending Tank the bottom two courses of a yellow stock brick wall were uncovered (Structure 122) cut into the alluvium. These bricks dimensions were 230 mm x 110 mm x 70 mm and of a pale yellow colour, common to this area in the latter half of the 18th century and into the 19th century. There was no bond between these bricks and this may be due to the fact that these courses were laid within the cut to provide a base for a wall that sat on top (Fig.3, Section 103 & Plan 101). The wall itself was 3.8 m

long and 480 mm wide and probably represents the remains of Marsh Farm, which occupied this area prior to the construction of the water treatment works.

4.1.2 The only evidence of activity within the site was a series of fence lines and foundations associated with the post-medieval farm known to have occupied the site prior to the construction of the Water Treatment works. These were discovered during the excavation for the Batch and Blending Tanks and the Administration Block.
