Magazine Stores
RSPB Rainham
Tank Hill Road
Purfleet
Essex

Historic Building Recording

Document Title: Magazine Stores, RSPB Rainham, Tank Hill Road,
Purfleet, Essex

Document Type: Building Recording and Investigation

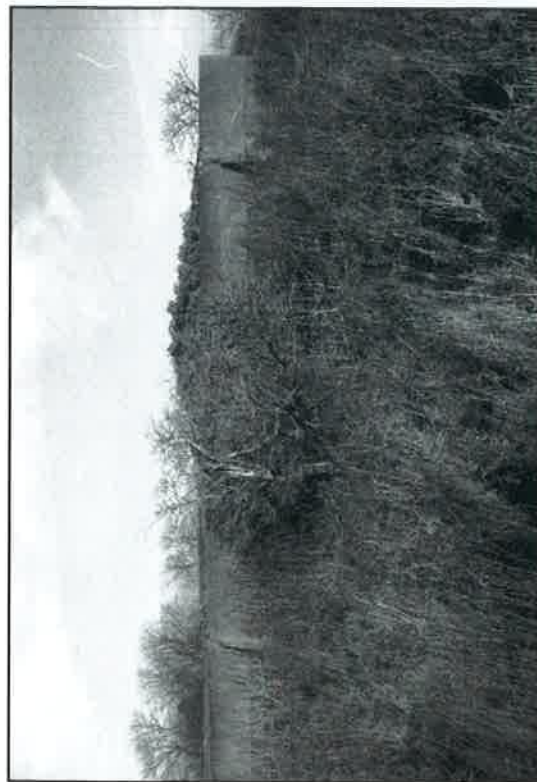
Plate 3: South-west view of buttress

- 3.2.3 Five reinforced concrete triangular buttresses placed at c.4 m intervals (Plate 3) support each length of the outer blast walls. The area between the buttresses has been infilled by earth extending to c.0.5 m below the height of the blast walls. As a result the full extent of the buttresses is not visible. All magazines types constructed at this time would have had earth banked against them, this provided additional protection against enemy attack and explosions. Some of the most substantial bombproof magazines were covered by earthen mounds, such as those at Chorley and Swynnerton. Purfleet is typical of later magazines, such as those at Elstow, which are free standing with no overhead cover beyond the concrete roof slab (Cocroft, 2000).

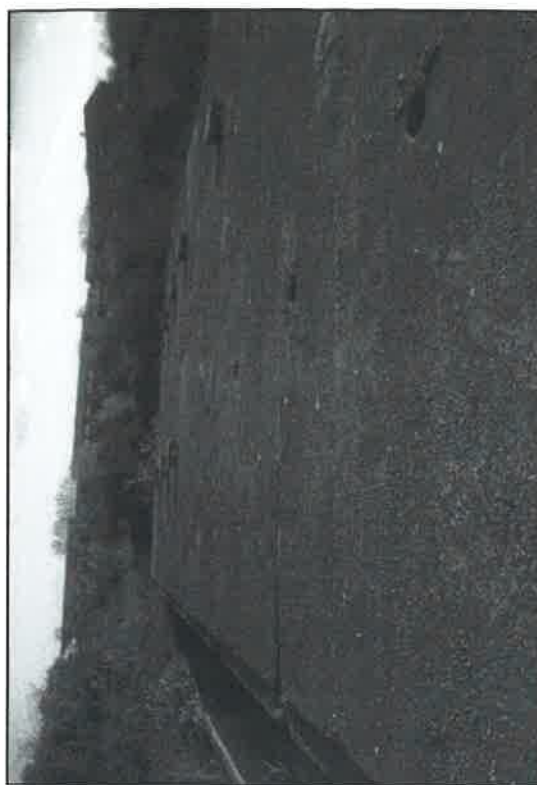
Plate 4: East view of roof, Magazine E

- 3.2.4 The flat roof of each magazine is constructed from reinforced concrete and only extends over the inner core. The passageways between the tall inner core walls and the lower blast walls are now open but they would almost certainly formerly have had a pitched roof cover (probably of asbestos sheeting). This has since been removed, presumably as a result of health and safety requirements. There is evidence that something has been removed from the top of the core walls but there are no clear signs of sockets at the top of the blast walls. Flat concrete roofs were common as a constructional expedient as they afforded some protection from incendiary bombs (Lowry 1995).

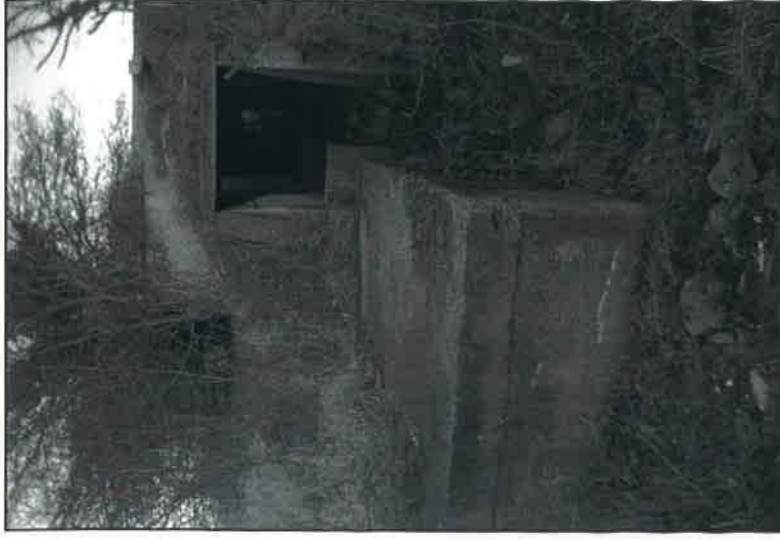
Plate 6: North-east entrance, Magazine G

- 3.2.5 Access to the magazines is provided by four rectangular openings, two lying at each end of the magazine (Plate 6). Each opening has the form of a short tunnel measuring

- 1.2 m by 1.9 m, the walls are at a 45 degrees gradient meeting a flat concrete roof, which extends c.1.9 m from the outer wall. An earth embankment extends to the height of the tunnel roof.

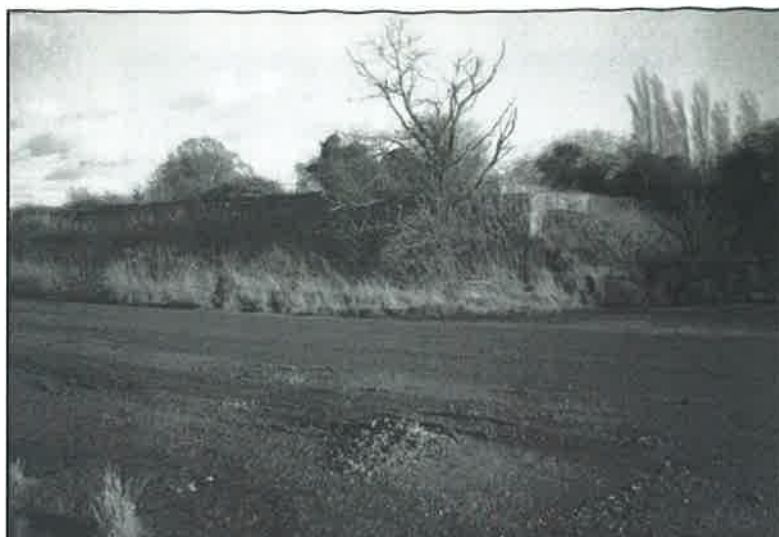
Plate 9: South-eastern view of service road, Magazine A

- 3.2.8 Access to the site is provided by a service road, this would originally have been concrete with a thin layer of asphalt (Plate 9). This runs from the site entrance, between the site two groupings of magazines and to the northwest of the NW-SE group of magazines. This was a common feature of such sites, being necessary to allow trucks/lorries to dispatch ammunition to and from the magazines (Cocroft 2000).

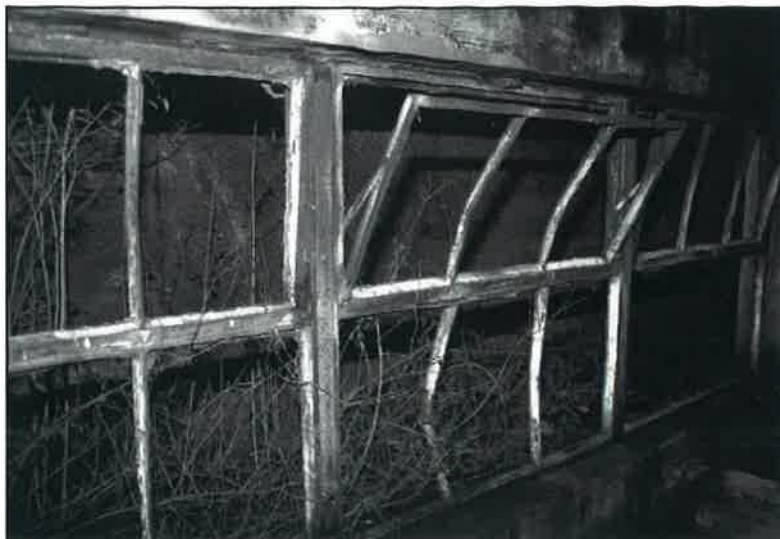
Plate 16: North view of window, Magazine H

- 3.3.2 Each magazine houses two windows on the lengths of the core walls, all are identical throughout the magazines measuring 2.93 m by 0.94 m (Plate 16). They are constructed of a simple metal frame with 'T' section glazing bars and eighteen lights. Three upper lights are contained in the central bay and each has a horizontally hung casement. These windows face the blast wall and would have allowed some additional light to enter the magazines, this was beneficial as artificial lighting presented a potential fire risk. It is probable that the glass was wired which was a technique which was generally adopted in such buildings in the first half of the 20th century (Cocroft 2000).

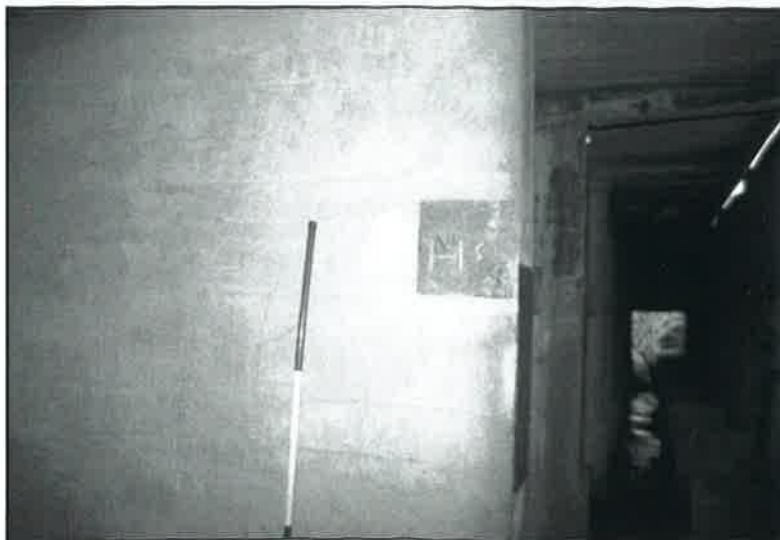
Plate 17: South view of bay label "Bin No H8", Magazine H

- 3.3.4 Each magazine contains two sections of nine storage bays, these have been labelled consecutively in black paint on both sides of the bay walls from 1 to 9 and 10 to 18 (Plate 17). The sign: 'Warning: do not touch or rub out markings' has also been painted in red on the core wall at the entrance to the storage bays.
