**HATHERSAGE
ROAD,
ARDWICK,
MANCHESTER**

**Archaeological Excavation
Report**

September 2015

Nuffield Health

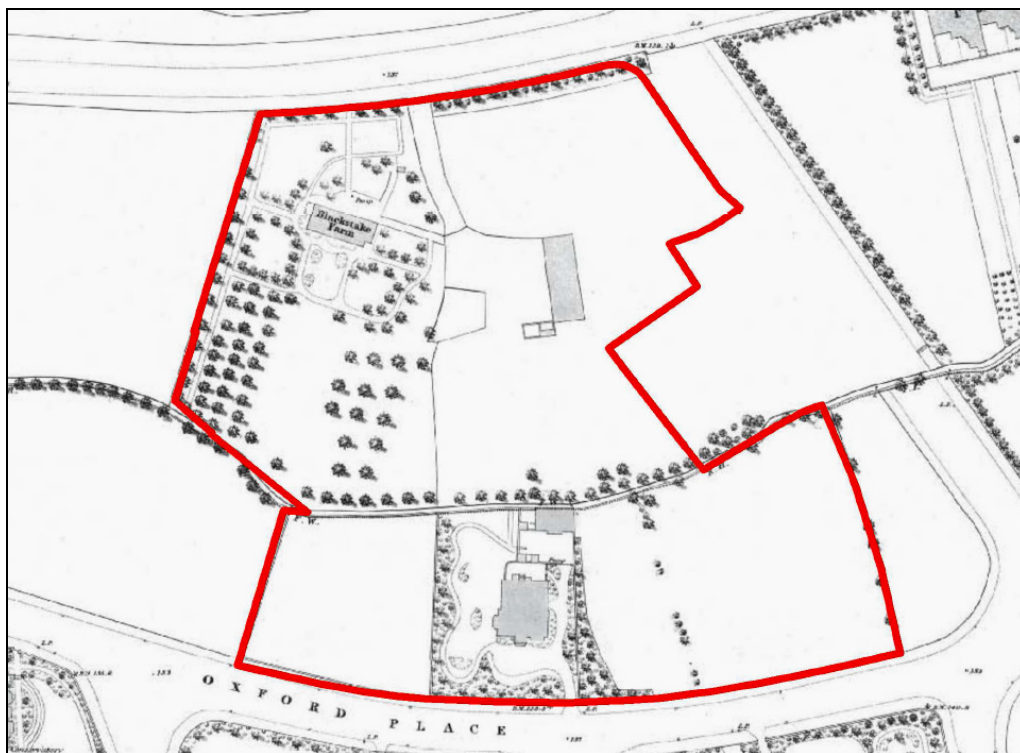
Plate 3: Extract from the Ordnance Survey 1:1,056 map of 1850, showing the boundary of the proposed development area

- 3.2.2 The rapid pace of development during the following decades can be seen on the first edition Ordnance Survey 6": 1 mile map that was surveyed in 1844 (Plate 2). The Ordnance Survey also produced a detailed map of the area at a scale of 1:1,056 in 1850, based on a survey that was completed during the previous year. This map clearly annotates Blackstake Farm, seemingly set in landscaped grounds, with what may have been an orchard to the south-west of the farmhouse (Plate 3). The farm was approached via a drive from High Street (Hathersage Road), which led to a central farmyard. A rectangular building on the eastern side of the central yard probably formed a barn and/or was used for livestock. The southern edge of the farm complex was formed by the historic township boundary ditch.

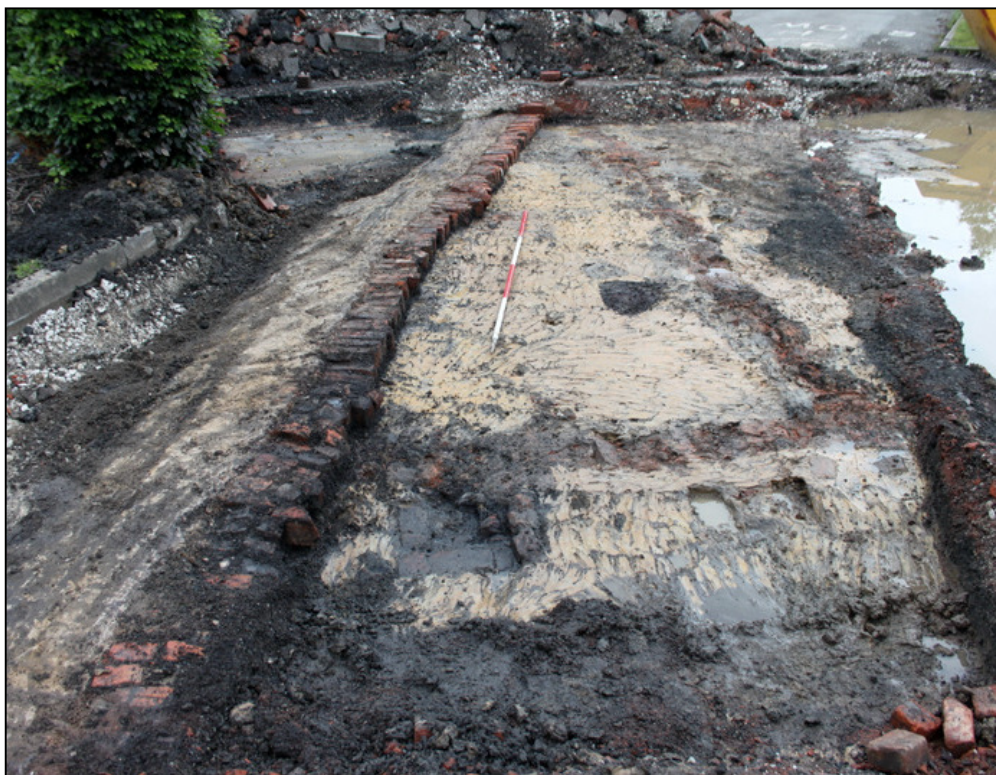
Plate 5: General view of Area A, looking south

4.2.1 This part of the excavation measured 8.7 x 7.5m, and was placed on an approximately east/west alignment, overlapping the earlier evaluation Trench 2. Excavation was halted at the kerb of the edge of the road, due to service cables underlying an extant hedge. The area of proposed excavation to the east was excavated as a separate trench (Area B; Fig 2).

- 4.2.3 The most significant of these features was an L-shaped brick wall, of full-brick thickness (**014**), surviving to a depth of only a single course (Plates 5 and 6). It comprised hand-made, mould thrown brick, the majority being heavily degraded, and representing the foundation of a full-brick thickness wall, with the bricks all apparently pressed into the natural clay (presumably by the weight of the wall above), rather than being placed within a cut trench (Plate 6). The approximately north/south-aligned section of wall (Fig 2) comprised two rows of bricks, forming a stretcher wall face, and measured 5.63m in length, continuing beyond the southern section of the trench. The perpendicular eastward return measured 2.42m to the section of the trench, and comprised a single edge-set brick placed across the wall (Plate 6), presumably forming a foundation plinth, but probably indicating a construction in English bond, which comprised alternating courses of stretchers and headers.

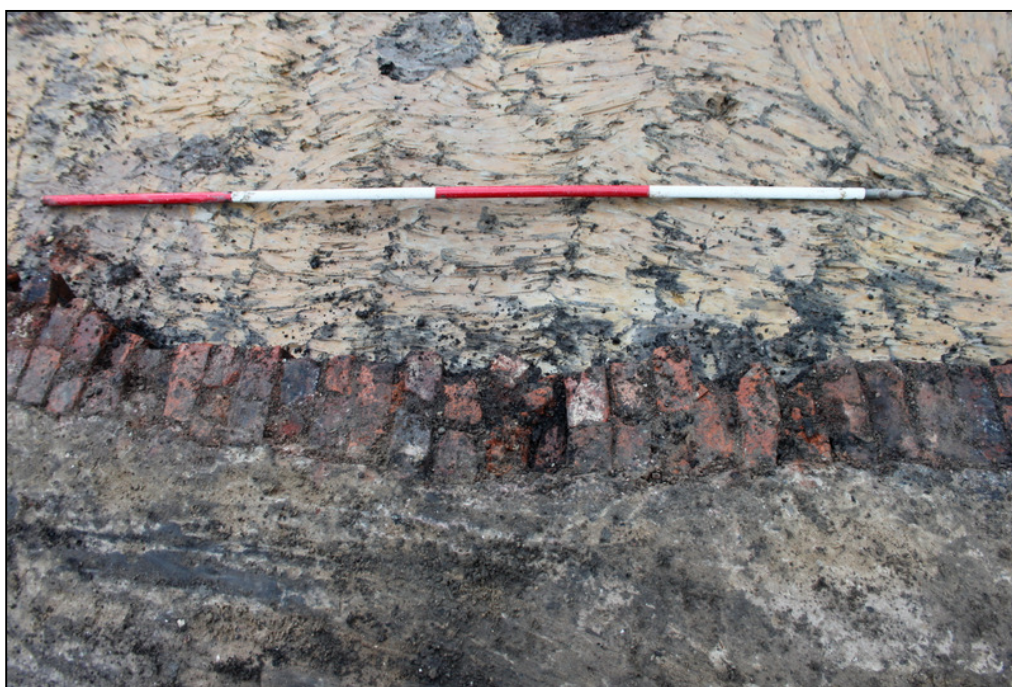
Plate 6: Detail of northern return of wall 014

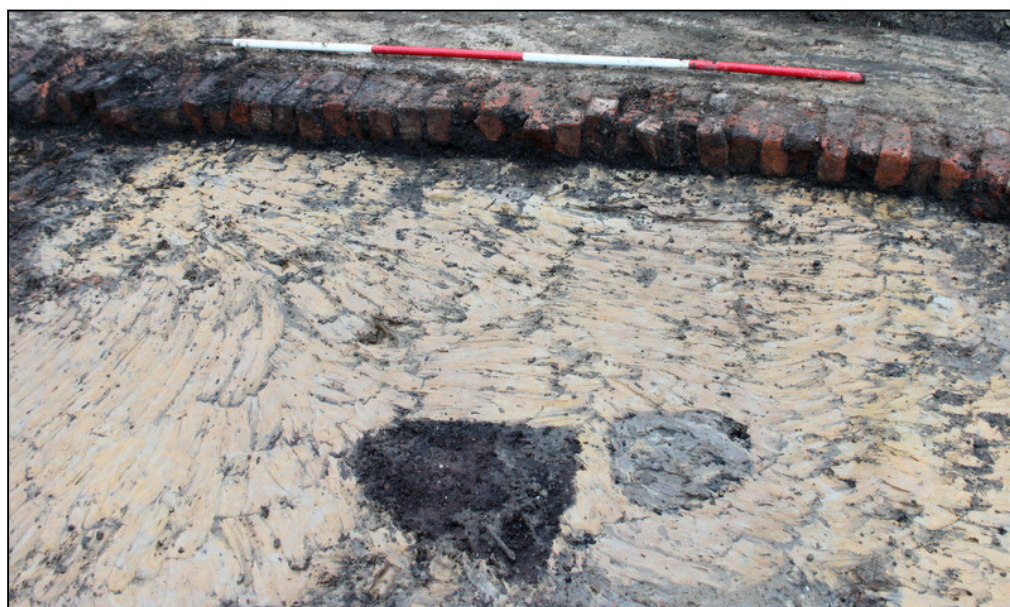
Plate 8: Late, irregular features **017** and **018**, with Wall **013** and concrete beam **012** to rear

- 4.2.5 Two further features were cut into the plastic clay (**09**) within the internal area to the south-east of wall **014** (Fig 2; Plate 8). The northern of these comprised an almost triangular-shaped feature (**016**), measuring 0.40 x 0.50m, and filled with dark black silty clay soil containing fragments of plastic, confirming its modern origin. Immediately to the south, a 0.30m diameter sub-circular feature (**017**) was only 40mm deep, and was filled with a pale-grey clay containing a high percentage of ash (**018**). No dating evidence was recovered from the feature, which was probably cut through the later layers above.

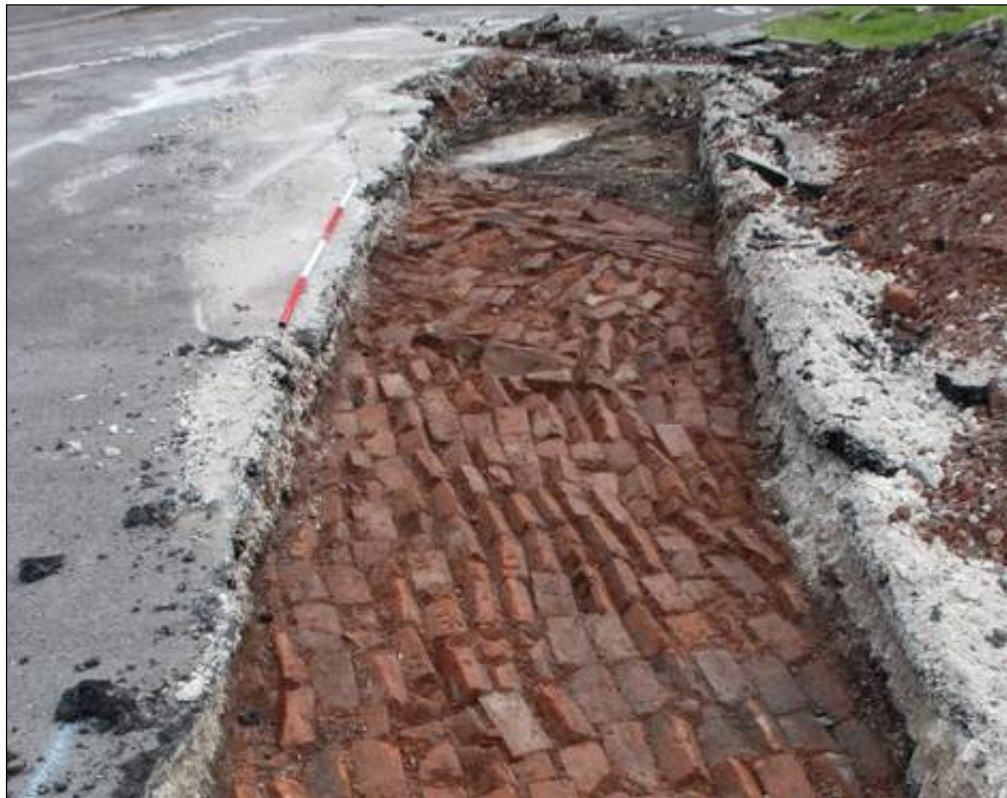
Plate 9: Brick surface 204 with concrete beam 022 in background

- 4.2.8 The row of bricks appeared to have originally survived to two courses in height, the upper course forming part of a rough brick floor (**204**) observed within the earlier evaluation Trench 2 (OA North 2015a; Plate 9), and which continued across Area A to the upper course of Wall **013**. The uneven brick surface (**204**) comprised hand-made bricks, with occasional fragments of sandstone, which appeared to have been laid in north/south-aligned rows. It was overlain by a 0.15m thick layer of mid-brown silty clay (**202**), which was sealed by a 0.7-0.25m deposit of MOT grade limestone chippings (**201**) that formed levelling material for the modern asphalt surface. To the east, the brick surface was cut by the limestone chippings, overlying beam **012**, and also at its south-western extent above concrete beam **022** (Plate 5).

5.2.1 The extensive brick floor observed within evaluation Trench 2 (Plate 9) was demonstrated to post-date the main occupation of the farmhouse, sealing earlier features and possibly relating to a yard associated with the construction or early use of the college erected in 1912.

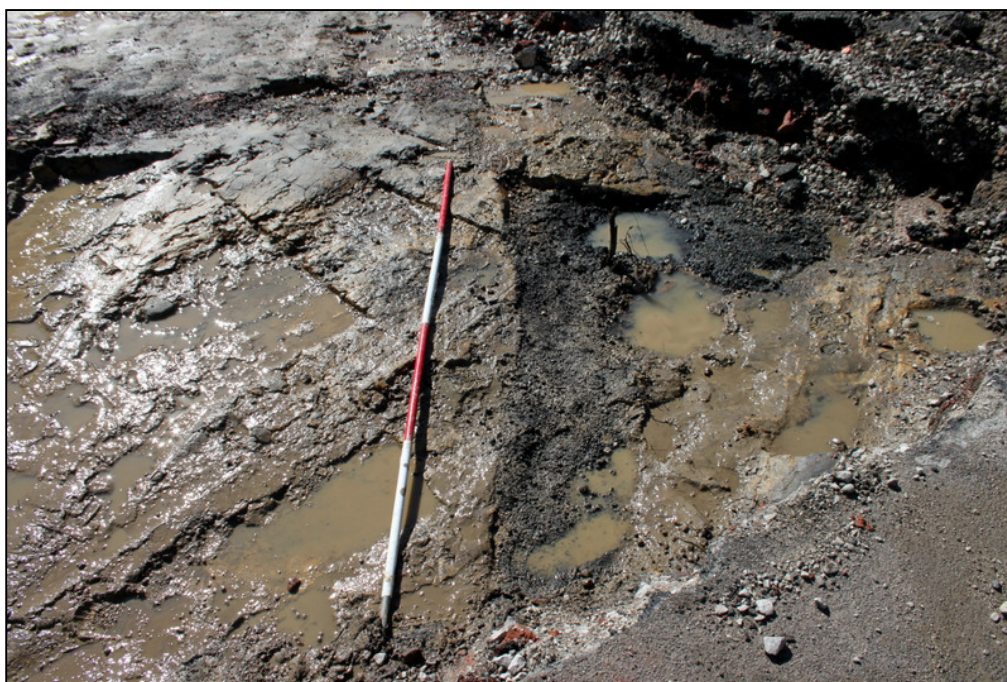
Plate 10: Clinker fill of beam cut 019

- 4.2.6 In the south-western corner of the trench, the natural clay (09) was cut by a steep-sided trench (019) housing a concrete sill beam (022), L-shaped in plan (Fig 2), and observed previously within Trench 2 of the earlier evaluation (OA North 2015a; Plate 9). Below the 0.12m thick concrete beam, the vertically-sided trench was filled with black clinker (Plate 10).

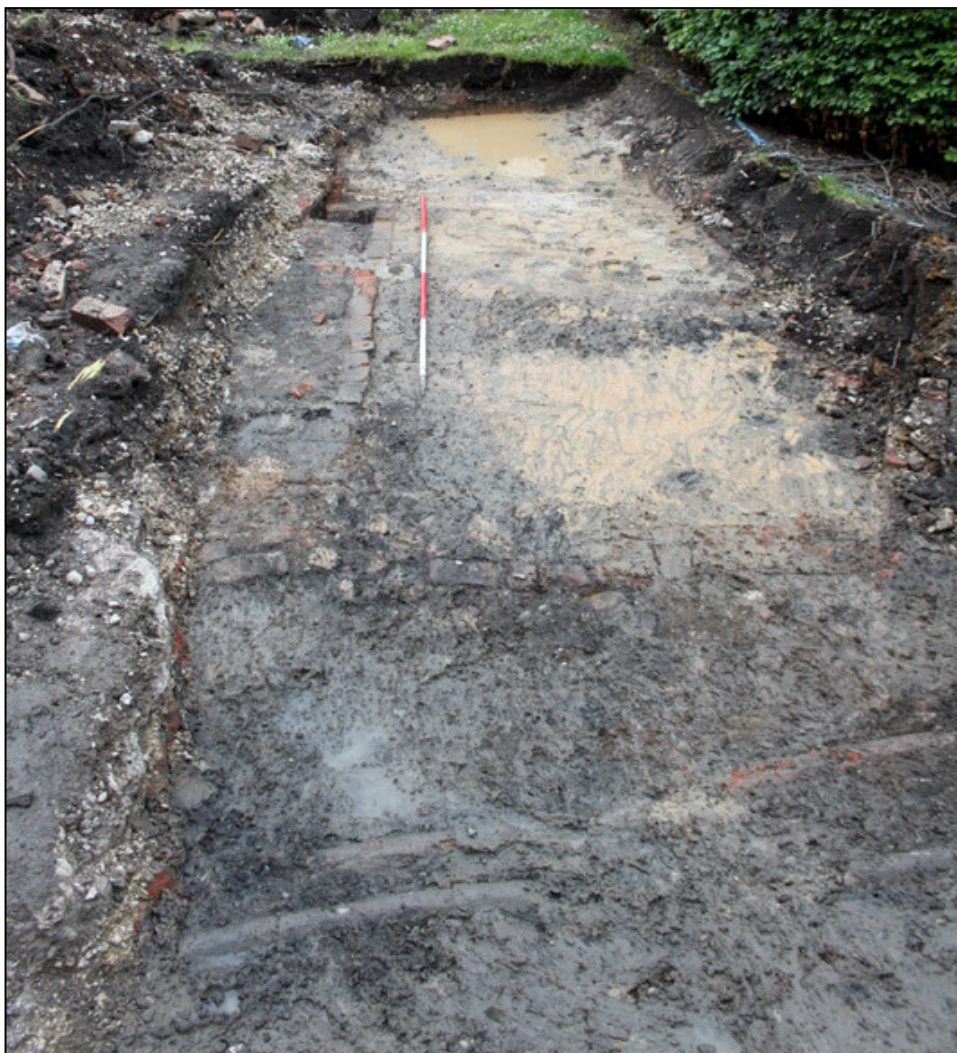
Plate 11: General view of Area B, looking south

- 4.3.1 The eastern of the two excavation areas measured 8.2 x 4.0m, and was placed on an approximately north/south alignment, and at a distance of between 0.5m and 1.5m from the eastern extent of Area A (Fig 2). The proposed position of the trench continued further to the east, incorporating the western part of the earlier evaluation Trench 1 (OA North 2015a), but extant shallow service cables rendered this unfeasible. Unlike Area A, this part of the excavation site was excavated beneath a turfed and landscaped part of the site, to the east of the access road. (Fig 2; Plate 11).

- 4.3.2 Excavation revealed similar natural yellowish plastic clays to those within Area A (**09**), 0.35m below present ground level (Plate 11). This was cut by several features, mainly located in the northern and eastern parts of the trench (Fig 2).

- 4.3.7 To the north of Wall **05**, the natural clays were not observed at the same depth as to the south (Plate 11). Instead, the loamy dark clay subsoil (**01**), which contained brick fragments, continued to a greater depth, and housed two ceramic drains (**02** and **03**), running from east to west, and both comprising 0.30m long cylindrical sections (Plate 11). Although parallel in the eastern part of the trench, where they were sealed by a concrete beam (**04**) which underlay the modern service cable (Fig 2), the southern of the two pipes (**03**) dog-legged slightly to the south, apparently aligning it with vertical drain **015** (Fig 2). The deeper deposit of subsoil backfill to the north of Wall **05**, may represent infilling after the insertion of a deeper drain to the base of Drain **015**, along the northern side of Wall **05/014**.

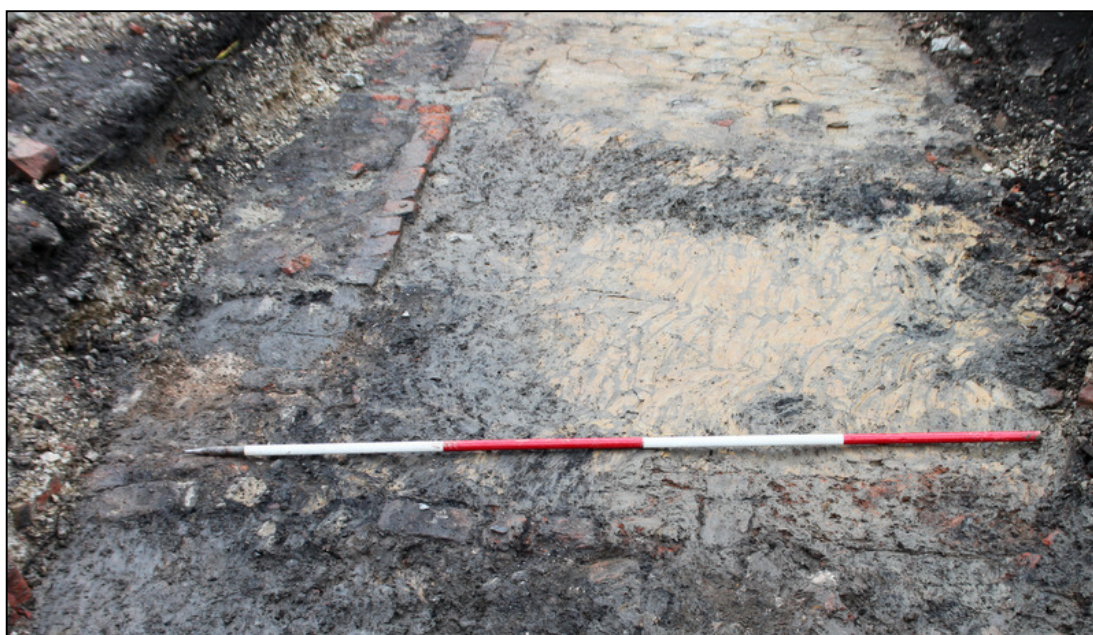
Plate 12: North wall 05 with narrowing to right of junction with single-skin wall 07. A shallow linear depression, 010, is visible in the background

- 4.3.3 An approximately east/west-aligned wall (**05**) was on similar alignment to Wall **014** within Area A, and represented a continuation of the same feature (Fig 2; Plates 11 and 12). It was similarly constructed to a full-brick width, but with a lower basal course surviving, and comprising edge-set hand-made bricks (Plate). Towards the eastern part of the trench, the upper extant course of the wall reduced to only a single-skin thickness for a length of 0.97m (Fig 2; Plate 12).

- 4.3.4 A perpendicular single-skin wall (**07**) to the immediate east of this narrowing of the wall appeared to have been keyed into Wall **05** (Plate 12), and continued southwards for a distance of 3.53m, before returning beneath the eastern section of the trench (Fig 2; Plate 13). This was again of hand-made brick construction, but was cut deeper into the natural clay, surviving to a depth of at least five courses, and forming the partition to a shallow cellar, or more probably a sunken larder (Plate 14). Partial excavation of the feature revealed an unbonded brick floor (**020**), laid parallel to the adjacent wall (**07**), and comprising bed-set and edge set rows of hand-made brick (Fig 2; Plates 14 and 15). These were placed only 0.32m below the extant wall top, and continued to the east, below the service ducting that formed the eastern limit of excavation. At its northern extent, the floor was accessed via a set of three steps (**021**), each apparently 0.61m wide, with a 0.35m tread formed by a single-piece, 0.08m thick sandstone step above two courses of brickwork (Plate). The upper step formed the southern extent of a degraded Welsh slate floor (**06**), which measured 0.5 x 0.36m, and partially overlay Wall **07**, possibly suggesting the position of a doorway adjacent to the larder stair (Fig 2).

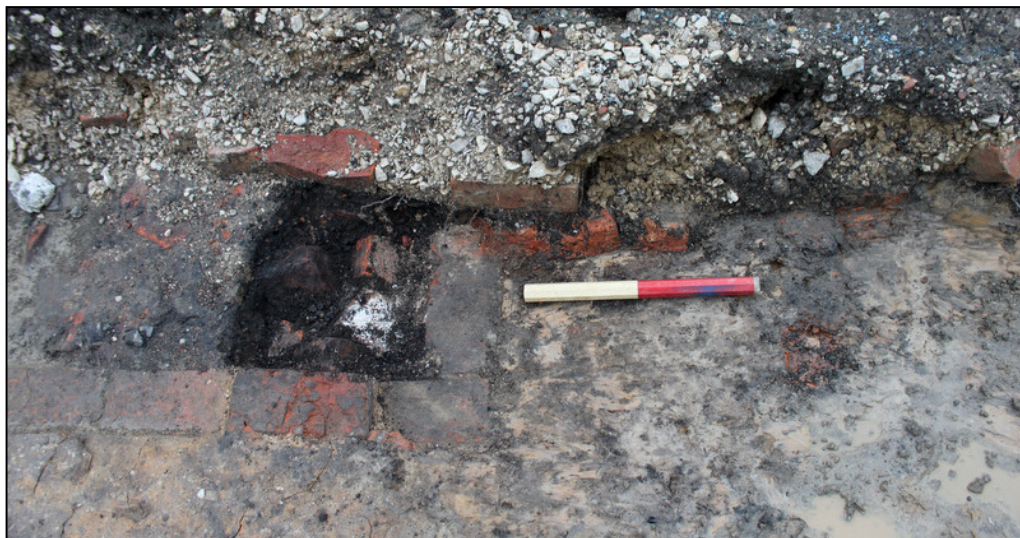
Plate 13: Dog-legged return of single-skin wall 07

- 4.3.5 The larder/cellar was infilled with typical late nineteenth-/early twentieth-century demolition rubble (**08**), comprising almost exclusively crushed lime plaster, brick and timber lath in the lower 0.15m, with darker silty clay containing clinker brick and less plaster above (Plates 13 and 14).

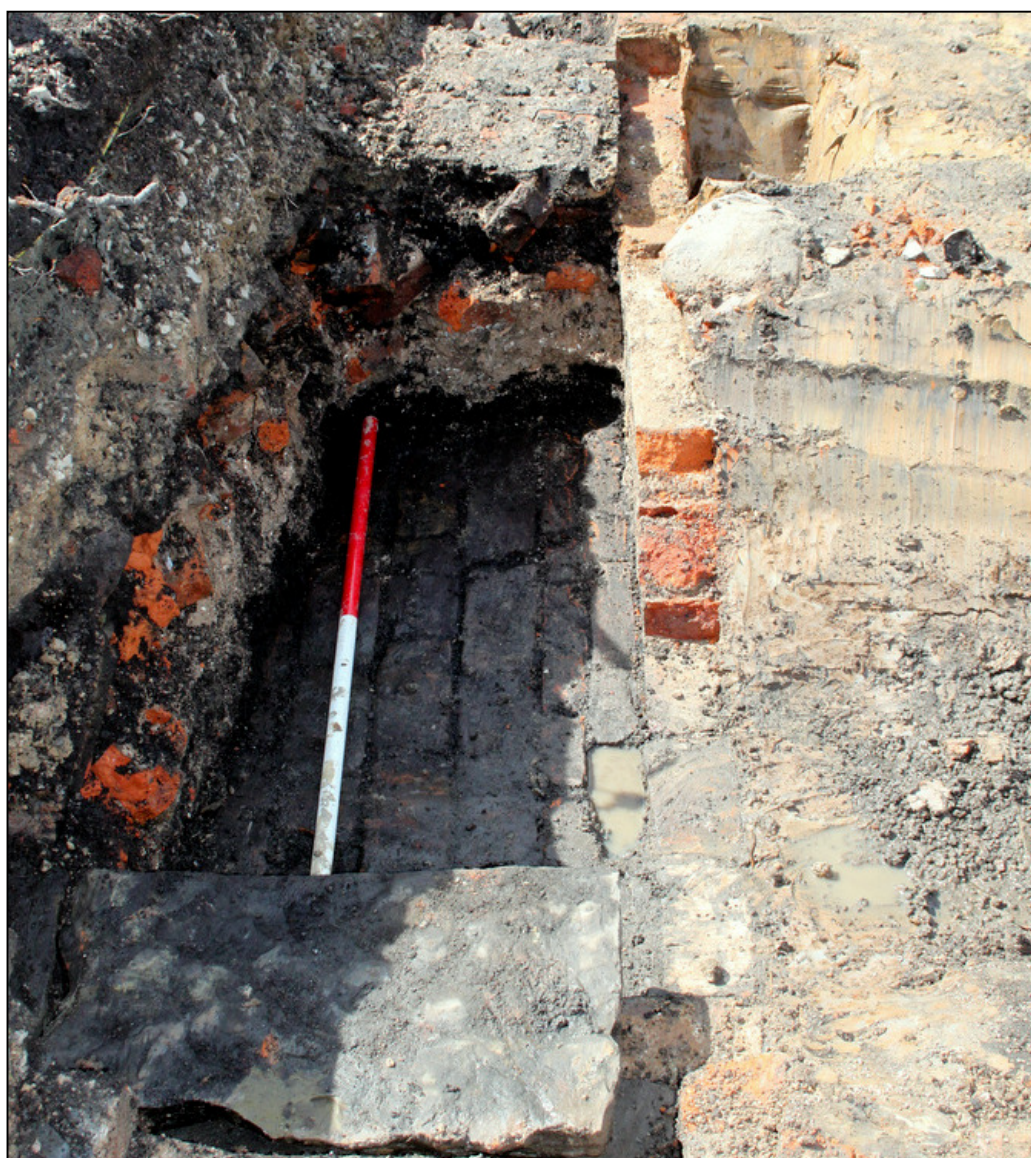
Plate 14: Shallow cellar formed by single-skin wall 07, with brick floor 020

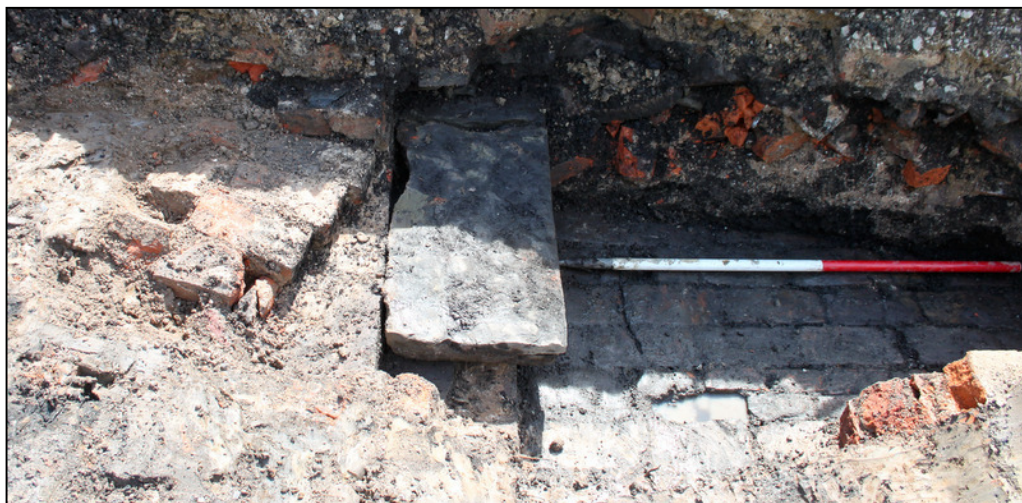
Plate 15: Cellar steps 021 and floor 020

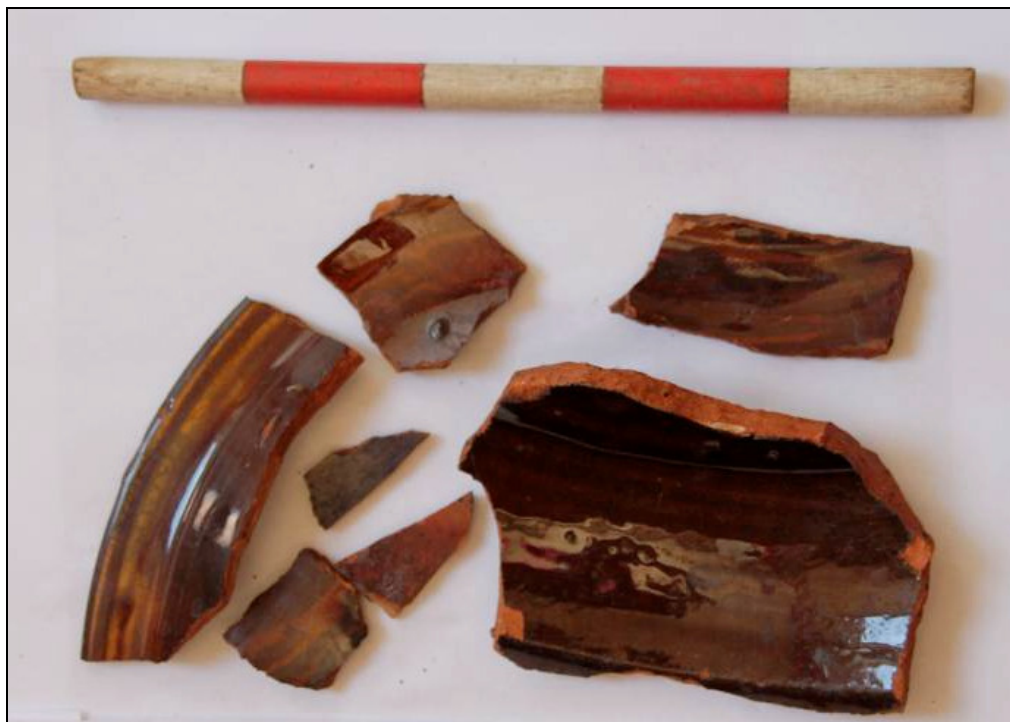
Plate 11: Fragments of mottled ware dishes/bowls

- 4.3.3 *Mottled Ware*: Barker (2008) suggests that manufacture of mottled ware occurred in *c* 1700-70, although Dr Plot, writing in the late seventeenth century, also notes that it was being produced at this time (Plot 1686, 123). The vessel forms that can be identified in the assemblage for the evaluation trenches includes dishes and/or bowls (Plate 11).

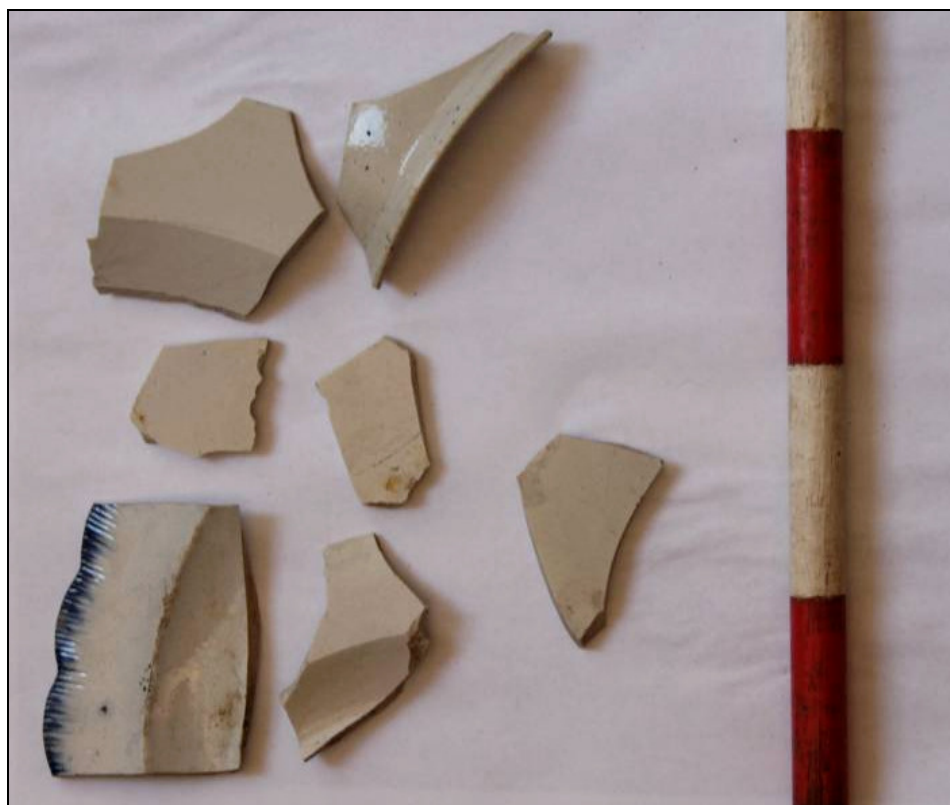
Plate 12: Fragments of pearlware, including a feather-edged plate

- 4.3.4 *Pearlware*: seven fragments of pearlware vessels were present in the assemblage, including at least one sherd of a feather-edge plate (Plate 12). This type of pottery had become the most widely used tablewares by the early nineteenth century, partially because of their cheapness (Barker 2010, 15). These date, in broad terms, to between 1780 and the 1830s (Barker 2008).

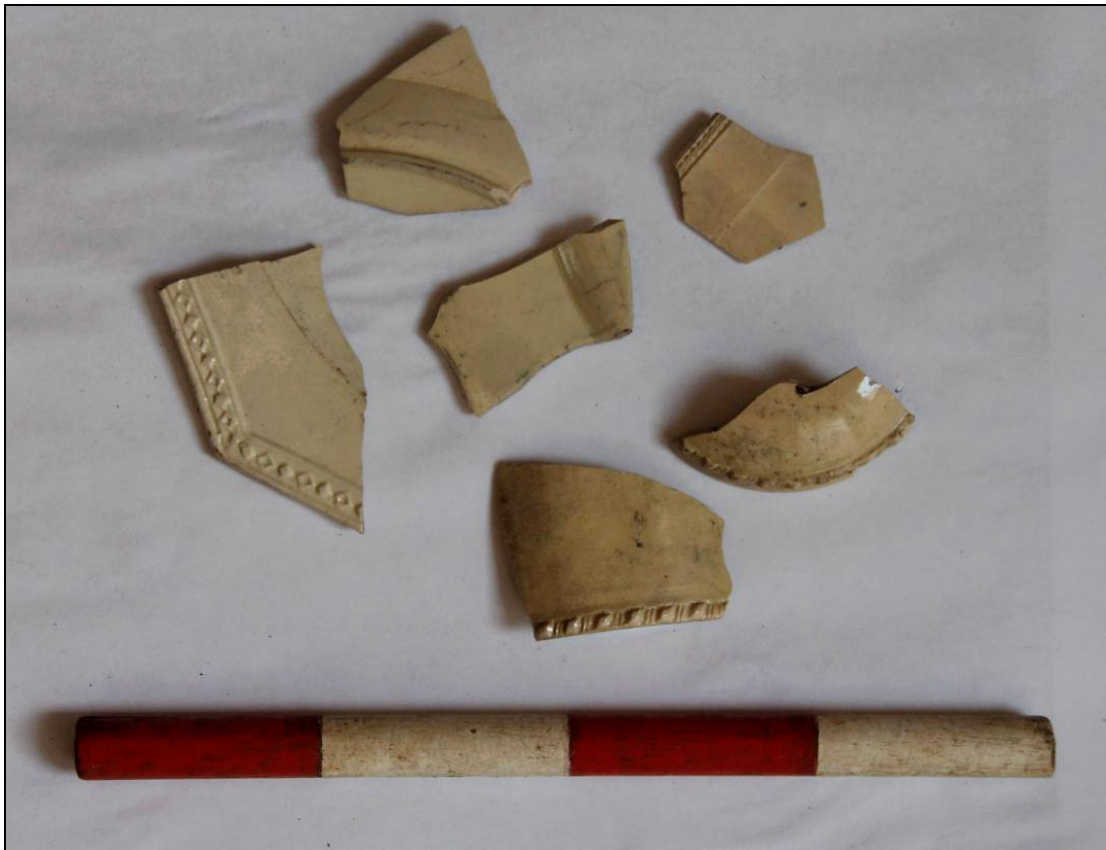
Plate 13: Fragments of white salt-glazed stoneware

- 4.3.6 White salt-glazed stoneware is quite brittle, and it can thus sometimes be difficult to positively identify vessel forms due to fragmentation. However, amongst the six sherds recovered from the evaluation (Plate 13), it seems that at least two fragments derived from cups or mugs, became common in the 1720s and 1740s (Barker 2010, 6).

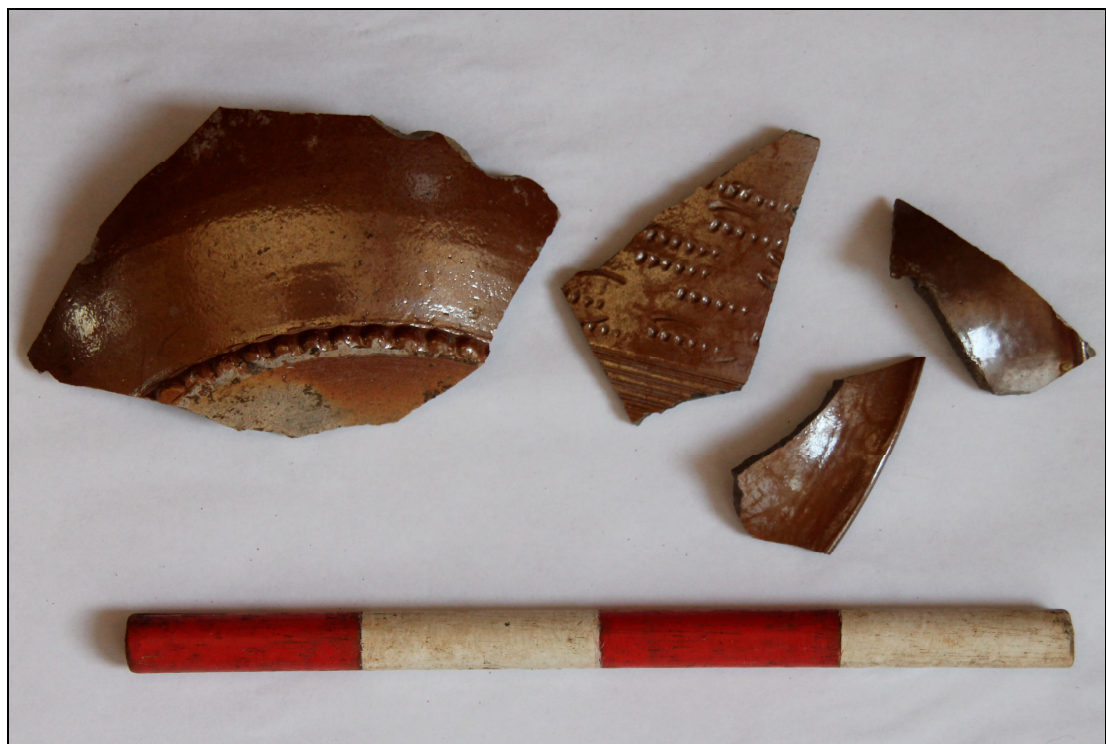
Plate 14: Fragments of brown salt-glazed stoneware

- 4.3.7 *Brown salt-glazed stoneware*: four sherds of this fabric type were recovered from the evaluation (Plate 14). One sherd displayed a rouletted decoration of a type that has been dated to the earlier eighteenth century (Danby and Philpott 1985, 77-84). None of the fragments were large enough, however, to provide a firm indication of their original form.

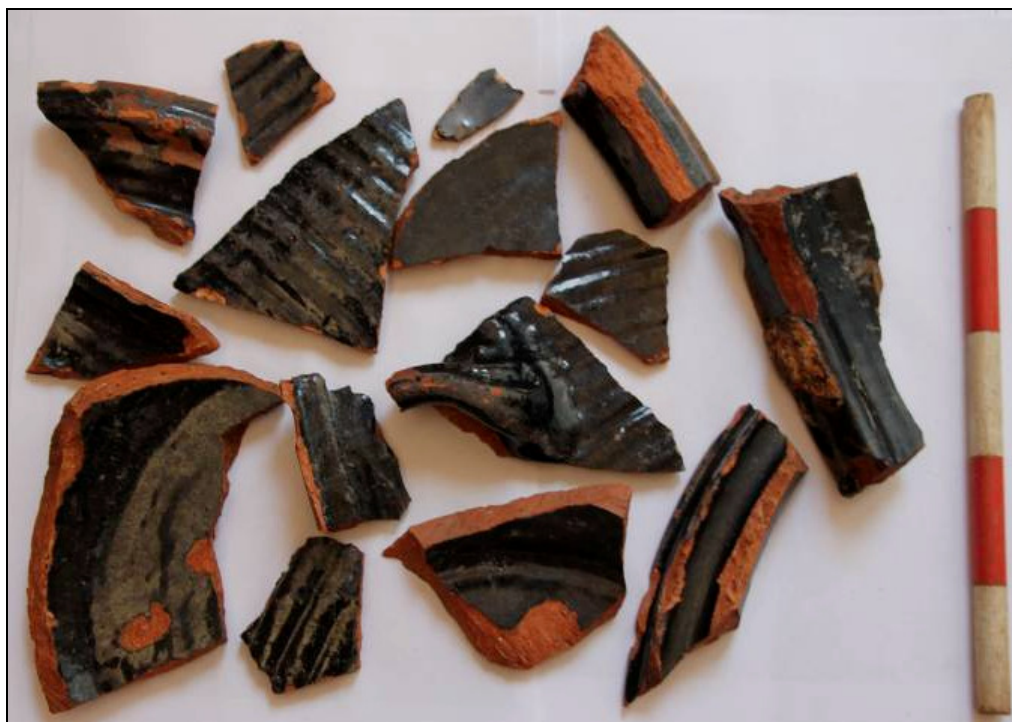
Plate 15: Fragments of dark-glazed earthenware

- 4.3.8 *Dark-glazed red earthenwares*: the largest group from the evaluation trenches consists of dark-glazed red earthenwares (Table 1). This particular ware was ubiquitous in the North West, and largely represents utilitarian kitchen wares. Notable groups of this pottery type have been recovered from Salford, Wigan and Liverpool (OA North 2014; OA North 2008; Philpott 1985). The vessel forms that could be recognised amongst the group from Trench 1 included cylindrical jars (Plate 15), typical used for storage purposes in a kitchen.
