**STOCKBRIDGE
AIRCO WORKS,
BLOSSOM
STREET,
ANCOATS,
MANCHESTER**

**Historic Building
Investigation**

October 2015

Manchester Life Development Company
Planning Application 110077/FO/2015/N1

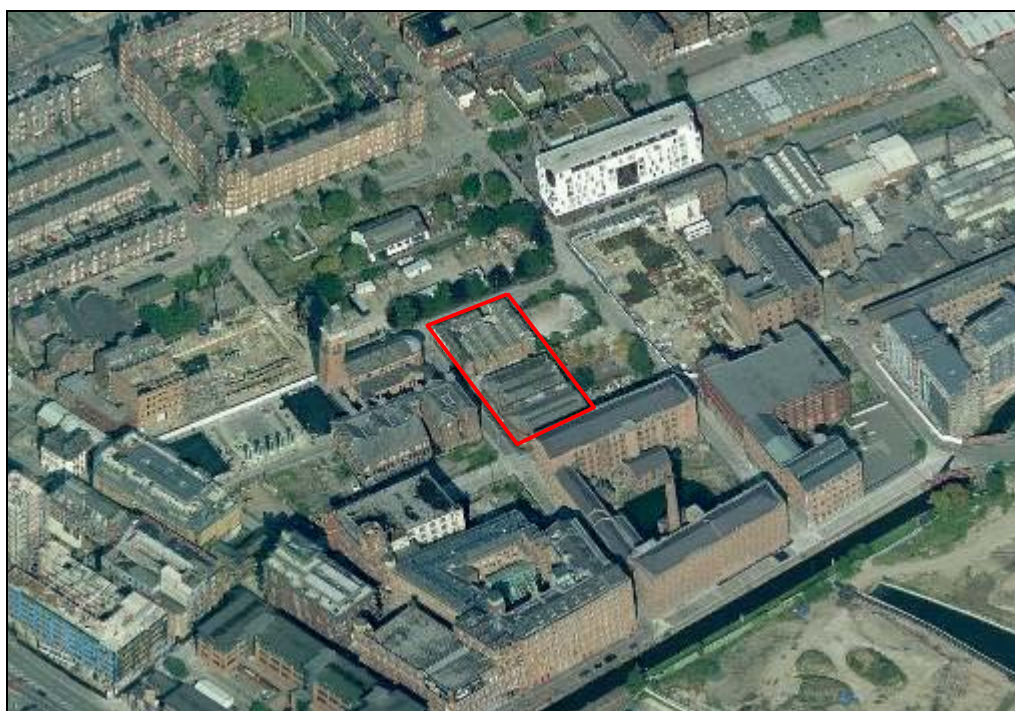
Plate 1: Recent aerial view across Ancoats, marking the location of the Airco Works

- 1.2.1 The study area lies within the Ancoats area of Manchester, which is situated less than 1km to north-east of the city centre (Fig 1), and lies at the western end of the Ancoats Conservation Area (centred at NGR 385010 398708). It comprises a 0.48ha site that is bounded by Jersey Street, Bengal Street, Blossom Street and Murray Street, and straddles the former line of Hood Street (Plate 1).

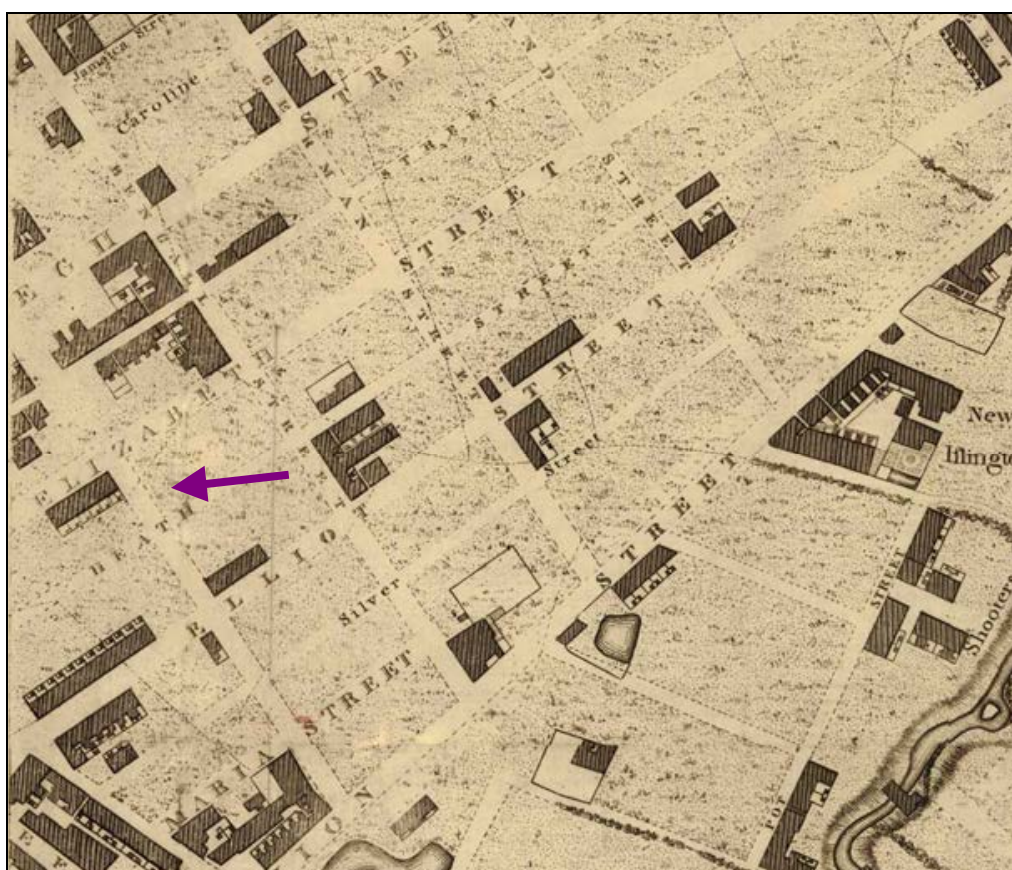
Plate 2: Extract from William Green's survey of 1787-94, marking the position of the Airco Works

- 3.2.1 The earliest reliable cartographic sources to show the study area is William Green's map of 1787-94, which shows the site to be situated within an existing street grid that included Jersey Street (formerly Elliott Street), Blossom Street (formerly Elizabeth Street) Bengal Street and Hood Street (formerly Heath Street). The only buildings in the present study area at that date comprised a rectangular building range along the Elliot Street frontage, with the remainder of the plot being undeveloped. Green's map does not identify the function of the building range in the study area, although it is likely that it represented a terrace of workers' housing.

- 5.2.1 The structures are of relatively late date within the industrial suburb of Ancoats, reducing their historic significance, particularly as they replaced structures relating to ancillary elements of the textile industry, presumably supporting the huge concerns of Messrs Murray and McConnell and Kennedy on the neighbouring Jersey Street, as well as Goodwin's own small cotton mill on the southern side of Hood Street (Plate 2).

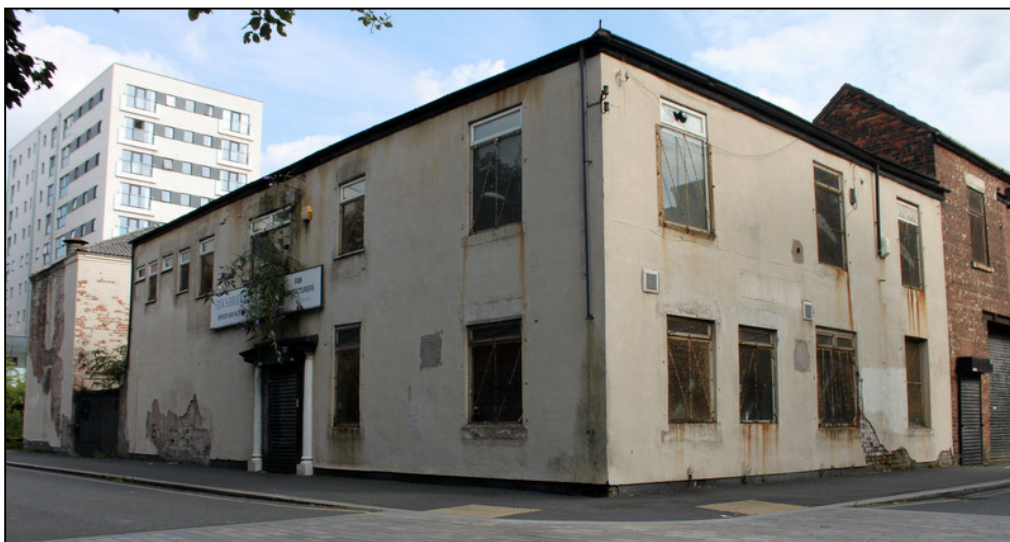
Plate 5: View of Building A, looking south-east, with Blossom Street to the left

4.2.1 This structure was placed in the north-western corner of the site (Fig 4), and comprised a two-storey, L-shaped structure of 4 x 3 bays (Plate 5). The building appears to be of consistent fabric and construction to be that shown on the Ordnance Survey editions of 1888 and 1893 (Fig 3), rather than the domestic structure shown on the corner of the plot on Adshead's map of 1851 (Plate 4).

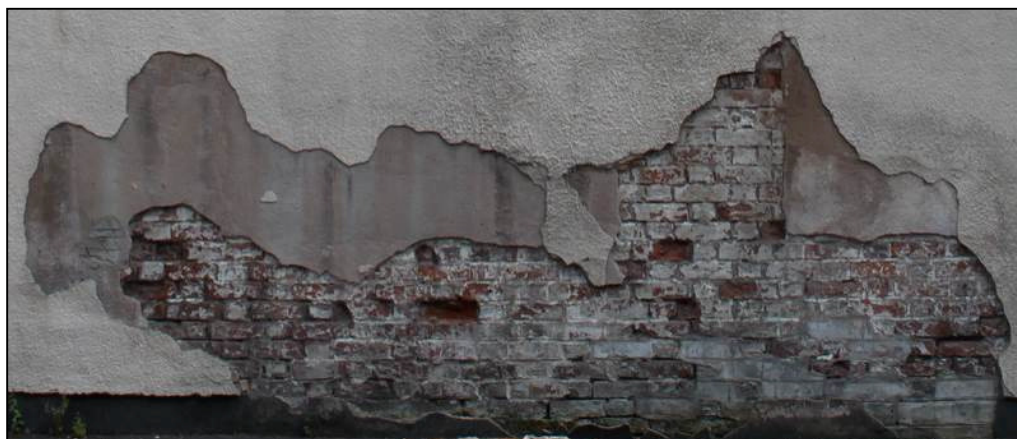
Plate 6: Flemish bond brickwork exposed beneath render in façade of Building A

4.2.2 The building is of red brick construction, and where this is visible below hard white render on the external northern and western elevations, it is of differing bonds, comprising Flemish bond in the north wall (Plate 6), and three-stretcher English Garden Wall bond to the west. The un-rendered rear walls within the enclosed later works, forming the southern and eastern external elevations had been heavily modified, but appeared to comprise five-stretcher English Garden Wall bond construction in its original form (Plate 7). This strongly suggests that the northern elevation formed the principal façade, having the higher-status brickwork fronting Blossom Street. This five bay elevation has a wide decorative doorway in the central bay, offset slightly west of centre, and flanked by Ionic columns (Fig 5), each with a simple torus to plinth and capital, below a simple moulded cornice forming the entablature (Plate 8). The doorway was remodelled subsequently to house a roller-shutter door within a

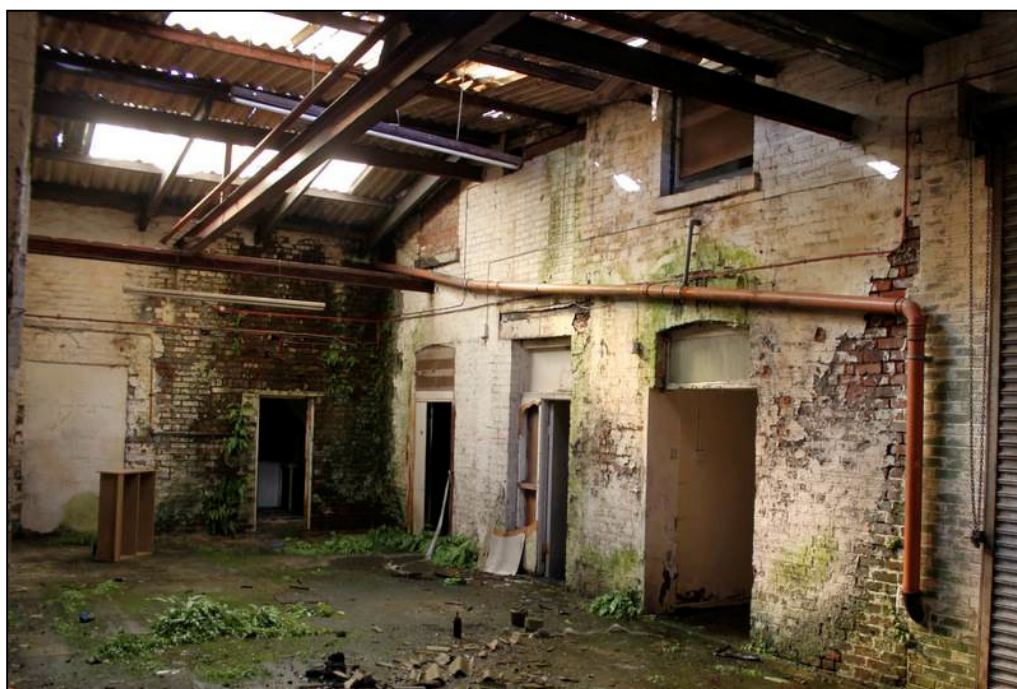
Plate 7: View of rear elevations of Building A, looking north-west

- 4.2.4 The rear, south, wall comprises only three bays, the western two being internal to the L-shaped structure (Fig 4). Each bay has a central doorway (Plate 7), all probably remodelled from windows, given remodelling of the jambs, with the outer two doorways retaining segmentally-arched lintels, latterly used as over-lights for the doorways (Plate 7). At first-floor level, the central window has been brick-blocked, but the two outer apertures retain original projecting sandstone lintels (Plate 7).

- 4.2.5 The rear wall of the west range is slightly narrower than the two southern bays, and retains a 3' doorway in the central bay, with a blocked, wider 4' doorway into the southern bay (Fig 4; Plate 7). There is no evidence for windows at first-floor level (Plate 7).

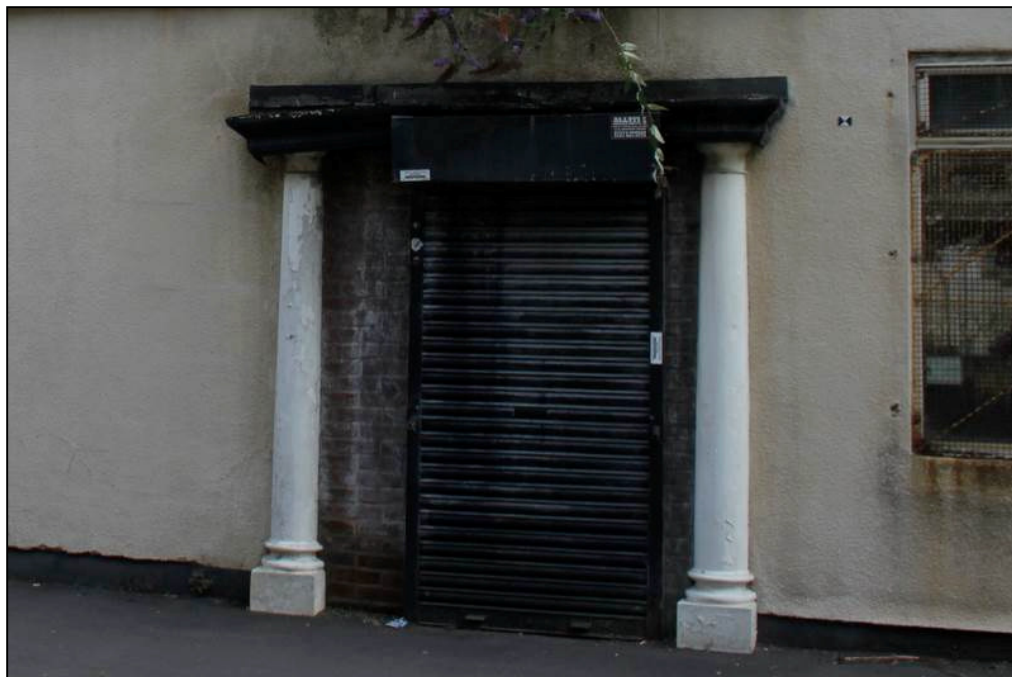
Plate 8: Detail of doorway, Building A

narrowed aperture (Plate 8). The original fenestration of the façade appears to survive only in the western bay, comprising vertical rectangular windows of 4' (1.22m) width, with projecting sandstone sills, and flush lintels, which are obscured, and judging by the rear elevation, of brick. The ground floor window does, however, appear to have been reduced in height, with the insertion of a flat concrete lintel (Fig 5; Plate 5). The first floor aperture appears to resemble original dimensions, although with a replaced three-light window (Plate 5). To the east of the doorway, the ground floor windows are blocked, with cement infill marking the position of the adjacent window, where the render has collapsed (Fig 5; Plate 6), suggesting that each bay had a 4' vertical window within the original construction. At first-floor level, all but the western window have been heavily remodelled, with a horizontal window inserted into the central bay (Plate 5), and five small one and two-light windows inserted into the wall to the east, with no apparent respect for the original window positions (Fig 5; Plate 5).

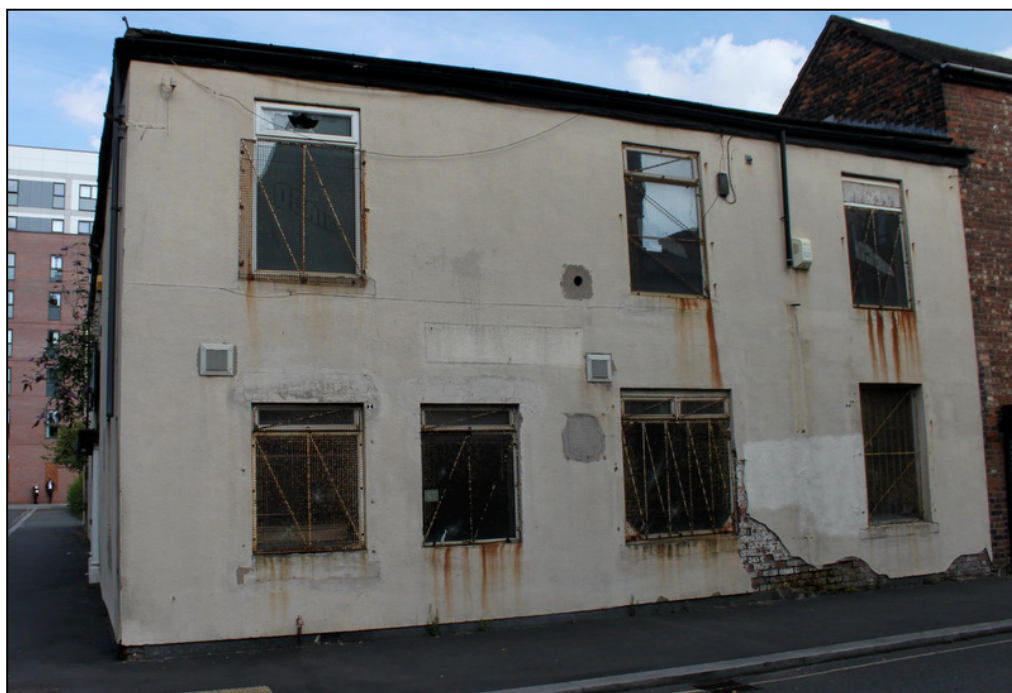
Plate 9: West elevation of Building A

4.2.3 The west elevation has two narrow bays at its southern end, with a wider northern bay (Figs 4 and 6), and again appears remodelled, but probably retaining original window apertures at first-floor level in all but the penultimate northern bay, where it has been blocked (Plate 9). The ground floor windows are unevenly spaced, with two short windows in the northern bay, both possibly representing original apertures, as does the taller southern window (Fig 6; Plate 9). That of the central bay, however, appears to have been remodelled into a wider aperture (Fig 6; Plate 9).

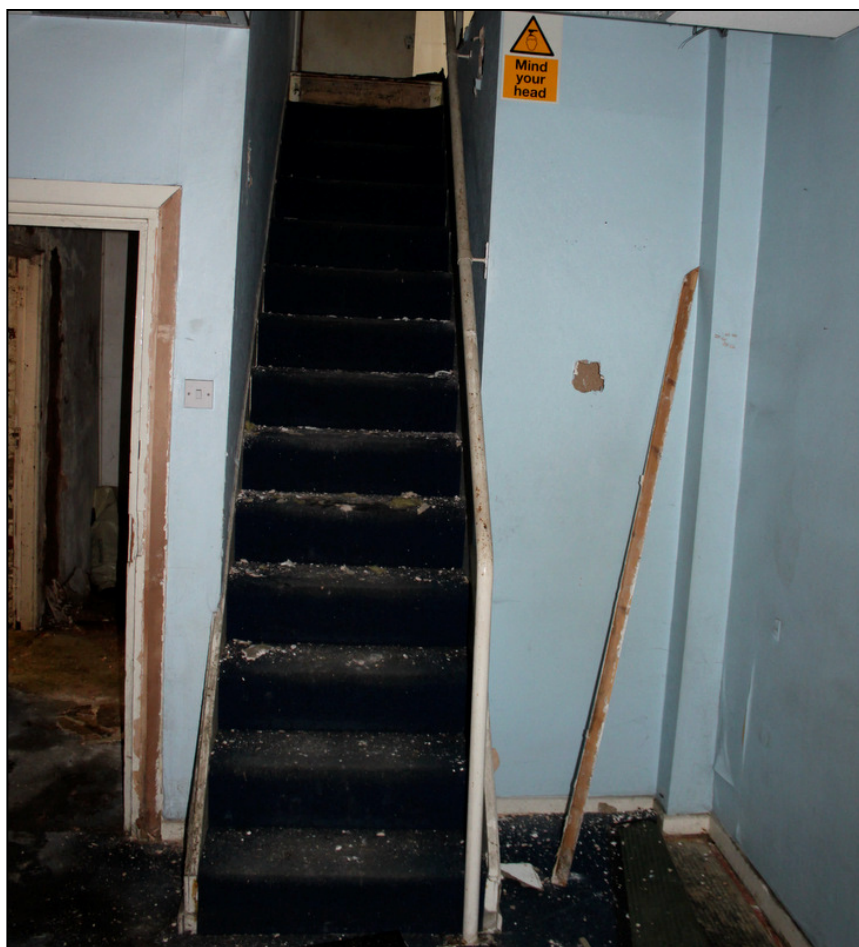
Plate 10: Inserted staircase within Building A, looking south

- 4.2.6 Internally the structure has been very heavily remodelled, although several original internal, full-brick thickness partition walls survive (Fig 4). The northern range is of only a single bay depth, comprising a single room to each bay, with brick walls extant between the eastern two bays, and to the immediate west of the doorway in the north wall (Fig 4). The door presumably originally afforded access to the central bay, but a late clinker-block partition remodelled access through a possibly original internal doorway into the bay to the west (Fig 4). This bay houses a relatively late, and inserted straight stair to the upper floor (Fig 4; Plate 10), with a doorway on its eastern side affording access to the rear rooms of the western range (Fig 4).

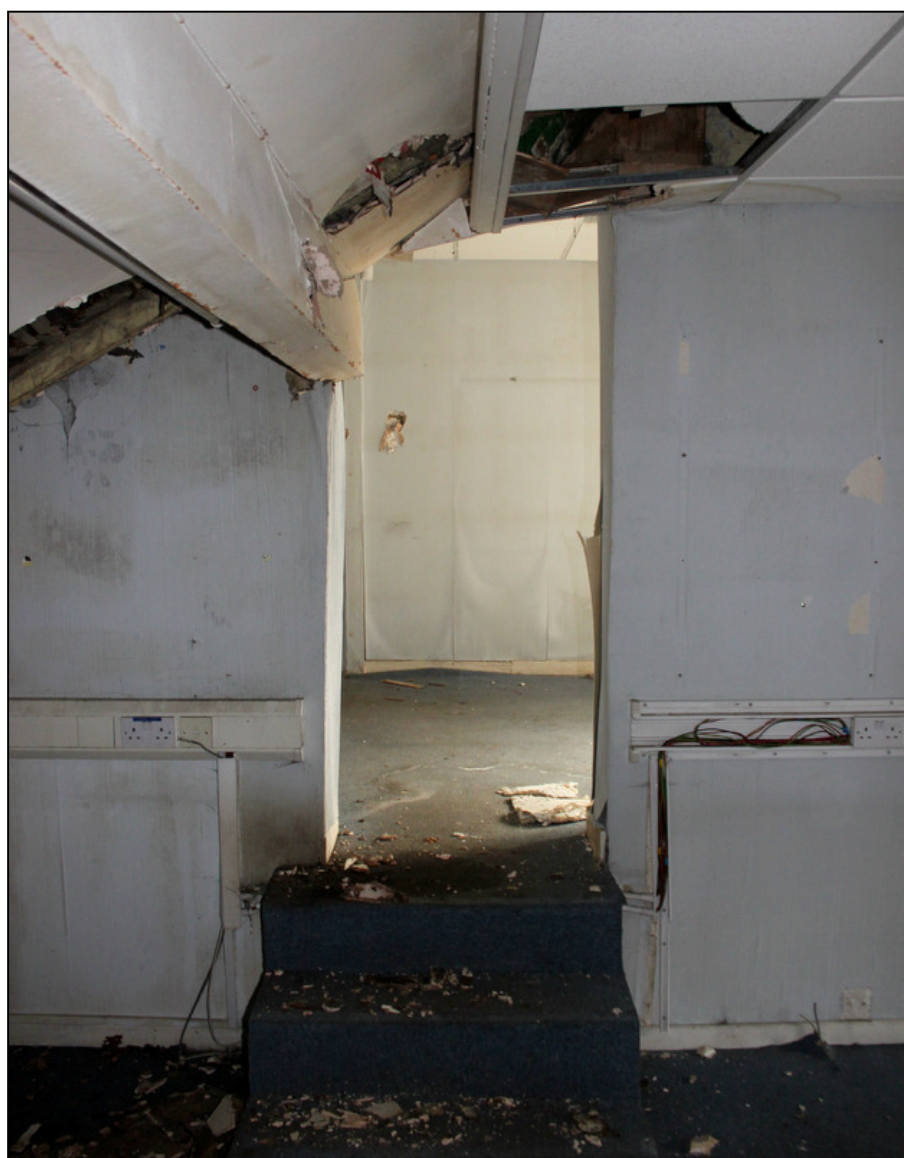
Plate 11: Sloping ceiling of rear first-floor rooms in west range of Building A, and steps up to Building B

- 4.2.8 The plaster ceiling appears to remain intact above a late fibreboard suspended ceiling, obscuring any details of the roof structure of the pitched roof (Plate 11).

- 4.3.17 The western range of Building B had two narrow rooms, placed approximately 0.45m higher than that of the earlier structure to the north (Plate 11). Both rooms were internally rendered, with suspended ceilings but had open doorways in the adjoining walls, and to Building A (Plate 11)

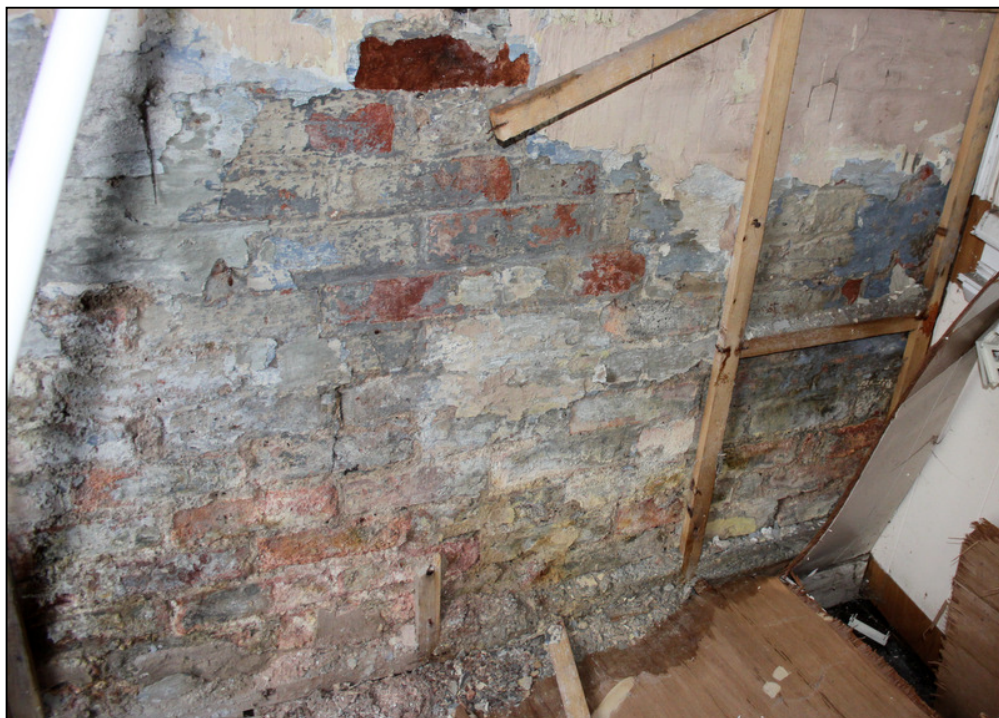
Plate 12: Chimney breast at first-floor level in west range of Building A

4.2.7 At ground-floor level, the western range retained all transverse bay divisions, but with those dividing the front and rear rooms surviving only in the northern two bays (Fig 4). In the southern room this has been removed, and replaced with a stud partition to the west (Fig 4), but the rendered chimney breast for a fireplace survives in the north wall, and would have been positioned centrally within the front room (Fig 4). At first-floor level, all partitions between the front and back rooms has been removed, with a pier marking its position only visible in the southern room. The rear rooms of the western range, where it extended beyond the north range have a sloping ceiling (Plate 11), demonstrating that the rear wall was lower than the front wall, suggesting that light was originally provided by skylights in the eastern pitch, explaining the lack of fenestration within the upper wall. The southern room retains a chimney breast within what would have been the front room, although removal of the wall panelling revealed no evidence for a fireplace within the face (Plate 12), suggesting that it served only a ground-floor fireplace.

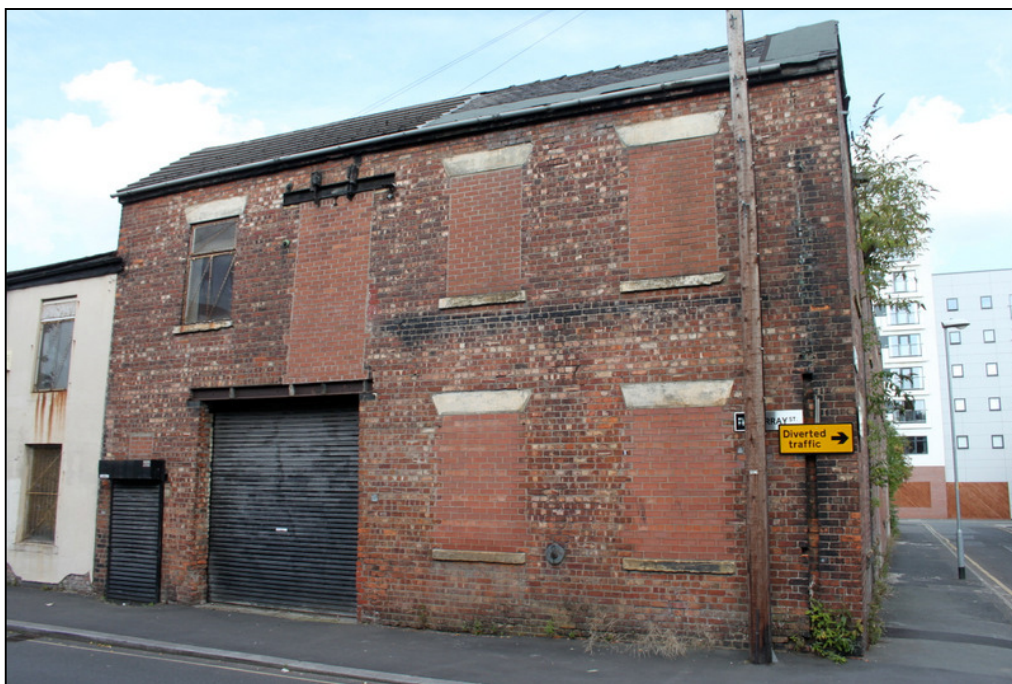
Plate 13: Western elevation of Building B, fronting Murray Street

- 4.3.2 Its principal façade was that fronting Murray Street (Fig 6), and is of salt-glazed red brick, erected in three-stretcher English Garden Wall bond (Plate 13), which is continuous around the Hood Street frontage (Plate 14). At ground-floor level, it has a pedestrian doorway at its northern end (Figs 4 and 6; Plate 13). This has been remodelled to house a roller-shutter door, and appears to have had a small over-light above the doorway that was brick-blocked (Plate 13). A large loading door immediately to the south has a rolled steel I-section lintel, and appears inserted, with its slender sandstone pads for the beam being set within ragged cut brickwork (Fig 6; Plate 13).

- 4.3.3 A blocked loading doorway above retains an external beam and some of the hoist gear (Fig 6; Plate 13), but probably also represents a contemporary inserted feature, with evidence for an infilled window lintel above. Elsewhere, the elevation retains its original apertures, comprising 4.6m (1.37m) wide windows with projecting sandstone sills and flush, splayed flat sandstone lintels (Plate 13). These were arranged in pairs to each bay, with all but the upper northern example having been brick-blocked. The extant window has a three-light steel frame (Plate 13), and represents a replacement, probably of early/mid-twentieth-century date.

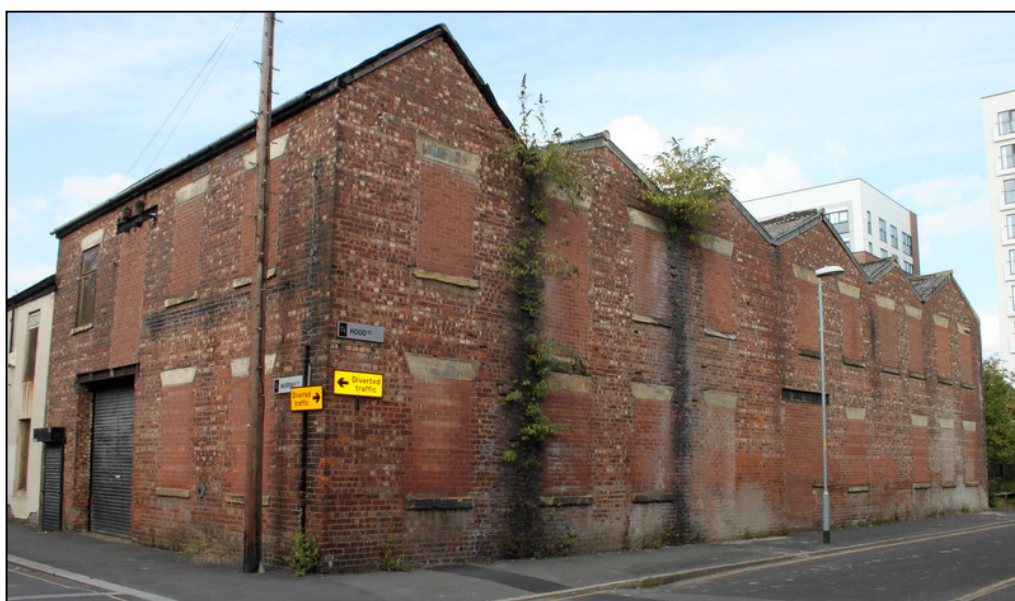
Plate 14: Hood Street Elevation of Building B

- 4.3.4 The south elevation appears to represent a single continuous build from the Murray Street frontage, but comprises bays of differing width and height, each with a gabled roof (Fig 7; Plate 14), possibly suggesting a re-facing of the wall. The western bay is a narrow tall bay, of approximately 13' width and 28'6" height, and houses a single, centrally-placed window on each floor, similar in style to those of the western façade (Plate 14), and also being brick blocked.

- 4.3.5 Elsewhere, the windows were arranged in pairs to each bay, with the exception of the third bay (from the west), where a single window to each floor was offset slightly to the west of centre (Fig 7; Plate 16), and the penultimate eastern bay, where the lower west window was absent (Fig 7; Plate 16). That in the western part of the fourth bay had also been remodelled to form a doorway, prior to being brick blocked (Fig 7; Plate 14). The second and third bays were approximately 14' wide, and a lower 25'6" high, with the fourth and eastern bay being approximately 19'6" wide and 27'3" high (Fig 7; Plates 14 and 16).

- 4.3.6 The penultimate eastern bay was of similar width to the west bay, but of lower height, more similar to the second and third bays (Fig 7; Plate 14). Although the bay spacing appears somewhat random, it is consistent with the partitions depicted on the Ordnance Survey editions of 1888 and 1893, with walls shown at either side and centrally within the position of the wide fourth bay (Fig 3).

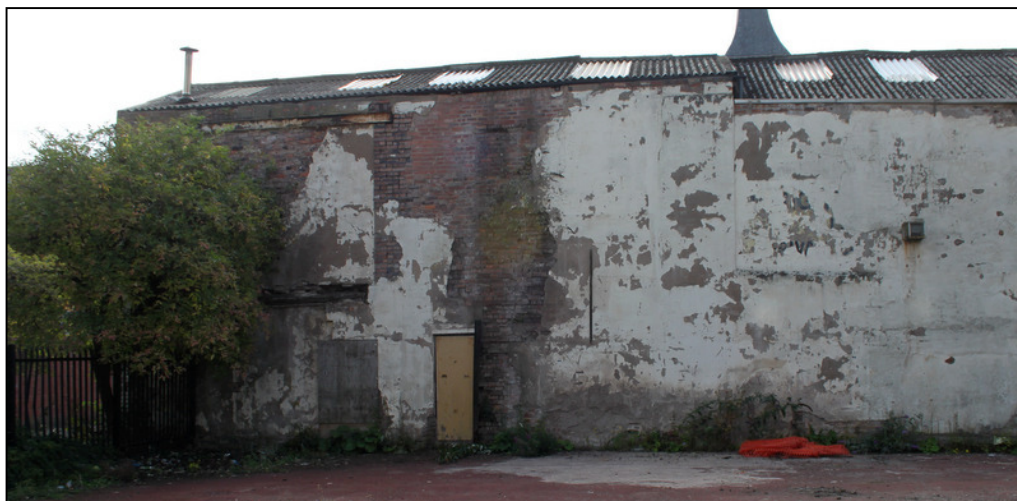
Plate 15: East elevation of Building B, with Building C on right

- 4.3.7 The east external elevation is heavily remodelled, and appears to represent at two phases of construction, with a change in wall height at its approximate mid-point (Plate 15). The taller southern part represents the original east return of Building B, and is external covered with hard cement render, which covers a probable buttress of approximately 3' (0.91m) width. It also has a large blocked opening to each floor, that on the upper floor retaining an I-section steel lintel above a degraded large-scantling timber sill that formed the lintel of the aperture below, which latterly incorporated a pedestrian doorway at its northern side (Fig 4; Plate 15). A further narrow doorway at ground floor level was placed only 4' (1.22m) to the north (Fig 4), and appeared inserted.

- 4.3.8 An area of exposed brickwork within the wall face revealed infilling on the northern side of the upper aperture, undertaken using a black sooty mortar, typical of the very late-nineteenth and early-twentieth centuries, and with more recent rebuilding of the upper eight courses of the wall to the north. The wall below appears to have been erected in an irregular bond of varying courses of headers and stretchers (Plate 15).

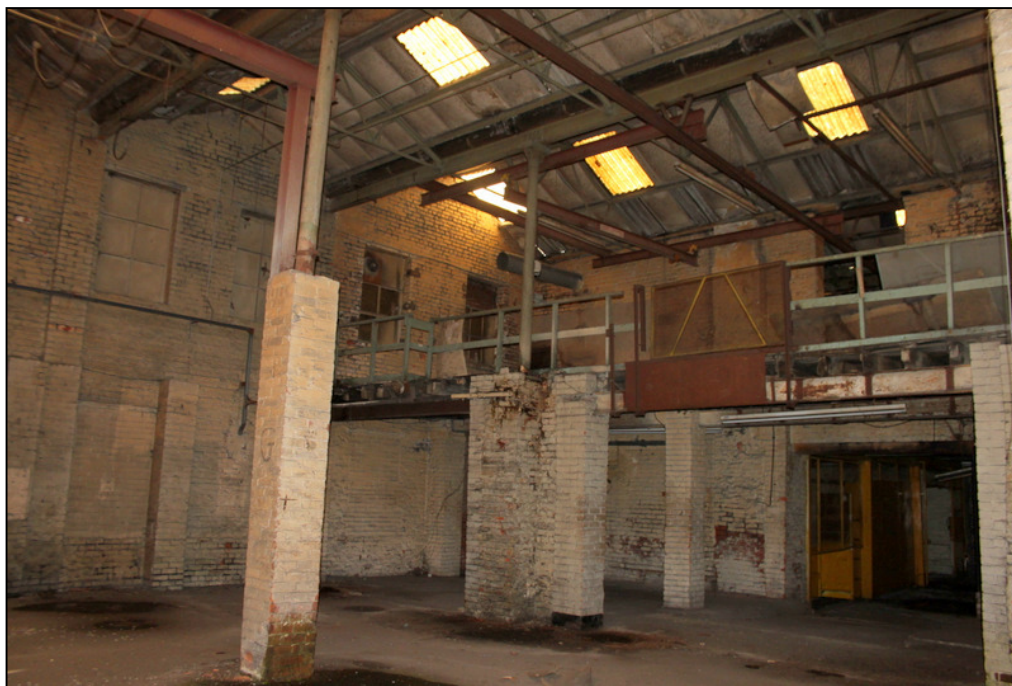
Plate 17: Internal view of Building B, from east bay, looking south-west

- 4.3.9 Internally, the structure is in a poor state of repair, having suffered both fire damage, and that caused by the continual ingress of water. It has also been remodelled into two main rooms, although several wall stubs of earlier walls do survive (Fig 4; Plate 17). The western four bays retained an upper floor, the eastern of which latterly formed a mezzanine above the open shed to the east (Plate 17), and with no safe access possible to either room at this level, due to the unsafe nature of the floor. cursory inspection was however possible from the upper floor within Building A.

4.3.12 The south wall of Building B has brick piers at each bay division (Plate 17), carrying the ends of the ceiling beams. Each bay also retains the window frames of the upper floor internally, each comprising a six-light fixed timber frame, below an internal timber lintel (Plate 20), and nine-light frames with night-vents in the western three bays, and also at first-floor level in the west wall (Plate 21).

- 4.3.14 Further wall stubs represent the original east wall of the fourth bay (Plate 17), and a small partitioned 7'2" (2.13m) structure in the north-eastern corner of the fourth bay, shown on the Ordnance Survey edition of 1893 (Fig 3).
- 4.3.15 The upper floor of wide timber boards is carried on large scantling timber beams, aligned north/south across the western three bays (Plate 24). In the southern range of the structure, columns placed on ground-level brick walls survive in all but the eastern bay, where it has been moved onto a later pier to the north (Fig 4; Plate 17), comprising hollow cylindrical cast-iron columns with ribbed capitals to cruciform-section headplates (Plate 21).

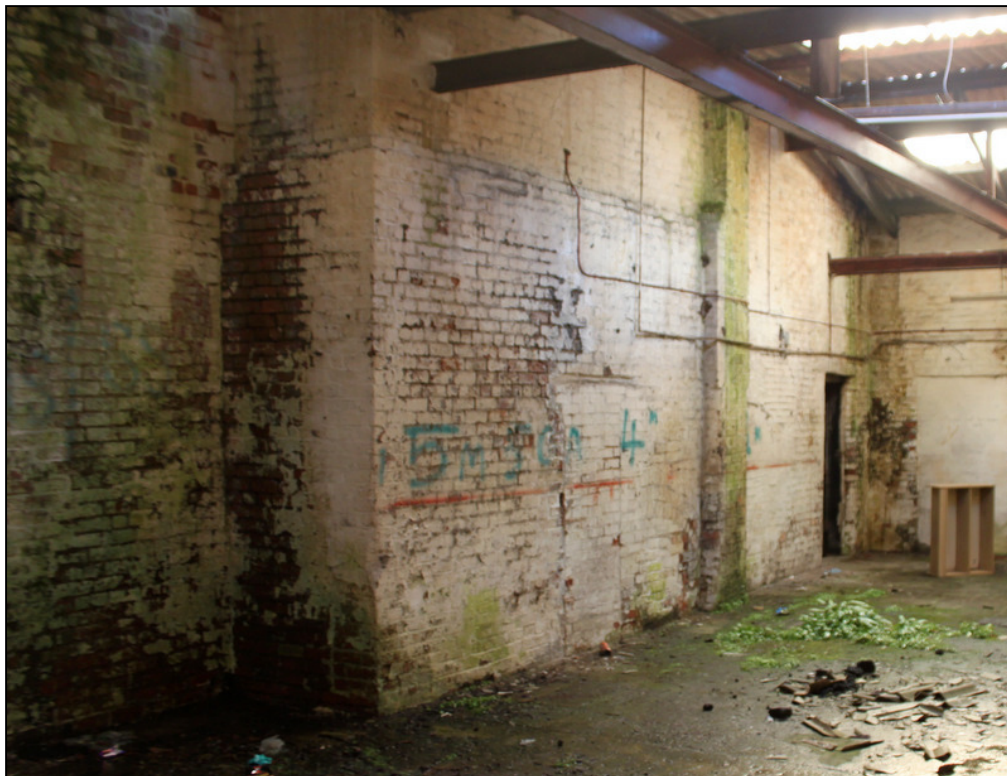
Plate 18: North external wall of Building B, looking south-west

- 4.3.11 Beyond the south wall of Building A, the north wall of Building B projects 4' (1.22m) to the north (Fig 4), demonstrating it to be a later structure, enclosing the southern end of the earlier building. A 4' (1.22m) wide doorway to the east may represent an original aperture (Fig 4; Plate 18), with a similar blocked doorway placed in the adjacent bay (Fig 4), although this appears to have been inserted through an earlier low aperture with three-rowlock round-headed arch (Plate 19). This also has a projecting buttress on its northern face, with moulded brick transitioning from the bull-nosed brick of the ground floor, at approximate door lintel height to the standard brick above (Plate 19). The north wall has a southward return at the eastern edge of the fourth bay (Fig 4; Plate 18), as shown on the Ordnance Survey mapping of 1888 and 1893 (Fig 2). A 4' northward return of the wall in the eastern bay has been partially rebuilt, forming part of the rebuilt structure to the north (Building C), and demonstrating that the new building was erected within the same footprint as the earlier structure.

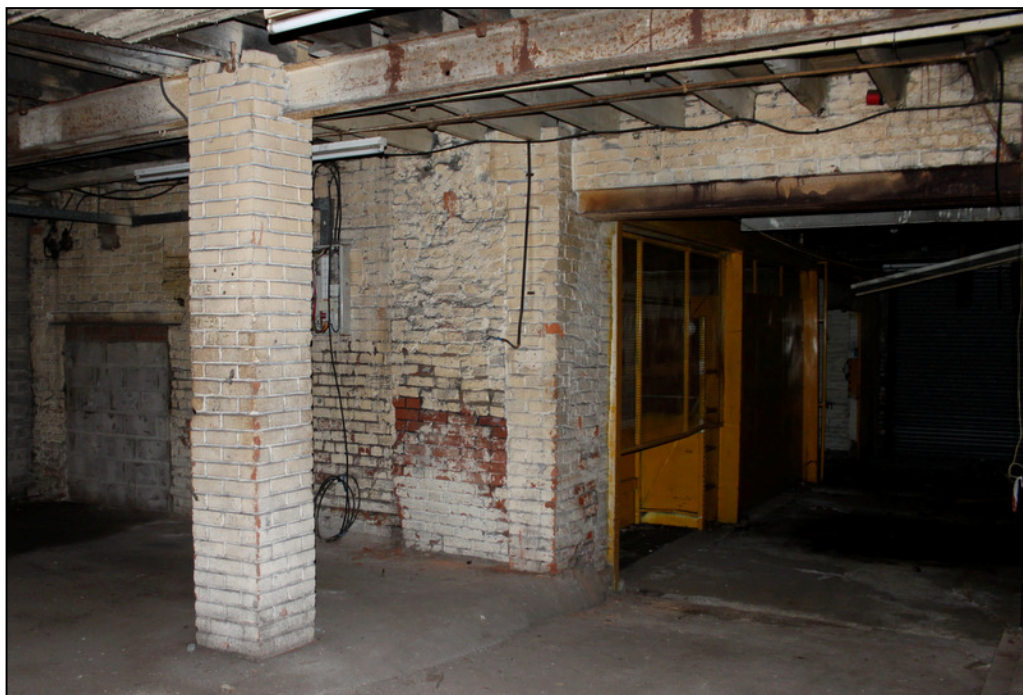
Plate 22: View across Bay 4, with steel cage across Bays 1-3 to rear

4.3.13 Additional brick piers butting the wall appear to relate to relatively late supports for the first floor in the eastern two bays, this having been removed subsequently (Plate 17). Several internal brick partitions survive within the wider fourth bay, the most intact of which forms a partition to the western bays, surviving to first-floor ceiling height (Plate 17). A wide loading doorway has been inserted in the north bay of the western part of the building, with a concrete ramp cut into, and traversing Bay 4 to the higher structure to the east (Plate 22). The 18" (0.45m) thick wall has an inserted doorway in the southern part, blocked subsequently with clinker block (Plate 23), and a ragged brick pier projecting on both faces of the wall at ground and first-floor levels, possibly representing a flue (Plates 22 and 23). An 18" (0.45m) square bearing box above the inserted doorway (Plate 23) represents the only evidence for power transmission within the structure, although such boxes were often re-used as ducting apertures within later structures, and may therefore not be indicative of original line shafting power.

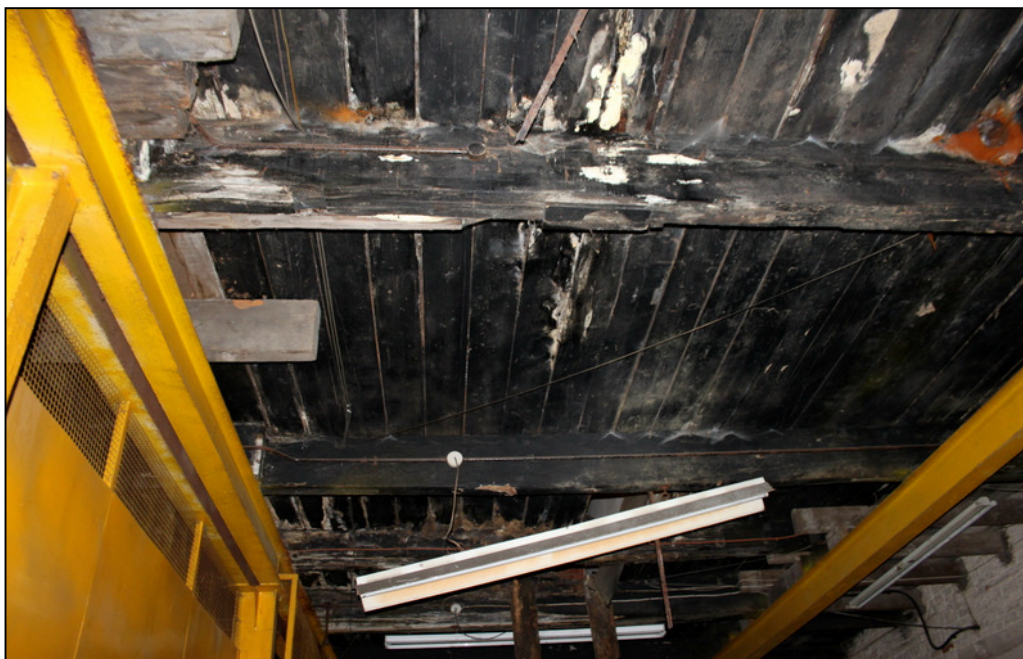
Plate 24: Extant ceiling detail in western bays of Building B

- 4.3.16 The columns carry I-section rolled steel beams, supporting L-section steel lattice trusses in all but the northern bay, where an original timber roof is concealed above a lath and plaster ceiling (Plate 21). The junction between ceiling beam and column appears somewhat unnatural, with the simple clasping headplates seen in many contemporary weaving sheds of I-beam roof construction offering a simpler and stronger joint, suggesting that the eastern five bays were re-roofed.

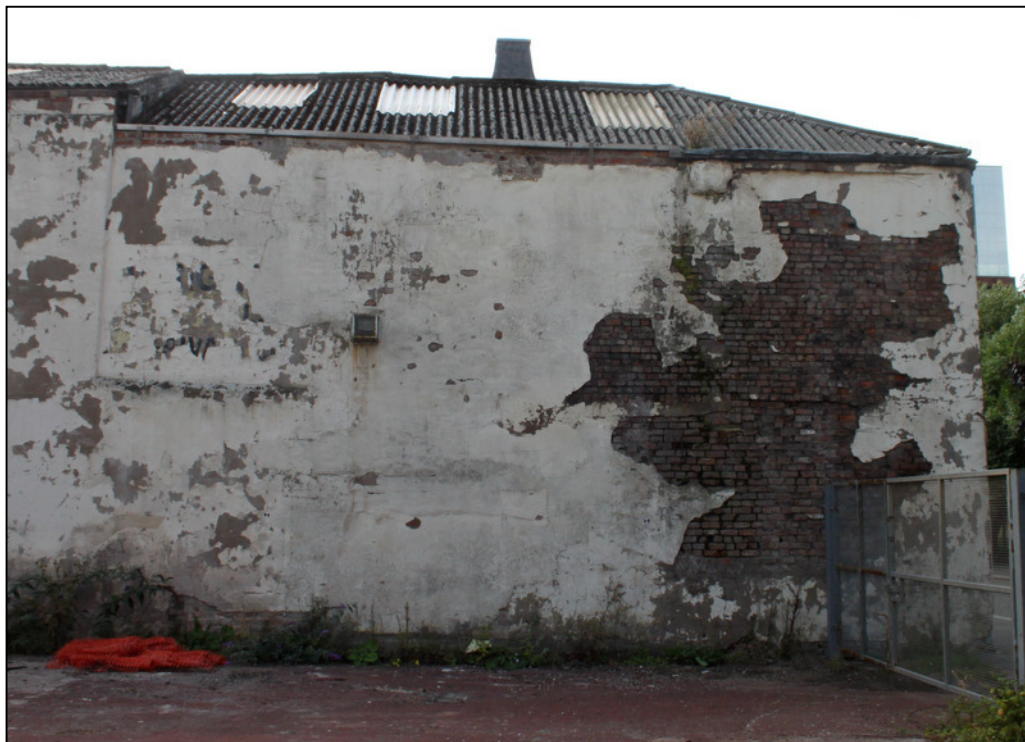
Plate 25: East external wall of Building C

- 4.4.2 Its longer east external wall is almost exclusively concealed behind white-painted concrete render (Plate 25), obscuring all but a small section of wall. This comprised almost exclusively crimson-coloured coarse brick, in random coursing of headers and stretchers. Two narrow sandstone pads were also visible within the wall face, one placed below wall head height, with the other at ground floor ceiling height, below a rendered projection from the wall head (Plate 26). The roof is of similar cementitious corrugated asbestos sheet to Building B to the south, but has a hipped northern bay (Plate 25).

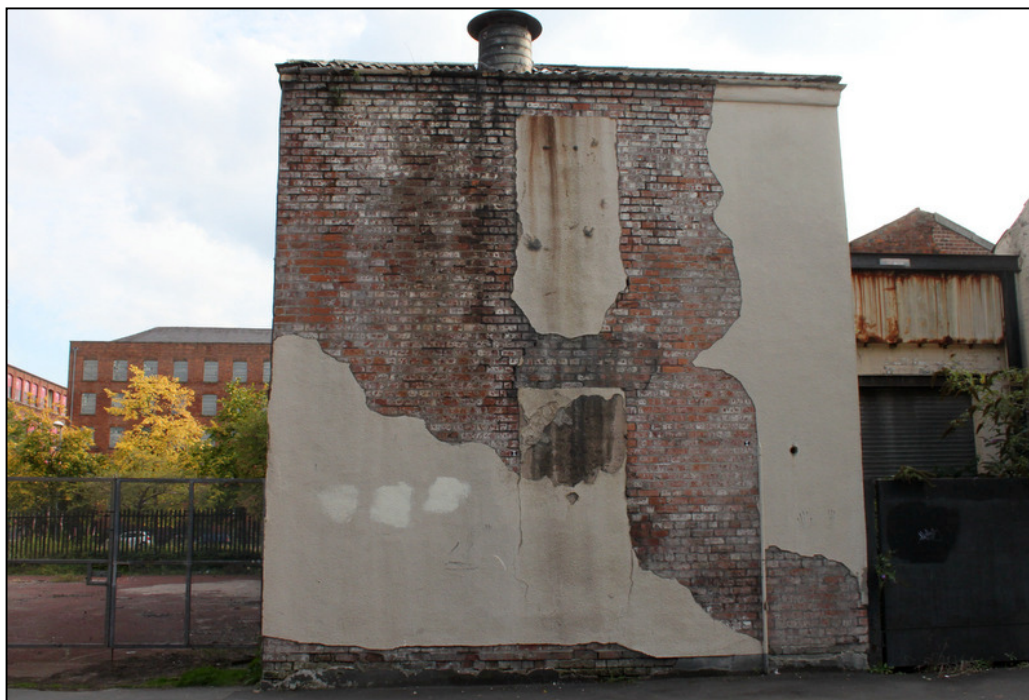
Plate 27: North external wall of Building C, facing Blossom Street

- 4.4.3 The northern gable faces Blossom Street, and is again rendered, although much has collapsed, revealing orangey-red brick construction in three-stretcher English Garden Wall bond, and a central blocked tall window to each floor (Fig 5; Plate 27). The western return also has blocked windows to each bay of the upper floor, with segmental brick lintels (Plate 28), above a similar blocked aperture at ground-floor level, but with a three-rowlock brick arch (Plate 29), and an inserted wider doorway at the northern end of the wall, with an apparent iron lintel, and blocked subsequently (Plate 29).

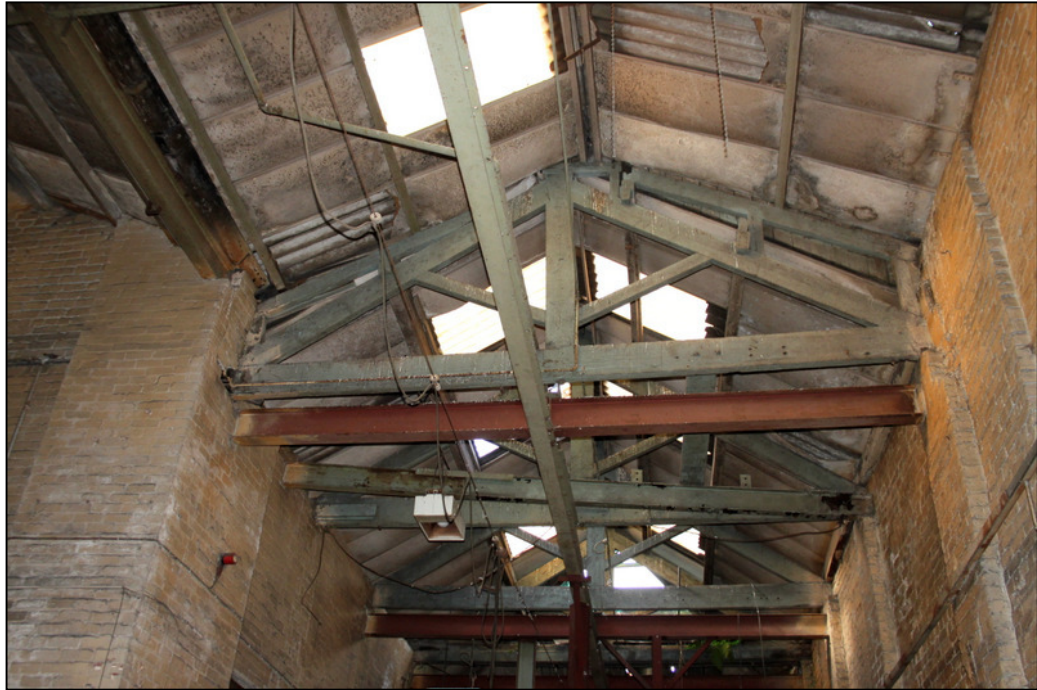
Plate 30: Internal view of Building C, with roof truss detail, looking north

- 4.4.5 The first floor of the east wall above comprised recessed panels between brick piers carrying the ends of timber (Plate 30), rather than steel trusses, again suggesting that the trusses of the earlier Building B represent a replacement. The four trusses comprise braced timber king post trusses, each carrying a trenched purlin to either pitch of the roof (Plate 30). The corrugated cementitious asbestos sheet roof probably represents a replacement, being undersealed with asbestos sheets, and containing skylights in each pitch within each bay (Plate 30).
