**STOCKBRIDGE
AIRCO WORKS,
BLOSSOM
STREET,
ANCOATS,
MANCHESTER**

**Historic Building
Investigation**

October 2015

Manchester Life Development Company
Planning Application 110077/FO/2015/N1

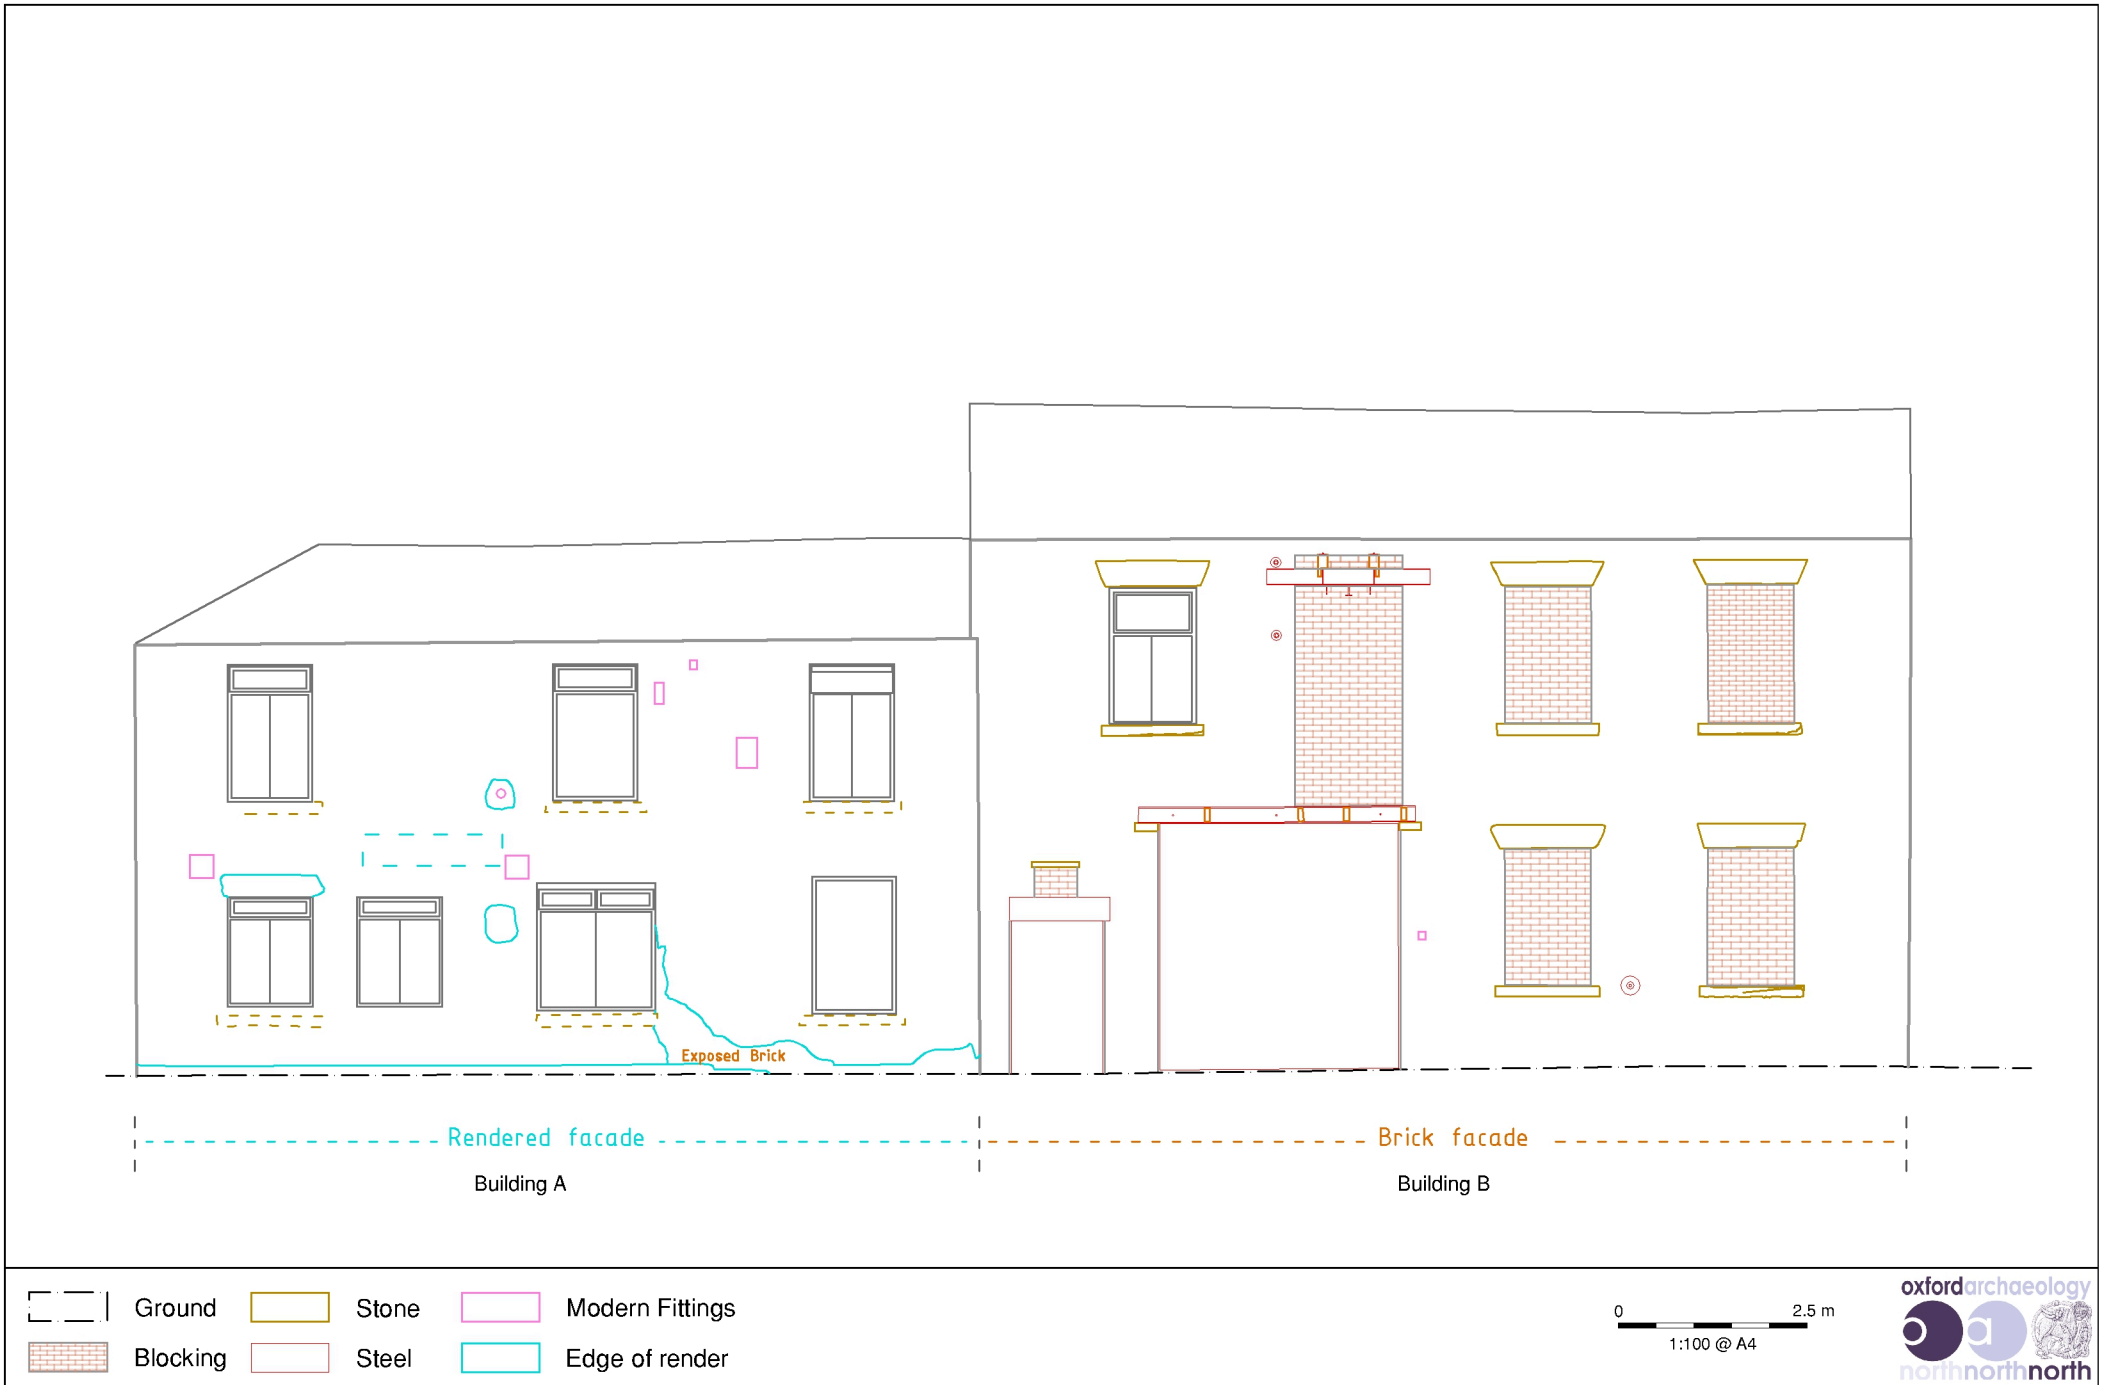
Figure 6: West elevation of buildings A and B

4.2.3 The west elevation has two narrow bays at its southern end, with a wider northern bay (Figs 4 and 6), and again appears remodelled, but probably retaining original window apertures at first-floor level in all but the penultimate northern bay, where it has been blocked (Plate 9). The ground floor windows are unevenly spaced, with two short windows in the northern bay, both possibly representing original apertures, as does the taller southern window (Fig 6; Plate 9). That of the central bay, however, appears to have been remodelled into a wider aperture (Fig 6; Plate 9).

- 4.3.2 Its principal façade was that fronting Murray Street (Fig 6), and is of salt-glazed red brick, erected in three-stretcher English Garden Wall bond (Plate 13), which is continuous around the Hood Street frontage (Plate 14). At ground-floor level, it has a pedestrian doorway at its northern end (Figs 4 and 6; Plate 13). This has been remodelled to house a roller-shutter door, and appears to have had a small over-light above the doorway that was brick-blocked (Plate 13). A large loading door immediately to the south has a rolled steel I-section lintel, and appears inserted, with its slender sandstone pads for the beam being set within ragged cut brickwork (Fig 6; Plate 13).

- 4.3.3 A blocked loading doorway above retains an external beam and some of the hoist gear (Fig 6; Plate 13), but probably also represents a contemporary inserted feature, with evidence for an infilled window lintel above. Elsewhere, the elevation retains its original apertures, comprising 4.6m (1.37m) wide windows with projecting sandstone sills and flush, splayed flat sandstone lintels (Plate 13). These were arranged in pairs to each bay, with all but the upper northern example having been brick-blocked. The extant window has a three-light steel frame (Plate 13), and represents a replacement, probably of early/mid-twentieth-century date.
