Long Buckby Water Inlet Main Replacement

Archaeological Monitoring and Recording Report

OA East Report No: 1684 OASIS No: oxfordar3-192800 NGR: SP 654 685

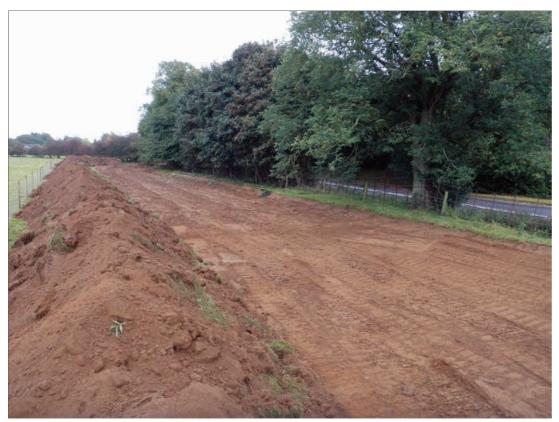
Plate 3: Stripping of Chainage 2000-2300

4.1.4 A total of 0.44m of topsoil was removed, uncovering a geology of clayey sand and sandstone fragments. No archaeological features were present.

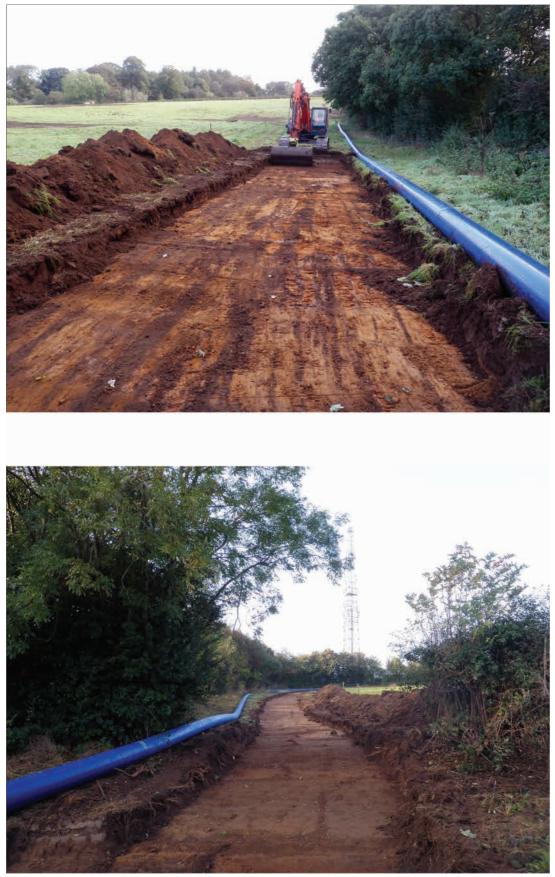
Plate 5: Chainage 2600-2900, looking north-west

4.1.5 A total of 0.35m of topsoil was removed, uncovering a geology of clayey sand and sandstone fragments. No archaeological features were present.
