Burford Road, Cirencester, Gloucestershire

Archaeological Watching Brief Report

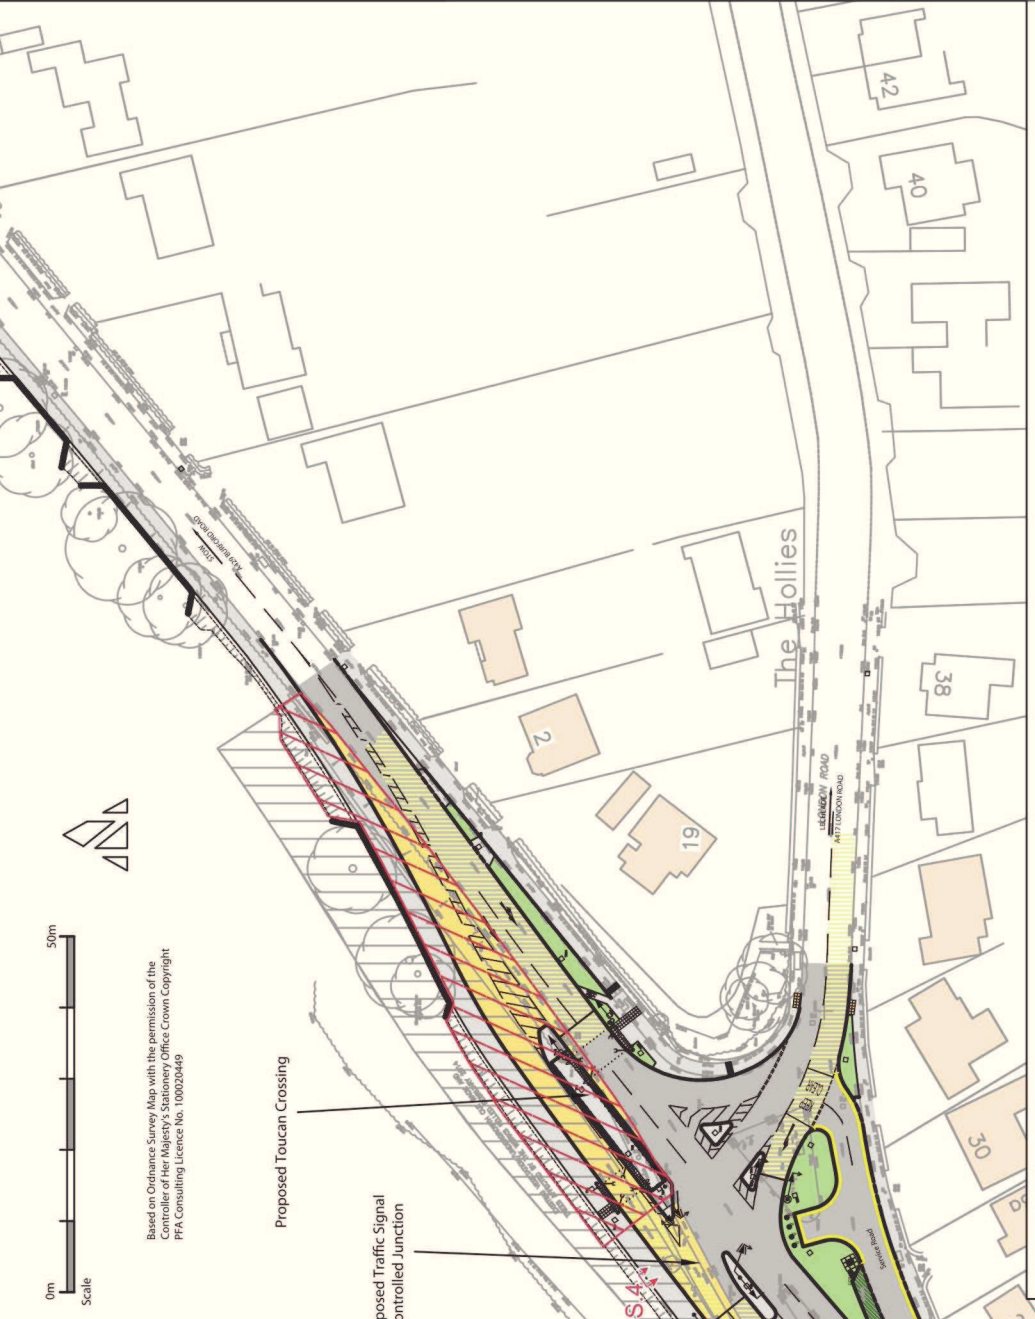
Figure 2: Site plan

- 3.1.1 The watching brief was undertaken in three distinct phases:
- Recording previously exposed soil profiles and the mound section (Fig. 2);
 - Monitoring of remaining ground works at the approach to the Grove Lane roundabout (Fig. 2);
 - Intermittent site visits during the construction of a new cycleway (Fig. 2, inset).
- 3.1.2 The observations made during the various phases of monitoring are described separately below, followed by an overall discussion and conclusion.

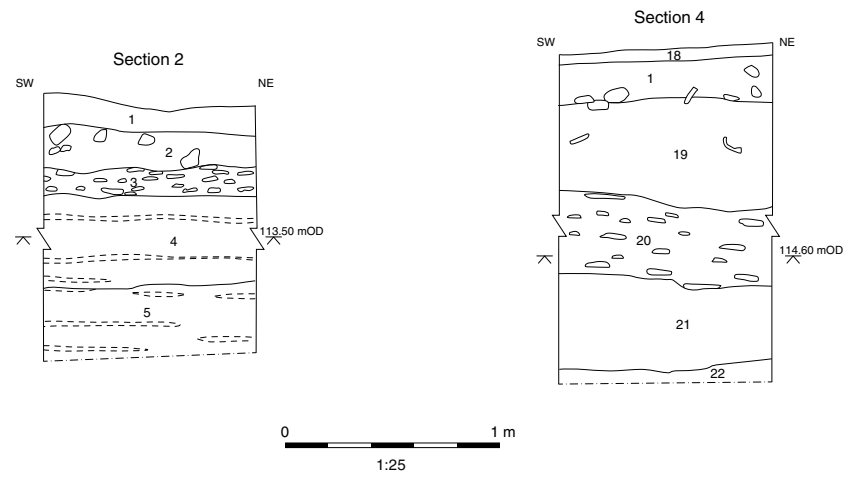
Figure 3: Sections

- 3.2.1 The soil profiles exposed in the south-east facing section of the excavations displayed a sequence of bedrock units of the Forest Marble Formation dating to the Upper Jurassic (Fig. 3, sections 2 and 3. Plates 1 and 2). The bedrock units (contexts 3, 4 and 5 in section 2 and contexts 20, 21 and 22 in section 4) varied slightly in colour and stoniness, but generally displayed a horizontal structure. The weathered upper bedrock horizons were overlain by a subsoil (contexts 2 and 19) composed of brown or olive sandy silt. which in turn was overlain by the modern topsoil (context 1). The topsoil was in places overlain by an organic leaf litter layer (context 18)

- 3.2.2 The exposed section through the mound (Fig. 3, section 1, Plate 3) consisted, at its base, of 1.35 to 1.55m of Upper Jurassic bedrock in several superimposed beds (contexts 7, 8, 9 and 10). The geological beds had slightly wavy contacts. At the south-west side of the mound, the geological beds formed a small local fold. The top bed of the fold (context 8) consisted of light grey angular mudstone clasts which clearly displayed the bend in the fold.

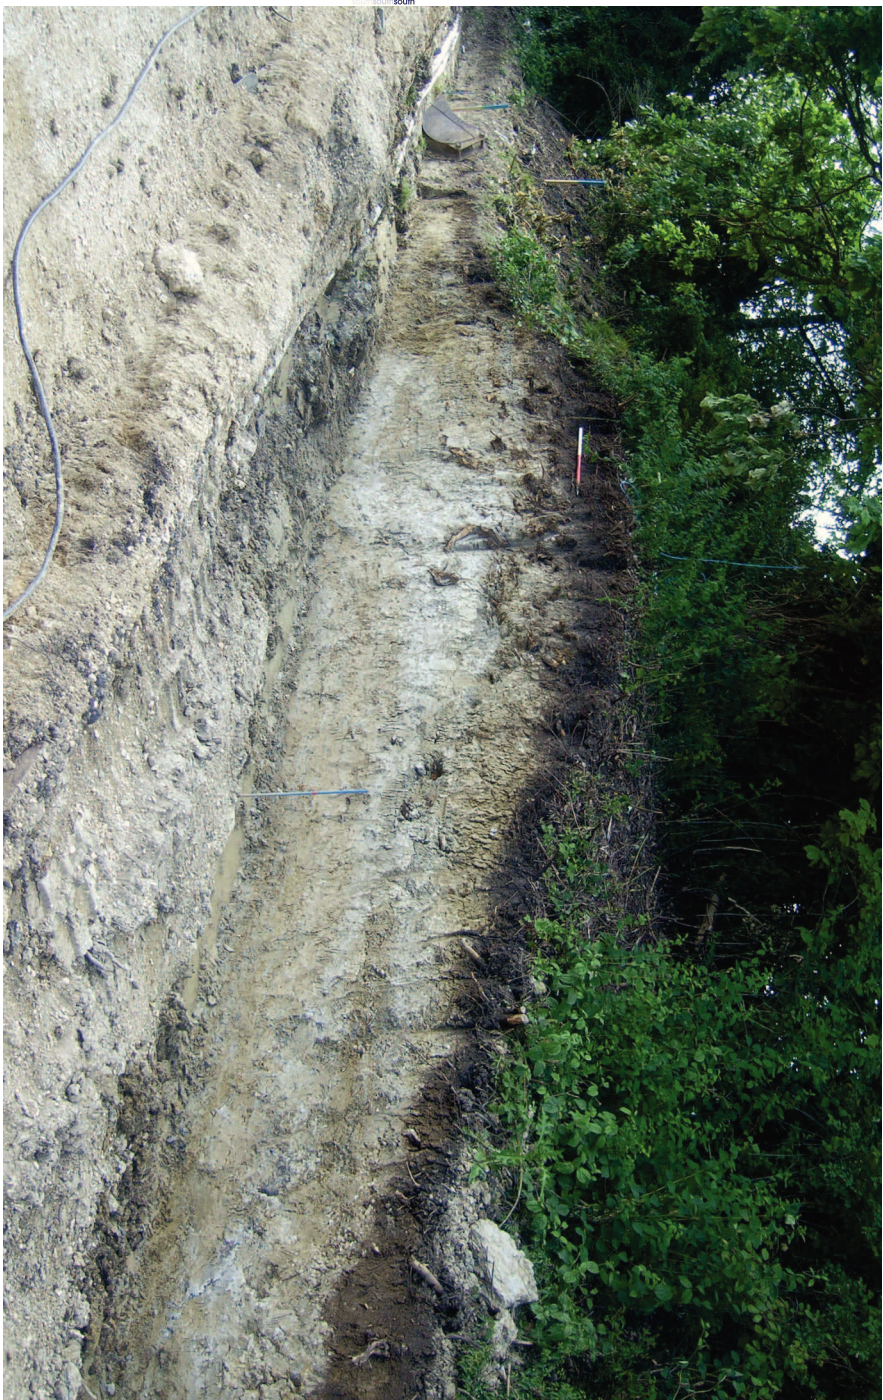
Plate 3: Section through mound

- 4.1.3 The mound at the north-west side of the road is built up from this local geological stratigraphy. The steeper south-west side of the mound section is caused by the firm brittle bedrock unit which forms part of a small local tectonic fold. The irregularly shaped feature at the north-east side of the mound section was filled by a mixed sediment, partially derived from topsoil and likely to be of recent origin. The presence of the mature tree on top of the mound has undoubtedly protected the mound from truncation during more recent road construction works.

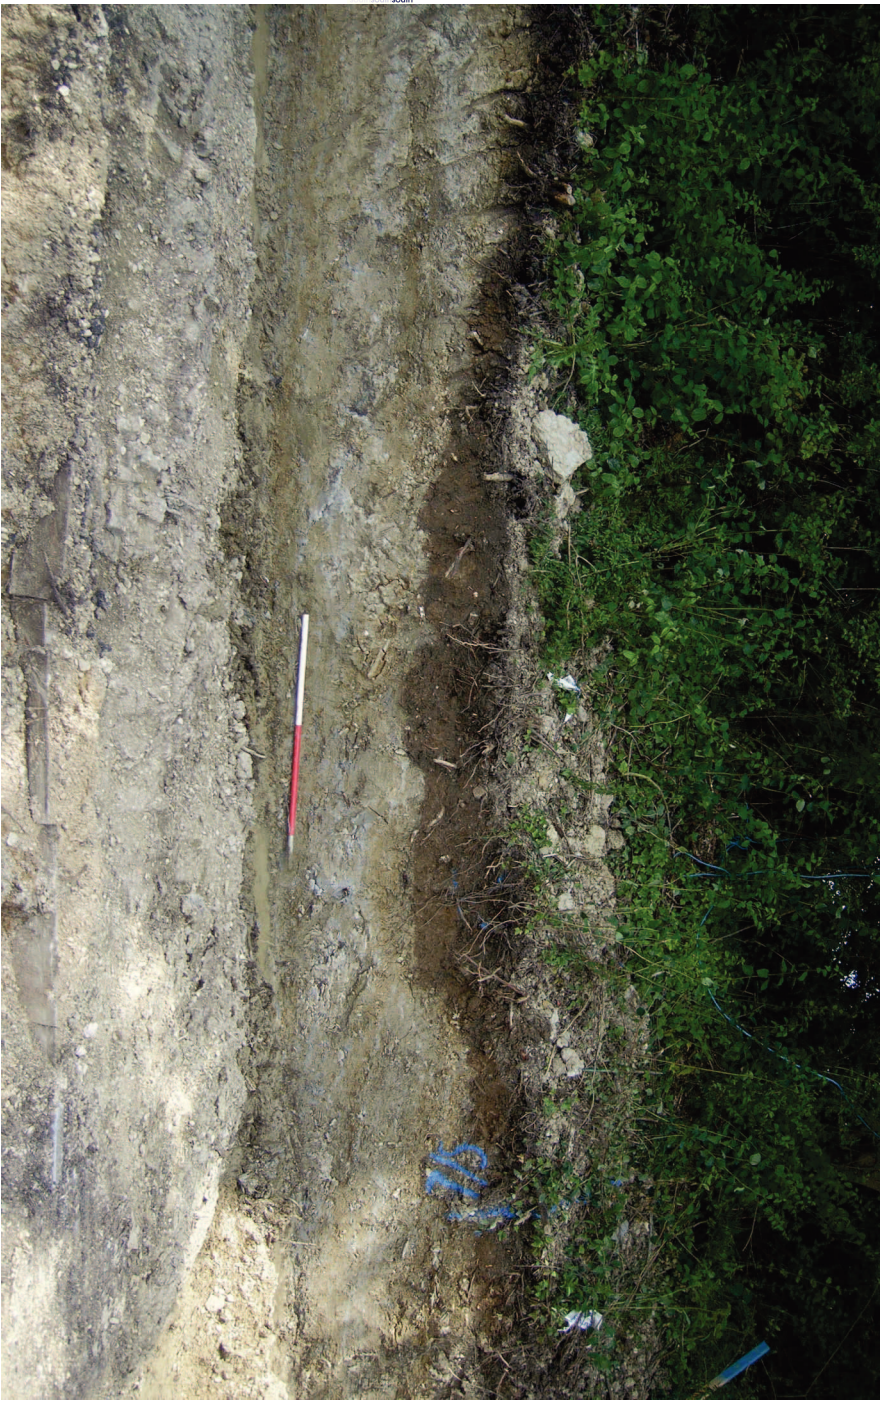
Plate 5: Feature 12

- 3.2.4 The top of the mound sequence was formed by a dark brown topsoil (context 1), 0.5m thick.
- 3.2.5 Particular care was taken to establish whether any evidence of ditches flanking the mound was present. No such evidence was present to the south-west of the mound. To the north-east, an irregularly shaped depression (context 12), up to 0.35m deep and 3.05m wide, was present, cut from immediately beneath the topsoil. It was filled with a mixed deposit, largely comprised of topsoil (13).

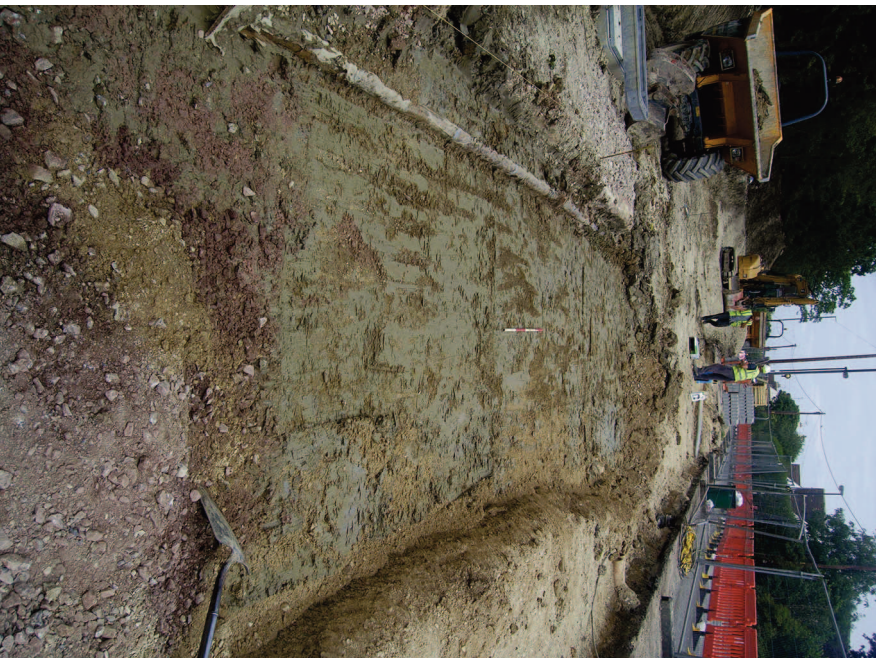
Plate 6: General view of ground reduction

- 3.3.2 The ground reduction exposed a number of service trenches cut into geological deposits. The geological sequence had been truncated across much of the width of the new works, presumably by earlier road construction.
- 3.3.3 The soil profiles exposed in the area were recorded in several sample sections These displayed a similar stratigraphy as recorded further to the south-west (see above).
- 3.3.4 No archaeological features or deposits were present
