Tatton Park Water Main, Tatton Park Cheshire East

Watching Brief: Supplementary Report

Oxford Archaeology North

June 2010

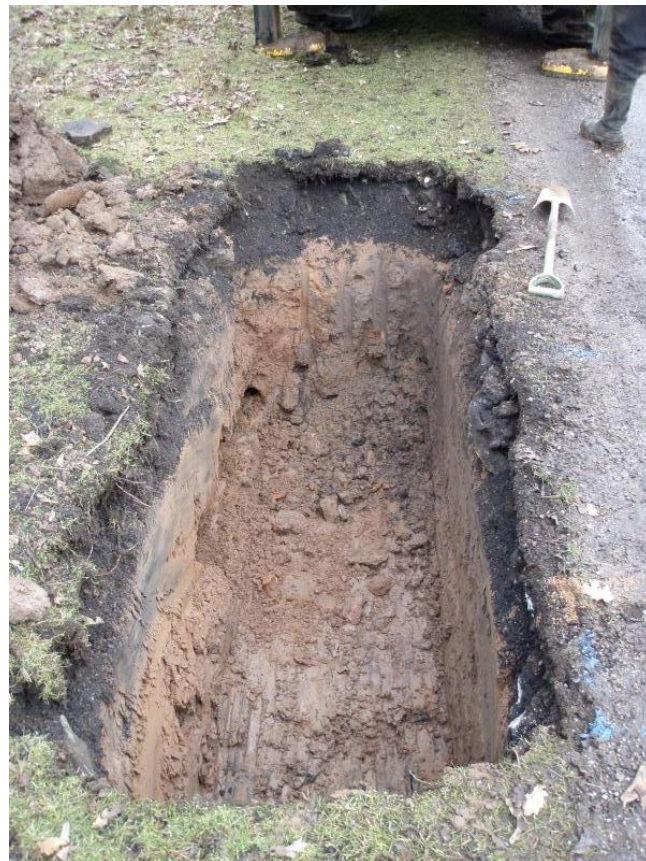
Plate 2: Test Pit 2, facing North

3.2.2 Test Pit 2 (Fig 2b; Plate 2) was situated within Site **239**, a post-medieval field, and measured 2m x 1m. The layer of made-ground as seen in Test Pit 1, was present. The subsoil and underlying geology was also present, as in Test Pit 1.

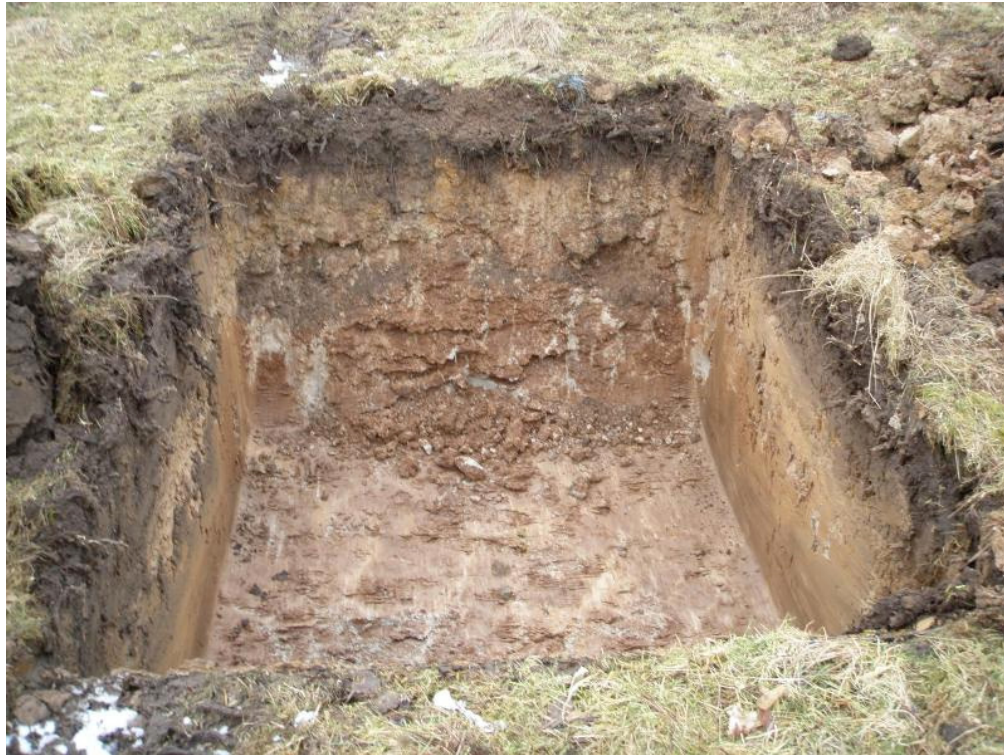
Plate 3: Test Pit 3, facing North

3.2.3 Test Pit 3 (Fig 2b; Plate 3) was located immediately to the north of Site **236**, an Industrial Period track, and within Site **250**, a post-medieval field. The pit measured 2m x 2m and was excavated to a depth of 1.2m. A 0.1m deep humic topsoil overlay a mottled grey firm clay natural. No archaeology was observed within this pit.

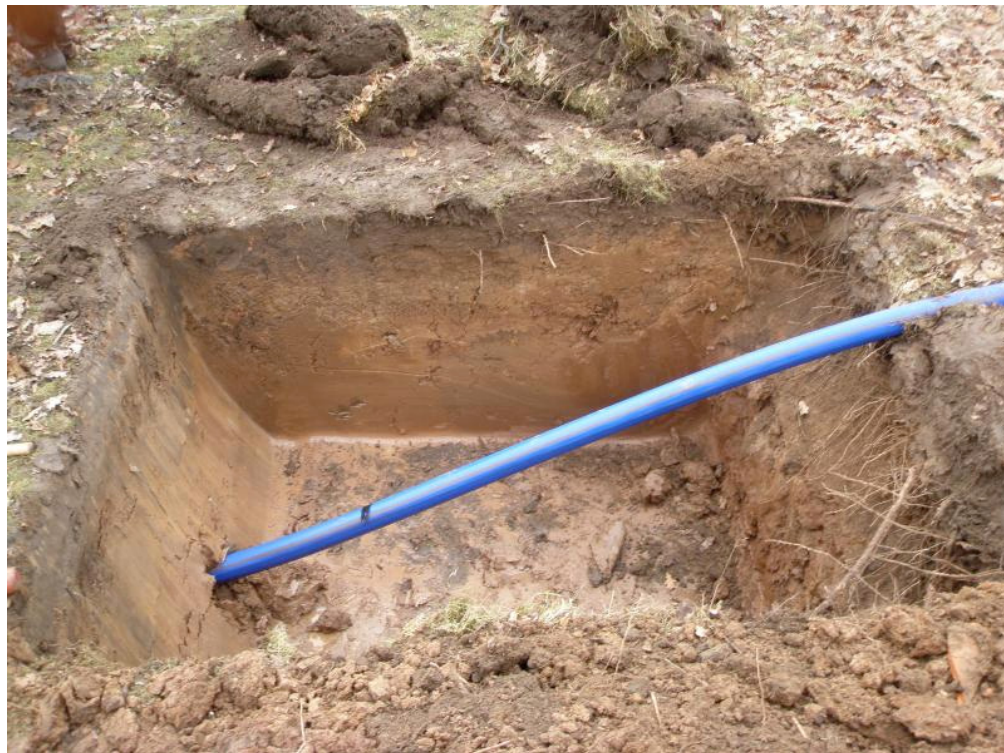
Plate 4: Test Pit 4, facing East

3.2.4 Test Pit 4 (Fig 2b; Plate 4) measured 2m x 2m, and was excavated to a depth of 1.2m. It was located within Site **250**, 'The Brickills', a post-medieval field. The topsoil in this area of the easement comprised a 0.2m deep dark greyish brown sandy-clay, overlying a natural reddish brown silty-sandy clay. No archaeology was observed within this pit.

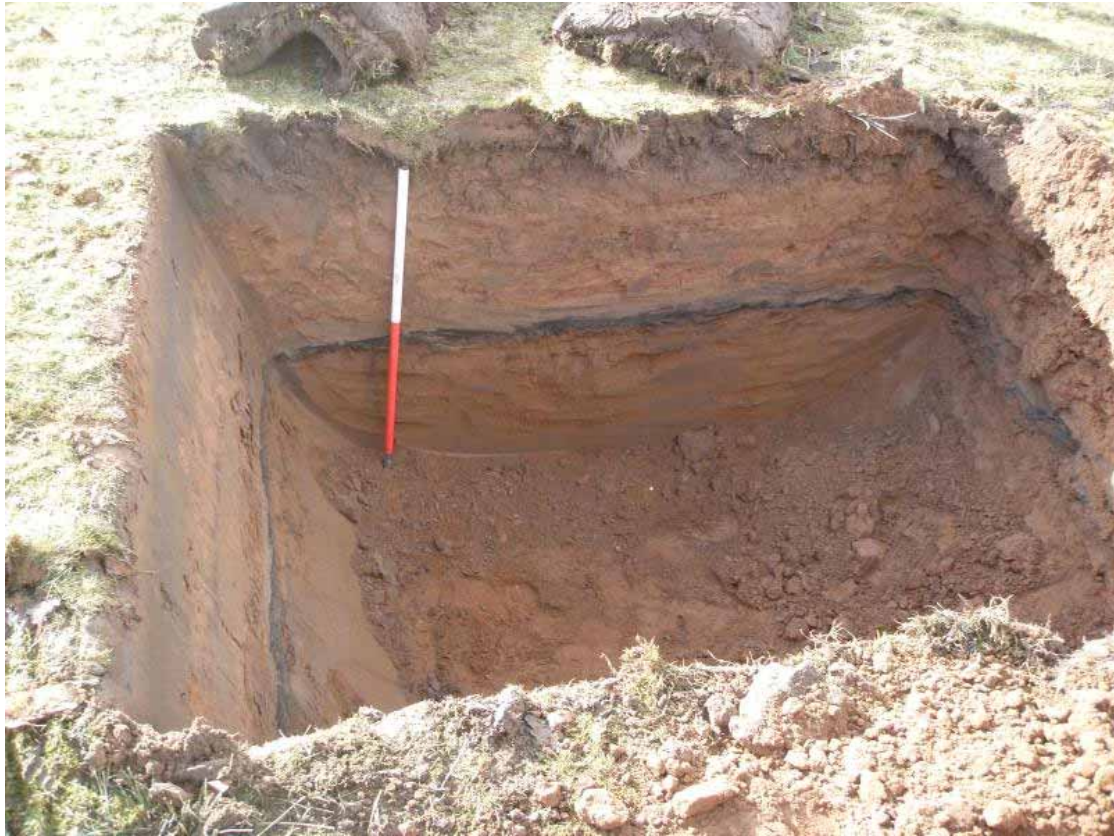
Plate 5: Test Pit 5, facing West

3.2.5 Test Pit 5 (Fig 2b; Plate 5) measured 2.5m x 1.8m and was excavated to a depth of 1.2m. The pit was located near to Sites **231** and **232**, Industrial Period scarps. The topsoil, a mid-grey soft sandy-clay, 0.2m deep, and a mid-reddish brown sandy-clay subsoil, 0.5m deep, were removed. The subsoil overlay a buried soil horizon, **5**, comprising a light grey sandy-clay, 0.03m deep. This in turn sealed a further buried soil, **3**, a dark greyish brown silty-clay, 0.05m deep. This overlay natural light brown sandy-clay.

Typically, the test pits were located within post-medieval fields, and it is unsurprising that no features were observed. No traces of field boundaries were detected. Two shallow bands of buried soil were observed in Test Pit 5. The restricted size of the test pit does not allow for any further interpretation.

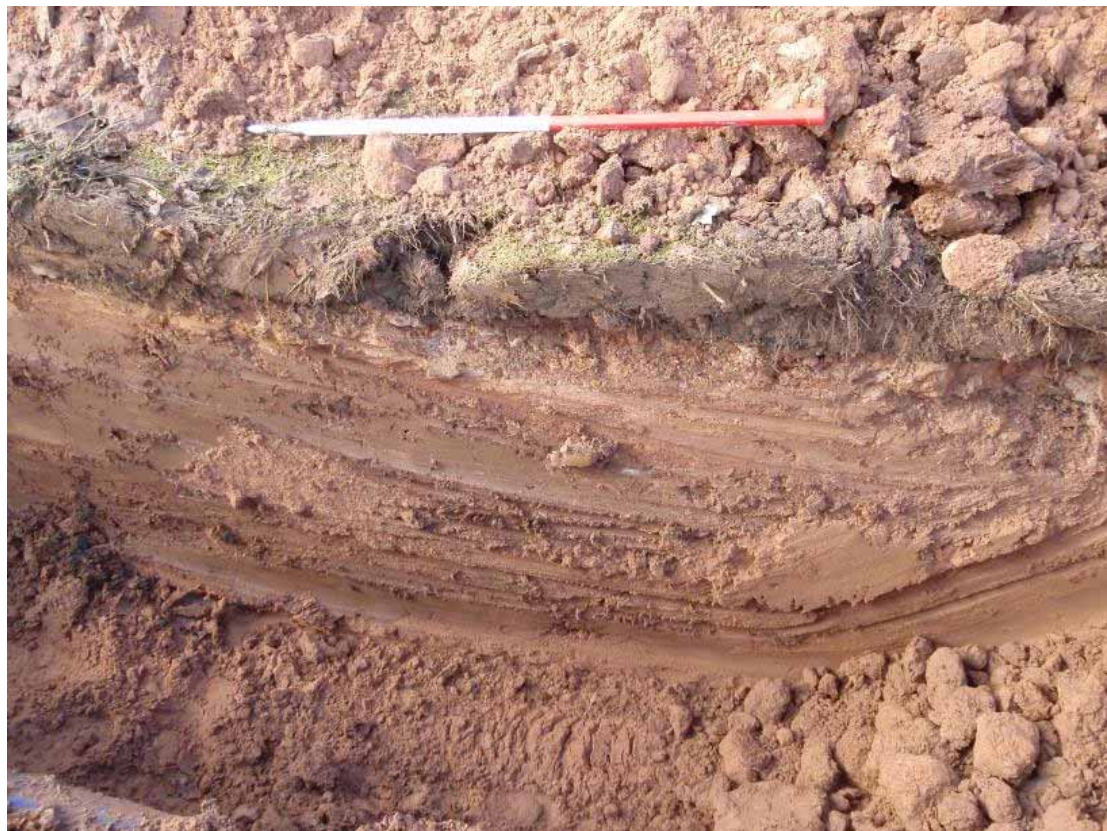
Plate 6: Test Pit 6, facing West

3.2.6 Test Pit 6 (Fig 2b; Plate 6) was made larger than the other pits, (10m x 1m, 1.4m deep), in order to locate and excavate around an existing water main. It was located close to Site **230**, a post-medieval field. The topsoil, a 0.2m deep dark pinkish-brown sandy-silt, and the subsoil, a mottled orange-yellow-red soft silty-sand, 0.5m deep, overlay natural orange-brown fine-sand. No archaeology was observed within this pit.

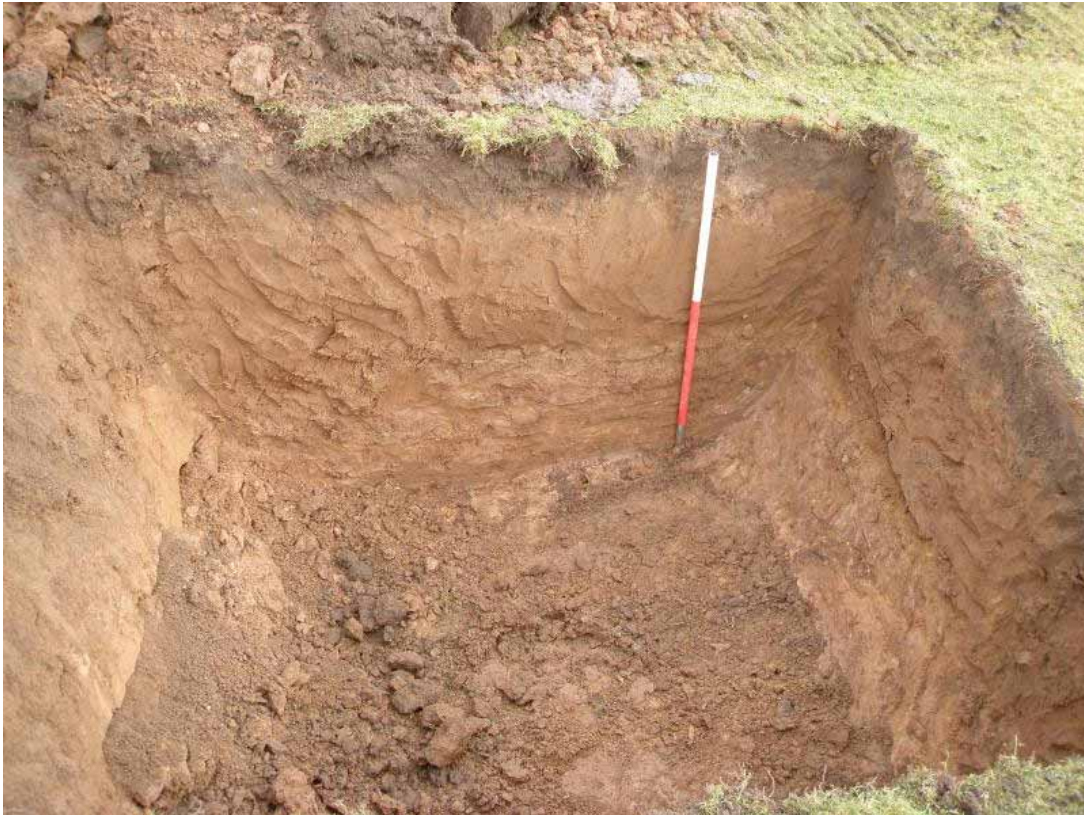
Plate 7: Test Pit 7, facing West

- 3.2.7 Test Pit 7 (Fig 2b; Plate 7) was located within Site **229**, a post-medieval field. It measured 2m x 3m and was excavated to a depth of 1.2m. The topsoil, a grey sandy-clay, 0.25m deep, sealed a reddish brown sandy-clay subsoil, 0.3m deep. This was above natural light red sand. No archaeology was observed within this pit.

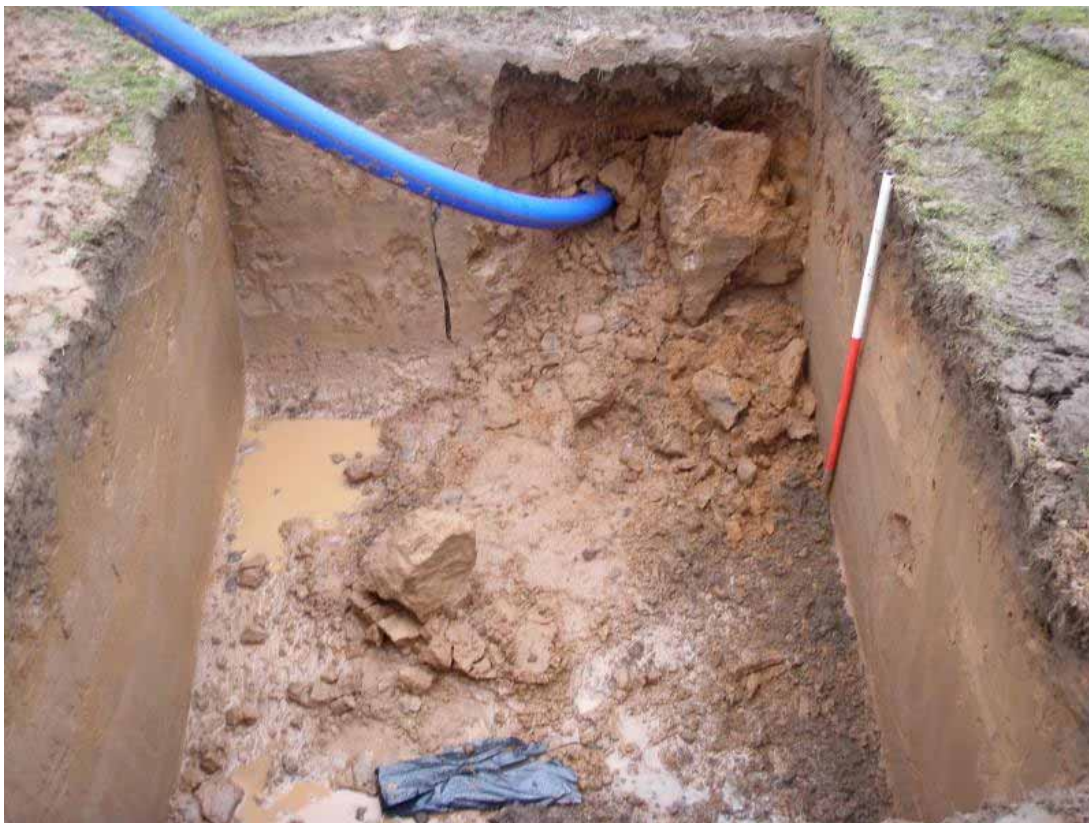
Plate 8: Test Pit 8, facing West

- 3.2.8 Test Pit 8 (Fig 2b; Plate 8) measured 2m x 3m, was excavated to a depth of 1.2m and located very close to Site **103**, an area of post-medieval ploughed land. The topsoil, a 0.2m thick grey silty-clay, overlay a light red sand with occasional stones. The top half of the pit showed signs of being heavily rooted. No archaeology was observed within this pit.

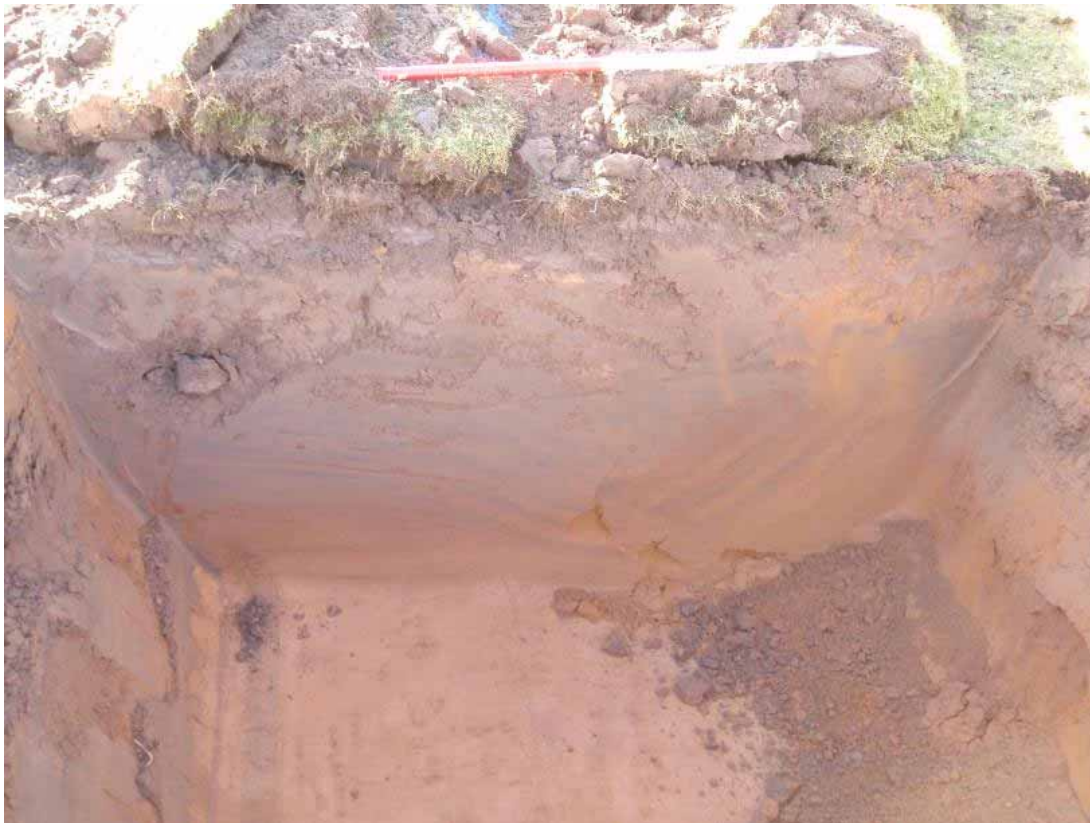
Plate 9: Test Pit 9, facing West

- 3.2.9 Test Pit 9 (Fig 2b; Plate 9) was located within Site **228**, a post-medieval enclosure. The pit measured 2m x 2m, and was excavated to a depth of 1.2m. The topsoil comprised a mid-pinkish brown soft sandy-silt, 0.2m deep, and beneath this the subsoil comprised a mid-brown sandy-silt, 0.2m deep. This overlay natural orange/red fine sand. No archaeology was observed within this pit.

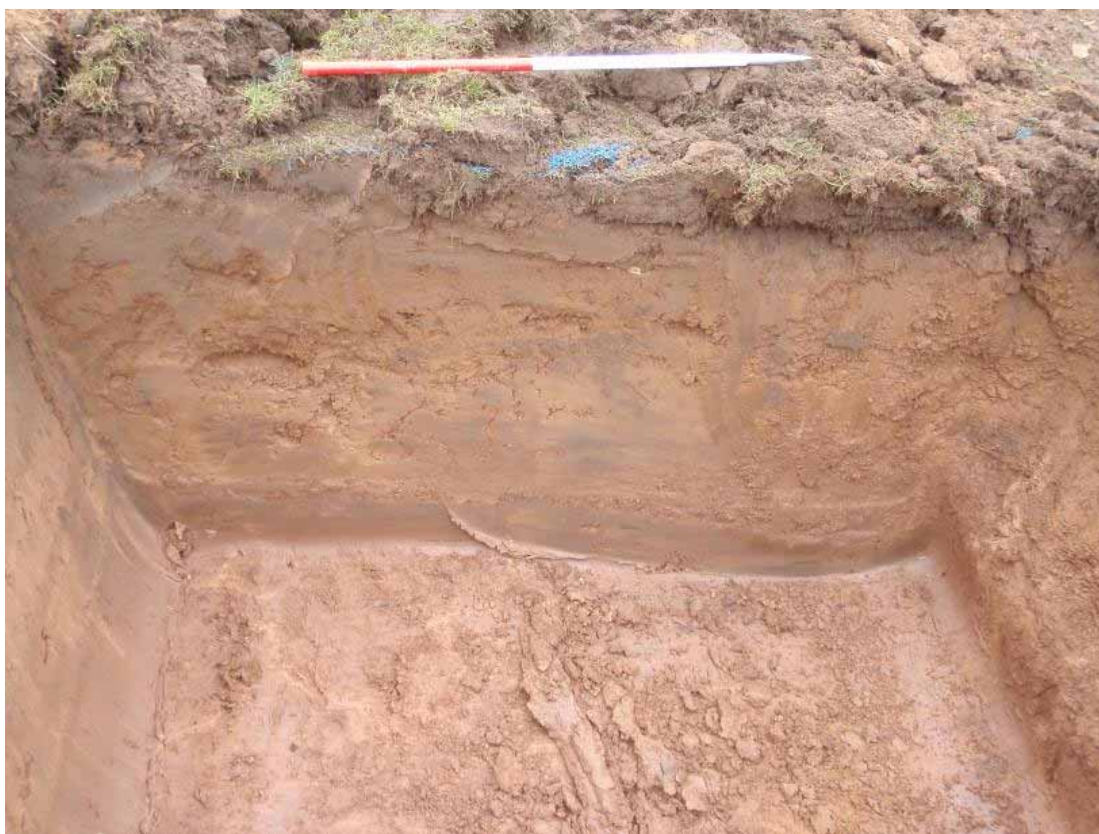
Plate 10: Test Pit 10, facing West

- 3.2.10 Test Pit 10 (Fig 2b; Plate 10) measured 2m x 2m and was excavated to a depth of 1.2m. It was sited within Lambs Acre Enclosure (Site **225**). The topsoil, a mid-greyish brown soft sandy-silt, 0.2m deep, overlay, light brownish orange silty-sand subsoil. The natural geology was a mottled orange, yellow and red soft silty-sand, 0.4m deep. No archaeology was observed within this pit.

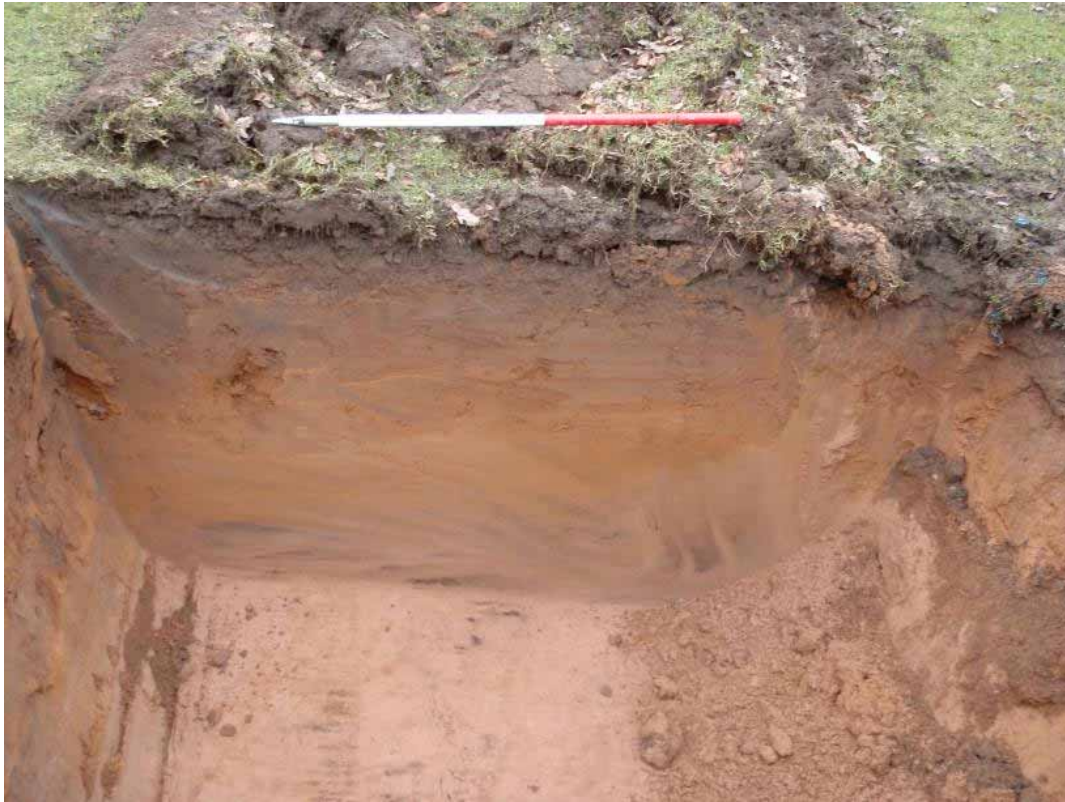
Plate 11: Test Pit 11, facing West

- 3.2.11 Test Pit 11 (Fig 2a; Plate 11) was located within Site **220**, a post-medieval enclosure. The pit measured 2m x 2m and was excavated to a depth of 1.2m. The topsoil and subsoil were as observed in Test Pit 10 and sealed the natural geology, which was a mid-orange fine sand with patches of coarse sub-rounded gravel, 0.5m deep. No archaeological remains were observed within this pit.

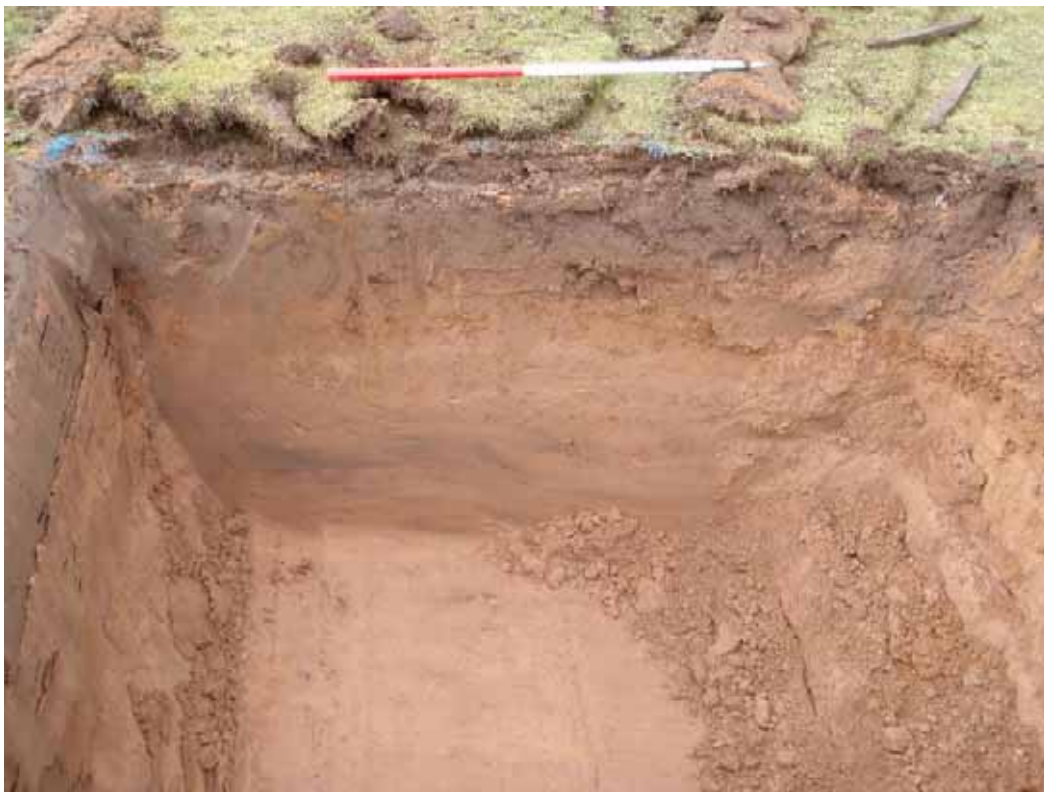
Plate 12: Test Pit 12, facing West

- 3.2.12 Test Pit 12 (Fig 2a; Plate 12) measuring 2m x 2m, and 1.2m deep, was situated just to the east of Site **117**, post-medieval narrow ridge and furrow. The topsoil and subsoil were also as observed in Test Pit 10 and overlay a mottled pinkish yellow and orange sandy-silt natural. No archaeology was observed within this pit.

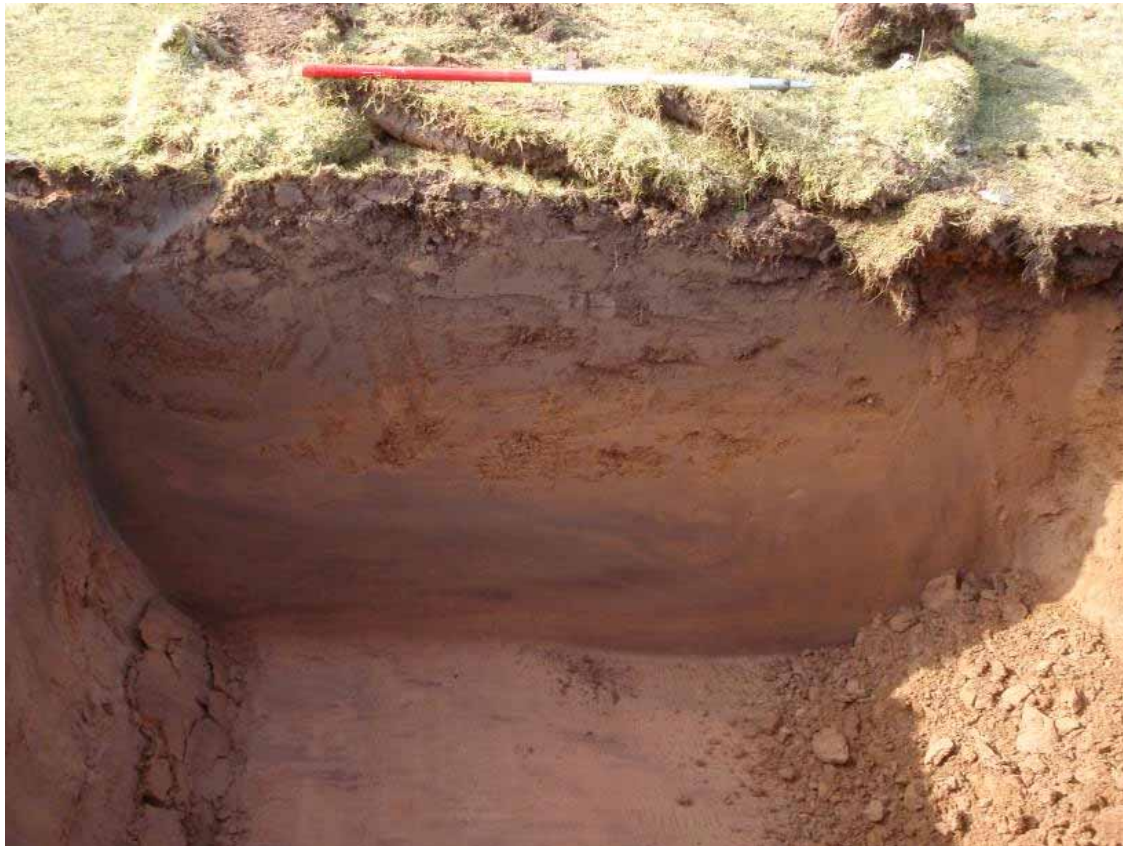
Plate 13: Test Pit 13, facing West

- 3.2.13 Test Pit 13 (Fig 2a; Plate 13) was located on the eastern edge of Site **121**, post-medieval ridge and furrow. The pit measured 2m x 2m, and was excavated to a depth of 1.1m. The topsoil and subsoil, as described in Test Pit 10, overlay the natural geology, which comprised mid-pinkish orange sand, and this was excavated to a depth of 0.6m. No archaeology was observed within this pit.

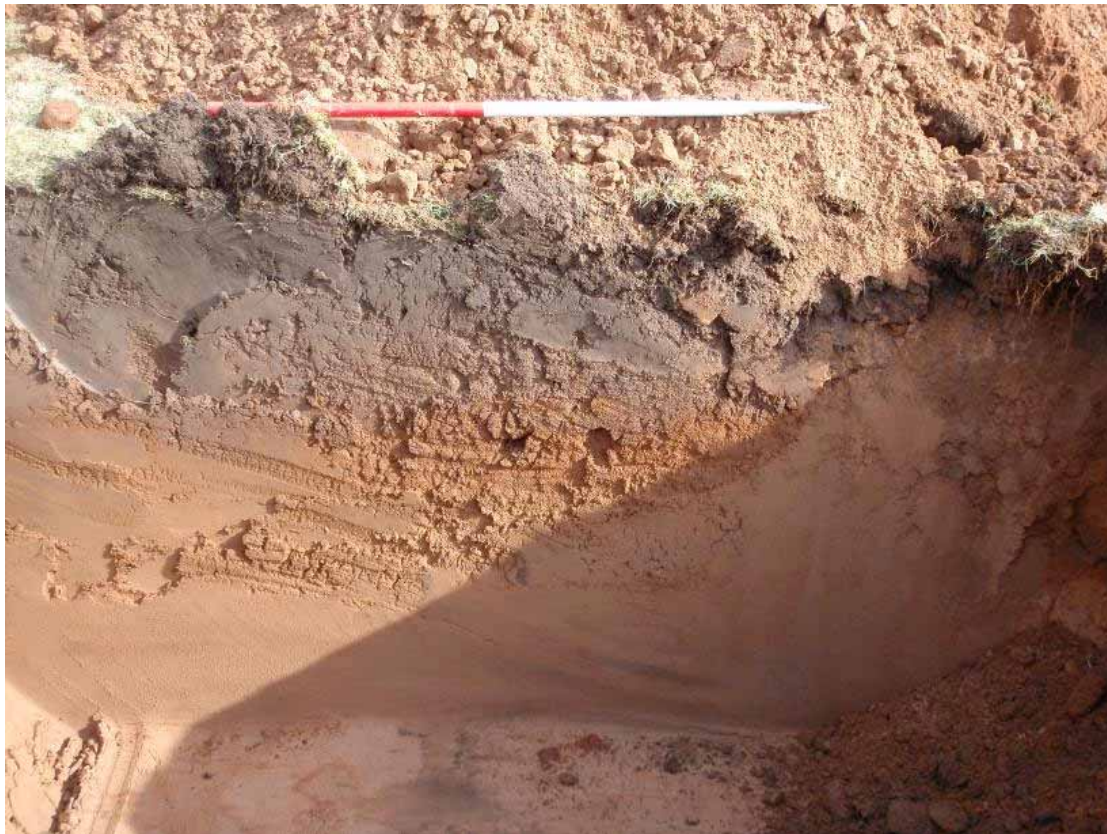
Plate 14: Test Pit 14, facing West

- 3.2.14 Test Pit 14 (Fig 2a; Plate 14) was situated within Site **128**, an area of post-medieval ridge and furrow. It measured 2m x 2m and was excavated to a depth of 1.2m. The topsoil, subsoil and natural geology were as described above (*Section 3.2.10*). No archaeology was observed within this pit.

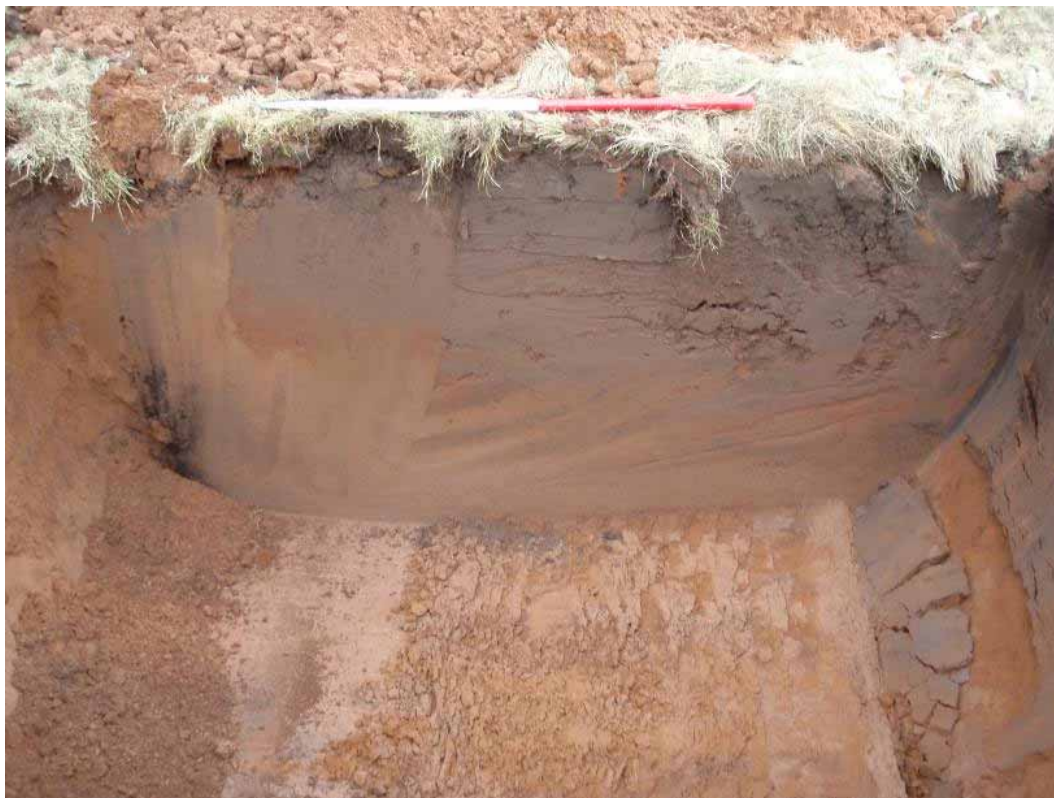
Plate 15: Test Pit 15, facing West

3.2.15 Test Pit 15 (Fig 2a; Plate 15) was the northernmost pit on the pipeline. It measured 2m x 2m and was excavated to a depth of 1.2m. The topsoil, subsoil and natural geology were as seen above (*Section 3.2.10*). No archaeology was observed within this pit.
