Furnace Hill, West Bar, Sheffield,

Archaeological Excavation Assessment Report

November 2015

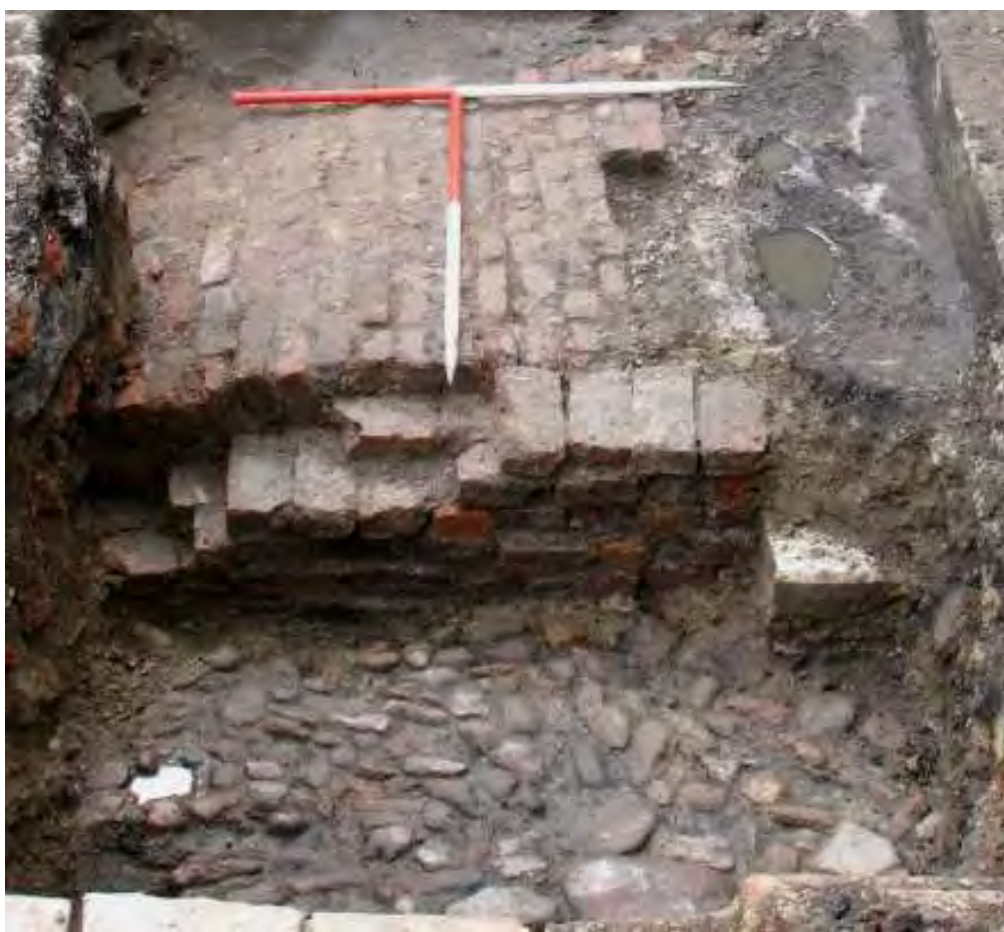
Plate 2: Eighteenth-century cobble surface (**235**) (foreground), which was cut by Room **231** (background)

- 4.3.3 To the south of this wall, the patchy, and heavily disturbed, remains of an eighteenth-century yard (**I89**, **201** and **235**) were discovered (Plate 2), which were originally also part of Samuel Shore's works. Only small areas of this yard survived, which together covered approximately 2.98m². The yard was identified at a height of 52.19m above Ordnance Datum (aOD), and was composed of variously sized river cobbles.

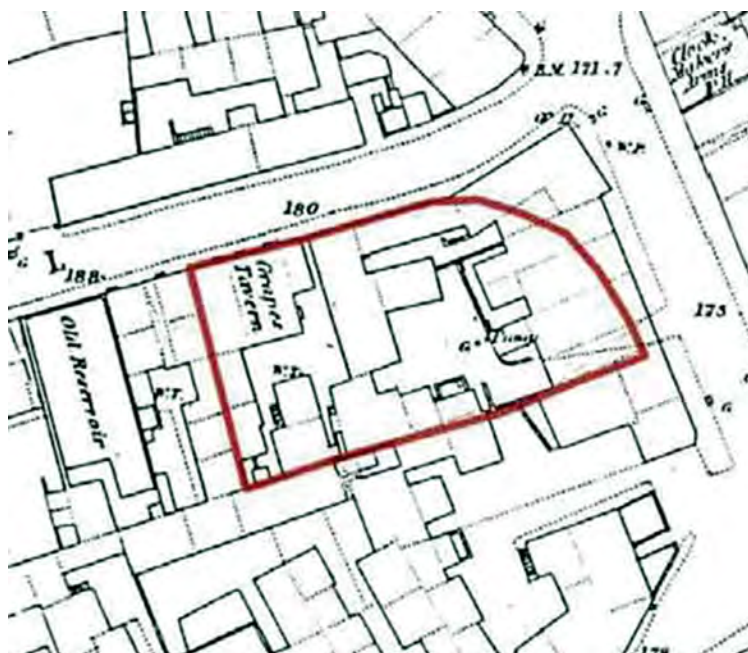
Plate 3: Extract from the 1853 OS map, showing the development of the site

- 4.4.6 Immediately to the north of the ash pits, beneath a flag surface (**166**; Fig 5), a brick wall (**253**) was excavated in the position of a wall of a building plotted on the nineteenth-century OS maps (Plates 3 and 4). This formed part of an L-shaped building, which clearly housed the crucible furnace, and this can now be interpreted as having been engaged in steel production. A surface of stone setts (**167**) was also found beneath later surface **166**, which butted against, and was probably contemporary with, wall **253**.

4.4.20 The 1853 (Plate 3) and 1890 (Plate 4) OS maps also depict a communal yard situated to the rear of, and between, the nineteenth-century buildings. The excavation exposed a 9 x 7.5m swathe of cobbles (**116**; Plate 12), which had been laid on a black ashy bedding deposit. Other surviving parts of this yard were composed of stone setts (**117**), whilst one small portion of the yard was constructed of stone flags (**152**). Several *in situ* kerbstones were also associated with this flagged surface, indicating that a walkway had been constructed to the rear of the buildings fronting West Bar.

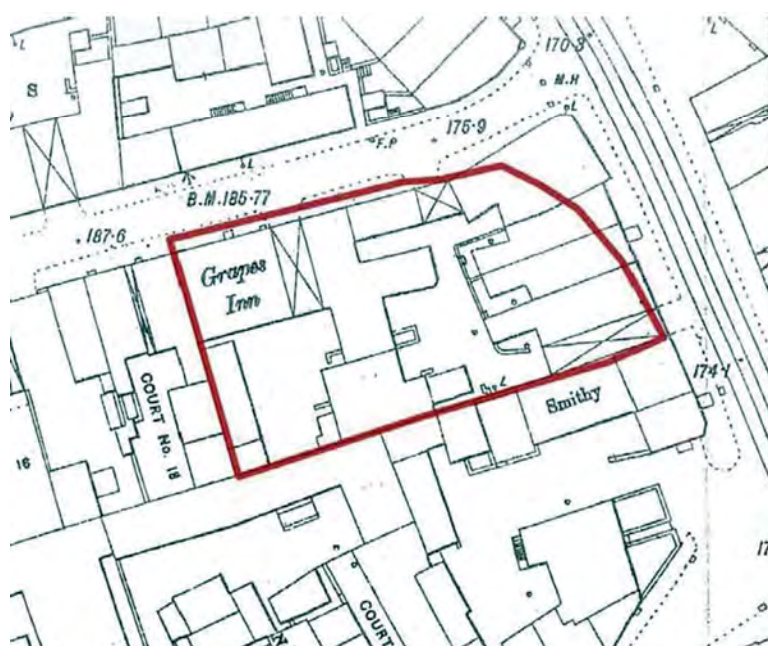
Plate 4: Extract from the 1890 OS map, showing the development of the site since 1853

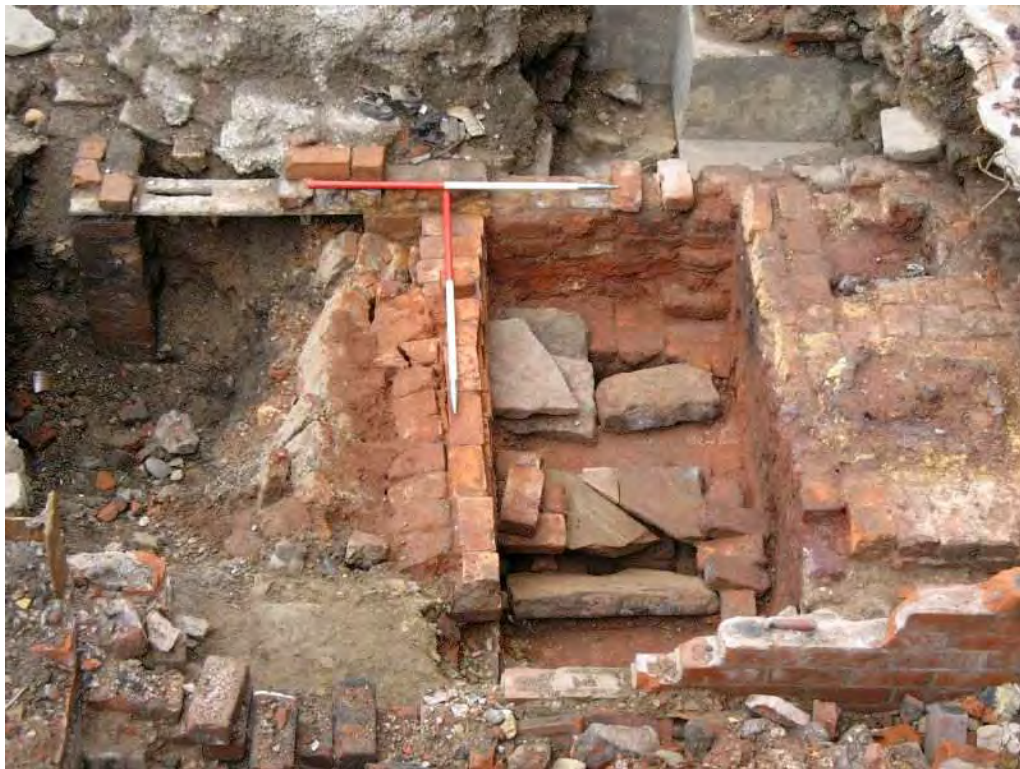
Plate 5: The nineteenth-century crucible furnace after initial cleaning, the flagstones marking the positions of the ash pits

- 4.4.2 The remains of a crucible furnace were discovered in the south-west part of the excavation trench. Significantly, the existence of this furnace was unknown prior to the excavation. Although this structure had been heavily disturbed at its western and southern ends, the elements which survived characterised the form and workings of this type of furnace (Plate 5). These elements included a brick-lined chamber, ash pits, a chimney stack (*173*), and a vaulted cellar (*180*), which allowed access to the ash pits (Fig 4).

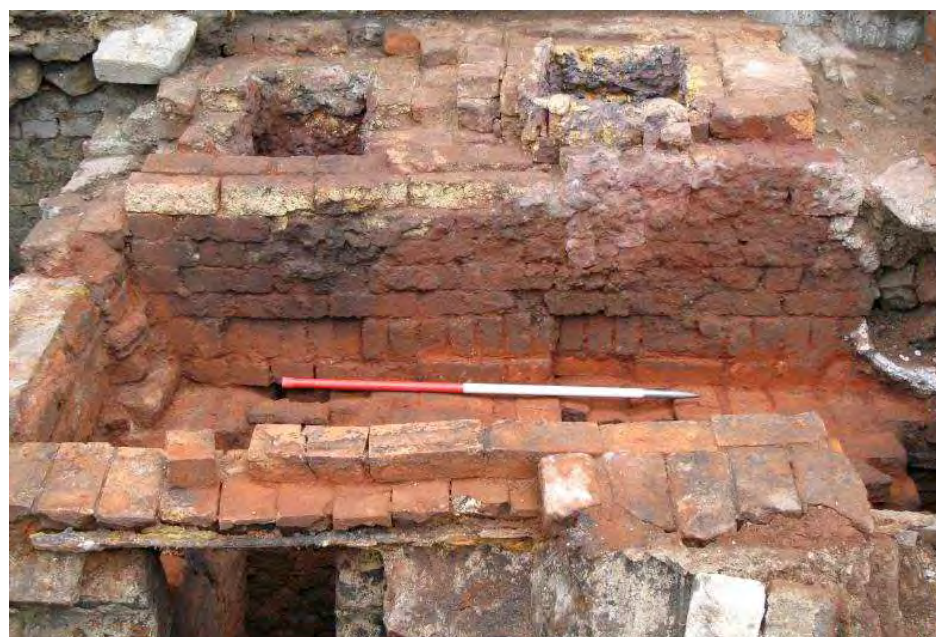
Plate 7: South-facing view of the furnace chamber, with chimney stack **173** behind, and vitrified brickwork

- 4.4.3 The surviving chamber of this furnace was 1m wide, and was defined on its southern side by the chimney (*173*) and on its northern side by a wall (*169*) constructed of refractory brick, which at its eastern end was two courses thick, widening to three courses in thickness to the west. The base (*172*) of the chamber was also built of refractory bricks, and contained three ash pits (*220*), spaced *c* 0.4m apart. Although one of these, on the western side of the furnace, had been disturbed, the remaining two each measured *c* 0.4 x *c* 0.8m. After the final firing of the furnace, these pits had all been capped with stone flags. The capping stones were all stained with soot on their undersides, which suggests that the slabs were placed above the ash pits when the furnace still contained hot ash.

- 4.4.4 The chimney stack (*173*), of which only a portion of the base survived, was found immediately south of the furnace chamber, which defined its northern edge (Plate 6). This chimney was constructed of refractory bricks, and the northern face, which formed the southern side of the furnace chamber, was heat-affected, particularly in two areas which aligned with the ash pits, and the surviving chimney flues (Plate 7). Indeed, these vitrified patches appear to have been caused by a heat source located above the ash pits. There were two

flues (**273** and **174**) visible in the chimney stack, which were each $c 0.4\text{m}^2$, and were aligned on the two complete ash pits discovered within the furnace chamber. It was found that flue **273** was filled with red/purple degraded brick and lumps of fuel slag, whilst flue **174** had been blocked with consolidated fuel slag and badly degraded lumps of refractory brick, which would probably have rendered the flue unusable.

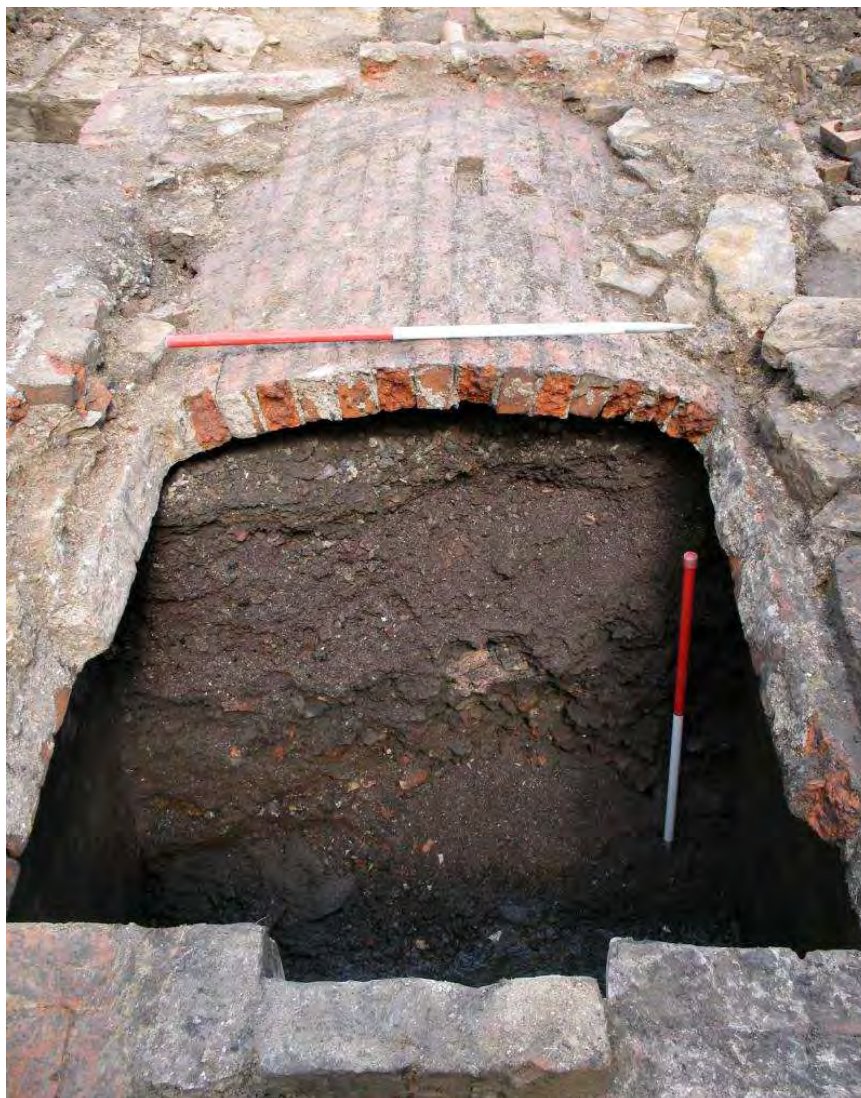
Plate 8: The barrel-vaulted chamber (Room 200) after excavation

- 4.4.9 Other excavated structures of significance, which date to this phase, but the position of which is not plotted on nineteenth-century mapping, include three subterranean brick-built vaults. One of these (Room **200**; Fig 3) lay beneath a flag surface (**118** and **161**; Fig 5), c 2.2 x c 3.4m in plan, and was constructed of two-course-thick walling (**192**, **246**, and **249**), which supported a barrel-vaulted roof (**193**) (Fig 3; Plate 8). The visible brickwork also indicated that at some stage the western side of this structure had been rebuilt (rebuilt **247** and **248**), whilst the eastern side of the vault was capped with stone (**191**). Internally, both the walls and the floor of the vault had been rendered with concrete. Although there was no access into the vault, a small square opening (**140**), 0.38m wide, was discovered in the flags overlying the vault. Moreover, the 1853 OS plan plots the position of a water pump in this position (Plate 3), which may suggest that the underlying vault functioned as a water cistern, supplying water to the adjacent houses. A curved brick wall (**123**; Fig 5) was located to the south of the vault, which is also identifiable on both the 1853 and 1890 OS maps (Plates 3 and 4), and this perhaps related to drainage in this part of the yard.

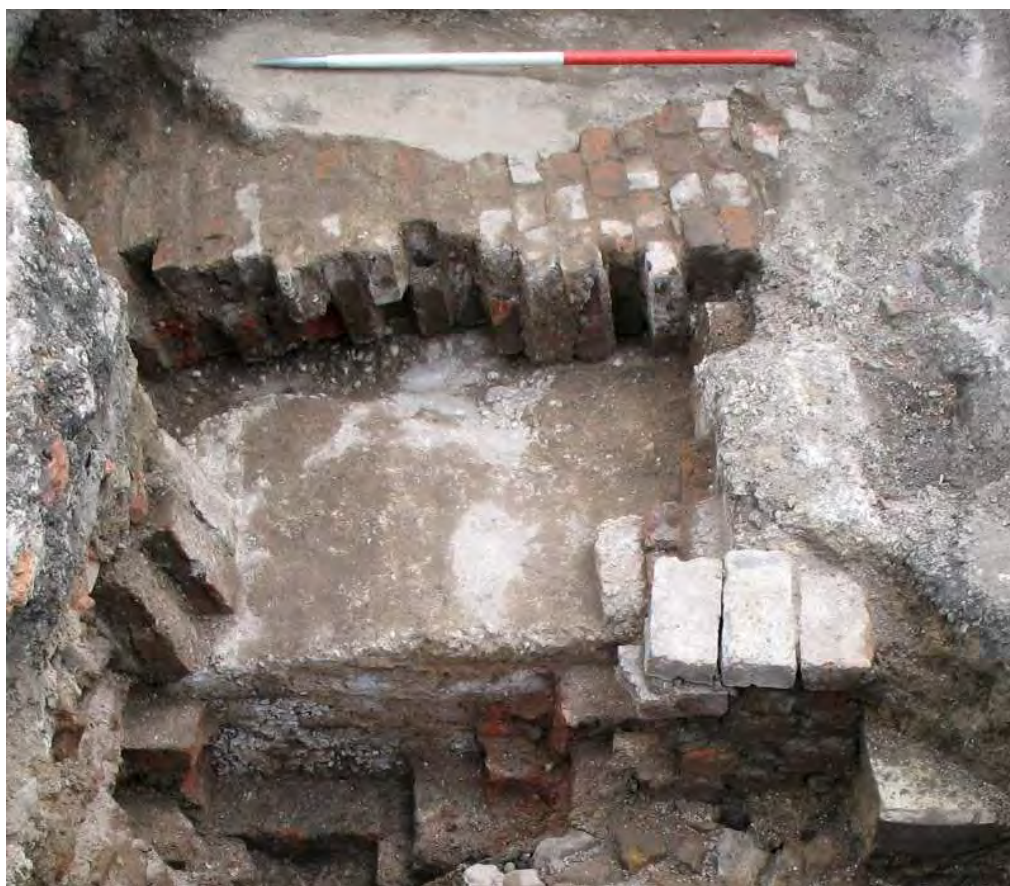
Plate 9: Vault (Room 231) with the roof and wall partially removed to reveal its concrete filling

- 4.4.11 The third vault was located close to the western margins of the excavation trench (Room **231**; Fig 3; Plate 9). Again, this structure was constructed of two-course-thick brick walling (**233**) supporting a brick vault (**232**), and nineteenth-century OS mapping indicates that it was positioned within a T-shaped building. As only a small portion of this vault was exposed, however, it was impossible to determine its full dimensions or, indeed, its function, particularly as the interior of the vault had been filled with concrete.

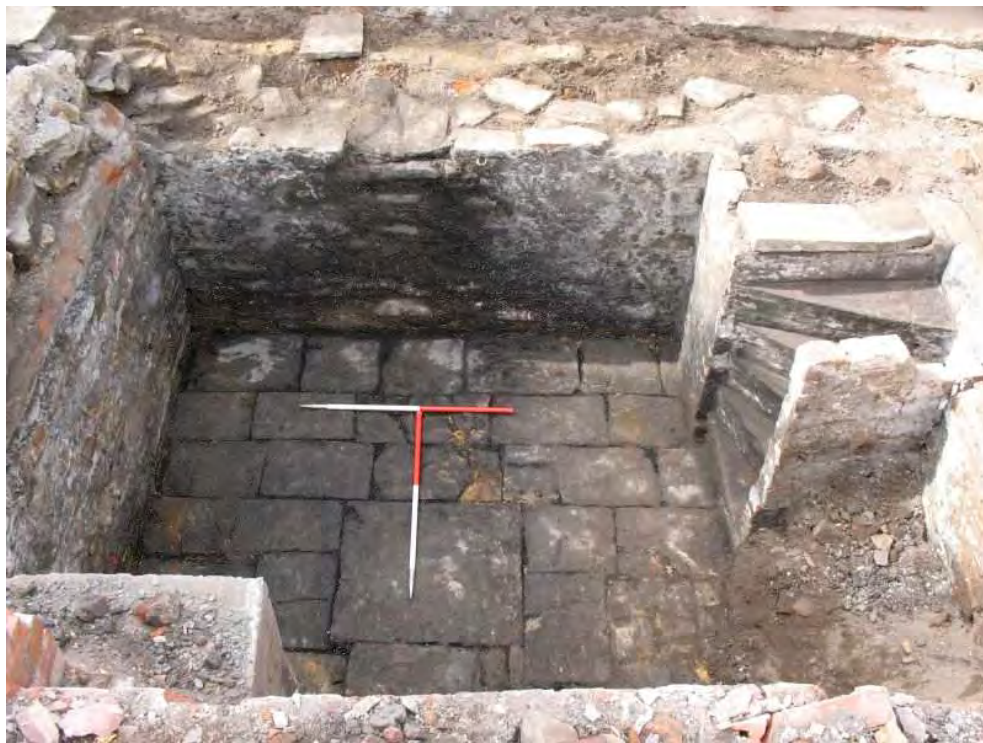
Plate 10: Cellar **100**, with staining visible on the wall

- 4.4.14 Both of the cellars (**100** to the north and **101** to the south) were found to be very similar in design and construction (Plate 10). They were both defined by

c 0.5m-thick sandstone walls (**104**, **106**, and **110**), cut into bedrock, and each had a barrel-vaulted brick-built roof. Although the vaulting in both cellars had been destroyed, it was evident that the vault originally sprang 1.24m above the floor of the cellars. This floor (**107**) was composed of sandstone flags and the interior of the cellars had been painted with a white/grey limewash.

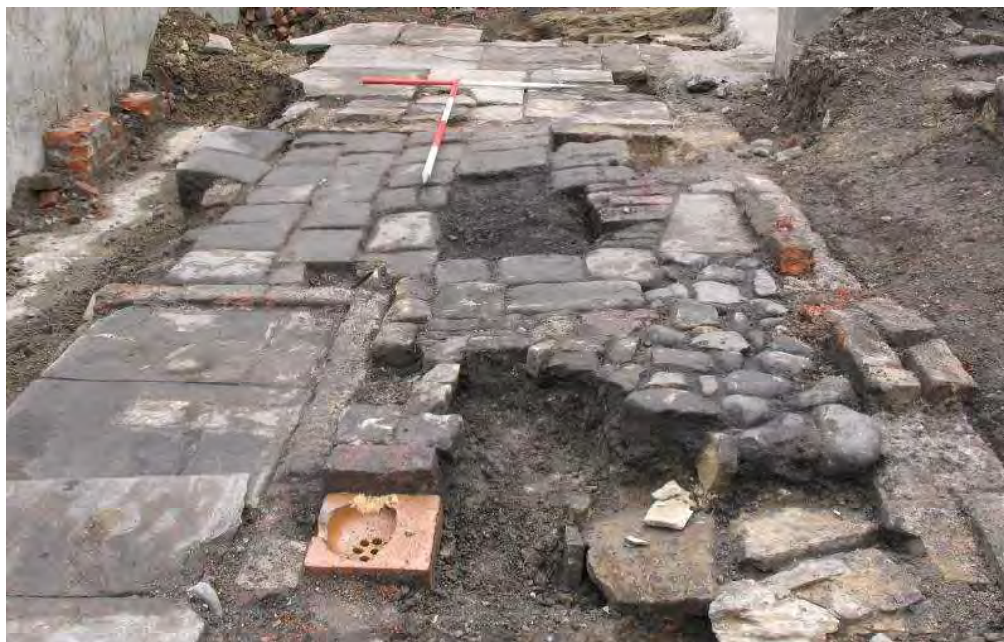
Plate 11: Yards and outshuts to the rear of the buildings fronting West Bar

4.4.18 To the west, immediately behind the early-mid-nineteenth-century buildings fronting West Bar, a small area of setts, flags, cobbles, and brick walling was exposed (Plate 11), which probably formed the remains of outshuts and an enclosed yard associated with these buildings. The positions of these features can be seen on both the 1853 and 1890 OS maps (Plates 3 and 4), but the features exposed by the excavation only covered an area of 8.25 x 2.3m, since much had been destroyed by later activity. This later phase of activity also obscured the relationship between the cellars and the outshuts. Only a small portion of brick walling (**159**), forming the western end of two of the outshuts, was present and, within the interior of these structures, a stone-flagged floor (**160**) was discovered.

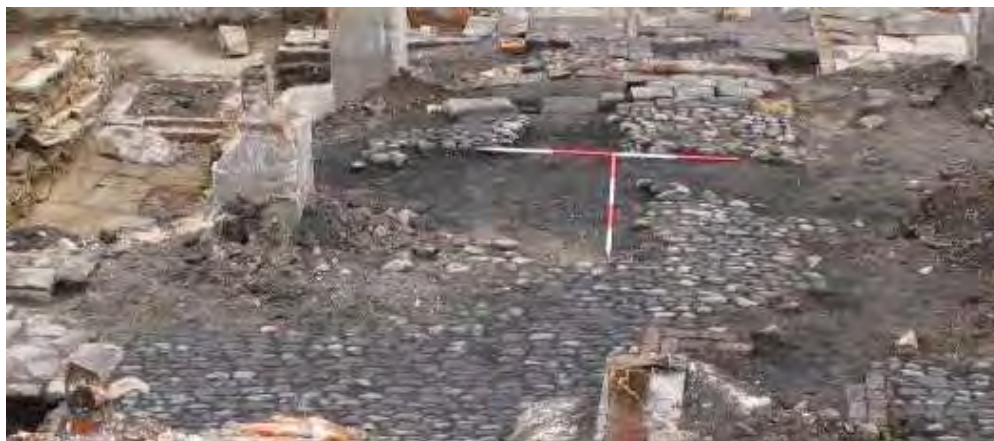
Plate 12: The central yard

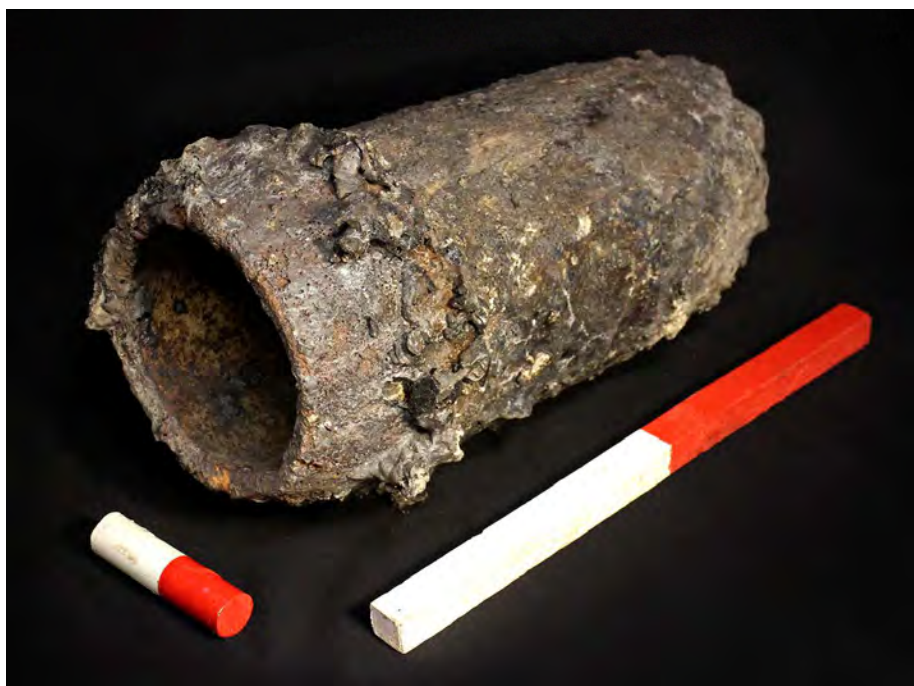
Plate 16: Complete crucible from backfill 199

- 5.9.1 An appreciable number of industry-linked artefacts were recovered. These included crucibles and crucible lids, together with ingot moulds. The crucibles, all from the backfill of cistern **190 (199)**; Plate 16), were largely fragmentary, but one complete example was recovered, standing *c* 470mm high. It tapers outwards slightly from a base with a diameter of *c* 140mm, to a mouth of *c* 170mm. It was badly affected by heat, being extensively blistered and partially vitrified, but the lip survived largely undistorted, giving an original wall thickness of *c* 10mm. Fragments of at least two other crucibles, probably of similar dimensions, were also amongst the assemblage. There was, in addition, a sample of three crucible lids, retained from an original group of 12. All are now distorted, but have an original diameter of *c* 150mm. They were probably originally discoidal, but use had caused some distortion, giving them a slightly domed cross-section. Other materials recovered included gannister and chunks of vitrified furnace lining (from flue **174**), which incorporated fuel slags.
