Burnley Campus (Barden High School), Heald Road, Burnley, Lancashire

Archaeological Building Recording Survey

Oxford Archaeology North

March 2010

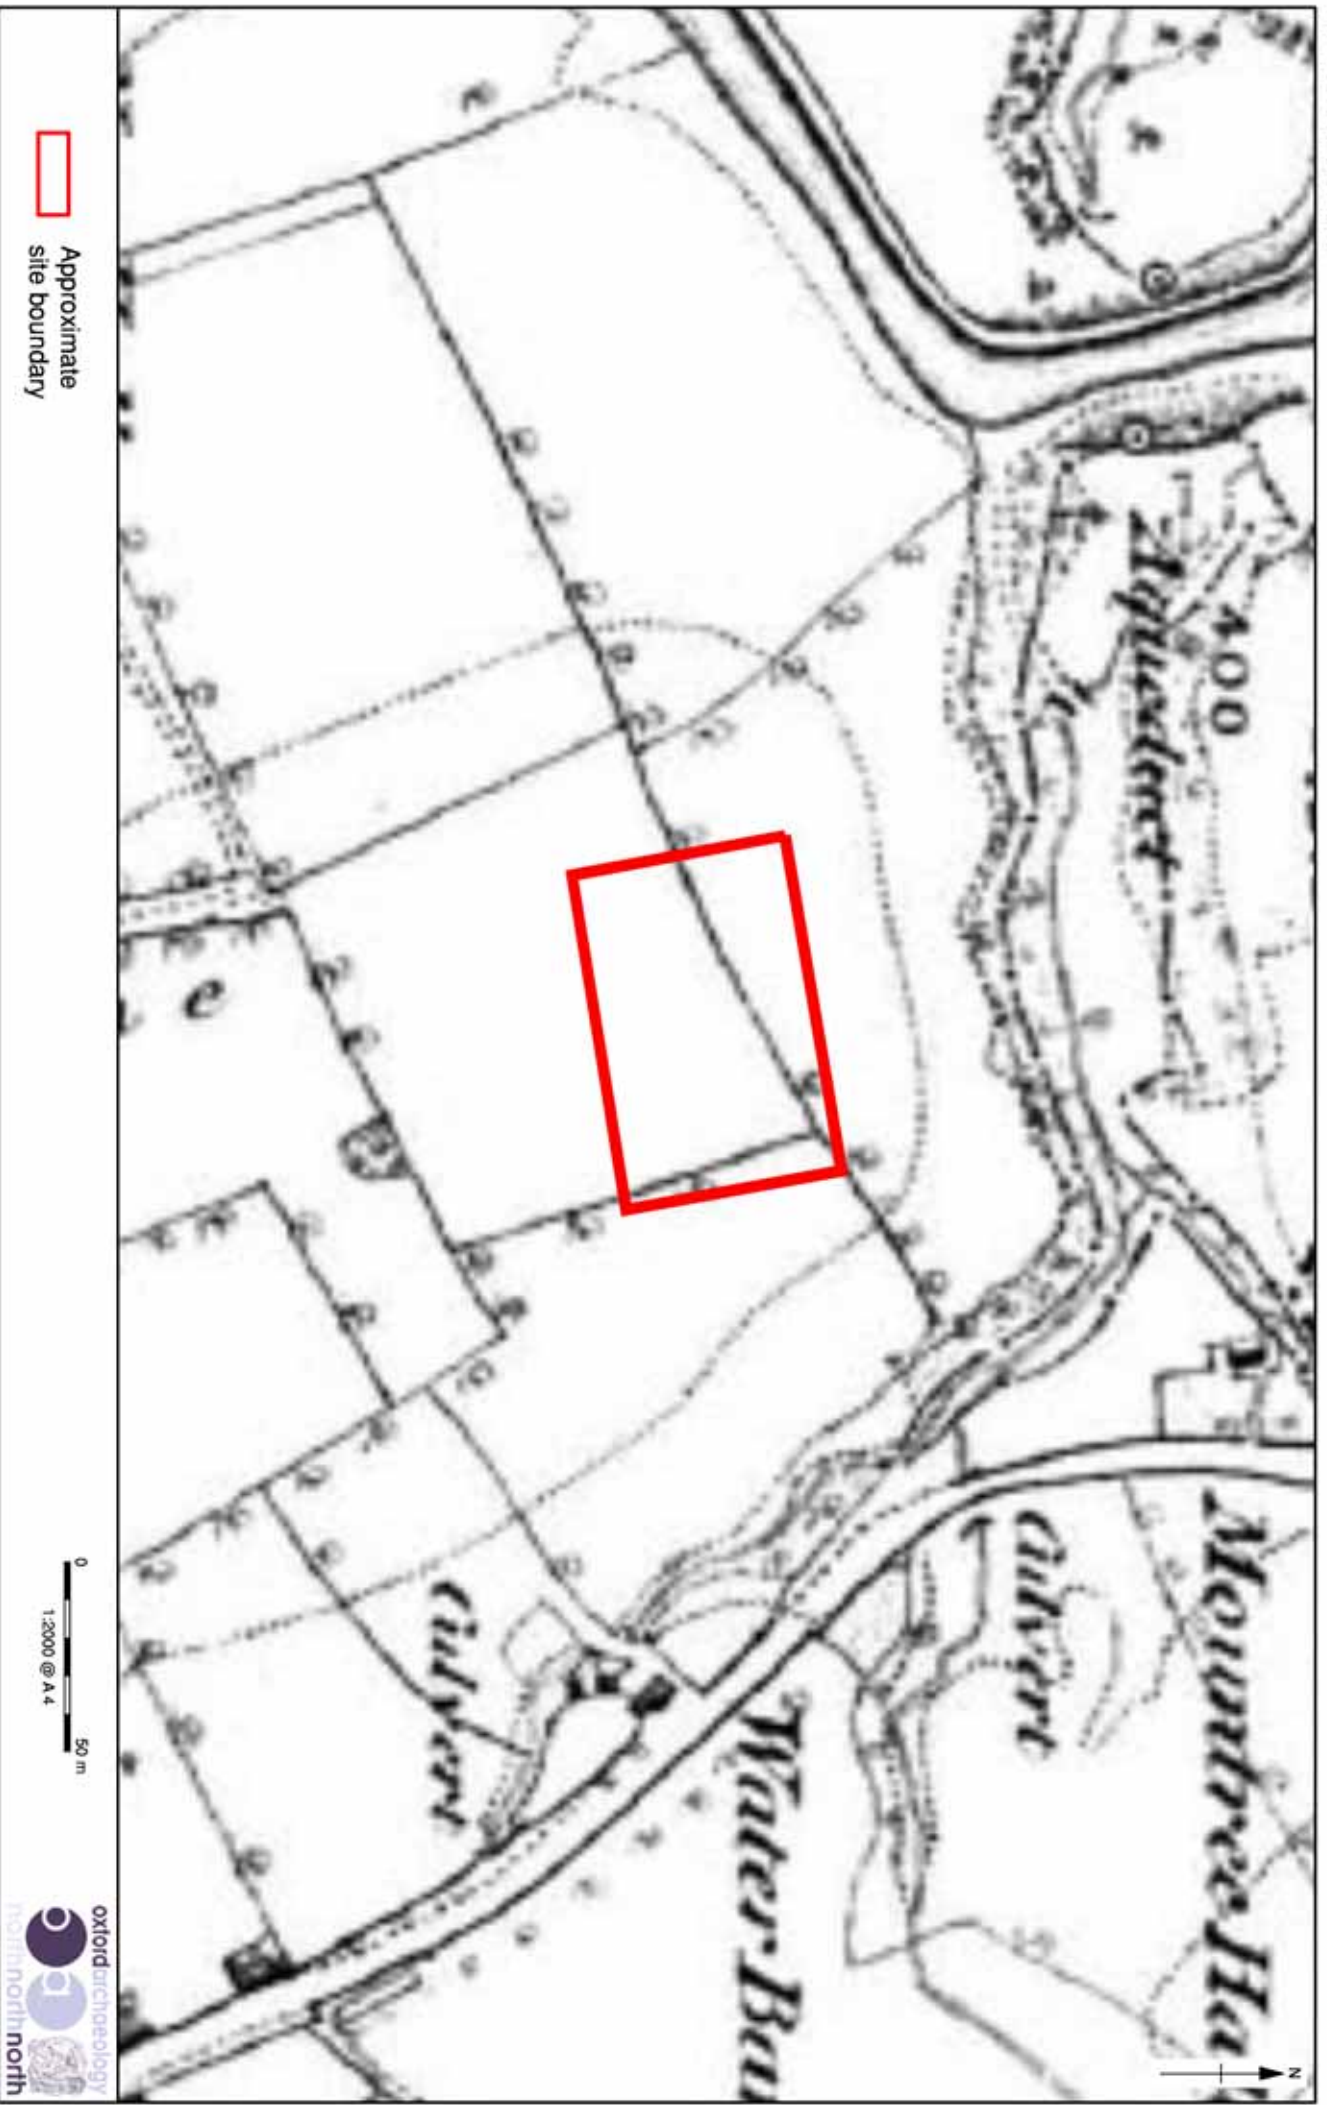
Figure 3 : Ordnance Survey First Edition 6" to 1 mile map, 1847

3.4.2 **Ordnance Survey First Edition 6" to 1 mile map, 1847 (Fig 3):** this map is more detailed than Hennet's but still shows the area to be undeveloped. The site of the school is open fields at the end of Burnley Old Lane.

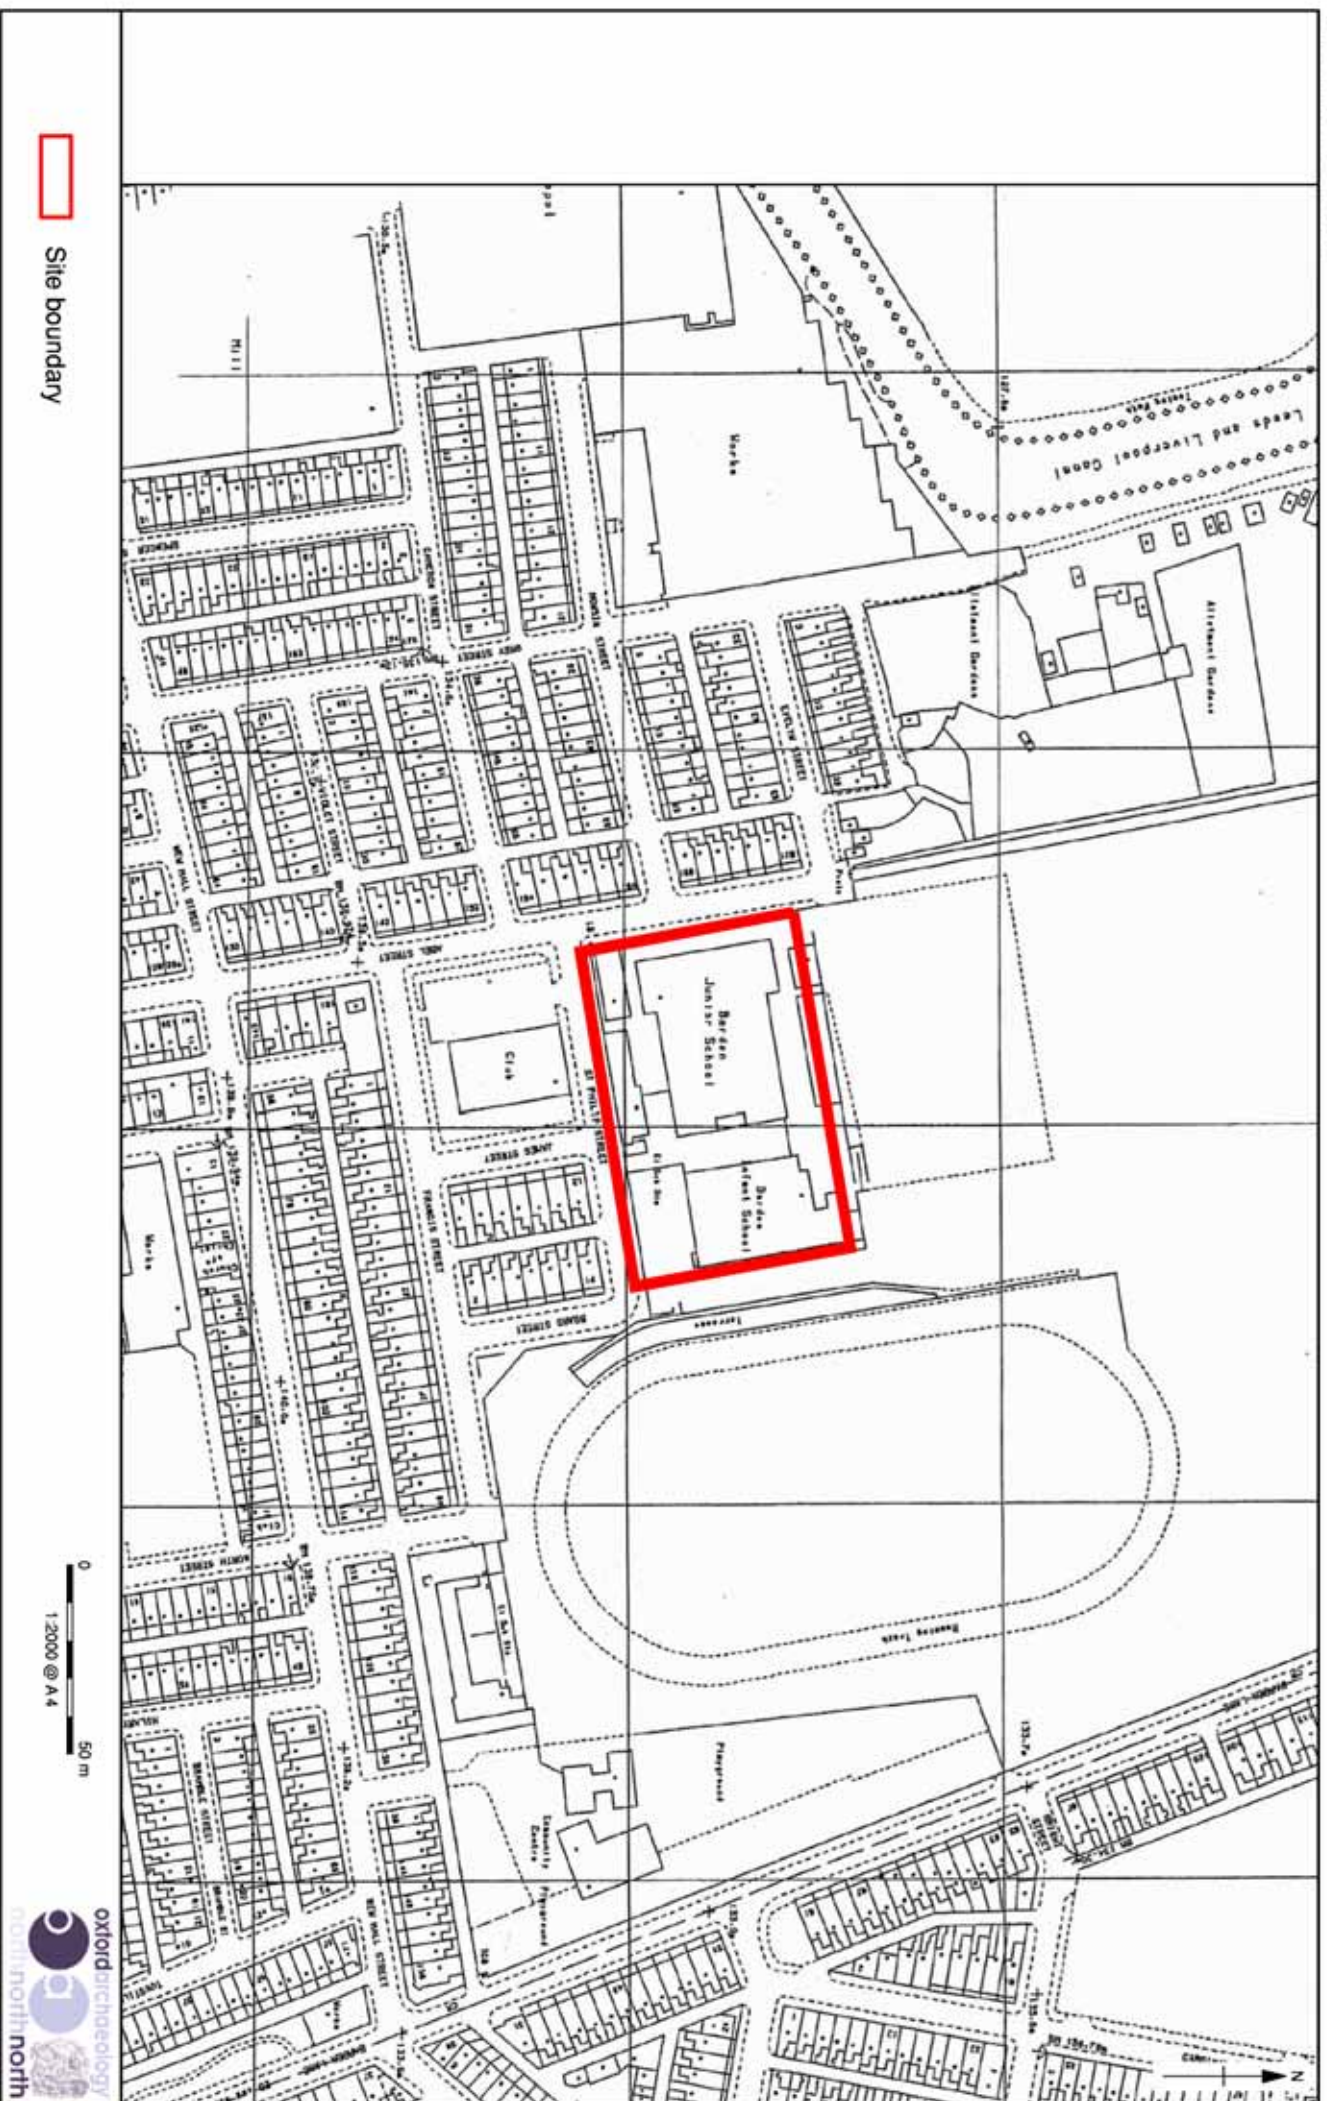
Figure 7: Ordnance Survey 1:1250, 1994

3.4.7 **Ordnance Survey 1:1250, 1994 (Fig 7):** changes to the surrounding area are quite marked on this map with the construction of the running track to the east and replacement of St Margaret's Church by a building labelled 'Club'. Further extension to the Infants buildings, now shown as Barden Infant

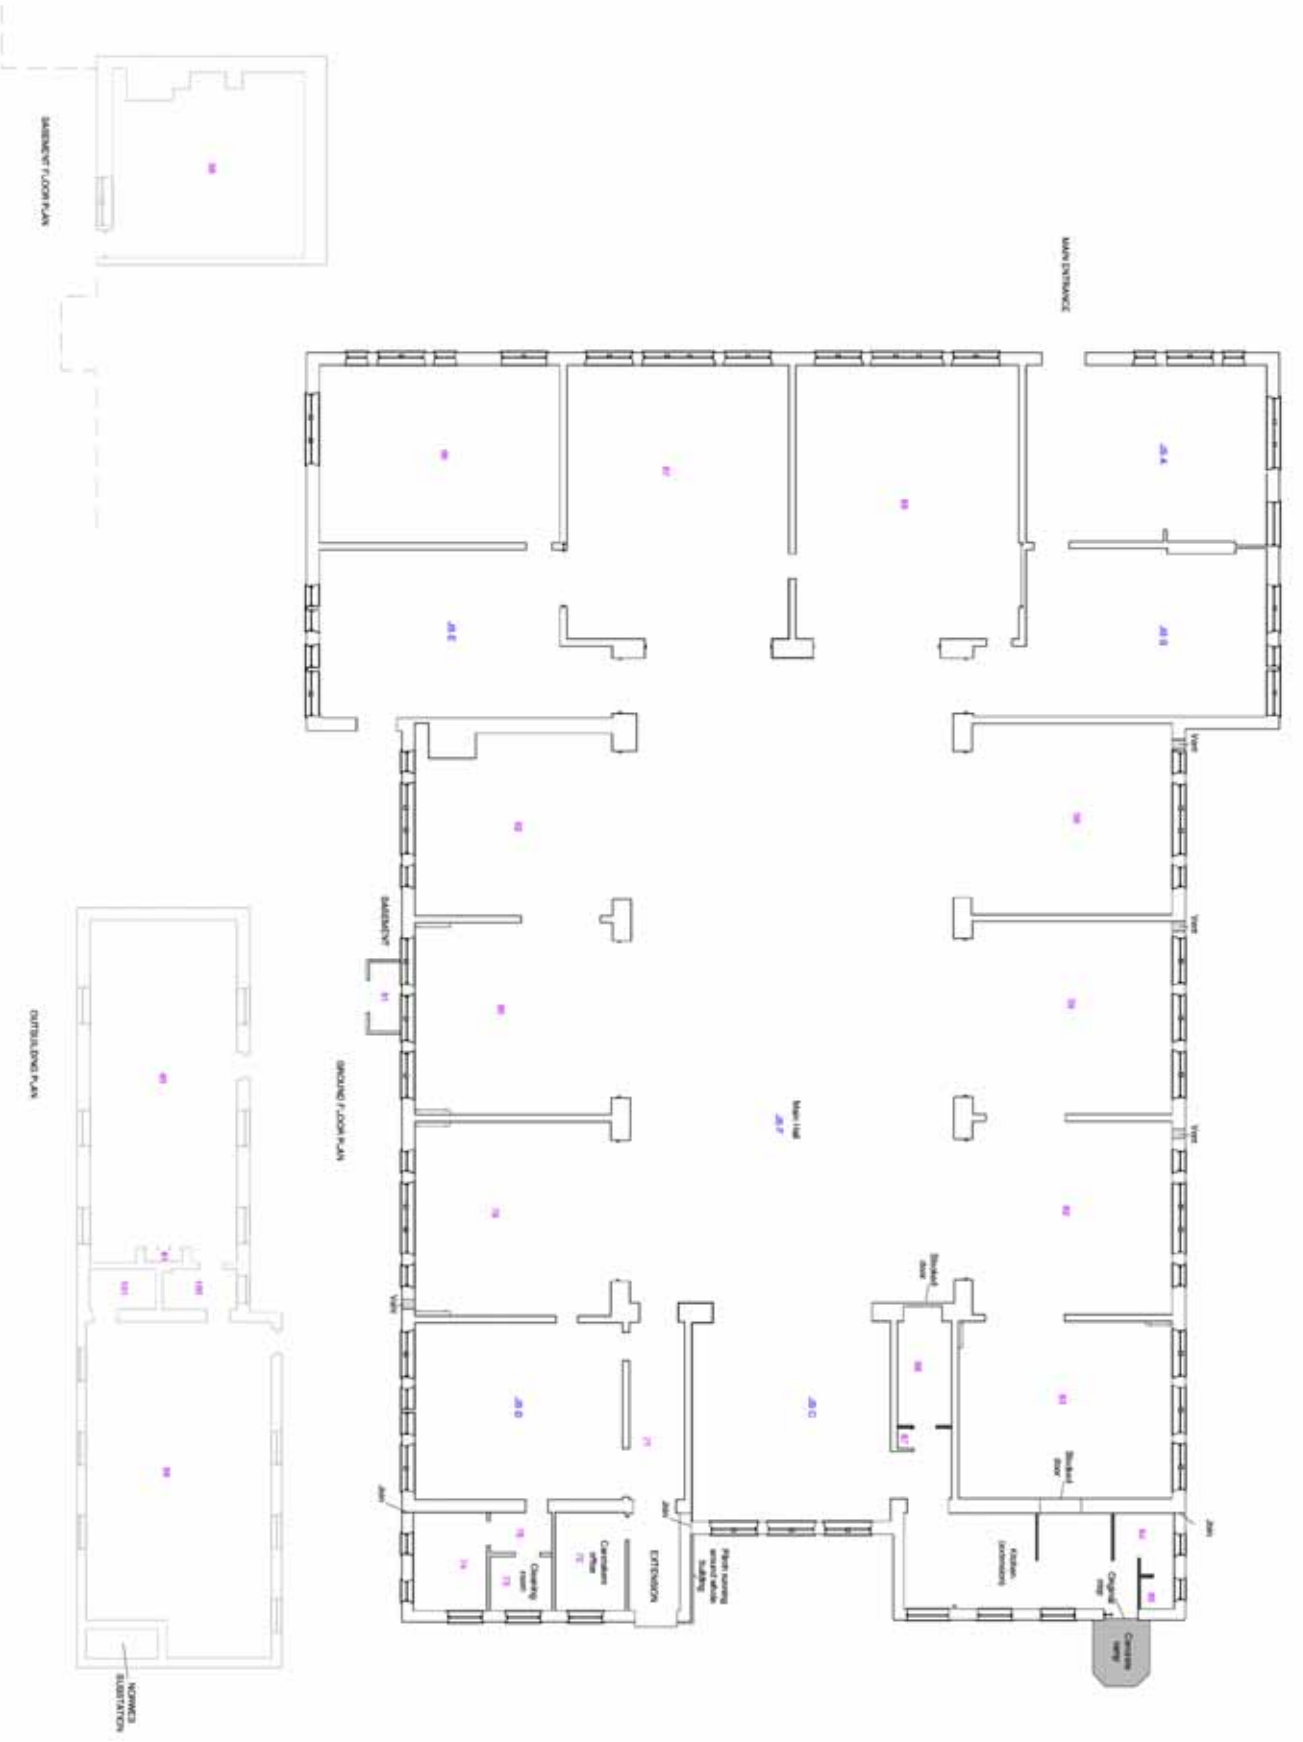
Figure 10: Ground floor plan of the Junior School and Science Building after soft strip

- 4.3.19 Following the internal strip, all of the partition walls that divided these rooms were found to be modern and were removed (Fig 10). This revealed that, structurally, the rooms had been created from a single large space (Room JS-A, Fig 10, Plate 18). This revealed the original height of the ceiling to be approximately 4.1m and divided into two parts by twin RSJs. The larger part of the ceiling has canted sides, whilst the other is pitched and follows the line of the roof over the former Boys' entrance. The full height of the fenestration was revealed, and the whole floor was laid down to herringbone wooden blocks over concrete and fixed with bitumen. There was a hearth (with brown square tiles) located at the east side of the room, indicating the presence of a fireplace. A similar hearth was present in the adjacent room.

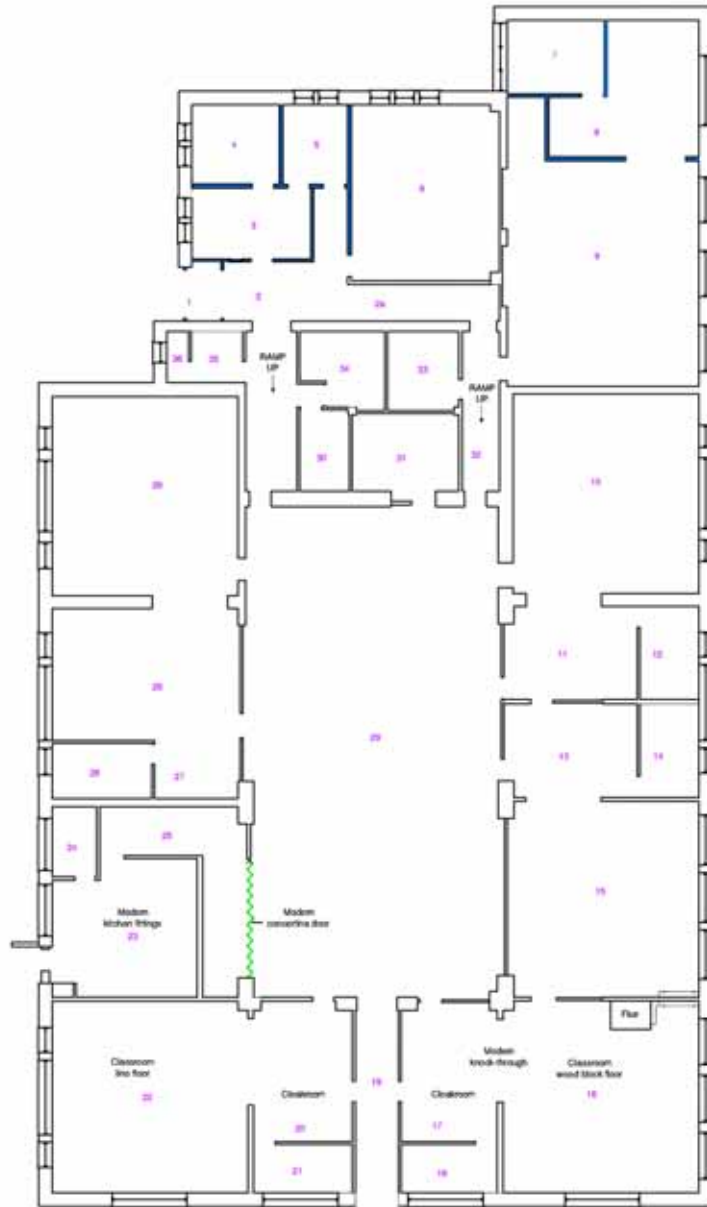
Figure 13: Ground floor plan of the Infant School prior to soft strip

4.4.30 **Rooms 11-14 (Room IS-C):** prior to soft stripping, these rooms consisted of toilets and cloakrooms (Fig 13). These were all of late twentieth century appearance and identical to those already described. The floors in Rooms 12 and 14 were laid down to vinyl, whilst Rooms 11 and 13 had herringbone block floors. There was a small section of checkerboard wooden block floor in Room 13 that appeared to have been inserted later and suggested either the floor was repaired or that there had been an additional smaller room.

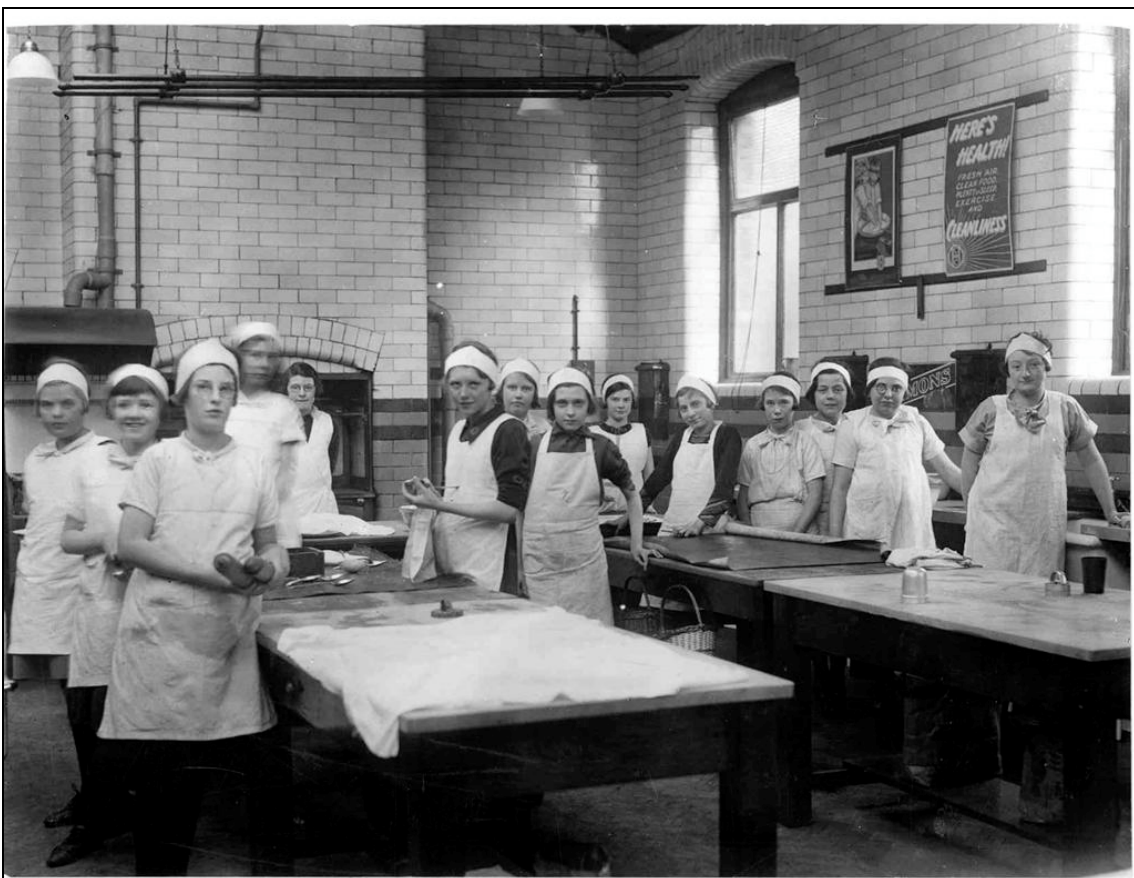
Plate 4: Photograph of Room 60, undated (possibly 1920s)

- 3.3.17 **Photograph of Room 60 undated (possibly 1920s), Plate 4:** this photograph is undated, but the general appearance suggests a mid-twentieth century date. This shows the appearance of one of the rooms in the science block (Room 60), which has changed little since this photograph was taken. One major change is the removal of the range cooker in the fireplace that has been replaced by a cupboard. There appear to be sinks and work surfaces along the wall, which are no longer present.

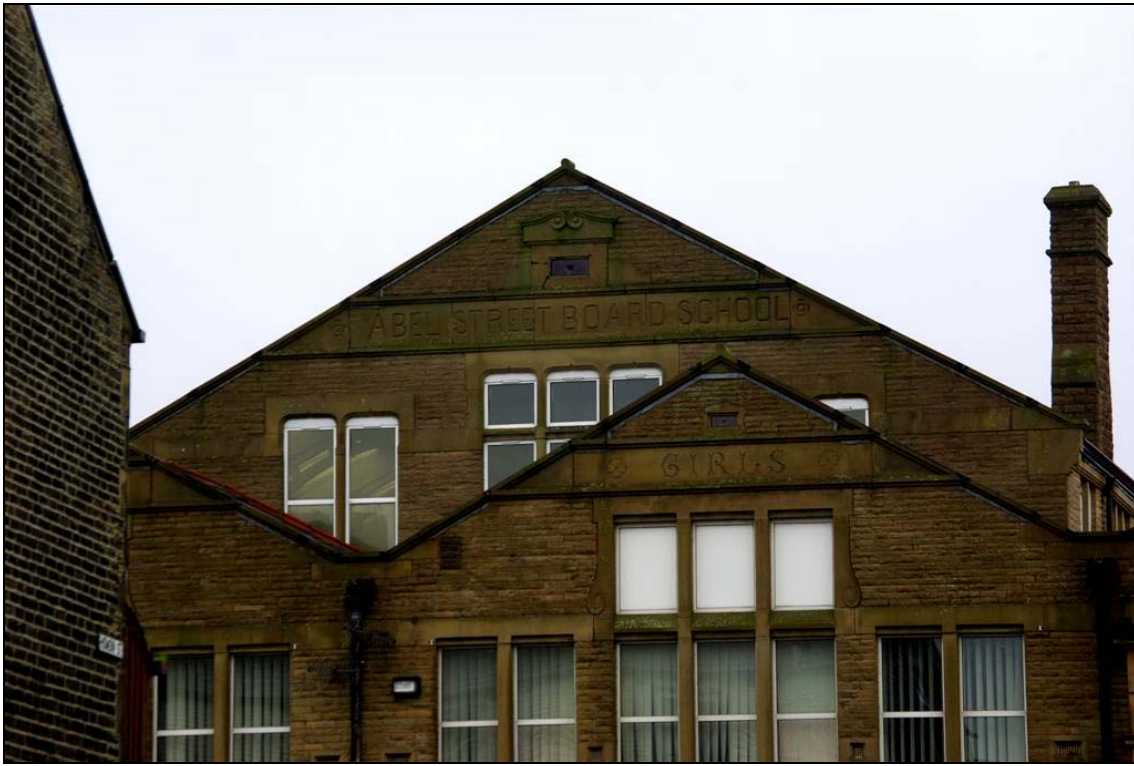
Plate 12: View of west elevation of the main hall of the Junior School

3.2.1 The school was originally called Abel Street Board School, the name adorning the upper west gable of the same structure (Plate 12). It was located at the northern end of the Daneshouse area of Burnley, to the south of the historic township of Reedley Hollows, and within the Forest of Pendle (Farrer and Brownbill 1912). This area was mainly developed in the latter part of the nineteenth century, as can be seen by comparing the Ordnance Survey (OS) maps of 1847 and 1893 (*3.4.2 and 3.4.4*, Figs 3 and 4). By 1882 Daneshouse was a suburb detached from the main town (LCC 2005), although rapid development of the Daneshouse Mills area led to its expansion and eventual submergence with the expanding industrial town of Burnley by around 1893 (Farrer and Brownbill 1912, 489).

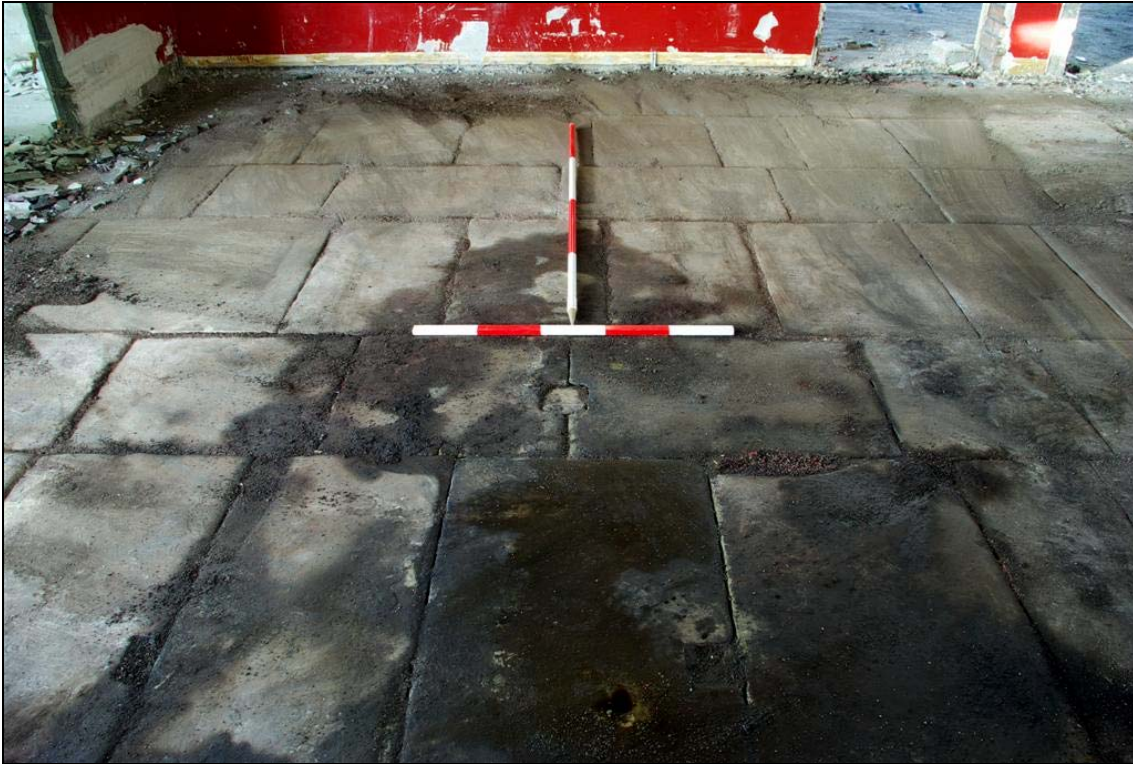
Plate 34: Flagged floor in Room 83 (JS-E)

Rooms 84 and 85 were not removed during the strip their cinder block construction was clearly visible. There was a large full height aperture leading into Room 87, which was of similar appearance to the partially blocked opening in Room JS-B. This had been modified and it was not possible to ascertain whether it was original. However, there was a tall opening leading into the main hall that was probably original. During the stripping, the vinyl floor was removed to reveal a flagged floor in good condition, albeit for some holes and notches relating to former fixtures (Plate 34). The average size of the flags was approximately 0.9m by 0.6m.

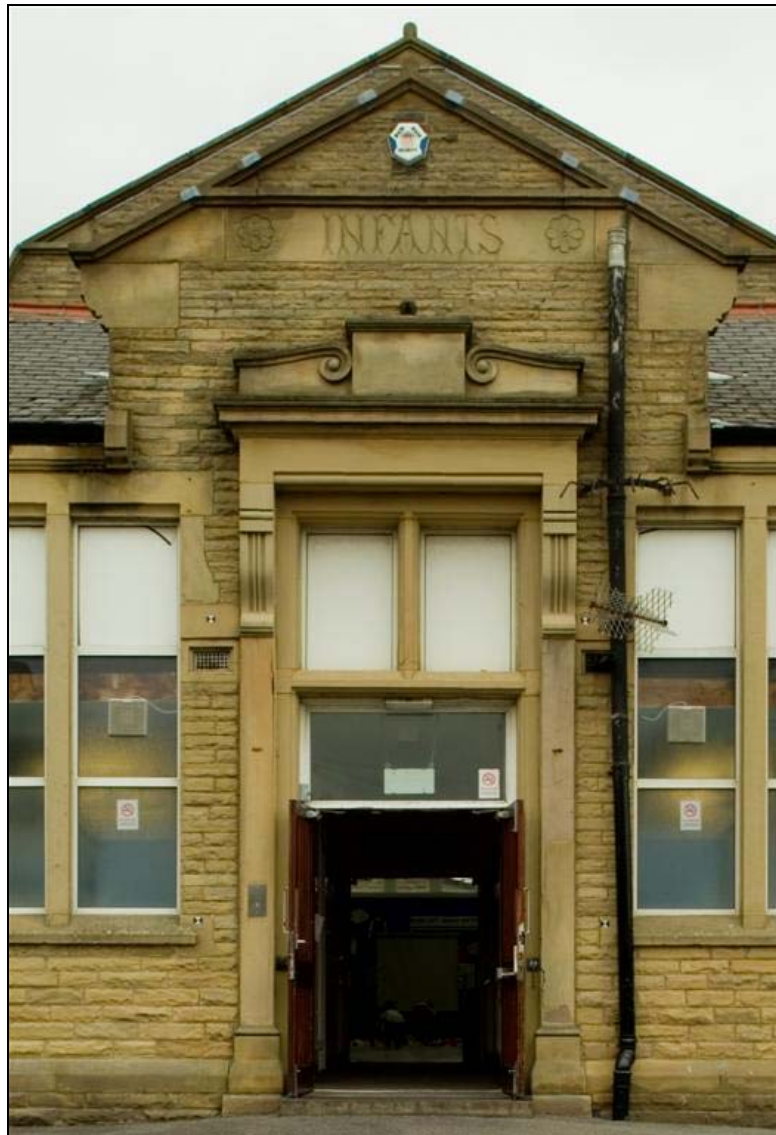
Plate 45: Main Entrance of the Infants School

- 4.4.9 The doorway was decorative in a manner similar to those on the Junior School (see 4.3.10) principal elevation, albeit with some slight differences (Plates 10, 11 and 45). There was a stone mullion transom light above the door, over which is a hood mould with scrolled volutes and centre block (pediment missing). Above the door is a small gablet with kneelers, and a flat panel inscribed with 'INFANTS' in the same script as those on the main elevation of the Junior School, although the two flower motifs differ slightly.

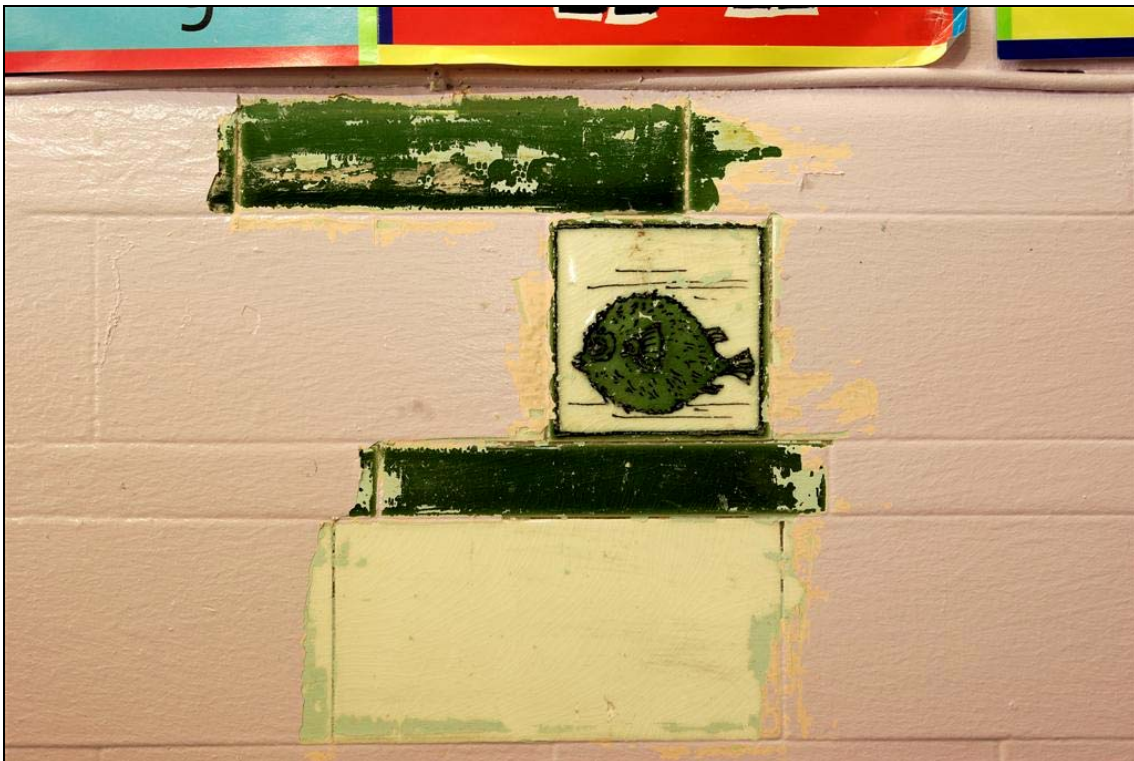
Plate 59: Decorative tiles in Room 9

4.4.38 Upon closer inspection it was revealed that all the rooms contained areas of wall tiles that were painted over and/or concealed. Most of these were plain red or white, but the tiles in Room 9 were found to be patterned and comprised mainly cream tiles with a green band and trimmer, and individual tiles with illustrations of various animals (Plate 59). The tiles covered the walls up to dado height (0.92m) (Plate 60).
