# Godmanchester Flood Alleviation Scheme

## Archaeological Evaluation Report

## **Godmanchester Flood Alleviation Scheme**

*Watching Brief*

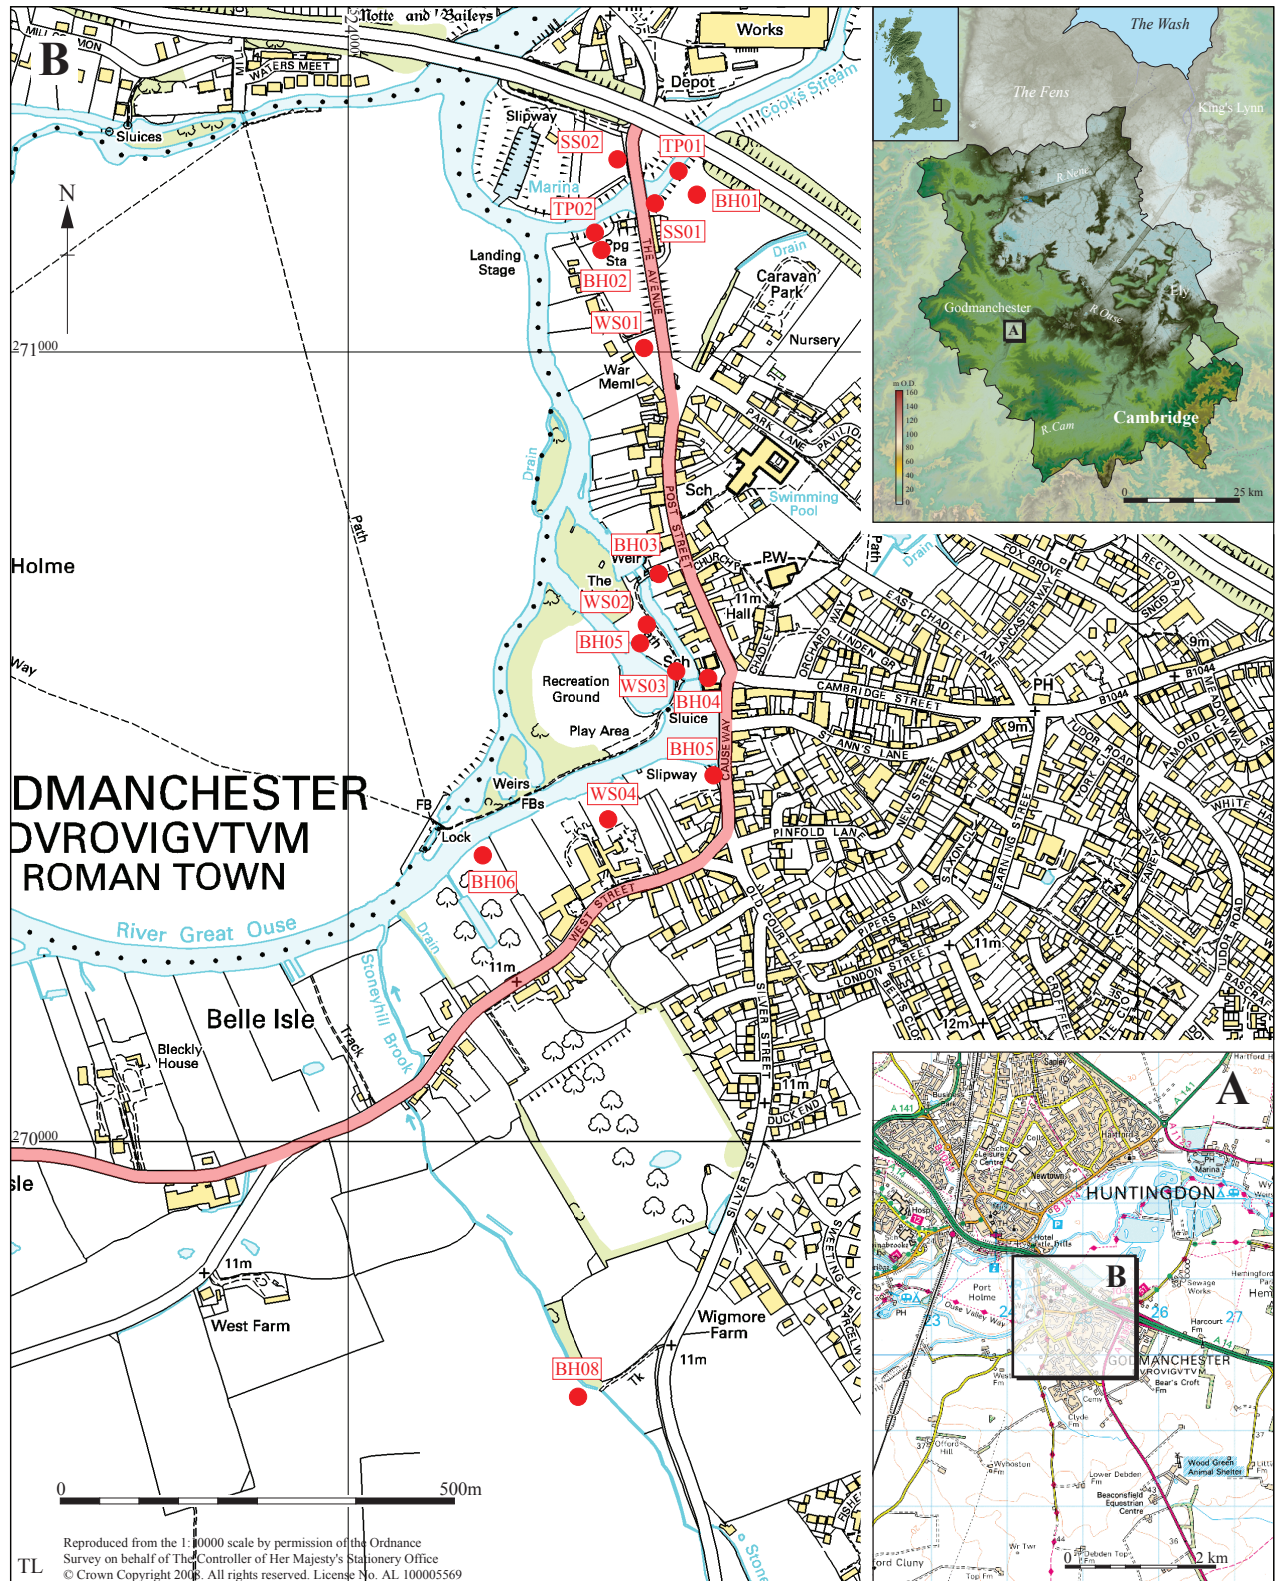
Figure 1: Location of Boreholes in red with focus area highlighted.

- 3.1.3 The area of investigation took in much of the main centres and western side of Godmanchester, with the various probing works being scattered along the line of The Avenue, Post Street, Causeway and West Street. Following the line of the river Great Ouse which runs through the centre of, and then out toward the west of Godmanchester. The location of these works is illustrated in figure 2.
