Bulstrode Park Gerrards Cross Buckinghamshire

Building Recording and Archaeological Watching Brief Report

Document Type: Watching Brief and Historic Buildings Survey

BUILDING RECORDING AND ARCHAEOLOGICAL WATCHING BRIEF REPORT

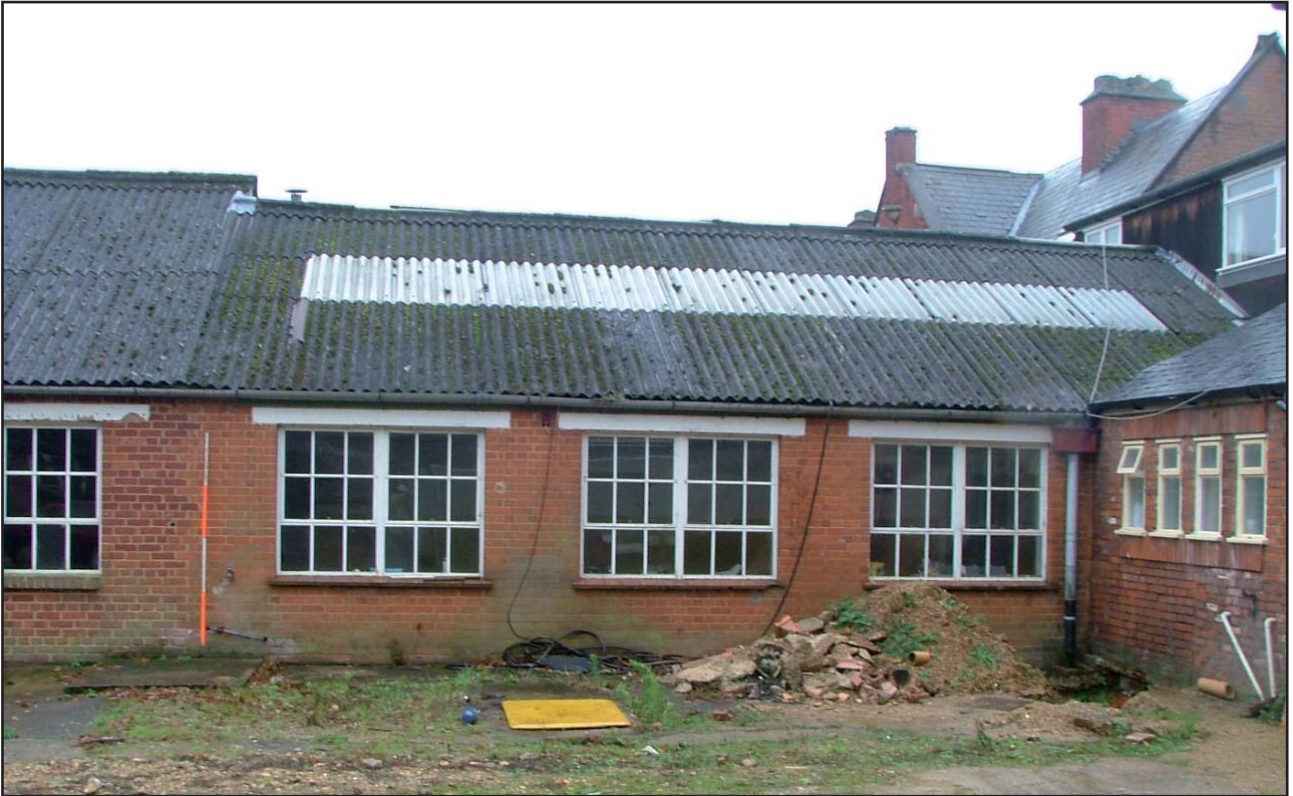
- 3.1.1 This building measured 23.9 m long by 11.9 m wide and butted up to the eastern face of the stable block. The building appears to have been constructed in 2 phases, the western block (Plate 1), which butts up to the stable block, and the eastern block which is joined to the east end of the western block (Plate 2).

- 3.1.2 The western block measured 10.3 m long by 11.90 m wide, with the height at the eaves 2.3 m rising to 5.2 m at the apex of the gable. The building was constructed using a plain red machine made brick measuring 0.217 m by 0.112 m by 0.065 m bonded with a cement mortar laid using English stretcher bonding. The windows were constructed using rolled steel bars, with 3 equally sized (1.9 m X 1.3 m) windows sited in the north wall and a single 1 m square window located in the south wall. The roof was constructed using corrugated asbestos sheeting over steel angle iron trusses. The ridge of the roof was slightly off centre to the north, with the southern side of the roof at a more shallow pitch than the northern.

Plate 1: Western end of print shop

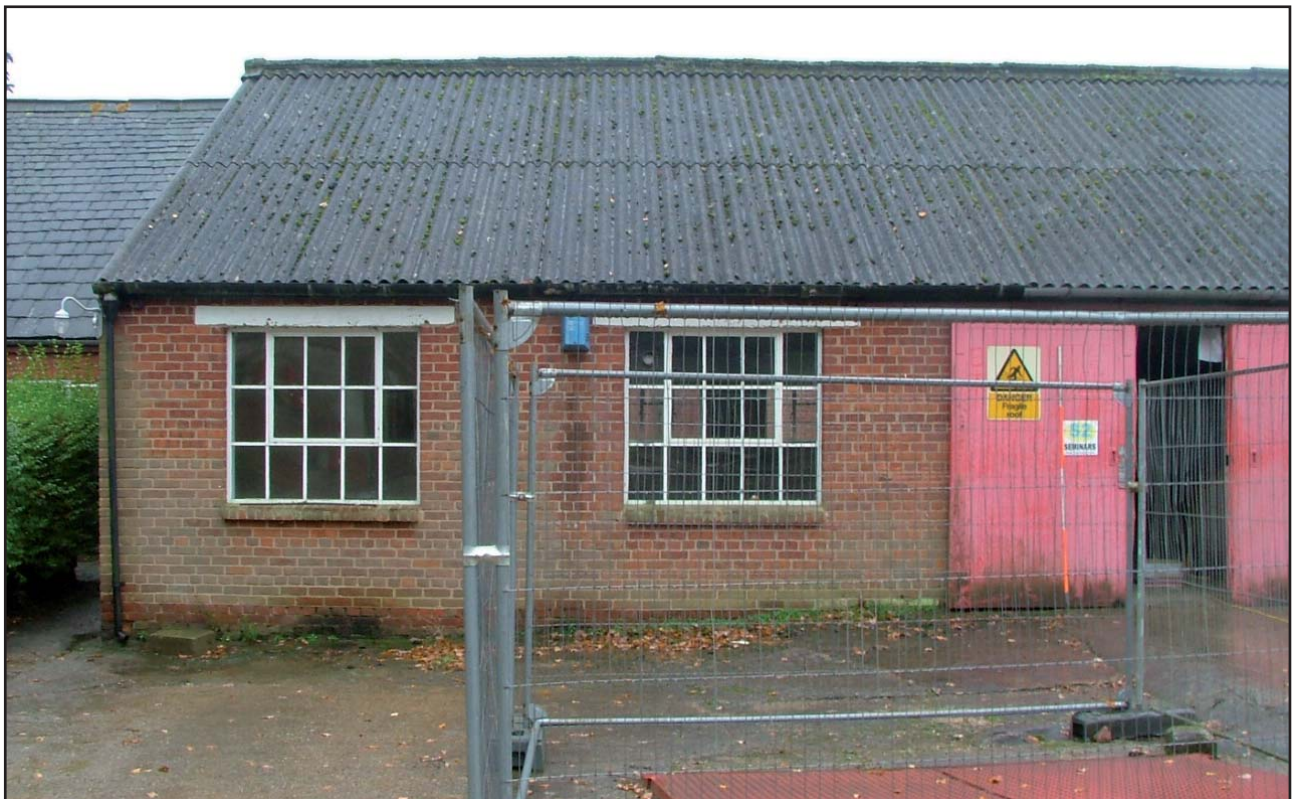
- 3.1.3 The eastern block measured 13.6 m long by 11.9 m wide, 2.3 m at the eaves rising to 5.6 m at the apex of the gable. This part of the building was constructed with a red machine made facing brick of the same size to that used in the western block, laid with cement mortar using English stretcher bonding. The brickwork between the two blocks was tied in to each other. In the north wall of the block were two 1.9 m by 1.3

Plate 2: Eastern end of the print shop

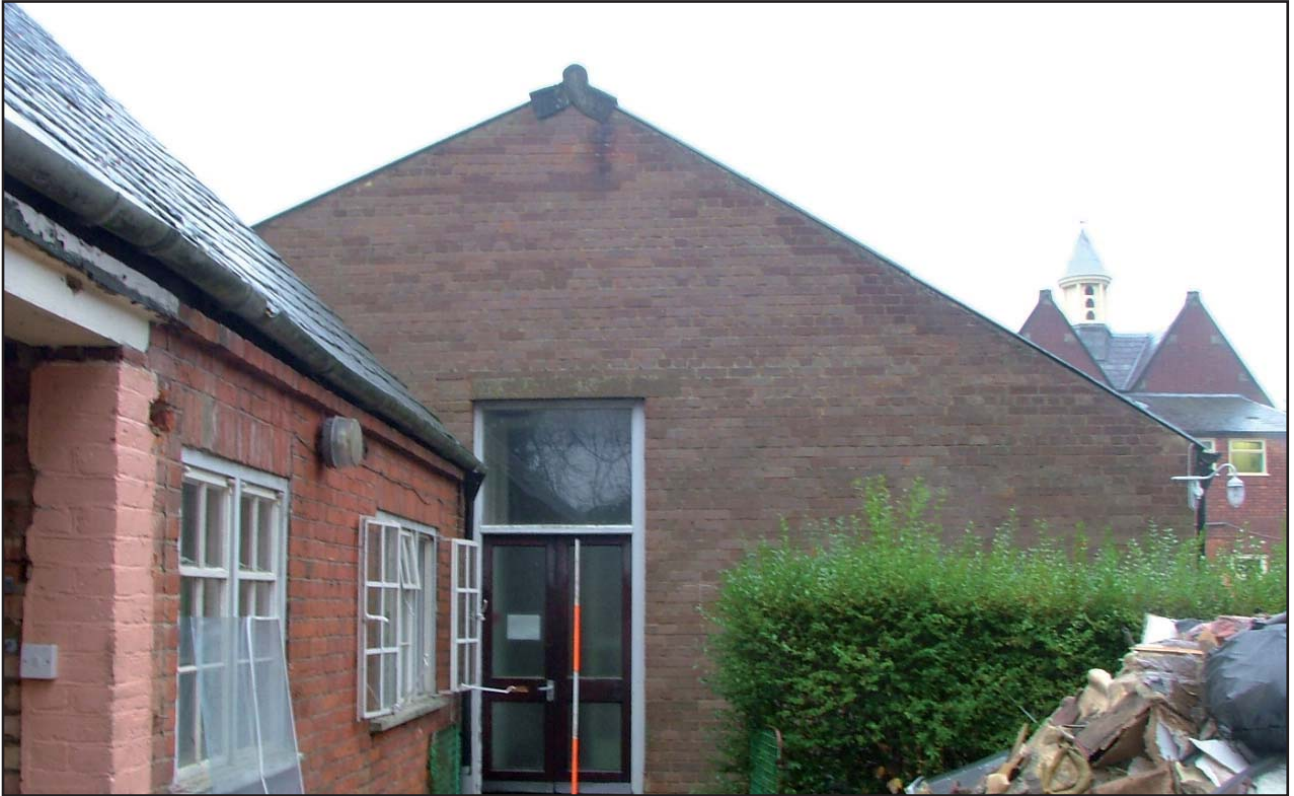
- 3.1.4 Within the east gable of the building were a double set of wood and glass doors centrally placed and measuring 2.1 m high by 1 m wide (Plate 3).
- 3.1.5 Internally the western block had 2 store/boiler rooms each 2.8 m wide by 5 m long built against the south wall. The eastern block had two offices and a storeroom built in the south-east corner of the building, each measuring 2.5 m by 3 m, and all constructed using stud and plasterboard partitions.

Plate 3: East gable of print shop

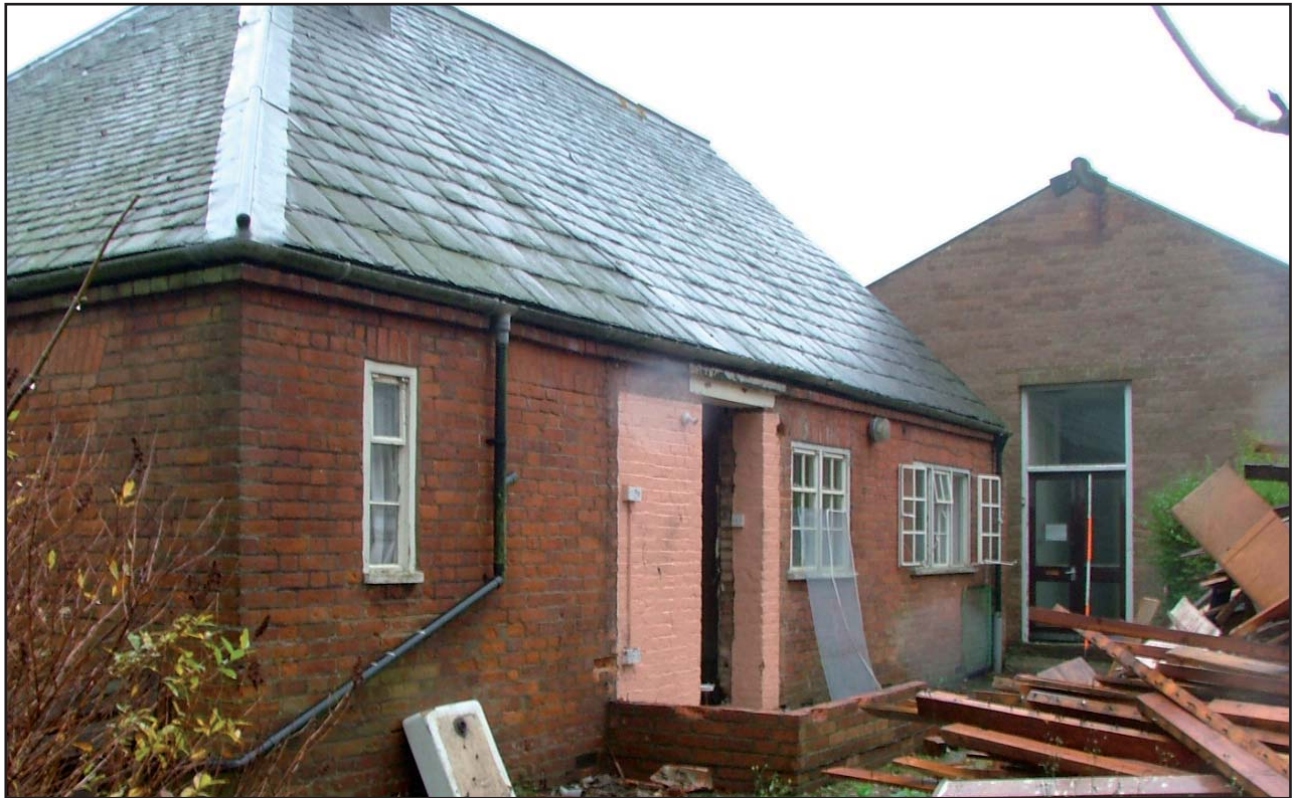
- 3.1.9 The 3 windows in the north wall measure 1.6 m wide by 1 m high, 1.1 m wide and 1 m high and 0.3 m wide and 1 m high respectively (Plate 4). These were constructed using rolled steel framing and are probably replacement windows, possibly installed when the building was converted into a cottage. The east wall had a 1.1 m wide by 1 m high window leading into the kitchen and a 0.38 m wide by 0.48 m high window leading into the bathroom (Plate 5). Also within the east wall were 3 bricked up windows, 2 measuring 0.9 m wide by 0.8 m and 1 measuring 0.8 m square.

Plate 4: North wall of print shop

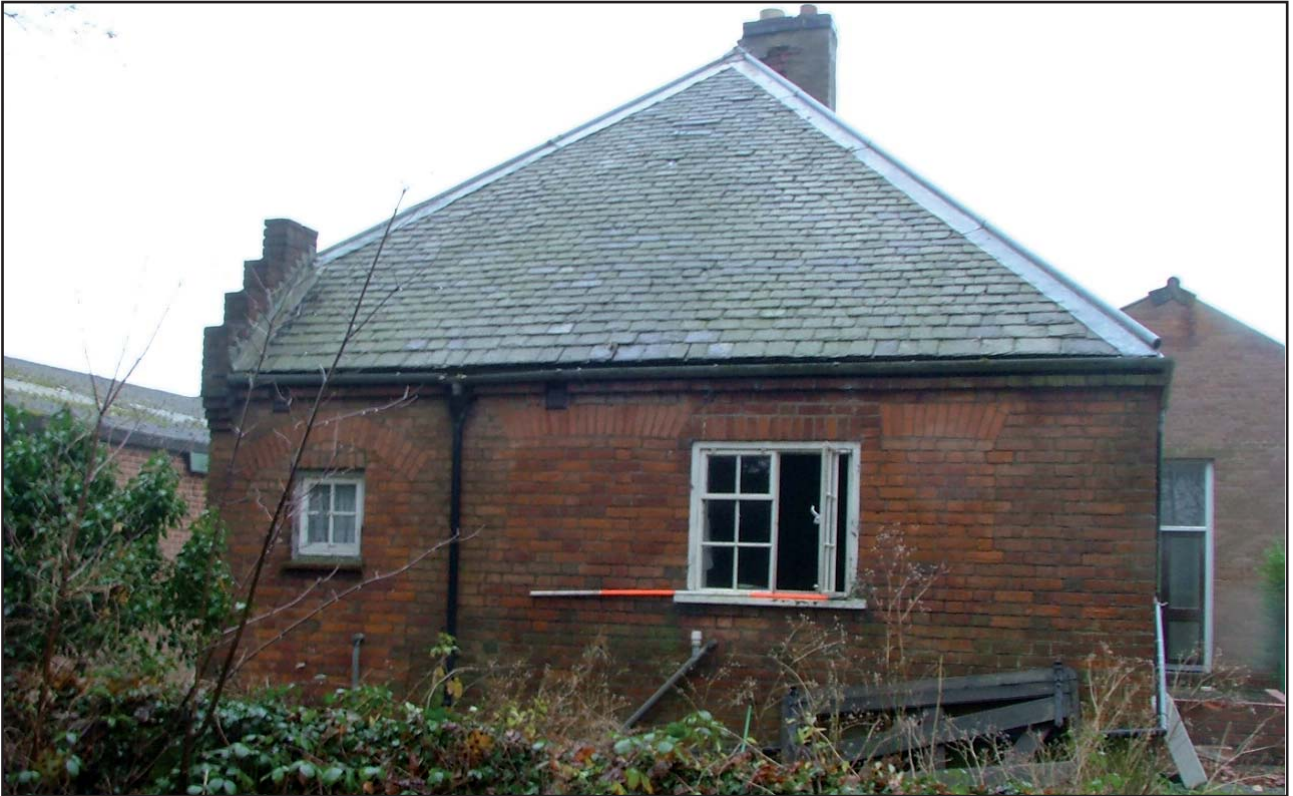
- 3.1.7 The north, south and east walls were all constructed of a plain red brick measuring 0.222 m x 0.10 m x 0.062 m laid using Flemish stretcher bonding with a lime mortar. The west wall consists of clay tiles hung on a single skin brick wall (Plate 6), and which possibly represents an original internal wall.

Plate 5: East wall of staff cottage

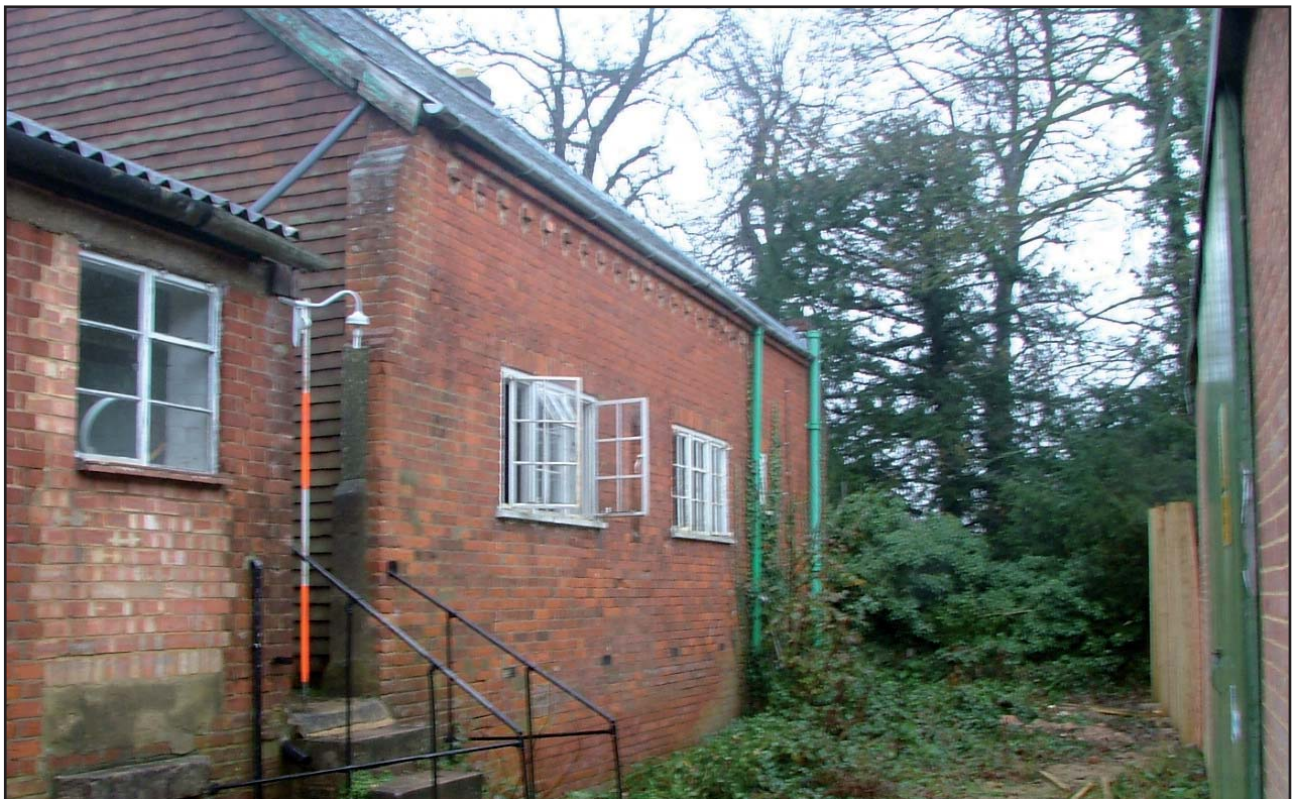
- 3.1.10 In the south wall were 3 windows, 2 measuring 1.6 m wide by 1 m high opening from a bedroom and the living room, and a 0.3 m wide by 0.4 m high window opening from what may have originally been the pantry (Plate 6). As on the northern wall these were rolled steel construction and were most likely replacement windows. The

wall was built using a similar brick and construction to the north and east walls, although there was a casellated decorative spur of brickwork rising above the south-east corner of the cottage.

Plate 6: South and west walls of the staff cottage

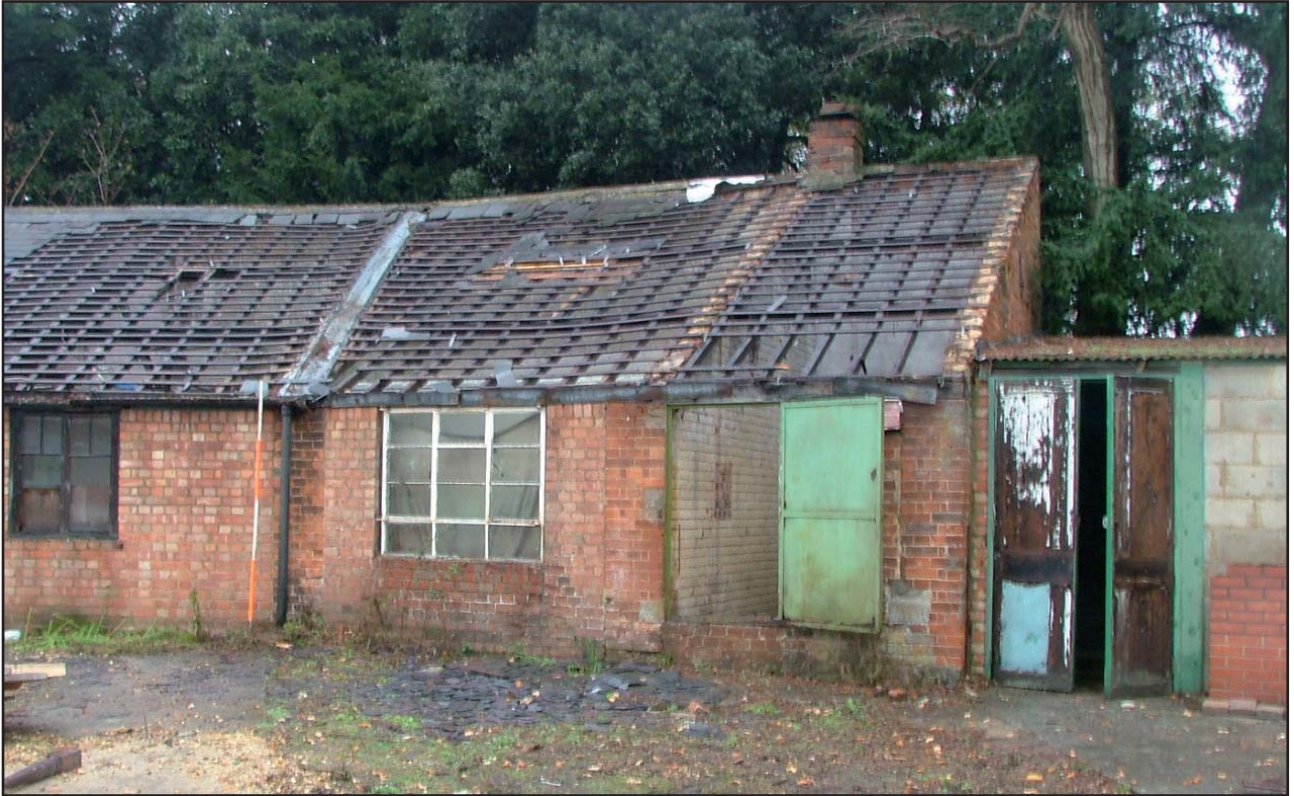
- 3.1.14 The range shows a consistent build throughout its length although the two parts are on different alignments (Plates 7 and 9). The southern, eastern and the internal walls were constructed using a handmade frogged red brick measuring 0.23 m x 0.105 m x 0.062 m laid using Flemish Stretcher bond with a lime mortar. Their size suggests a mid to late 19th-century date.

- 3.1.17 Located on the eastern end of the range was a 2.3 m wide by 4.7 m deep separate room (Plate 7). This had no windows but had a brick built hearth and chimney stack in the north-west corner of the room (Plate 8). A later steel door and frame had been

Plate 7: Eastern end of the workshops

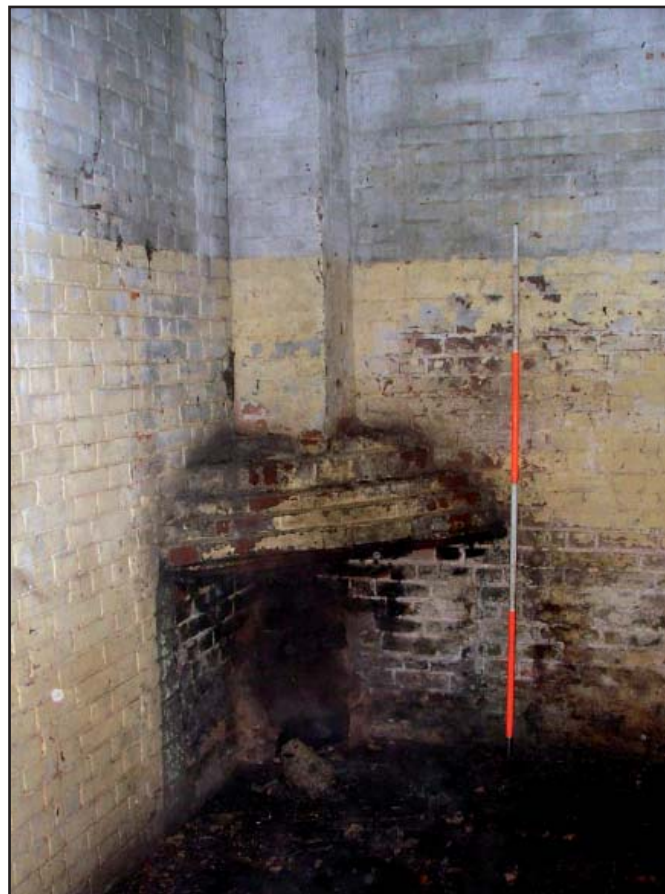
Plate 8: Hearth in "Farriers" shop

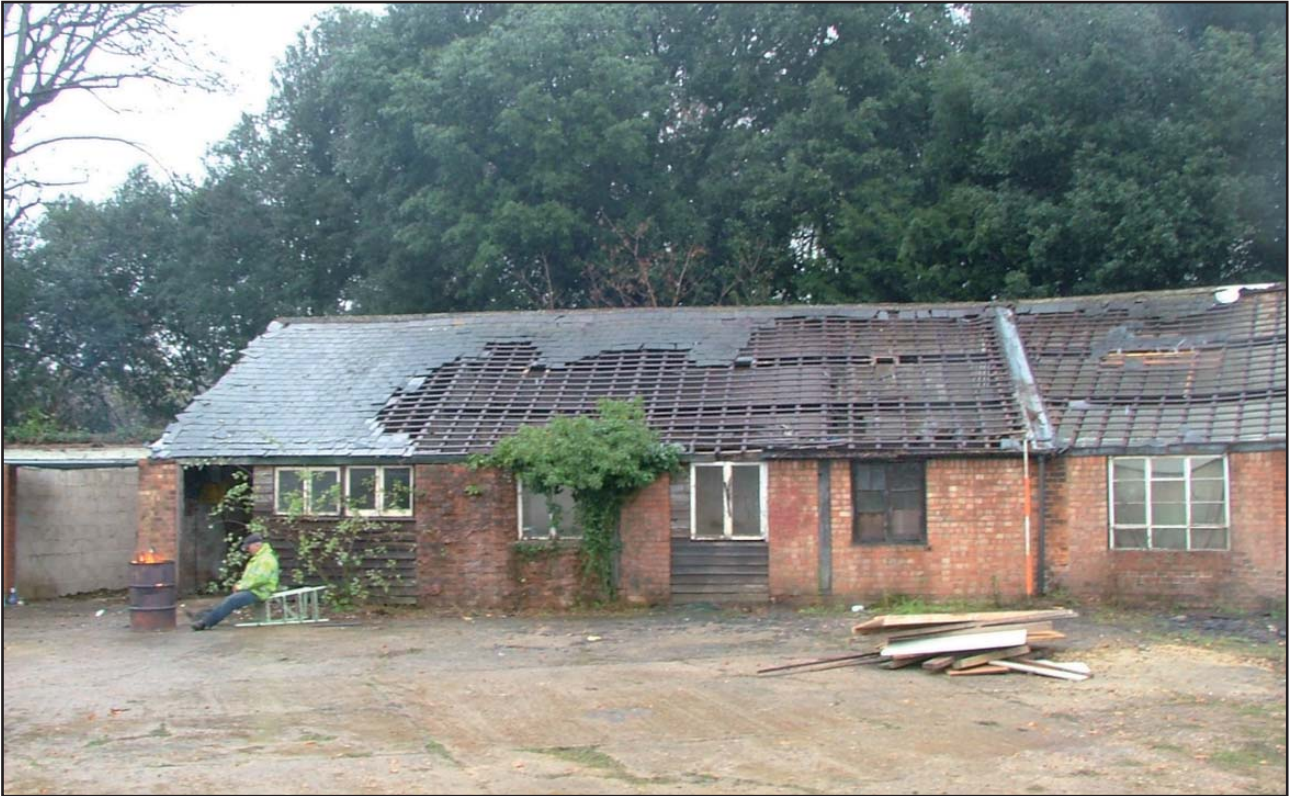
- 3.1.18 The centre of the range comprised a 12.6 m long by 4.7 m depth open workshop with a wedge shaped office accessed off its eastern end (Plate 9). This office measured 3 m along the southern wall and 4.5 m along the northern wall and ran the full depth of the building. The north-east corner of the office contained a fireplace which shared a chimney with the hearth in small room to the east (Plate 10).

Plate 9: Western end of workshops

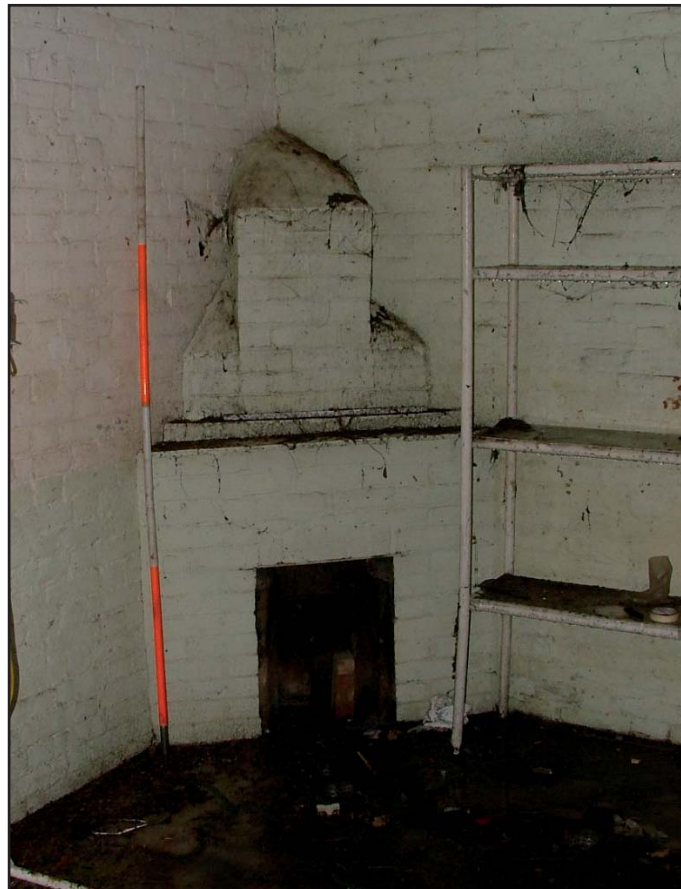
Plate 10: Fireplace in office/ tackroom

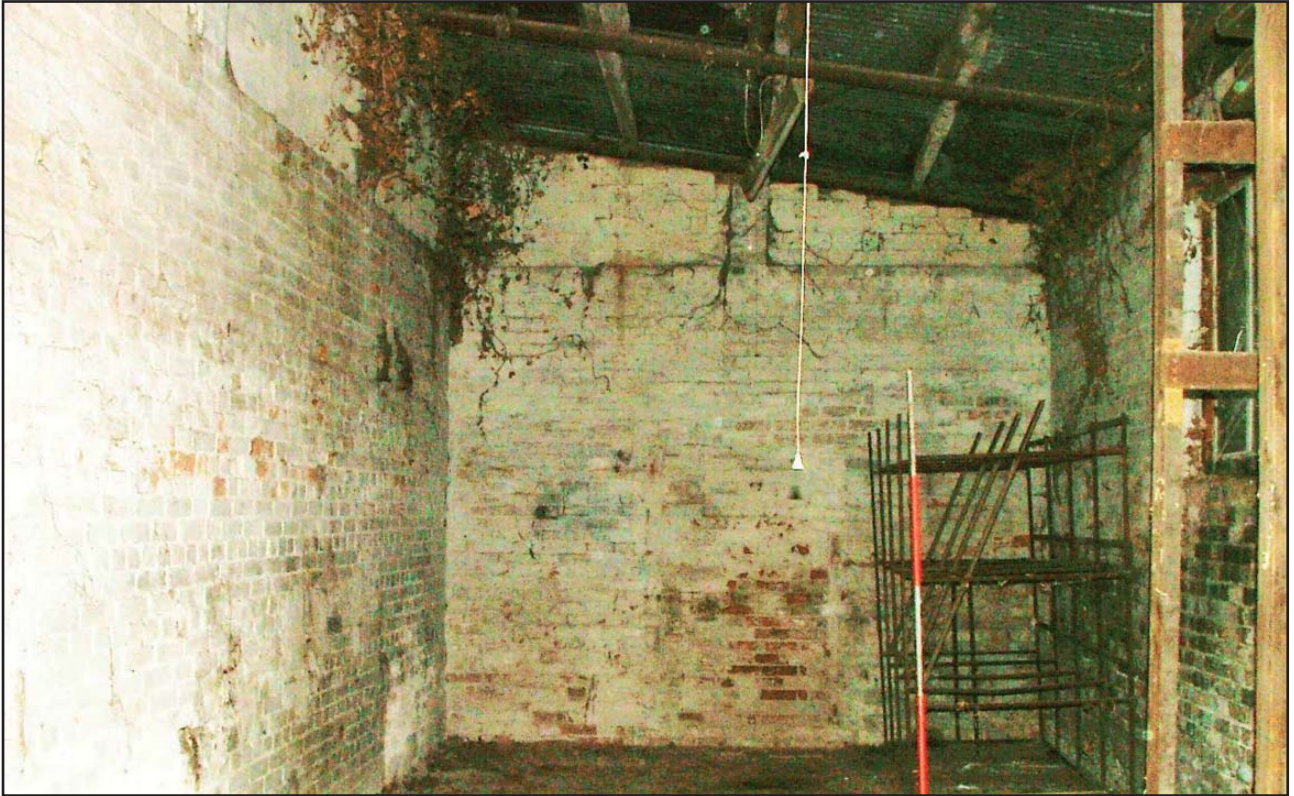
- 3.1.19 Attached to the western end of the workshop was a later 5 m long by 4.1 m wide brick built extension running northwards (Plate 11). This was constructed using a plain red hand made brick measuring 0.225 m x 0.115 m x 0.068 m laid using “Bastard” English stretcher bonding. This had a single pitched roof sloping to the east covered with corrugated iron sheeting. A single 1 m square window had been built into the eastern wall. The brick size and the use of corrugated iron sheeting suggest that this was a late 19th-early 20th-century construction.

Plate 11: Modern extension in workshops
