**NEW LIBRARY FACILITY AND BASEMENT,
ST HILDA'S COLLEGE,
COWLEY PLACE, OXFORD**

HISTORIC BUILDING RECORDING

OXFORD ARCHAEOLOGY

December 2003

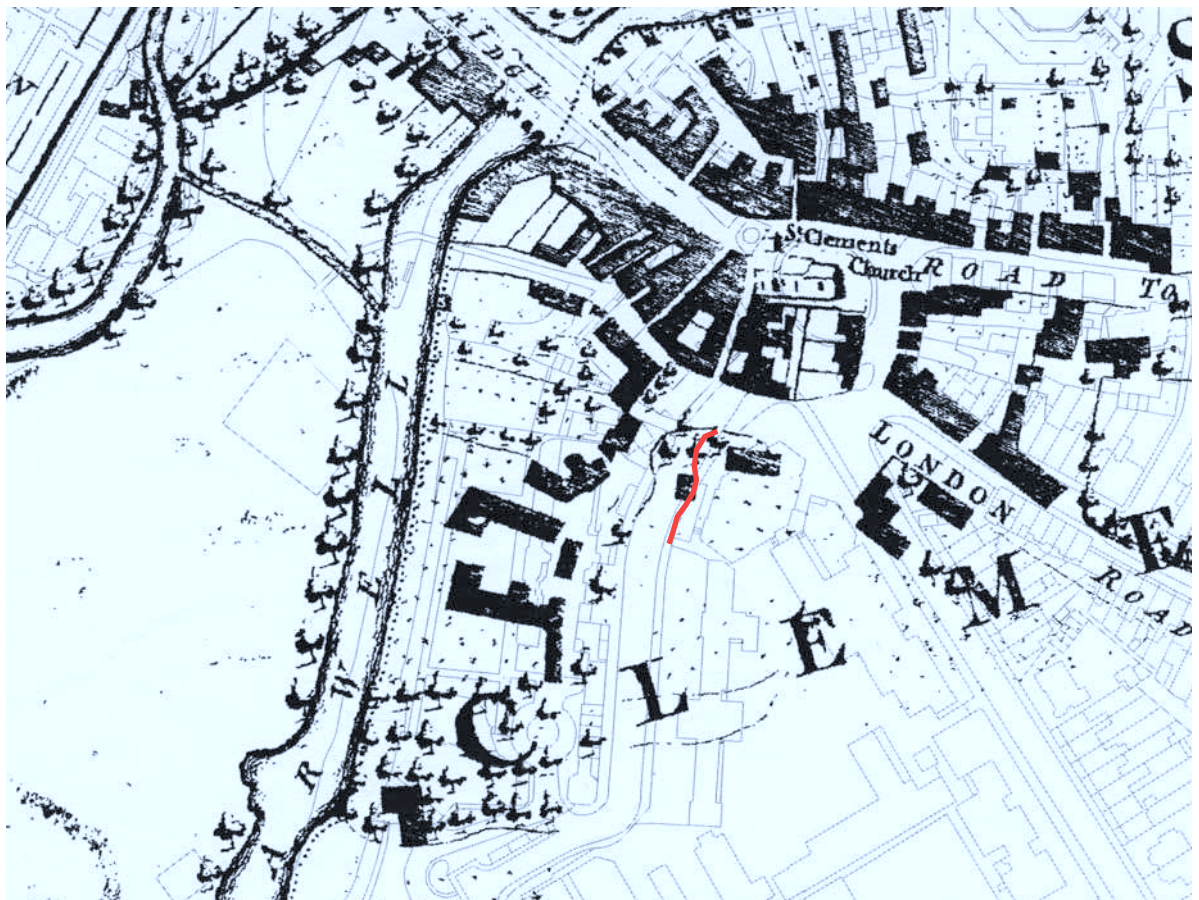
- 2.2.2 Taylor's map of 1750 shows the tenement wall existing, with some new buildings to the west. The first edition OS map of 1878 shows two cottages built towards the north end of Cowley Place. Their tenement plots are defined on the east side by the north-south wall, respecting the old tenement boundary, shown on Loggan's map.

Taylor's map of 1750

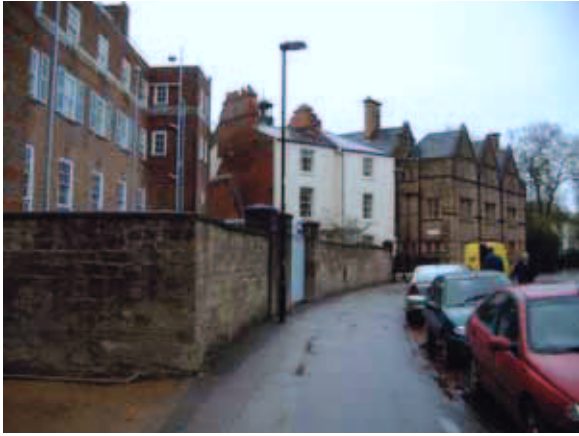
Plate 1

- 3.1.1 The wall follows a curved path, running north-south, which is reflected by the street on the east side. The wall returns at the south end, to the west, just north of St. Hilda's hall. The wall is approximately 11 metres long, with the return approximately 2.5 metres long (Plate 1).
- 3.1.2 A pair of gates is located towards the south end of the wall, framed by three gateposts (Plate 2). A further gatepost is located at the north end of the wall. These posts are constructed of limestone ashlar blocks and are decorated with carved panelling on the east and west faces. A miniature s-profiled string course runs around the top of the column and they are capped with a capital block, carved on the east and west faces with ornamental roundels. Further string courses run around the top of the capital, which finishes in a pyramid. The decor for the gate-posts has

3.2.2 The north end of the wall is shown in old photographs to have had a pair of gates, which have now gone. In their approximate position is a set of iron railings set into a low wall, which extend past the two cottages, and butts the south wall of Magdalen School (Plate 1).

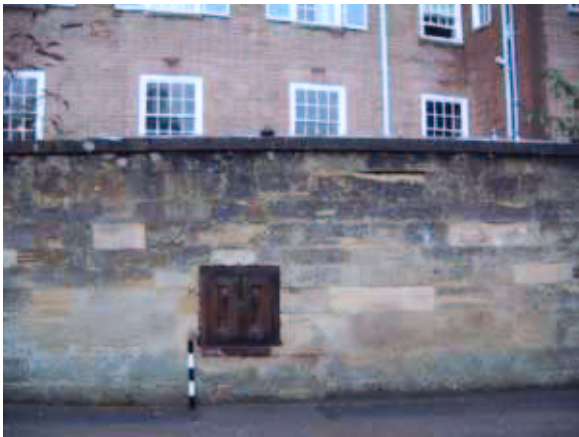
Plate 3

3.2.1 The east face is constructed of limestone ashlar blocks, bonded in thin, straight joints with a lime-rich mortar (Plate 7). The wall is evenly coursed and capped with limestone block coping that protrudes out from the wall. The blocks are of even size, but some are larger, and span two courses. Some blocks are severely weathered and cracked and some blocks have been replaced by new stones (Plate 3).

3.2.3 Approximately halfway along the length of the wall, is a pair of wooden doors, which have been inserted into the wall, cutting across courses. They are a later addition to the wall and may have been for receiving post (Plate 3).

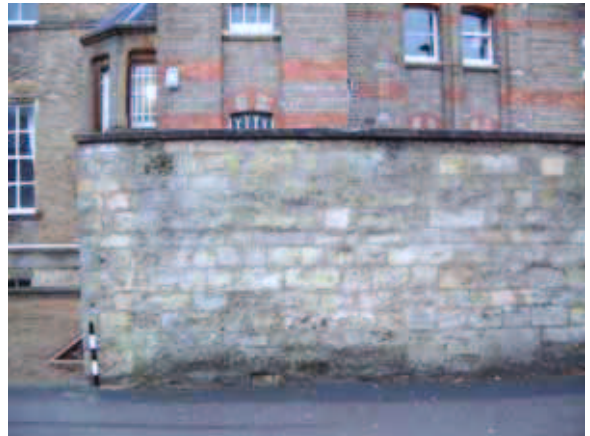
Plate 4

3.2.4 The south end of the wall, beyond the last gatepost, is constructed of less uniform limestone blocks, which are more weathered. This end of the wall has been re-pointed in a hard, unsympathetic material, which now protrudes out from the stones of the wall (Plate 4). The return is similar in build, with course re-pointing and weathered limestone ashlar blocks (Plate 5).

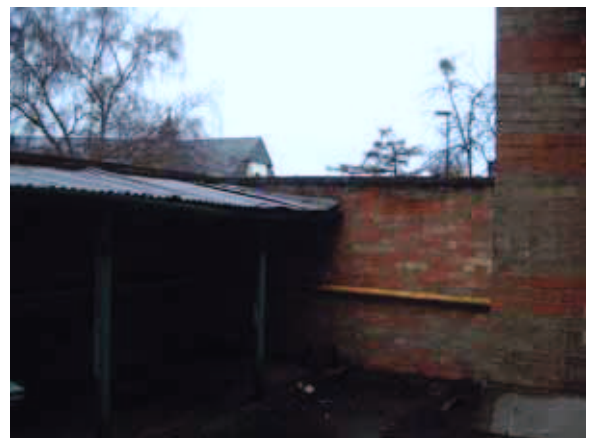
Plate 6

3.3.1 The west (internal) face of the wall is largely obscured by wooden lean-to sheds, with corrugated iron roofs. However, this side of the wall is constructed of red brick, which must butt the stone of the other side. The brick wall is of Flemish bond and capped with limestone blocks. The use of brick may have been a device to save expense, but still providing a substantial wall thickness (Plate 6).

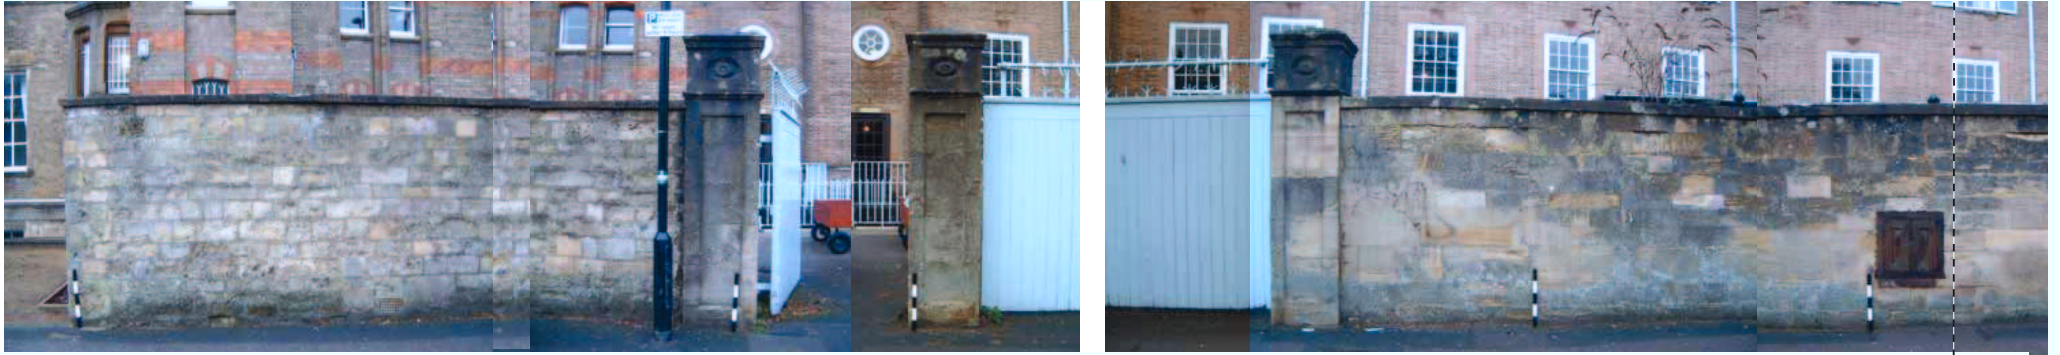
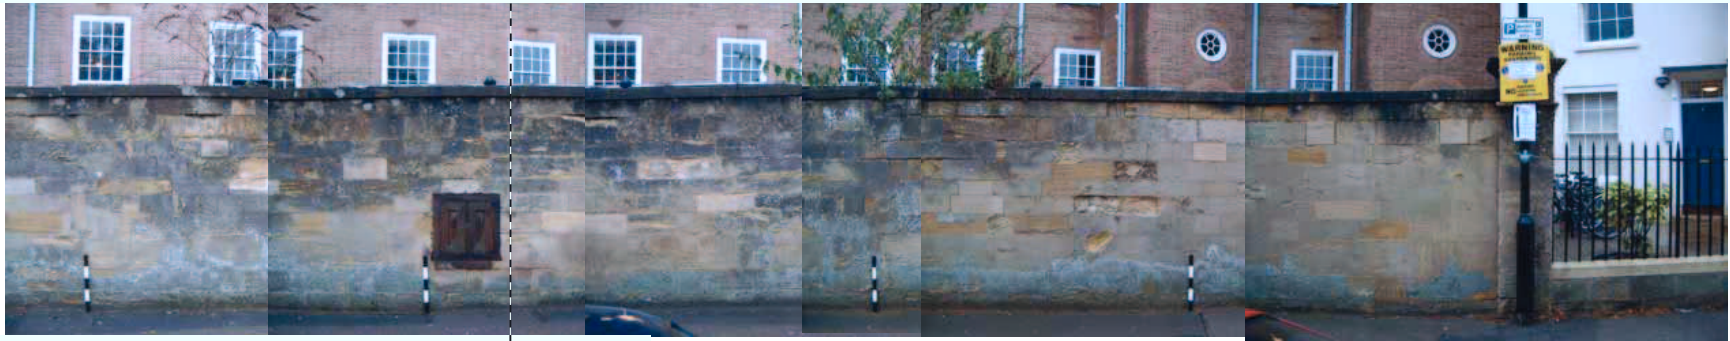
Plate 7: East side of wall
