Boundary Wall Repairs
St Peter's Church
Brackley
Northamptonshire

**Archaeological
Watching Brief Report**

Document Title: Boundary Wall Repairs, St Peter's Church Brackley,
Northamptonshire

Document Type: Watching Brief

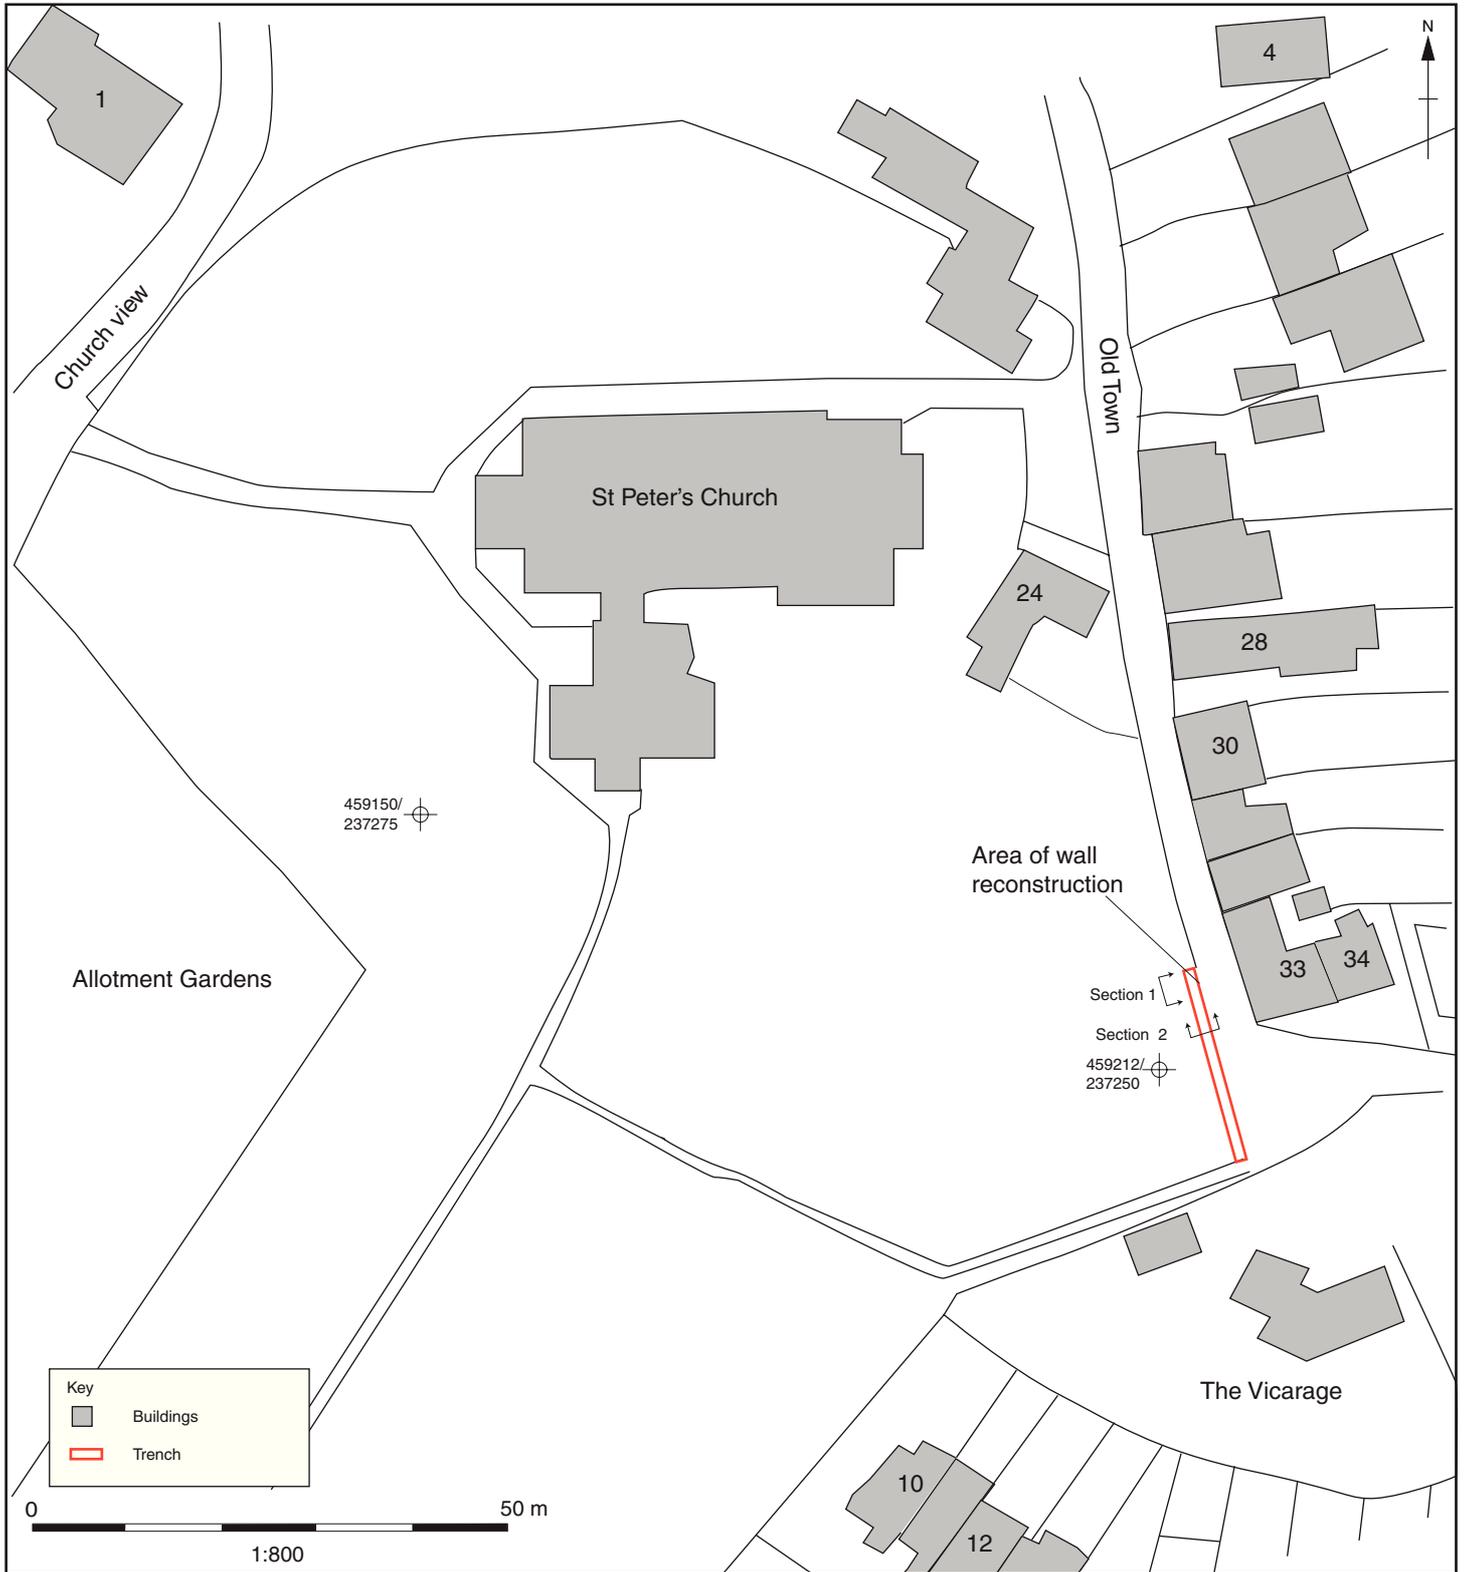
Figure 2: Site plan

- 2.2.1 The watching brief was undertaken as series of site visits during works that were likely to impinge or damage any potential archaeological deposits or features. These works included the dismantling of an approximately 17 m length of collapsed and unstable wall and the excavation of a new 0.7 m wide foundation trench for the reconstructed wall.

2.2.2 A plan showing the extent of the excavations was maintained at a scale of 1:100 (Fig. 2, Site plan) and any recorded sections were drawn at a scale of 1:20. All excavations, features and any recorded sections were photographed using digital photography, colour slide and black and white print film. A general photographic record of the work was also made. Recording followed procedures detailed in the *OA Field Manual* (ed D Wilkinson, 1992).

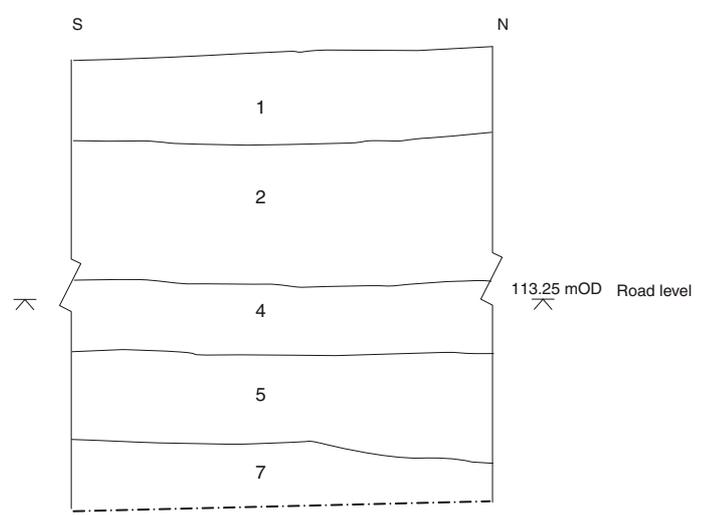
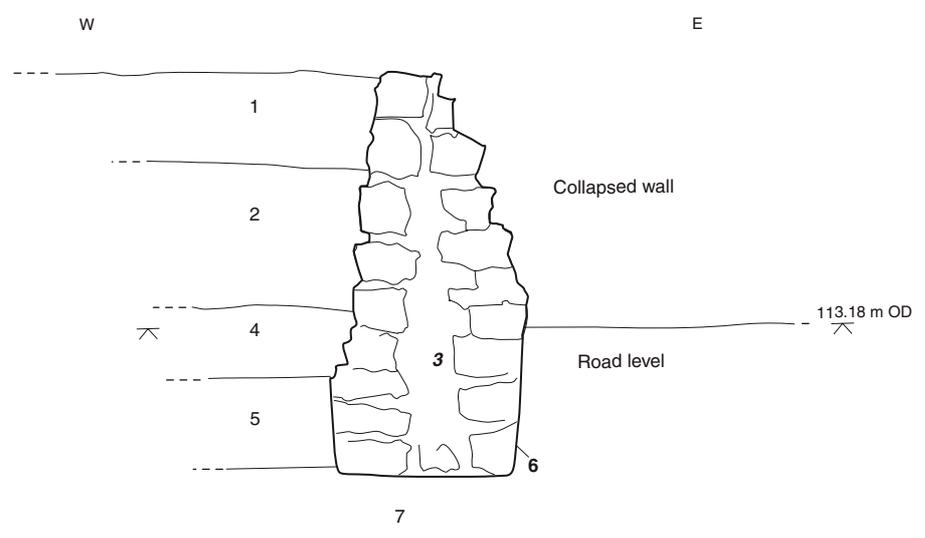
Figure 3: Sections

3.1 Description of deposits (*Fig 3, Sections 1 and 2*)

3.1.1 The underlying natural geology, a weathered limestone brash (7), was encountered approximately 1.3 m below the level of the churchyard. This was sealed by a 0.35 m deep layer of very dark grey silty clay loam containing abraded limestone fragments, mortar flecking and charcoal flecking (5). This had been cut by the 0.3 m deep foundation trench for the boundary wall (6). Built within this trench was a 1.4 m high wall (3) constructed using roughly dressed limestone blocks bonded with a light yellow-brown sandy mortar.

3.1.2 Butting up against the wall on the inside of the churchyard was a 0.2 m deep layer of very dark grey silty sand loam containing occasional abraded limestone fragments and charcoal flecking (4).

3.1.3 Overlying layer 4 and also butting up to the inside of the boundary wall was a grey-brown clay silt (2), between 0.3 m and 0.4 m in depth. This deposit produced charcoal flecking and abraded limestone fragments.

3.1.4 This was overlaid by a layer of grey-brown clay silt loam measuring 0.2 m in depth (1). This represents the current churchyard topsoil and turf.

4.1.1 The excavation of the new foundation trench allowed a complete stratigraphy of that area of the churchyard to be compiled.

4.1.2 Layer 7 represents a weathered deposit of the underlying natural geology, oolitic limestone.

- 4.1.3 Overlying this was a probable layer of worked soil (5). The presence of mortar flecking within this deposit suggests that may be contemporary with either the church's construction, or more probably, the original construction of the boundary wall. It may also represent an earlier layer of churchyard soil which has been subsequently buried.

- 4.1.4 This was overlaid by two distinct phases of churchyard soil, layers 2 and 4. Unfortunately no dating evidence was recovered from either.
- 4.1.5 Layer 1 represents the current churchyard topsoil and turf.

- 4.1.6 It is probable that both layers 2 and 4 had been built up against the wall in order to level that area of the churchyard.
- 4.1.7 No inhumations were disturbed during the course of the work and no charnel was recovered from any of the churchyard soil layers.
