Thremhall Priory Barns Takeley Essex

Archaeological Watching Brief Report

January 2008

Client: Cowper Griffith

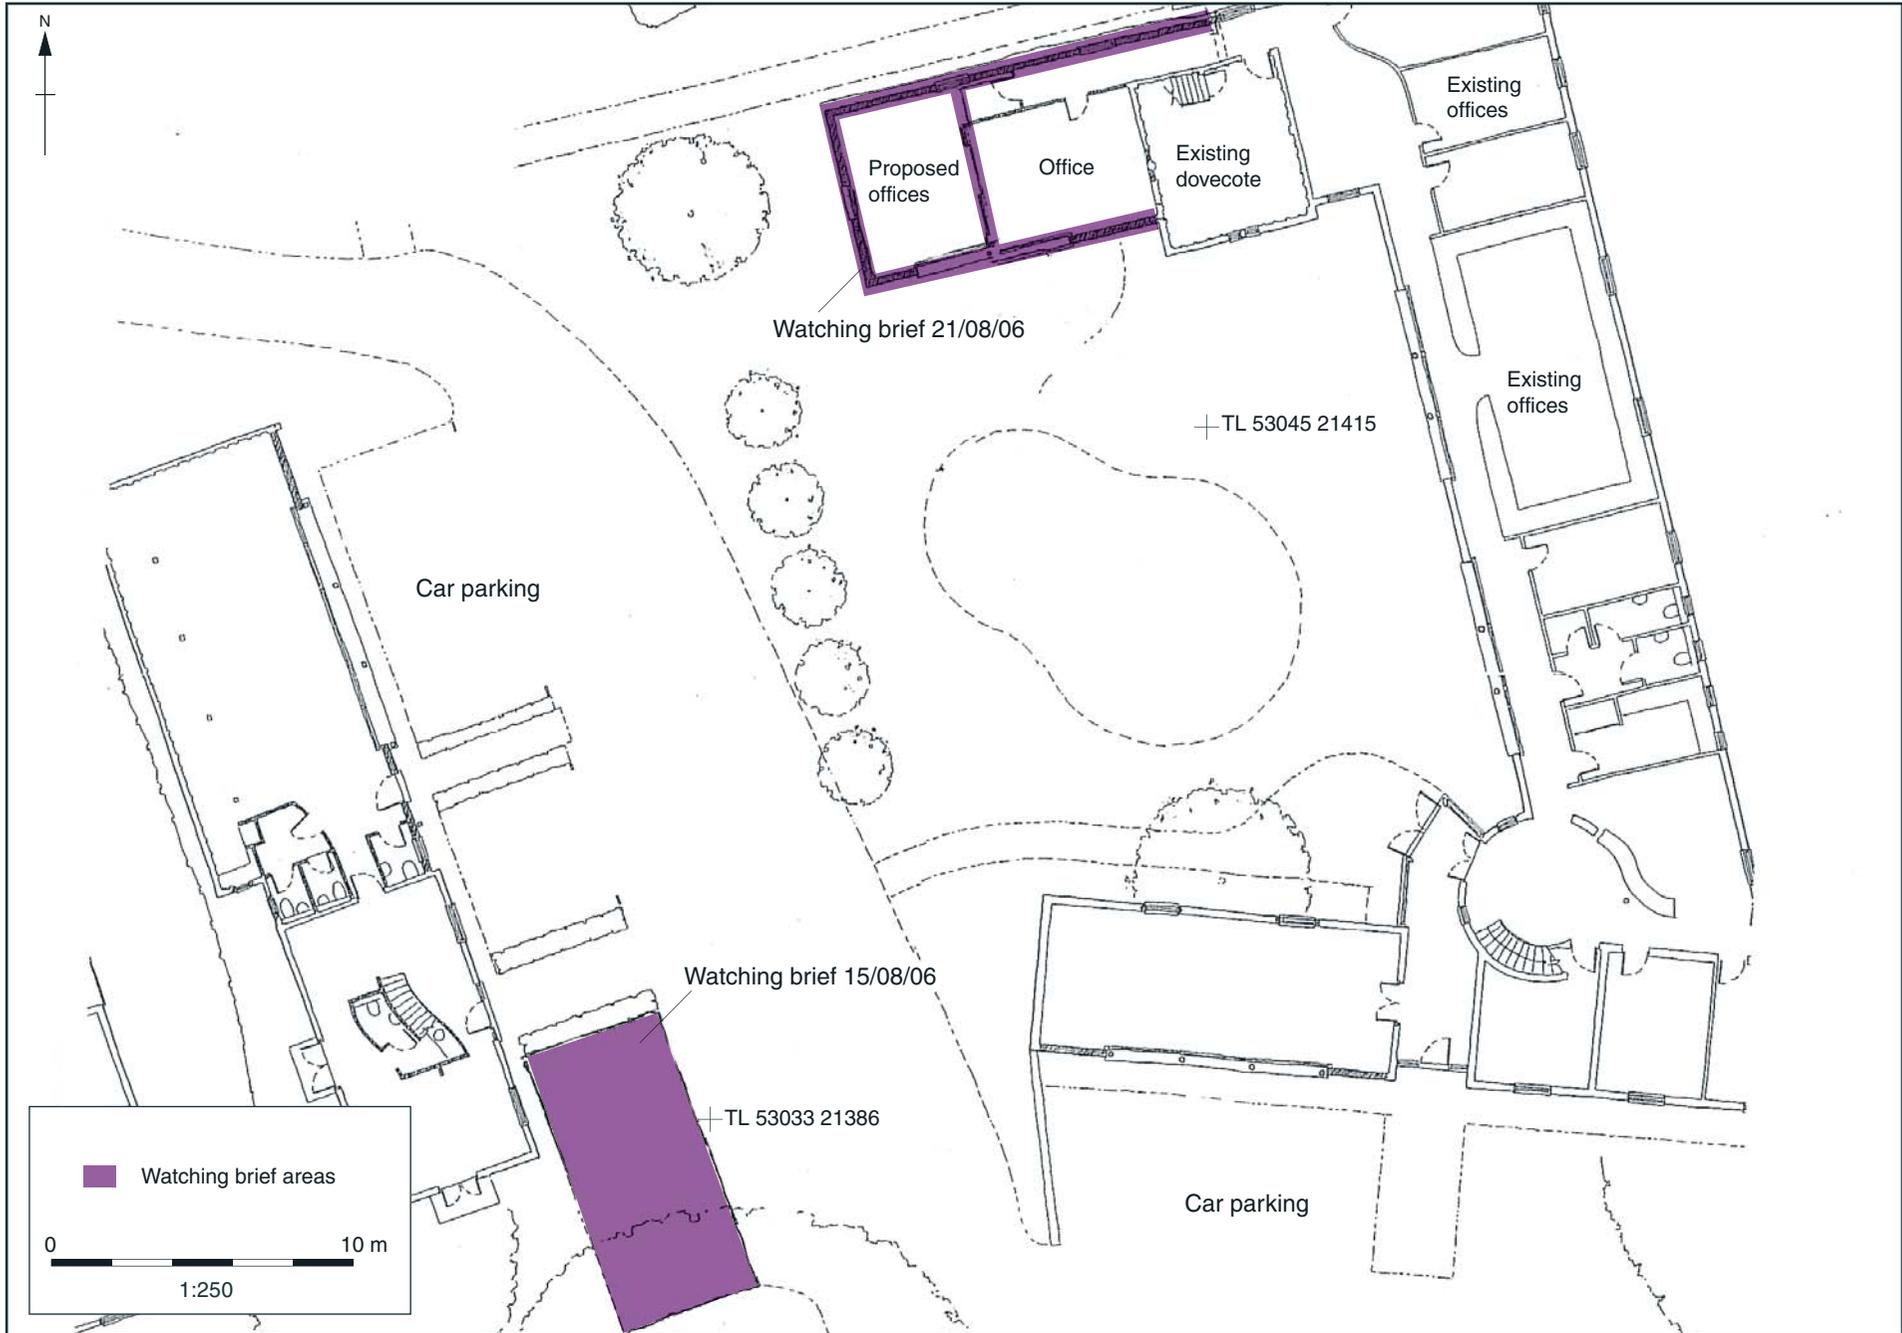
Figure 2: Site plan

- 3.1.1 The watching brief can be broadly divided into two separate areas, approximately 38 m length of 0.6 m wide trenching was excavated for the foundations of the new extension, while an area of approximately 100 m² was stripped in front of the proposed visitors office for a carpark.

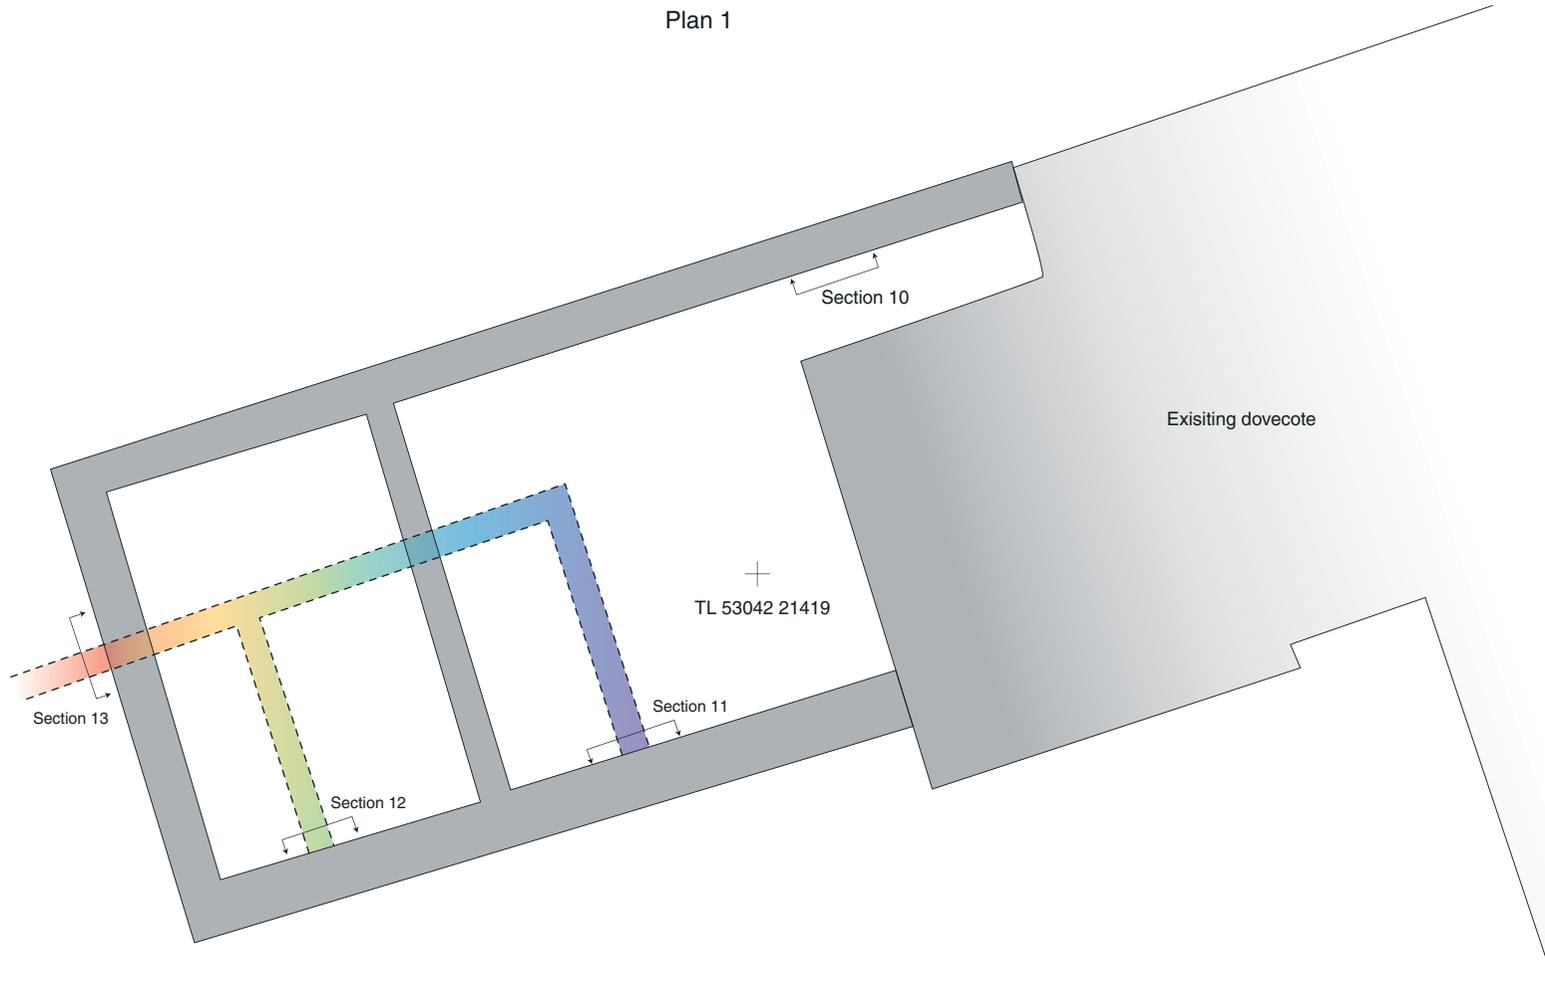
Figure 3: Plan of extension showing location of sections

- 3.1.2 Within the area of the new extension (Fig. 3) the underlying natural (13), a pale yellow-brown clay containing flint nodules was encountered at a depth of 0.5 m below the current ground level (Fig. 4). This layer was cut by a series of foundation cuts 15, 17 and 20 (Fig. 4, Sections 11, 12 and 13 respectively). Cuts 15 and 17 were exposed only within the northern side of the foundation trench suggesting that they were termini of walls. Cut 20 could be seen within both the north-south lengths of foundation trenching suggesting a linear feature. Within these cuts were trench built brick structures (14, 16 and 19) using similar sized hand made frogged bricks, measuring 0.22 m long, 0.105 wide and 0.06 m deep, probably early 19th century in date. These were laid using a lime mortar in English stretcher bond and it is highly probable that they are all part of the same building. All the structures had been truncated suggesting that it had been demolished down to ground level.

Proposed alignment of structure 21

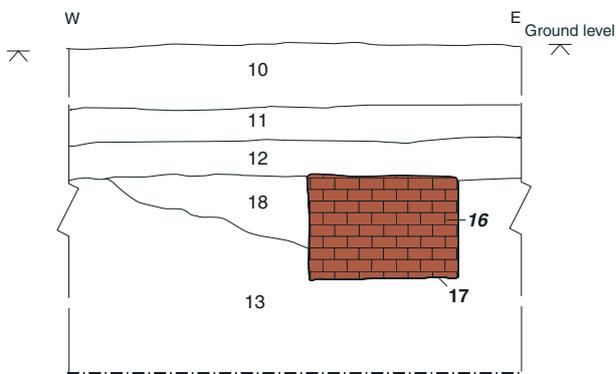
Section 12

- 3.1.3 Within the area of section 12, Structure 16 was butted by a layer of dark grey silt clay (18) containing wire cut brick fragments and a fragment of iron barrel hoop. This may be a result of animal disturbance such as pig rooting. Overlying this deposit and the structures was a layer of dark grey-brown clay silt (12) measuring between 0.1 m and 0.25 m in depth. This layer contained numerous abraded fragments of brick and tile. It's composition suggests that it may be the original topsoil horizon, however there is evidence (the unevenness of it's depth and level upper interface) to suggest that this had been truncated during an earlier phase of building work. Overlying this was a layer of made ground (11) composed of a yellow clay mixed with crushed limestone. This contained many examples of modern construction debris and measured between 0.15 m and 0.25 m in depth. A modern landscaping layer of topsoil and turf (10) completes the stratigraphy.
