Watching Brief during  
removal of unauthorised  
dumped material  
at Woodham Walter Hall  
Woodham Walter  
Essex

**Archaeological  
Watching Brief Report**

***Watching Brief during removal of unauthorised dumped material***

***at Woodham Walter Hall, Woodham Walter, Essex***

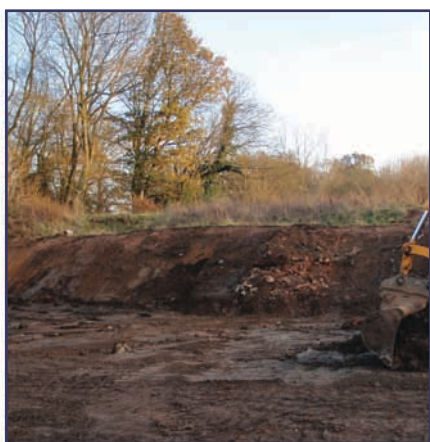
- Plate 1 (front cover) The dam and the steps after removal of dumped material. View from the north-west.
- Plate 2 The site of the swimming pool at the eastern end of the site, before removal of dumped material. View from the west
- Plate 3 Removal of dumped material over the swimming pool. View from the east.
- Plate 4 The eastern end of the site, showing 3m thickness of dumped material against the dam. View from the north
- Plate 5 Section of the dam, with the steps in the background. View from the north-east
- Plate 6 The site after removal of dumped material. The dam and the site of Falconers Lodge to the right; the swimming pool to the extreme left. View from the west

- 4.1.5 The steps showing on the RHCME surveys leading down from the top of the bank of the dam were exposed on the 6<sup>th</sup> December. These were located where they were anticipated to be, approximately halfway along the dam. The actual steps had been largely destroyed although some concrete blocks with granite slabs on top were still present. The steps were bounded on the east and west by a brick wall. The western brick wall survived to a height of 0.6m. The eastern brick wall was no longer standing but surviving blocks of brick were seen loose in section. 1970s 'commons' bricks had been used. The style of the bricks and the mortar used indicate that the steps were less than 40 years old (Plates 1, 5 and 6).

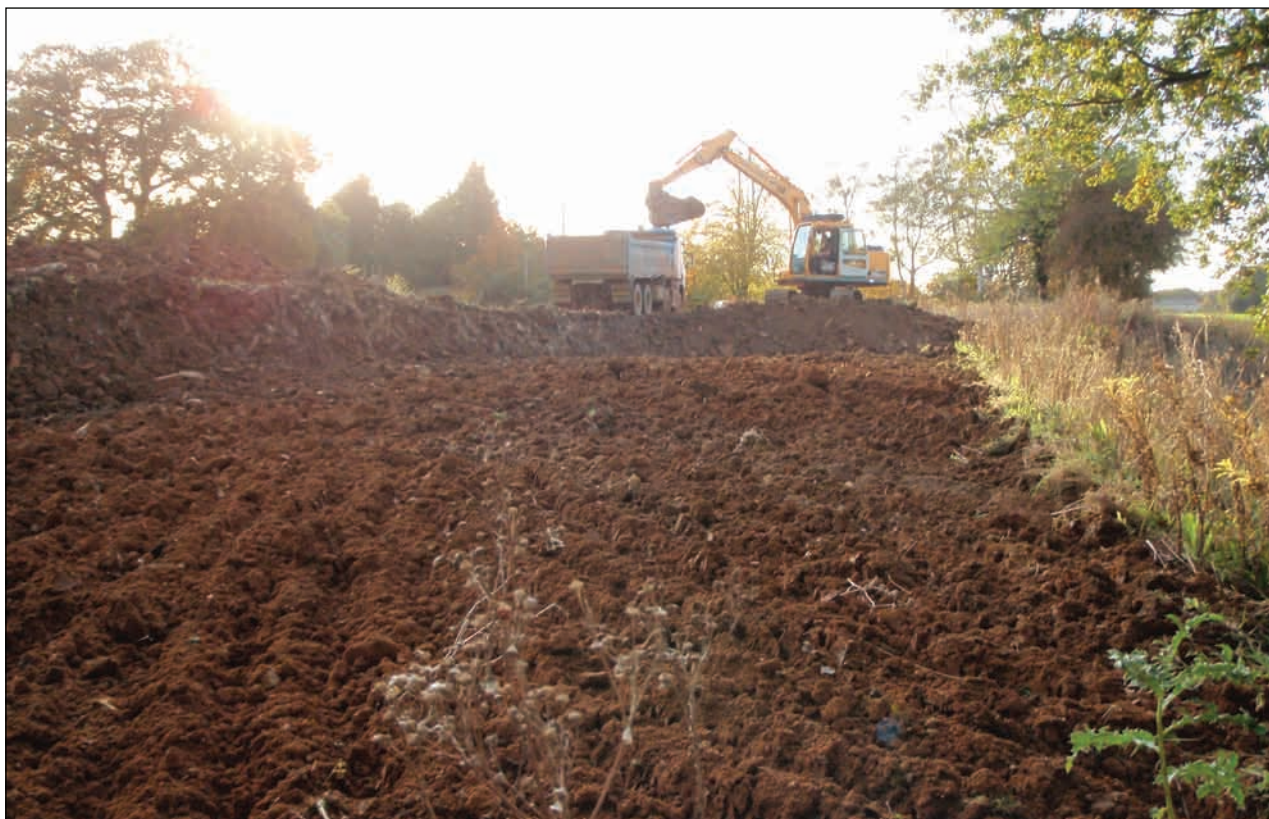
Plate 2: The site of the swimming pool at the eastern end of the site, before removal of dumped material. View from the west.

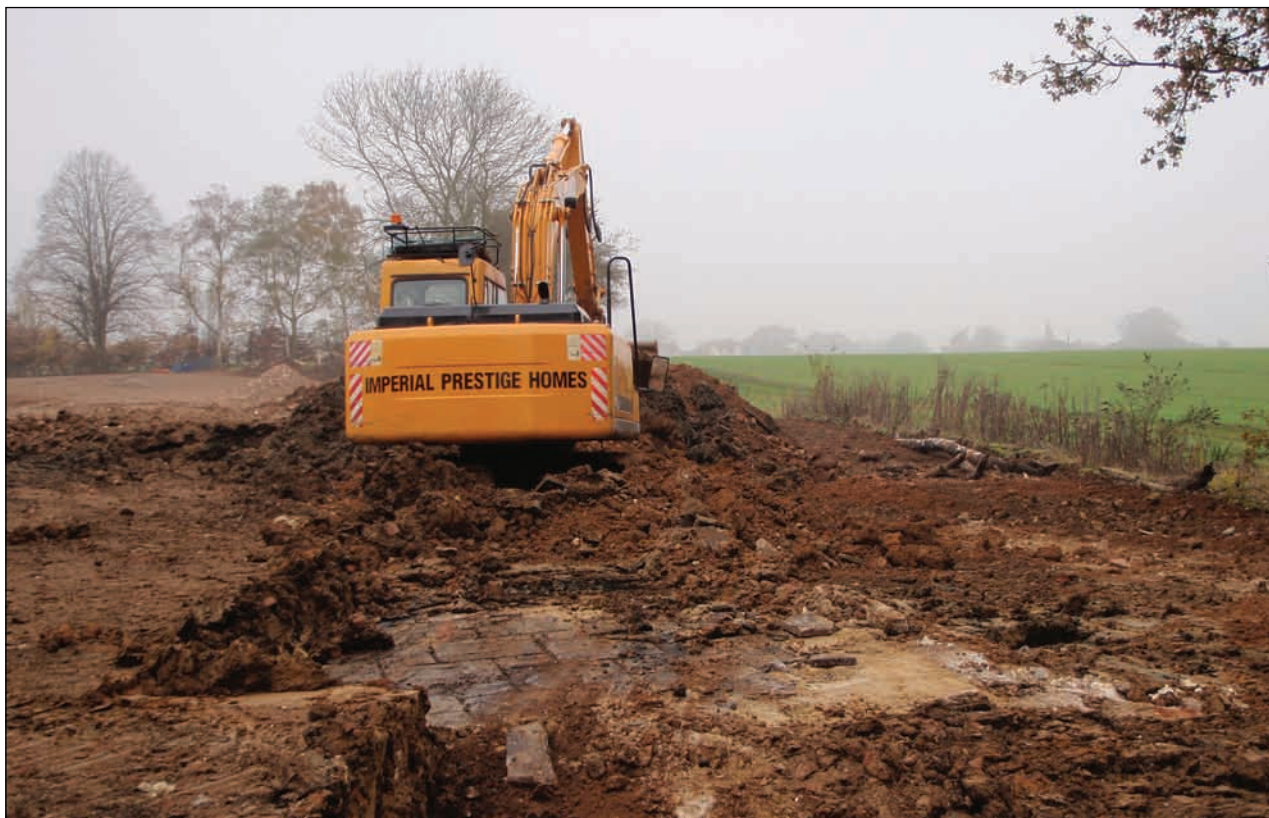
- 4.1.4 On the 21<sup>st</sup> and 22<sup>nd</sup> of November the filled in swimming pool was uncovered (Plate 3). As shown on the topographic survey the pool occupied a raised area (Fig. 3). The paving slabs surrounding the pool to the south were still *in situ*. The material immediately covering the paving slabs was a yellowy brown silty clay, 0.4m thick. Adjacent to the swimming pool, on its east side was the ground slab to the summer house. The western wall to the summer house still survived to 0.8m height but had been previously completely engulfed by the modern dumped materials.

Plate 3: Removal of dumped material over the swimming pool. View from the east.

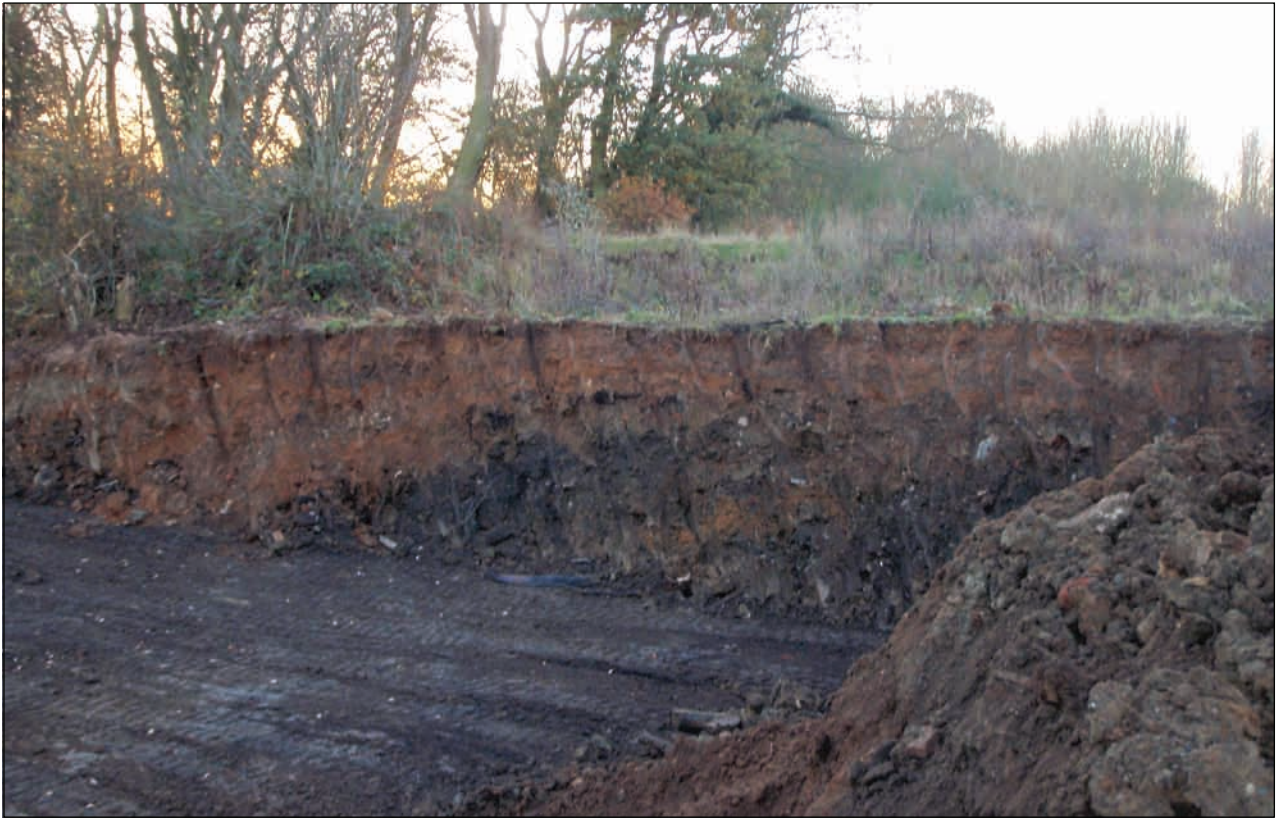
- 4.1.2 The mechanical excavator commenced removal of dumped materials from the eastern side, near the stream course, and worked westwards. The watching brief confirmed that the thickness of the dumped material decreased westwards with the rise of the valley slope. Only shallow depths of deposits were present around the site of Falconers Lodge. There was also a decrease of depth of dumped material from south to north. At the northern boundary of the site there was seen to be approximately 0.4m thickness of modern dumped material. The maximum thickness of dumped material was at the south-eastern corner, near the course of the stream. Here the material was up to 3m deep and completely engulfed the lower bank of the dam (Plate 4).

- 4.1.3 The modern dumped material consisted predominantly of an orange gravelly clayey silt. Interleaved with this and showing in section as obvious tip lines was a greyish brown sandy silt (Plate 4). Both deposits contained concrete lumps and modern bricks. Approximately 16m west of the stream course and just to the north of the dam a thick deposit of black humic material had been dumped prior to the orange and the greyish brown deposits. This black material contained modern brick, concrete and textile and is part of the same dumping event (Plate 4).

Plate 4: The eastern end of the site, showing 3m thickness of dumped material against the dam. View from the north.

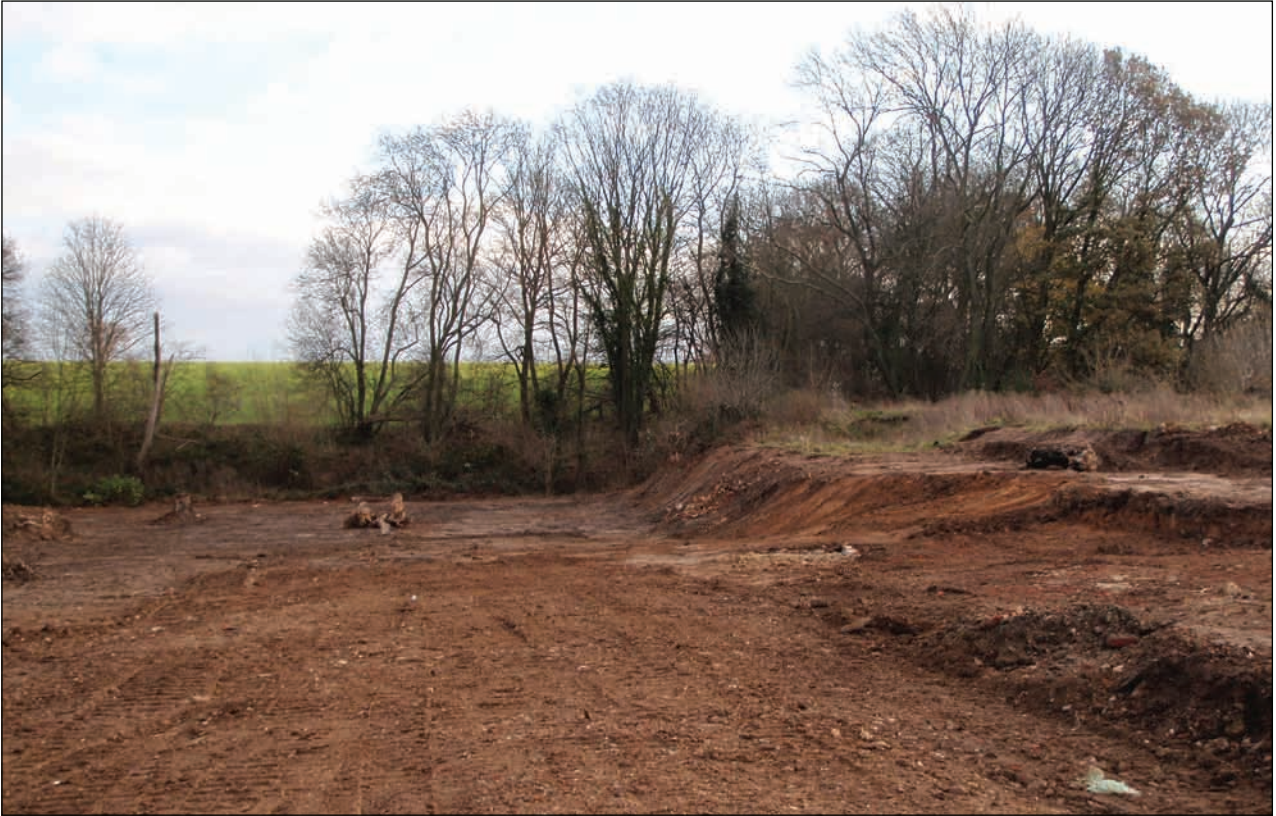
- 4.1.7 The bank was recorded as nearly 3m high near the steps. Its height reduced to zero at the western end by Falconers Lodge. At the eastern end by the stream it stood to approximately 3m high (Fig. 3). The reduction in height by Falconers Lodge was partly due to the natural rise in slope at this western end of the site and partly due to denudation by the builders of the Lodge. Here the dam had been reduced and flattened to create a platform for the former dwelling (Plate 6, right foreground).

- 4.1.8 The top of the dam had also been cut into just south of the former Falconers Lodge building (Plate 6, middle right). It is not known when this truncation occurred but it may have been at the time of building Falconers Lodge.

Plate 6: The site after removal of dumped material. The dam and the site of Falconer's Lodge to the right; the swimming pool to the extreme left. View from the west.
