**Land adjacent to Pooh Corner and Wildacre, Sandy Lane,
Northwood, Herts.**

ARCHAEOLOGICAL EVALUATION REPORT

Planning Application No. 99/1873/FUL

December 1999

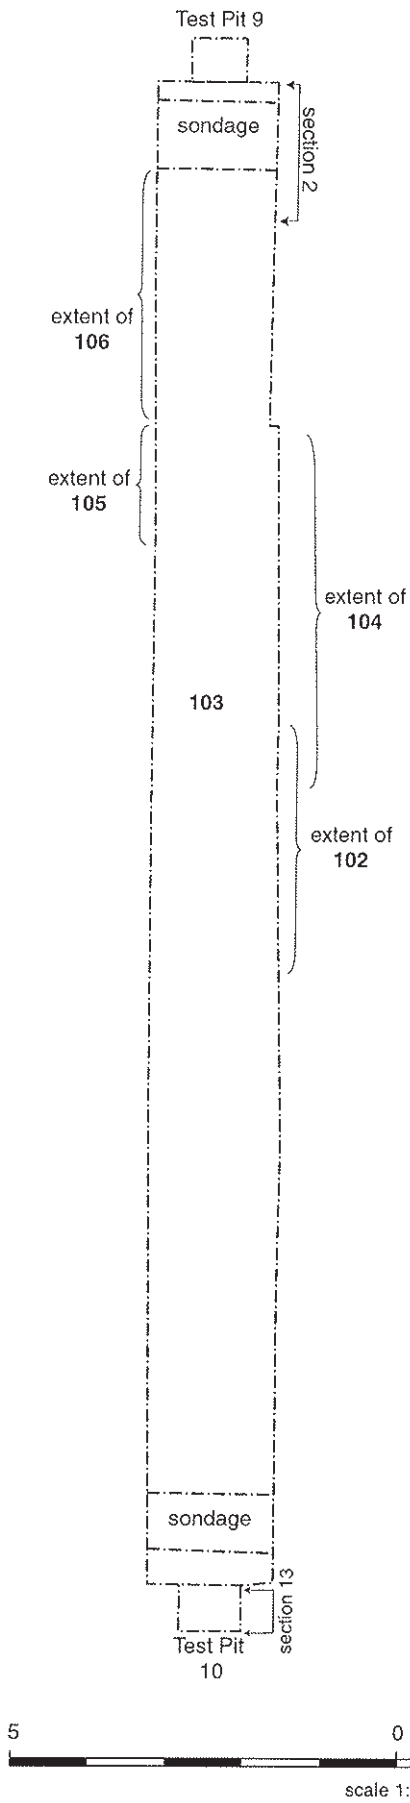
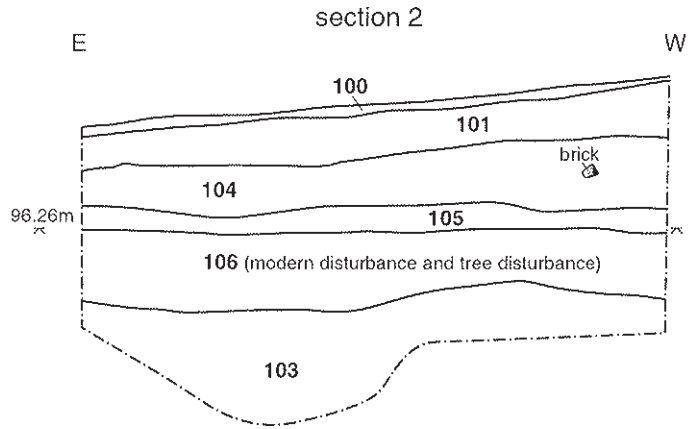
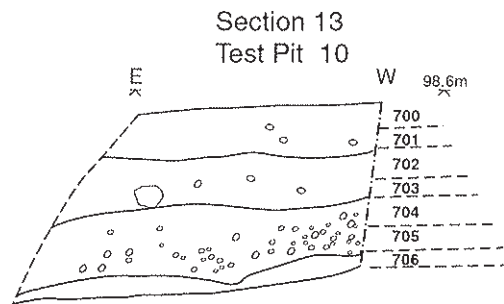
Figure 3: Trench 1, test pit 10.

The trench, orientated north-east/south-west, was located in the north-eastern area of the site and measured 20 m long, 1.80 m wide; it was excavated to a maximum depth of 0.85 m. A total of seven layers were identified in the trench. The natural (103) was a brownish-yellow-clay, that contained a low frequency of flint and pebbles. This was sealed by a series of deposits (106,

105, 104, 102) that contained small quantities of late 19th century plant pots and glazed wares. These deposits appeared to represent some form of garden build up, possibly as a result of landscaping during the Victorian period. The layers were sealed by topsoil (101) and turf (100).

This group of test pits was aligned north-east/south-west along the northern edge of the development area. The redeposited gravel layers in Test Pits 3, (352) and 10, (704, 705) (Fig. 3), and dump layers in Test Pit 9, (651, 652) appeared to have been very disturbed, possibly by the landscaping of the garden area. The dump layers (651, 652) both contained *c* 5% brick fragments and the layer (705) contained 19th-20th century pottery. Part of a frogged brick was recovered from the subsoil (402). The test pits were dug to a depth of between 0.38 m–0.60 m.

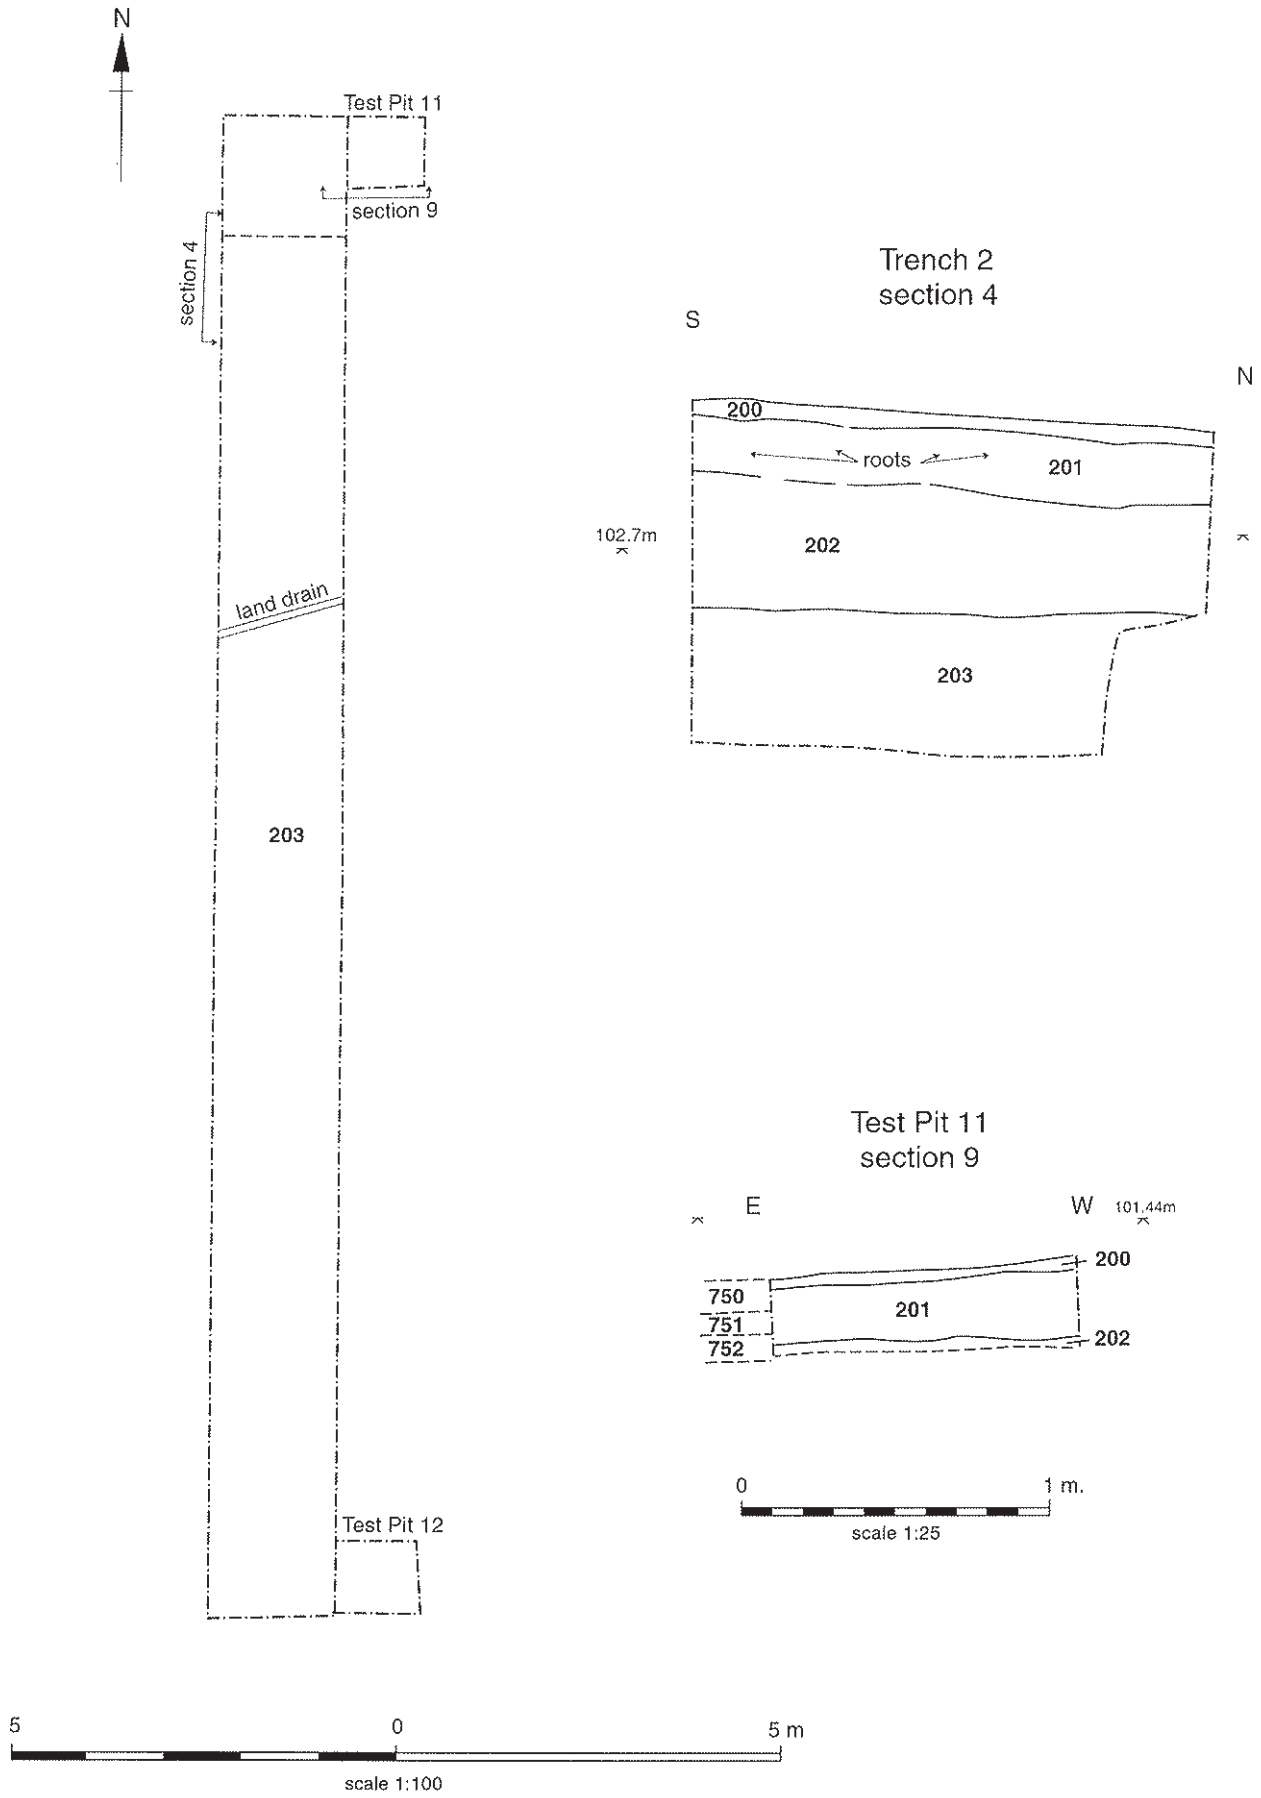
Figure 4: Trench 2 and test pit 11, plan and section

The trench, orientated north-west/south-east, measured 20 m in length, 1.80 m in width and was excavated to a depth of 1.20 m. A total of four layers were identified, these comprised two layers (202, 203) of mid-brown grey clay measuring 0.90 m in depth; neither contained any finds. These deposits appeared to represent garden build up layers. The other two layers comprised topsoil (201), which contained a small quantity of broken plant pot, and turf (200).

Test Pits 11 and 12 were excavated at the northern and southern ends respectively of Trench 2. The deposits encountered were the same as those identified in the trench and as a result, both were excavated only to a depth of 0.30 m to identify the garden build up layers.

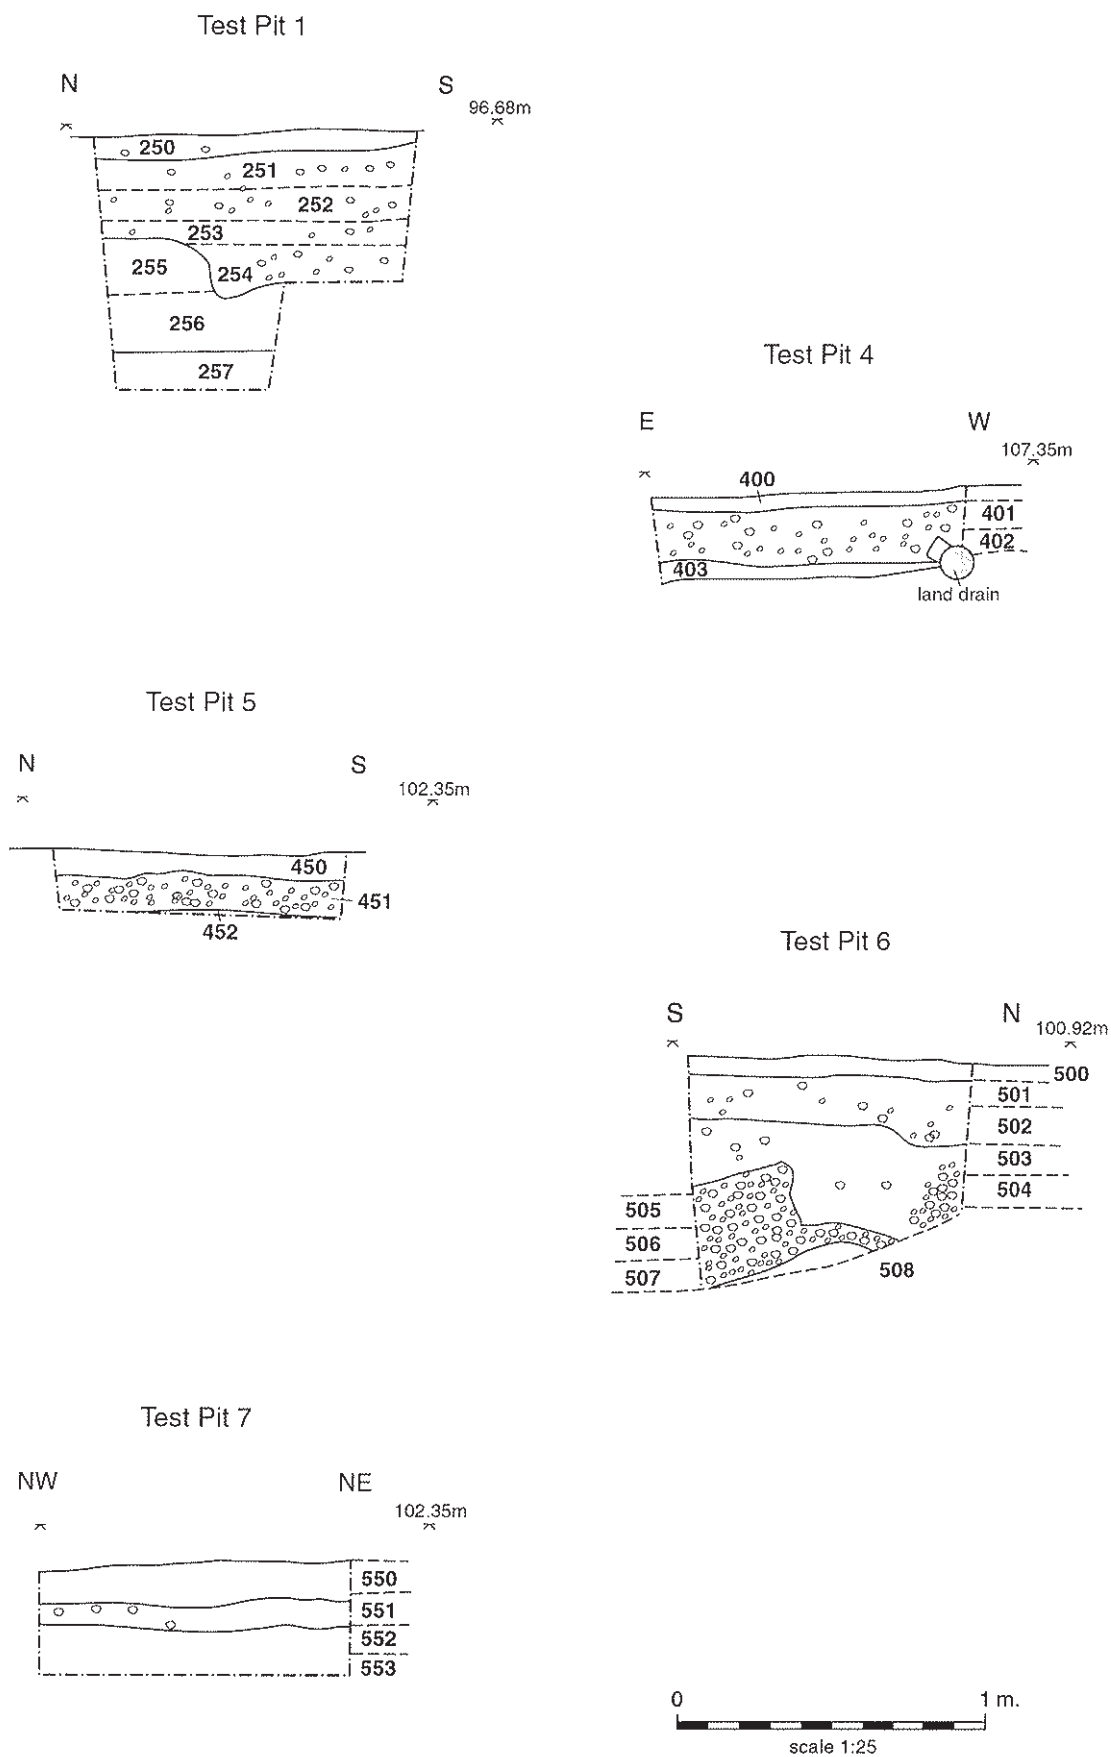
Figure 5: Test Pit sections

The test pits were located in the eastern corner of the site, to the south of Trench 1, and were excavated to a depth of 0.96 m and 0.60 m respectively. Both of the test pits identified layers of redeposited natural, which were sealed by layers of subsoil and topsoil. The redeposited natural (255, 256, 302-306) was a friable orange-brown silty clay that contained low frequencies of gravel. Layers 255 and 256 both contained low frequencies of late 19th century plant pots and glazed pottery. Layers 251-254 appear to represent a series of deliberate dumps, and are probably a result of Victorian or later landscaping of the area.

Test Pits 4 (see 5.1.4), 5, 6 and 7 form a co-axial line, orientated north-west/south-east, with Test Pits 3, 9 and 10 (see Fig. 2). Redeposited natural, apparently used as a levelling deposit, was identified in Test Pits 6 (503, 504) and 7 (552, 553). A dump of construction/demolition material mixed with subsoil (451) was identified in Test Pit 5. This was thought to be a result of the landscaping of the garden area similar to the deposits described above. The test pits were dug to a depth of between 0.35-0.82 m.
