Queen's House, Oakwood Hospital,
Maidstone, Kent

BUILDING INVESTIGATION AND PHOTOGRAPHIC RECORDING
IN ADVANCE OF BUILDING WORKS

Oxford Archaeological Unit
September 1998

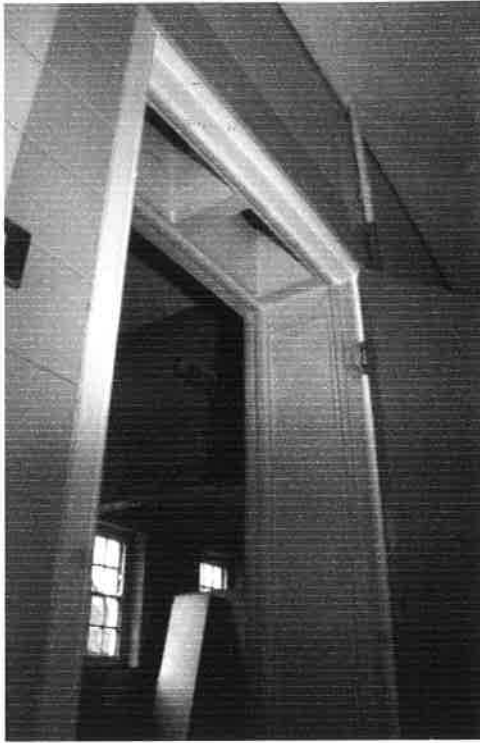
Plate 5: Void above door in F6

- 6.2.2 For example there are voids above most internal doorways, through the brick wall along the spines of the original C shaped building. In the majority of instances, the existence of a void is indicated by a thin, hollow sounding, covering board over the door opening, sometimes with six small holes. There are occasional exceptions, where the covering board is not present (and apparently never was), such as above the doorway to F6. Above this doorway there is a double chambered, brick lined void, which rises 1.32 m above the door head. The opening tapers as it rises and the two openings combine to form one. The awkward nature of the feature prevented a clear conclusion as to whether there is a horizontal flue extending through the wall linking the different openings. These features hint at a possible hollow heated wall, which is confirmed by the 1850 plan showing a series of vertical voids in the internal wall alongside the gallery. The features are present on each floor and both along the main north-south block and the perpendicular end blocks. A boiler provided warm air in the basement which would circulate around the ducting within the walls. The voids are generally arranged in sets of three, between each cellular ward and the adjacent gallery. The system would be designed to not only heat the building but also to create a strong air flow through the building to draw off foul air and was a common mid-nineteenth century device in institutional buildings such as prisons and lunatic asylums

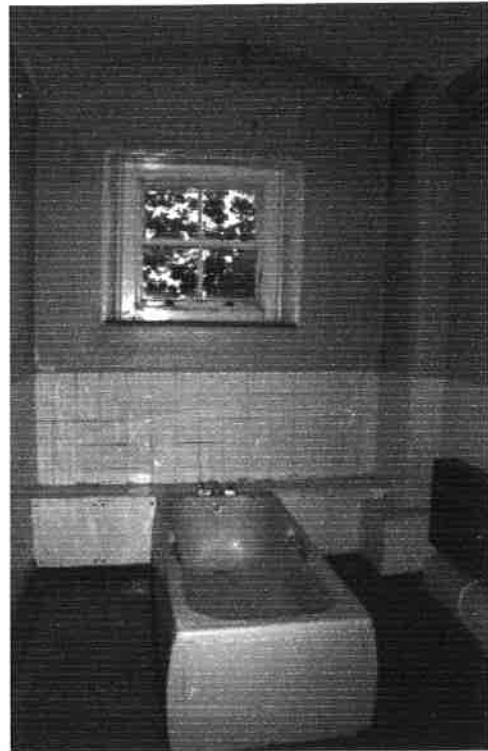
Plate 6: Central bath within F36

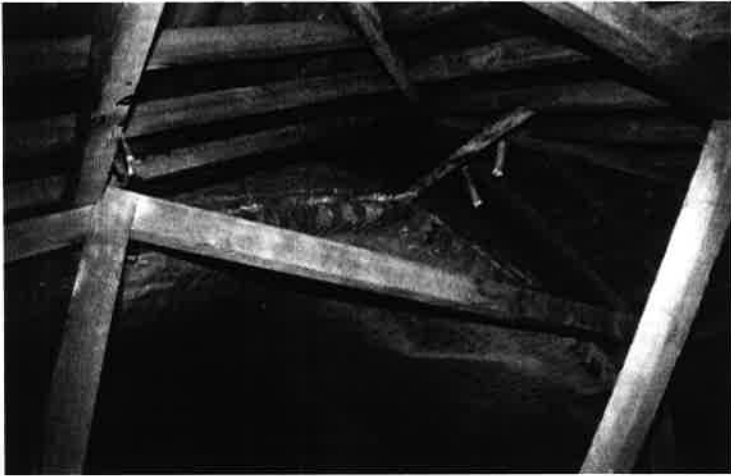
Plate 9: Junction between brick vaulted roof and central section

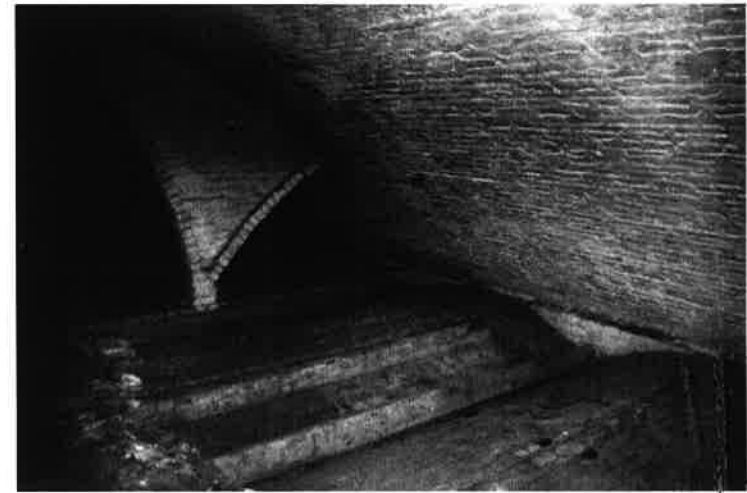
Plate 10: Brick ceiling arches from above

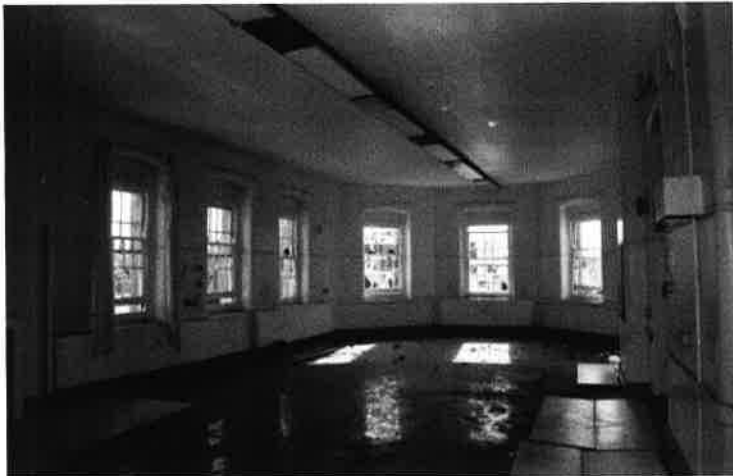
Plate 20: Contrasting windows and arches in F54

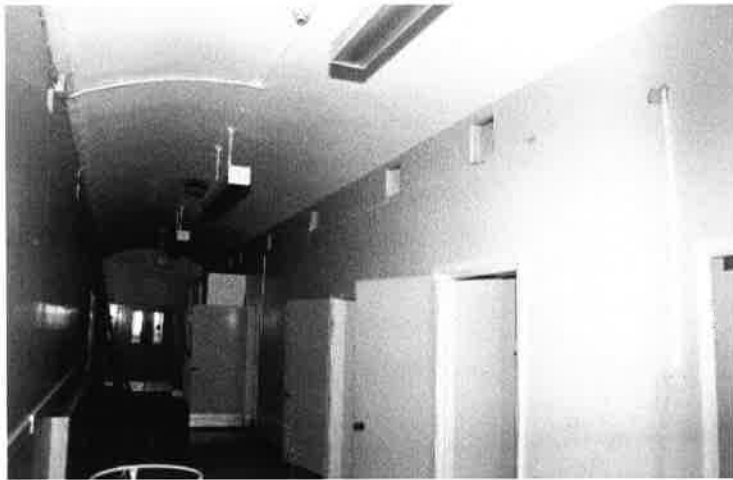
Plate 28: Vents within G82

- 6.2.4 Each of these have each been treated differently. The most impressive set is between G82, the corridor within the western projection and the rooms to either side. The four vents shared with G73 remain open and are surrounded by a simple, beaded timber frame. The nine vents within the opposite wall also remain open, the ones above doorways with a vertical shaft of unknown height while the others appear to be simply openings between spaces. Three vent openings exist between G90 and G65, between G84/83 and G64 and two between G103 and G65. Each of these have been blocked with plywood but retain their simple frame. The five vent holes between F38 and F3 have been covered with plywood as have the four holes between G9 and G10. The vents between F82 and F43 have been covered and plastered over, leaving a faint outline. In each of the dormitories adjacent to the central block, there are not only internal vents but also matching external vents, in each bay, now with plastic covers.

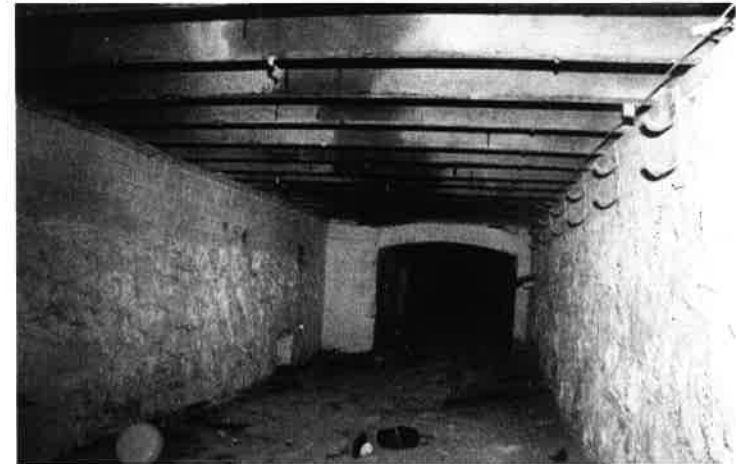
Plate 29: South cold air channel from north

- 6.4.4 The height of each of the cold air chambers gradually increases along their length from c 1.25 m close to the centre to c 1.75 m towards the far end of the building. The floor appears to be of concrete and the timber joists of the ground floor above are exposed.

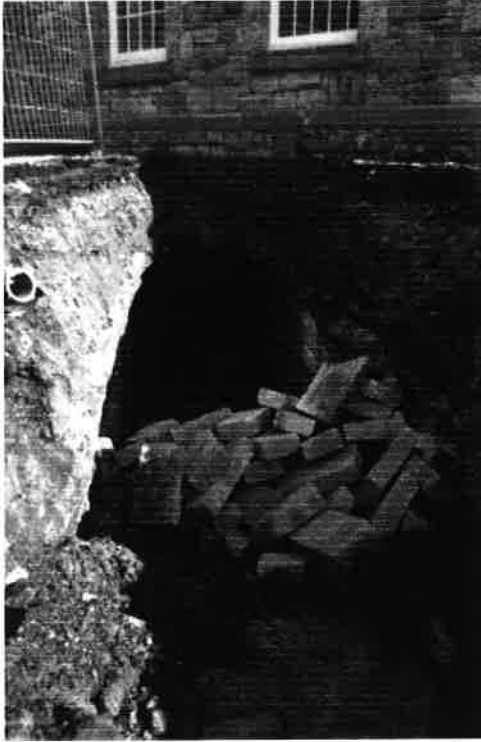
Plate 32: Cold air channel exiting south Wing during infilling

development area. Although there was no formal watching brief undertaken during these works an archaeologist was on site, undertaking recording on other structures and was able to observe the partially opened channel prior to its infilling. The side walls are of roughly coursed stone with a brick arch above (centre of arch c 1.75 m above floor). As suggested by the 1852 plan, the chamber runs south-east from Queen's House, terminating in a vertical shaft (covered over) and interestingly, another similar horizontal channel extends south from the shaft, towards the east end of St Andrew's House.

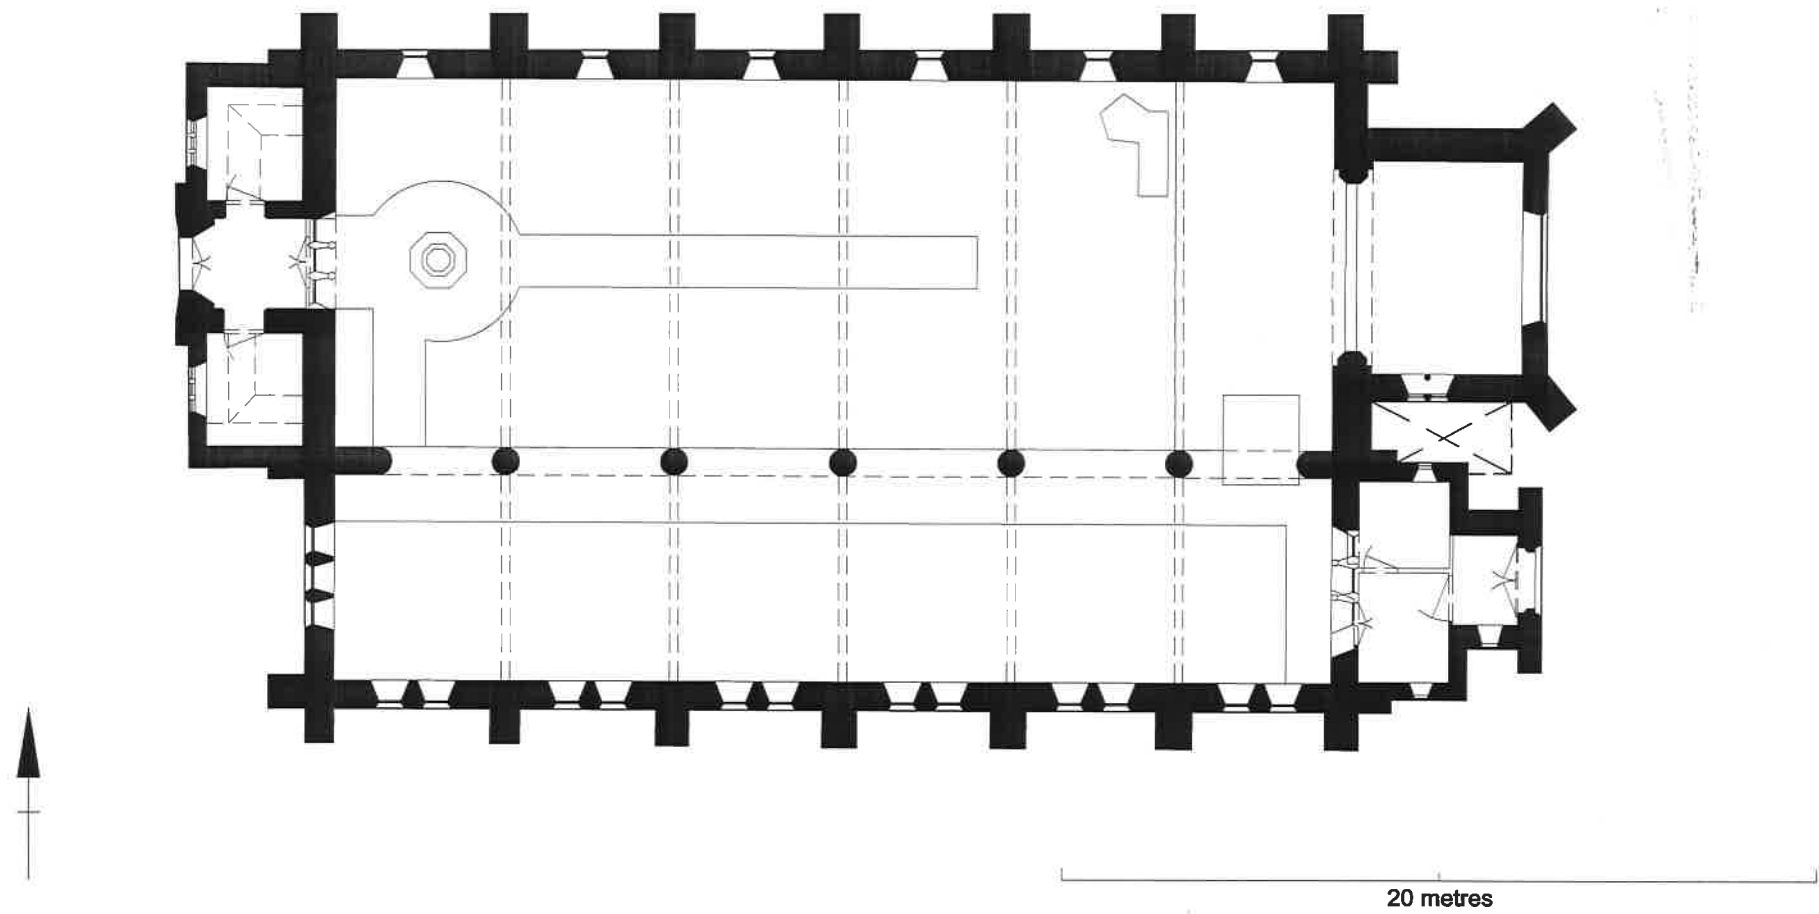
Figure 13: Floor plans,
 Secretary's Office
 Queen's House, Oakwood Hospital,
 Maidstone, Kent
 Oxford Archaeological Unit

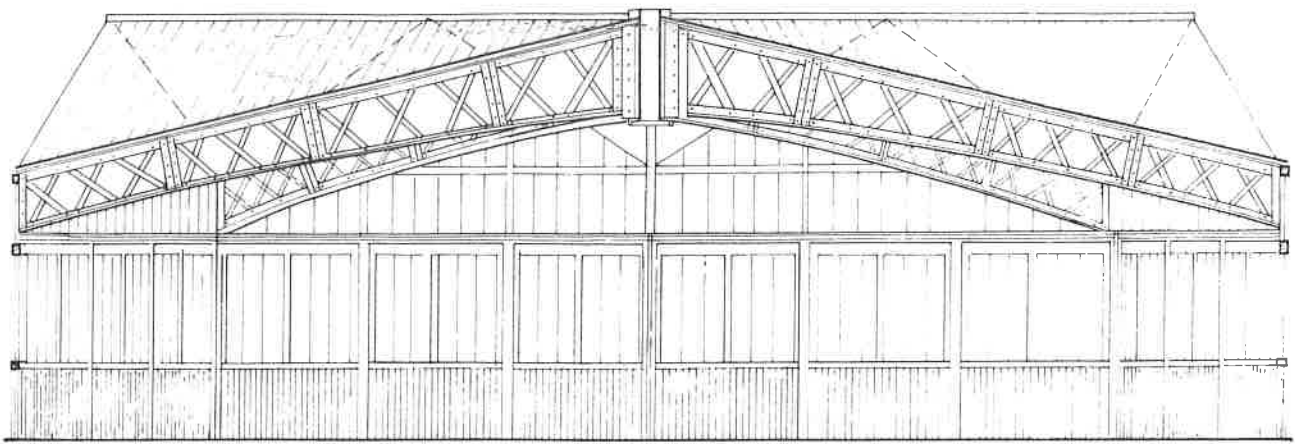
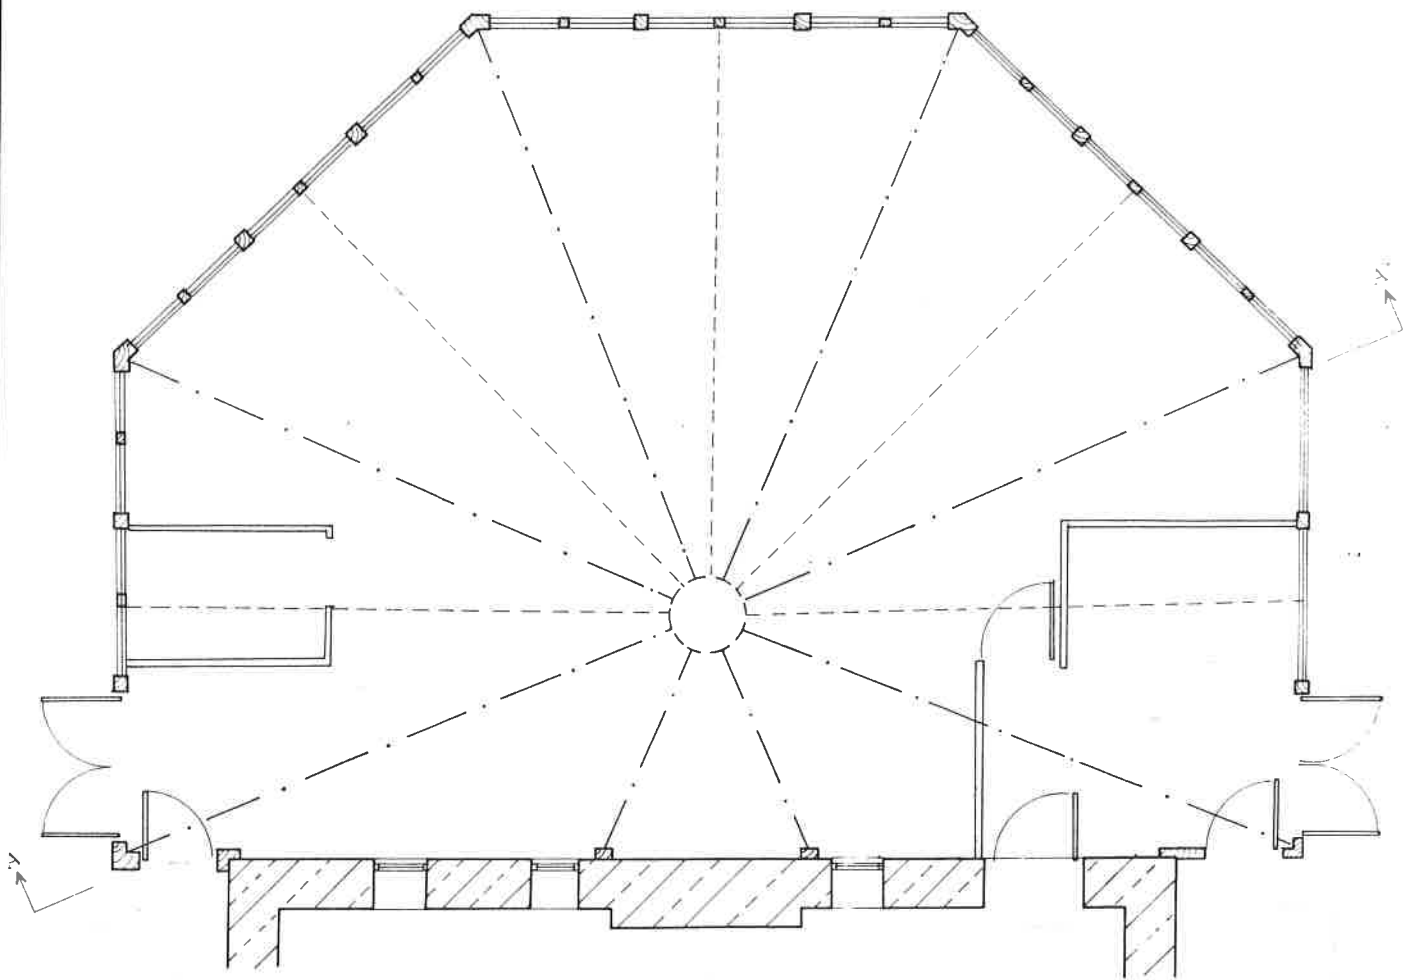
Oxford Archaeological Unit	
QUEENS HOUSE, OAKWOOD HOSPITAL MAIDSTONE, KENT	
Figure 15: Conservatory plan and section	
Sept 1998	Scale: 1:50 (at A2)

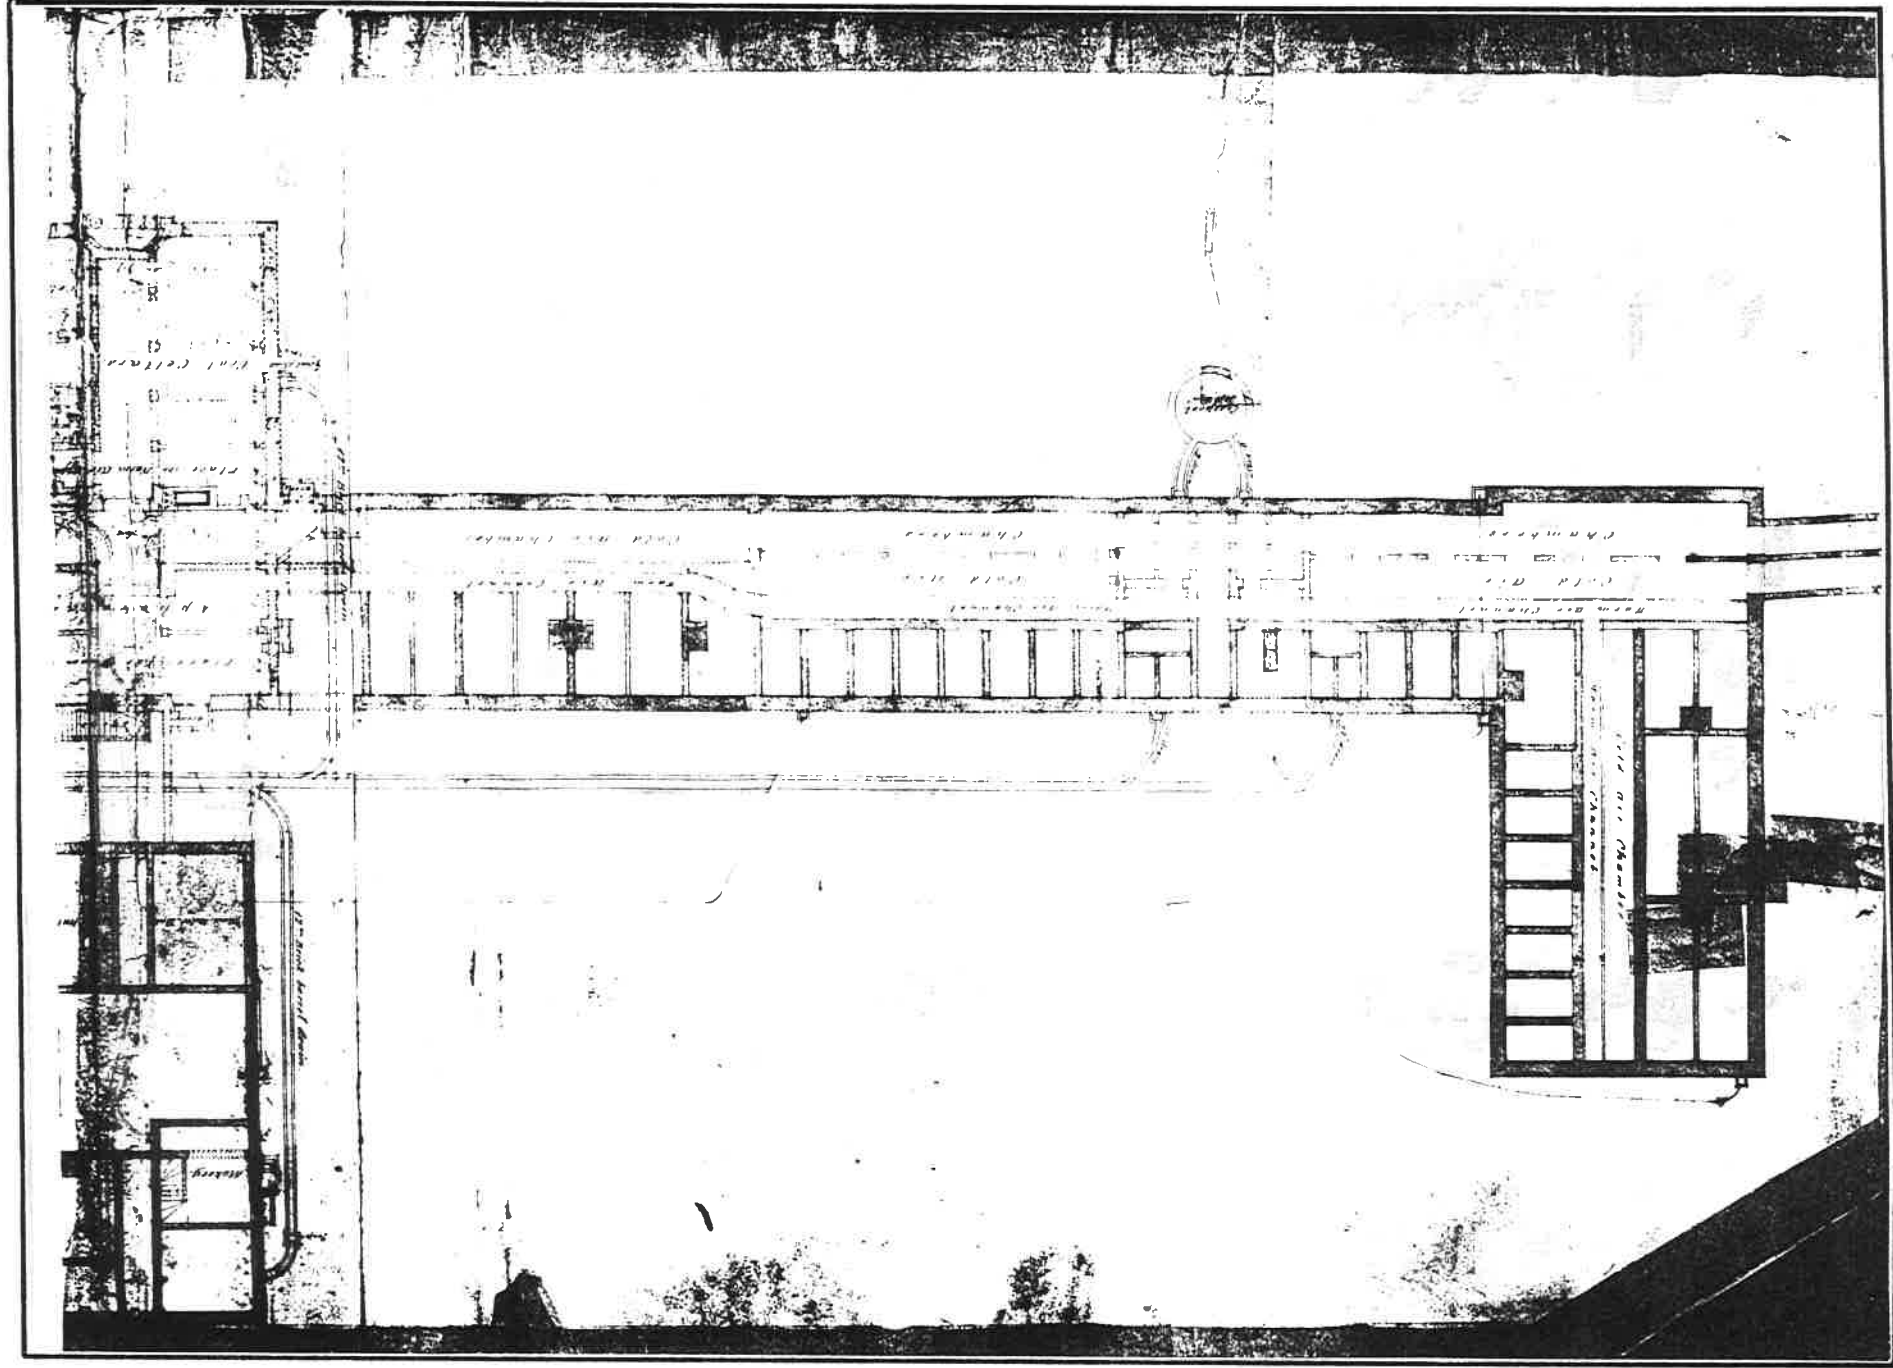
Figure 17 1850 basement plan south wing

- 6.4.2 The layout of the chambers is most clearly shown on the 1850 basement plan and a restricted, visual survey as part of the current recording project, has determined that the original structure is largely intact. The basic layout is of a central core for storage of fuel and furnaces for heating with two parallel ducts labelled on the plan *cold air chambers* and *warm air channel*, extending along either wing. In each wing the cold air chambers are to the east and are initially relatively narrow (for the first 22 m from the centre) before doubling in width to form two channels with a punctuated dividing wall. The double chamber continues to either end of the original building and proceeds beyond. The plan suggests that the horizontal flue beyond the north wing terminates about 10 m from the building (just past the later east extension) in a vertical *cold air shaft*, designed to ensure a strong draught. A site plan dated 1854 indicates, however, that the vertical shaft is significantly further from the building, c 35 m away and that it is shown closer on the basement plan simply to allow it to fit on the sheet.
