The Music Hall Shrewsbury Shropshire

Archaeological Evaluation Report and Building Assessment

November 2006

**Client: Shrewsbury and Atcham
Borough Council**

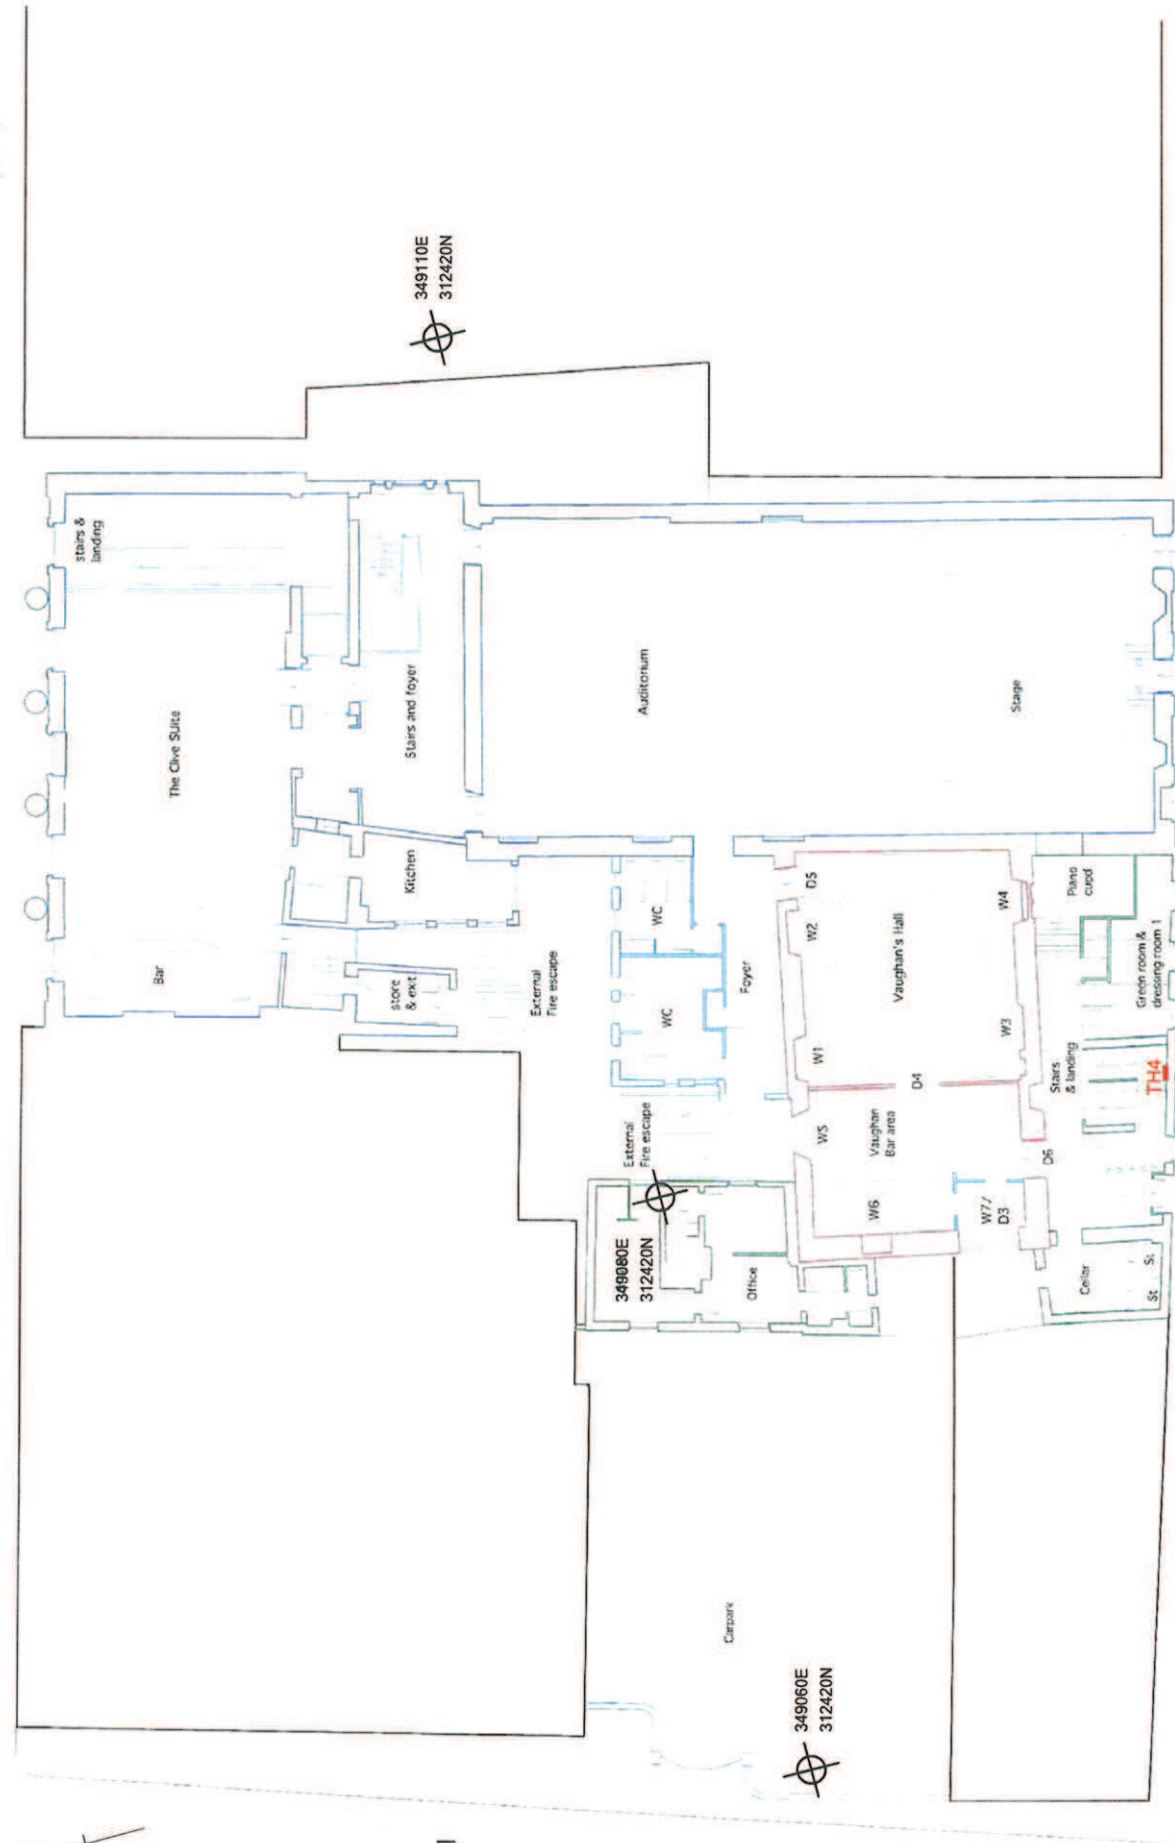
Figure 8: Trial hole location, 1st floor

Trial hole 4 (Fig. 8 and Plate 4)

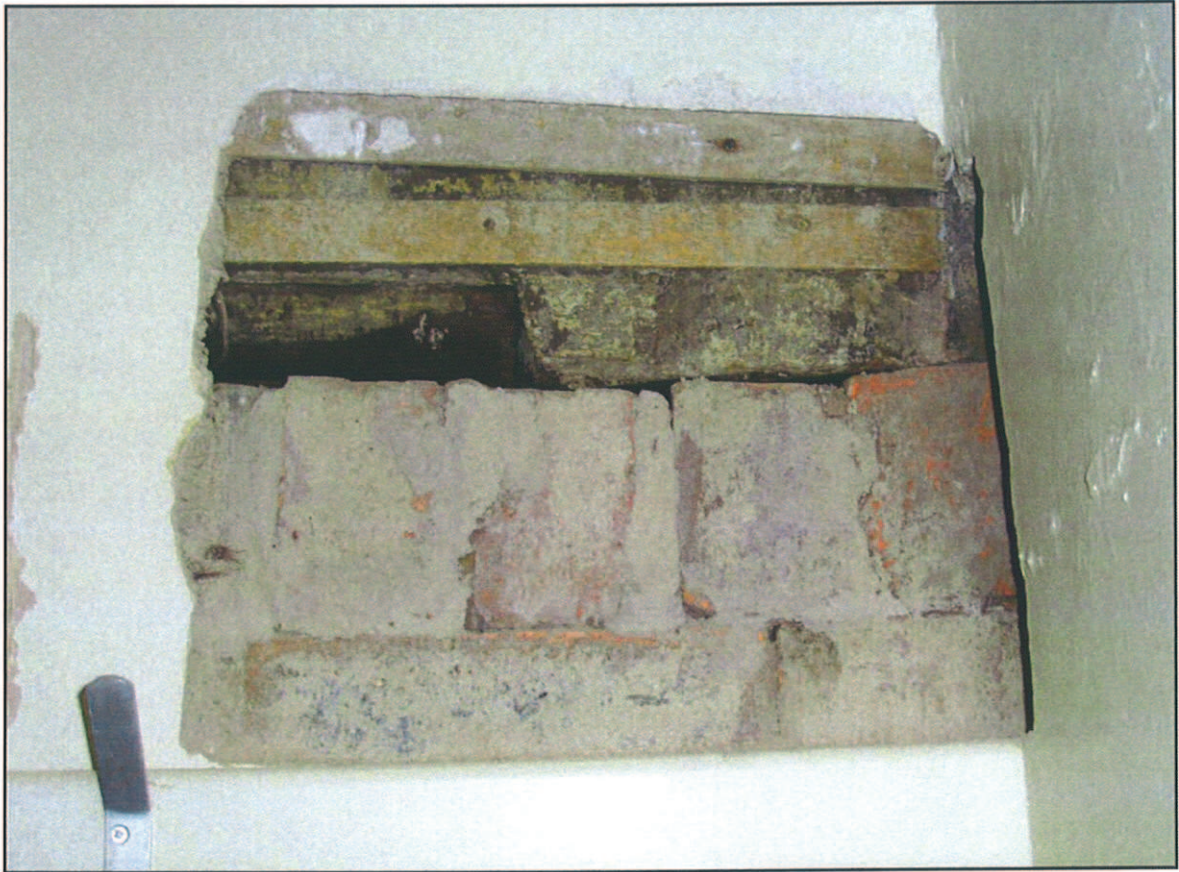
Plate 1: Trial hole 1

Trial hole 1 (Fig. 7 and Plate 1)

5.2.1 Trial hole 1 was located in the corner of the changing room 2 on the second floor and was *c* 2 m above floor height. The main hole measured 0.3 m wide and 0.35 m long and it was continued *c* 0.05 m around the corner to expose the construction of the adjacent wall. The main feature revealed was what appears to be the end of a tie-beam, with a stop-chamfered underside, which is tenoned into what appears to be a wall plate in the adjacent wall. The tie and the wall plate appear to be of oak. The tie beam was painted and the stop chamfer (0.07 m) was plain. Beneath the tie-beam is 19th-century brickwork with sandy cement bond and presumably the whole wall is of this date having been added beneath the older roof truss. The bricks measured 0.23 m x 0.12 m x 0.07 m and the uppermost course is a soldier course. Two laths (probably contemporary with the brickwork) have been nailed to the tie to hold the 0.03 m thick layer of plaster which now covers the wall. There is no mortar between the upper course of brickwork and the tie-beam.

- 6.2.7 The building assessment revealed that the exterior part of the southern wall of Vaughan's Mansion is likely to be relatively intact. The investigation of the wall at 2nd floor level revealed that substantial 19th-century alterations were undertaken but the wall plates and trusses from an older building at least partially survive.

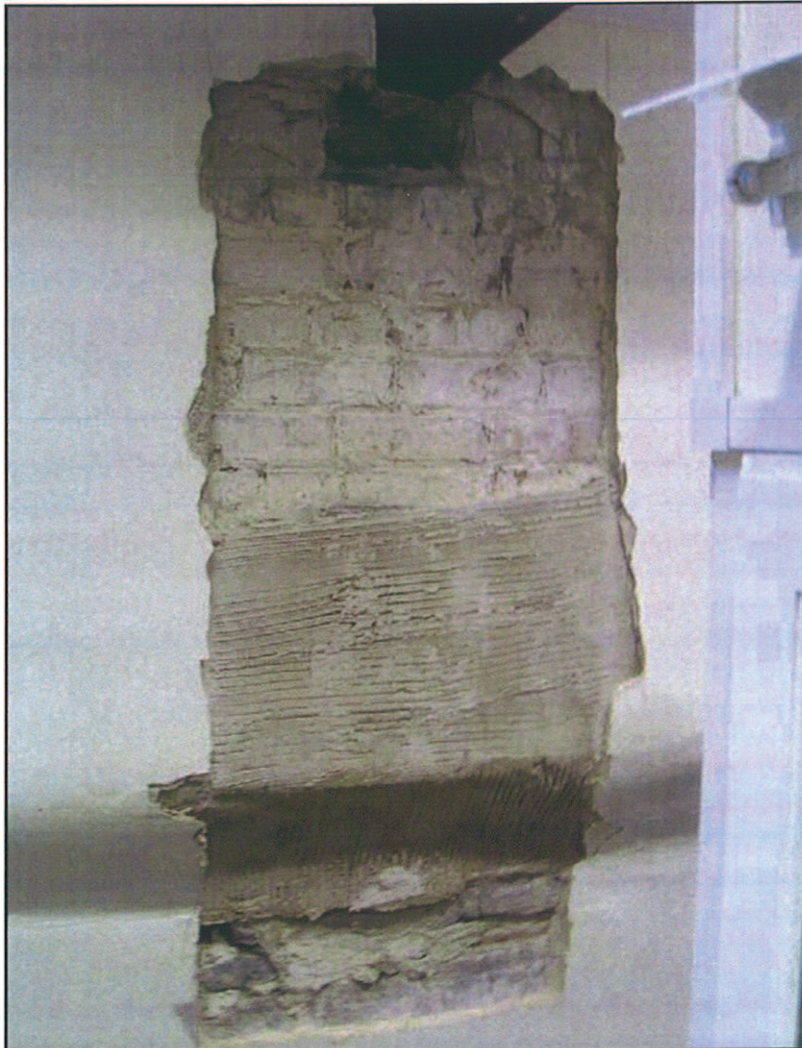
Plate 2: Trial hole 2

Trial hole 2 (Fig. 7 and Plate 2)

5.2.2 Trial hole 2 was also located in changing room 2, on the outer face of the southern wall of Vaughan's Mansion, measuring 1.45 m long and 0.6 m wide. The lower part

of the wall was seen to be constructed from rough hewn sandstone blocks with a light mortar bond but the upper part, which was offset 0.1 m to the south, comprised a 19th-century brick wall constructed from bricks measuring 0.23 m x 0.12 m x 0.07 m. These are contemporary with the bricks in Trial hole 1 and they were laid in a rough English bond, with a light sand cement and a flush pointed finish. The point where the stonework and brickwork joined was covered in a 0.03 m skim of modern hard waterproof cement. Above the bricks a small section of what appears to be a wall plate was exposed and this supports a tie-beam spanning the room. Roof tiles were laid against the wall plate to bring the surface flush with the rest of the wall face and allow a continuous line of plaster. The bricks were presumably added to strengthen or consolidate the wall and they may have replaced a timber framed upper section.

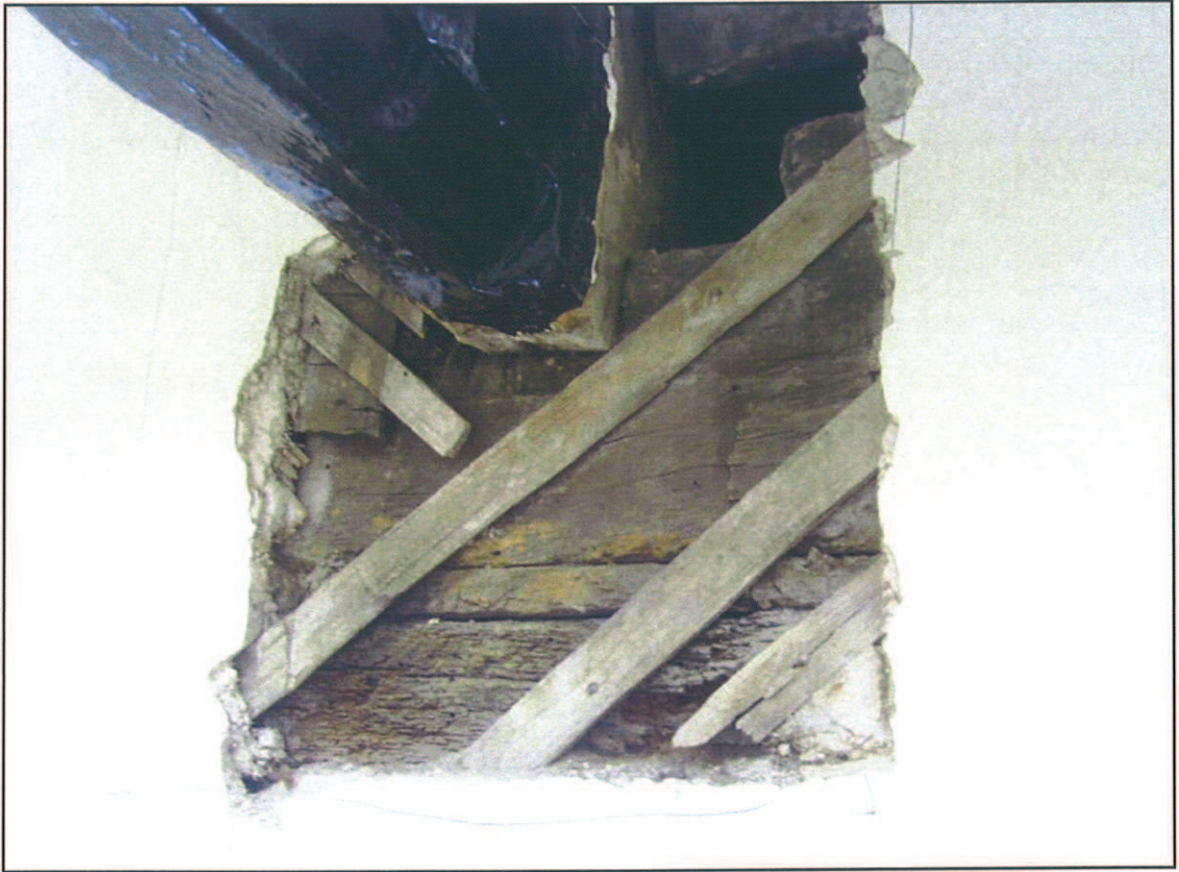
Plate 3: Trial hole 3

Trial hole 3 (Fig. 7 and Plate 3)

- 5.2.3 Trial hole 3 was also located in changing room 2, above the inside edge of the window looking out onto College Hill Street. The hole was 0.40 m long and 0.35 m wide and it was placed to investigate the point at which the stop-chamfered tie-beam enters the wall. The hole confirmed that the wall plate remains in-situ at this point and that the tie-beam rests on it. Laths supporting the 19th-century plaster which now covers the area have been nailed to the wall plate. The wall plate measured 0.24 m wide by 0.17 m in depth but there is another timber immediately beneath it. This may be a later packing piece.

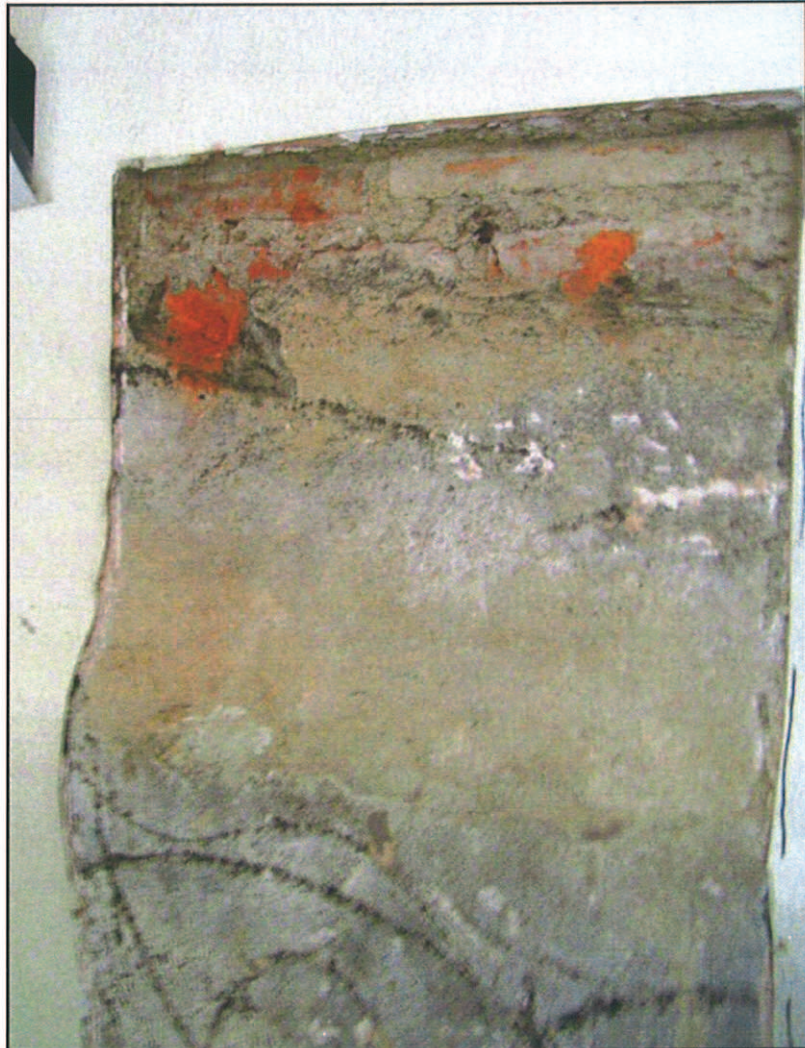
Plate 4: Trial hole 4

- 5.2.4 Trial hole 4 was located in the stairwell on the first floor, and measured 0.6 m long and 0.4 m wide. At this point there is a 0.06 m offset in the wall, at street level. The trial hole revealed that this whole area now comprises 19th-century brickwork. The lower part was covered in modern grey sand cement with scoring to fix the 0.02 m thick plaster.
