Site/Project Name: **Oxford Beaumont Street Void**

Site Code: OXBEVO 09

Site/Project Type: Watching Brief

Title Trenching Adjacent to the Ashmolean Museum Beaumont Street Oxford, Archaeological Watching Brief Report

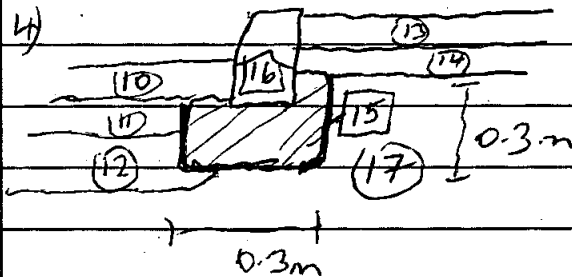
Context No. **14/15**

- 1) straight edged linear
- 2) vertical sides flat base
- 3) 0.3m deep 0.3m wide

- 5) N.A
- 6) Filled by **16**

Construction cut for kerbstones **16**

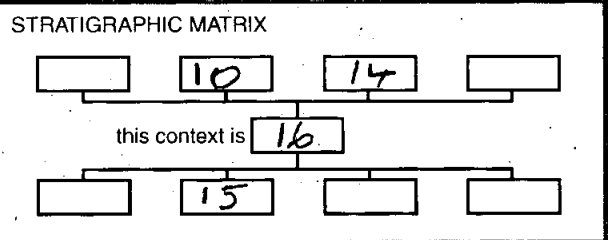
Context No. **16**

1) Concrete kerbstones, concrete base
 2) Kerbstones 0.9m x 0.18m x 0.12m
 3) ~~4) Batted~~
 5) Linear feature along edge of road

Interpretation/Discussion: **Masonry concrete kerbing along northern edge of beaumont street**

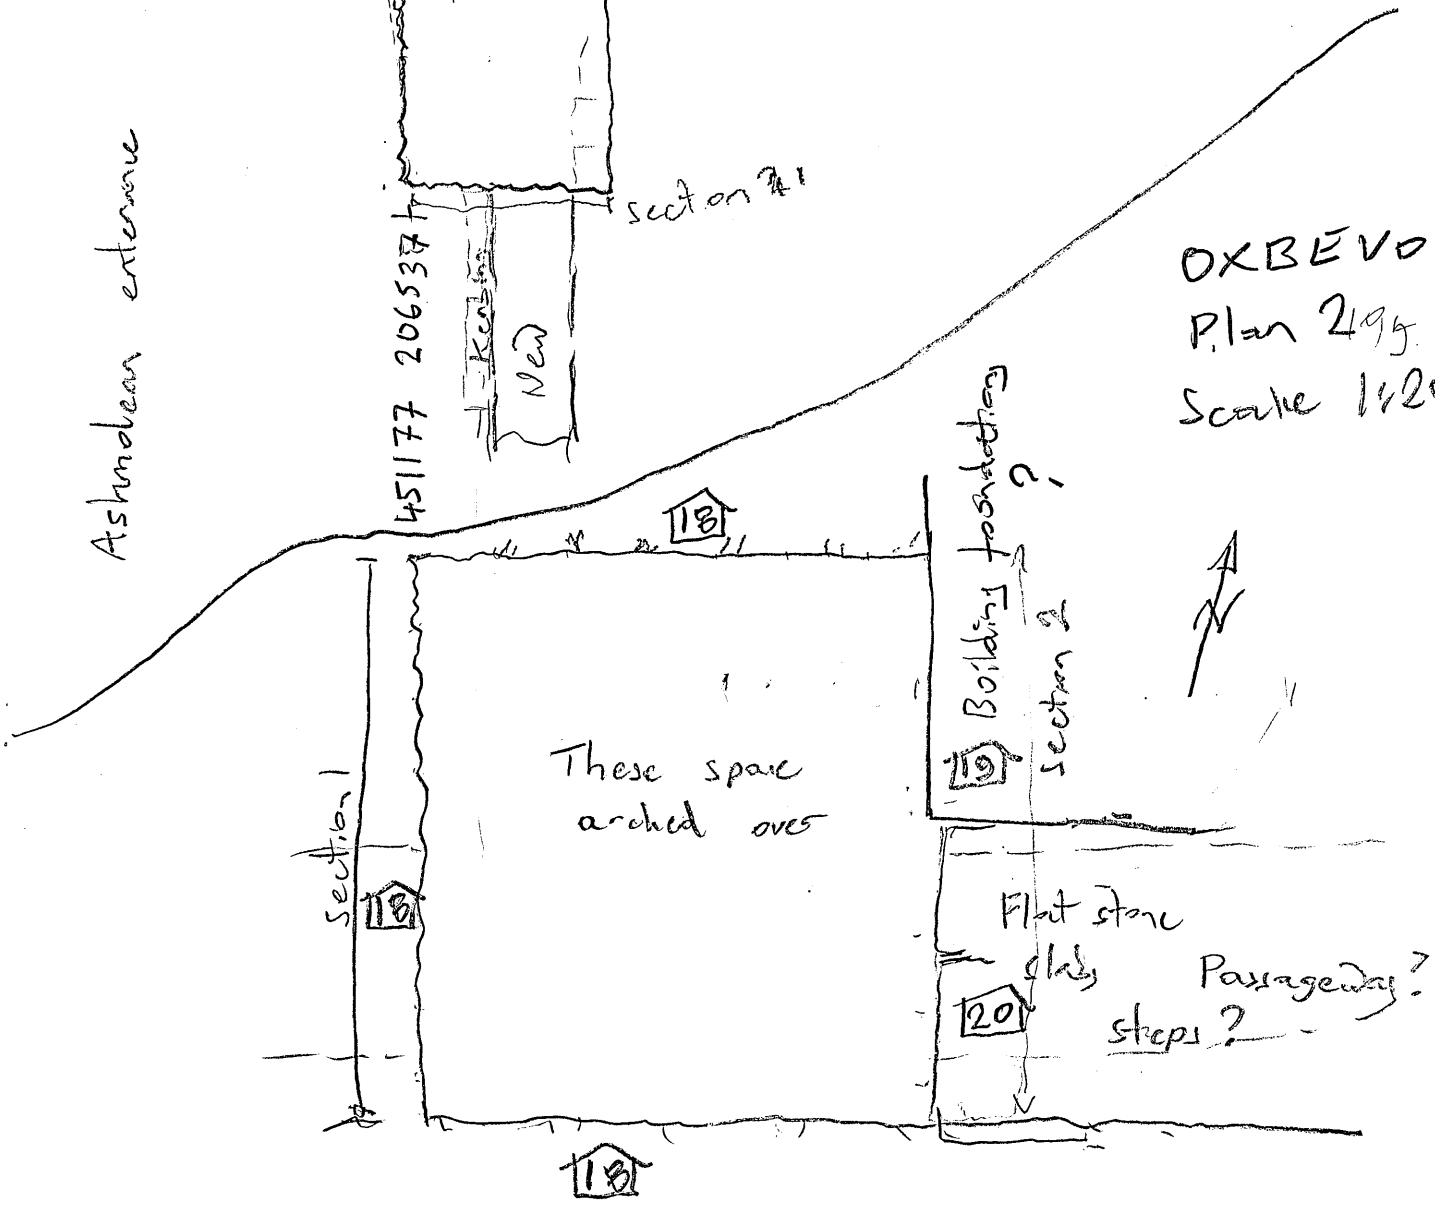
Plan 295

Void was collapsed stone vaulting over square stone pit approx 2m x 2m

Passageway leading off to east ~~end~~ covered with stone slabs

N.E. corner of pit makes use of earlier stone structure - Building foundations?

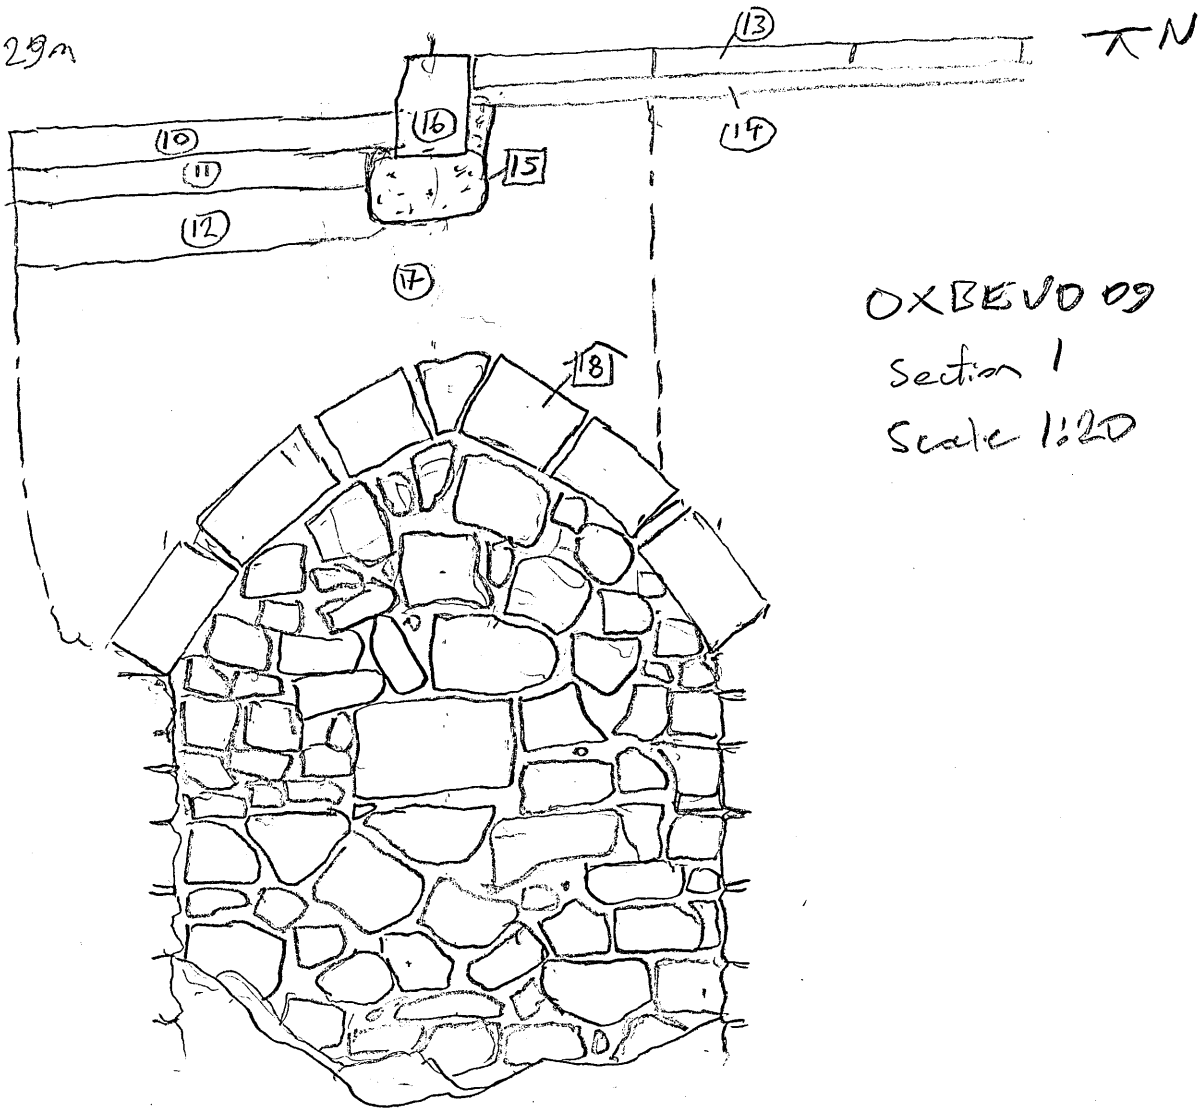
OXBEVD 09
Section 1
Scale 1:20

Stone lined cess pit. interiorheavily organic stainedsides rough built stones used for arching/vaultingwell dressed + squared.Passeway 0.85m wide leading off to east.

Corner of earlier structure / Possible gable or chimney stack of earlier building reused used as NE corner of cess pit [18]

Fallen in material

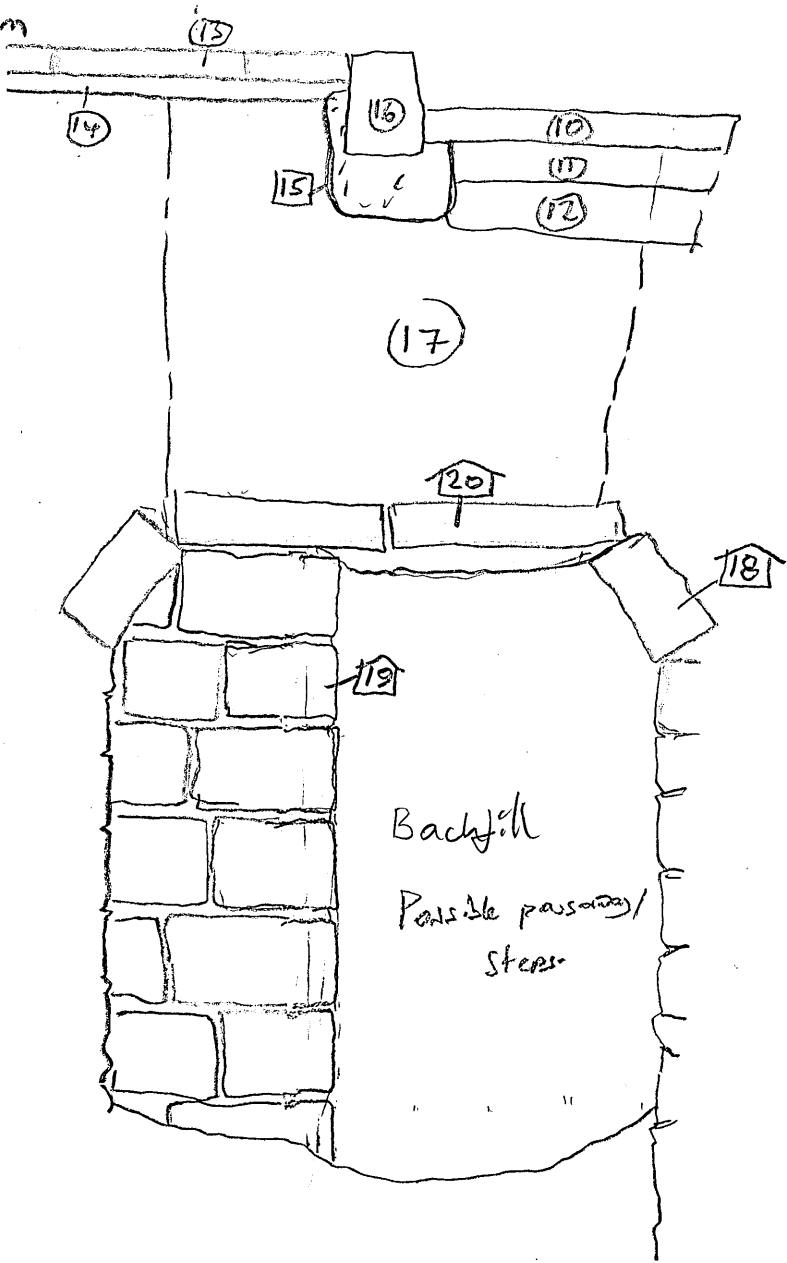
OXBEVD 09
Section 2
Scale 1:20

Stone slab roof over passageway leading eastwards off Cess pit 18
