The National Trust  
(Thames and Chilterns Region)

**BOARSTALL TOWER, BOARSTALL, BUCKINGHAMSHIRE**  
ARCHAEOLOGICAL MONITORING DURING BUILDING WORK

**Oxford Archaeological Unit**  
February 2000

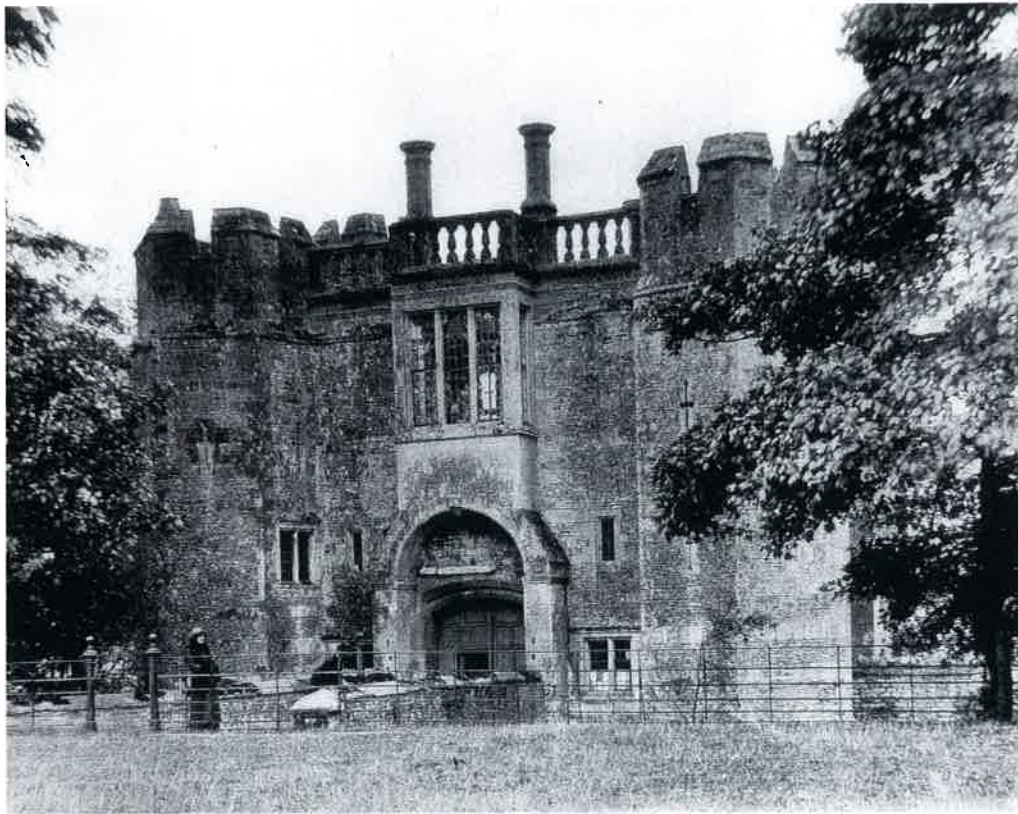
**Figure 9:** North-west elevation, photographed in 1911

(photo: RCHM Crown copyright reserved)

<sup>6</sup> A RCHM photograph of 1911 (Figure 9) shows the doors in their original arrangement.

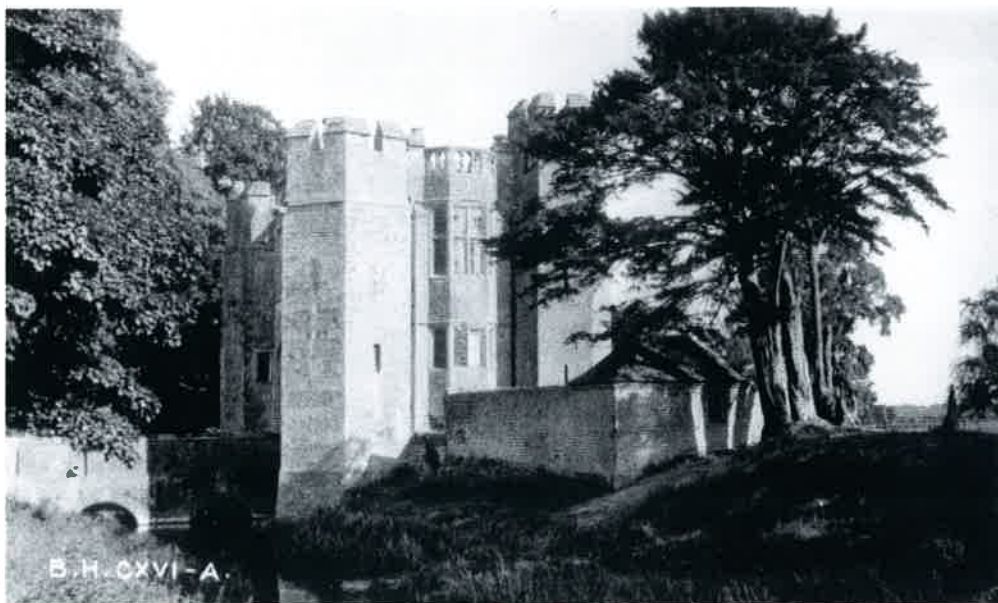
**Figure 10:** north-east elevation, photographed in 1911

(photo: RCHM Crown copyright reserved)

The southern structure is not clearly represented by the photographic record or by structural evidence. The RCHM photograph of 1911 (Fig.10/32) clearly shows the north-eastern brick wall of the southern structure though it would appear, by this date, to terminate some distance from the main block, the continuation being a lower wall of stone construction (the extant 'plinth', possibly dating to the 17<sup>th</sup> century – see above). It should also be noted that the photographic evidence indicates that, at this date, the brickwork represents a free standing wall rather than part of a roofed structure. The termination of the brick wall, short of the main tower, is confirmed by structural evidence; a straight joint can be discerned in the brickwork of the north-east wall at a distance of 3.55m north-west of the main block. It must be assumed that, if the southern structure did originally extend as far as the main tower, any fabric related to its south-eastern end has been lost.

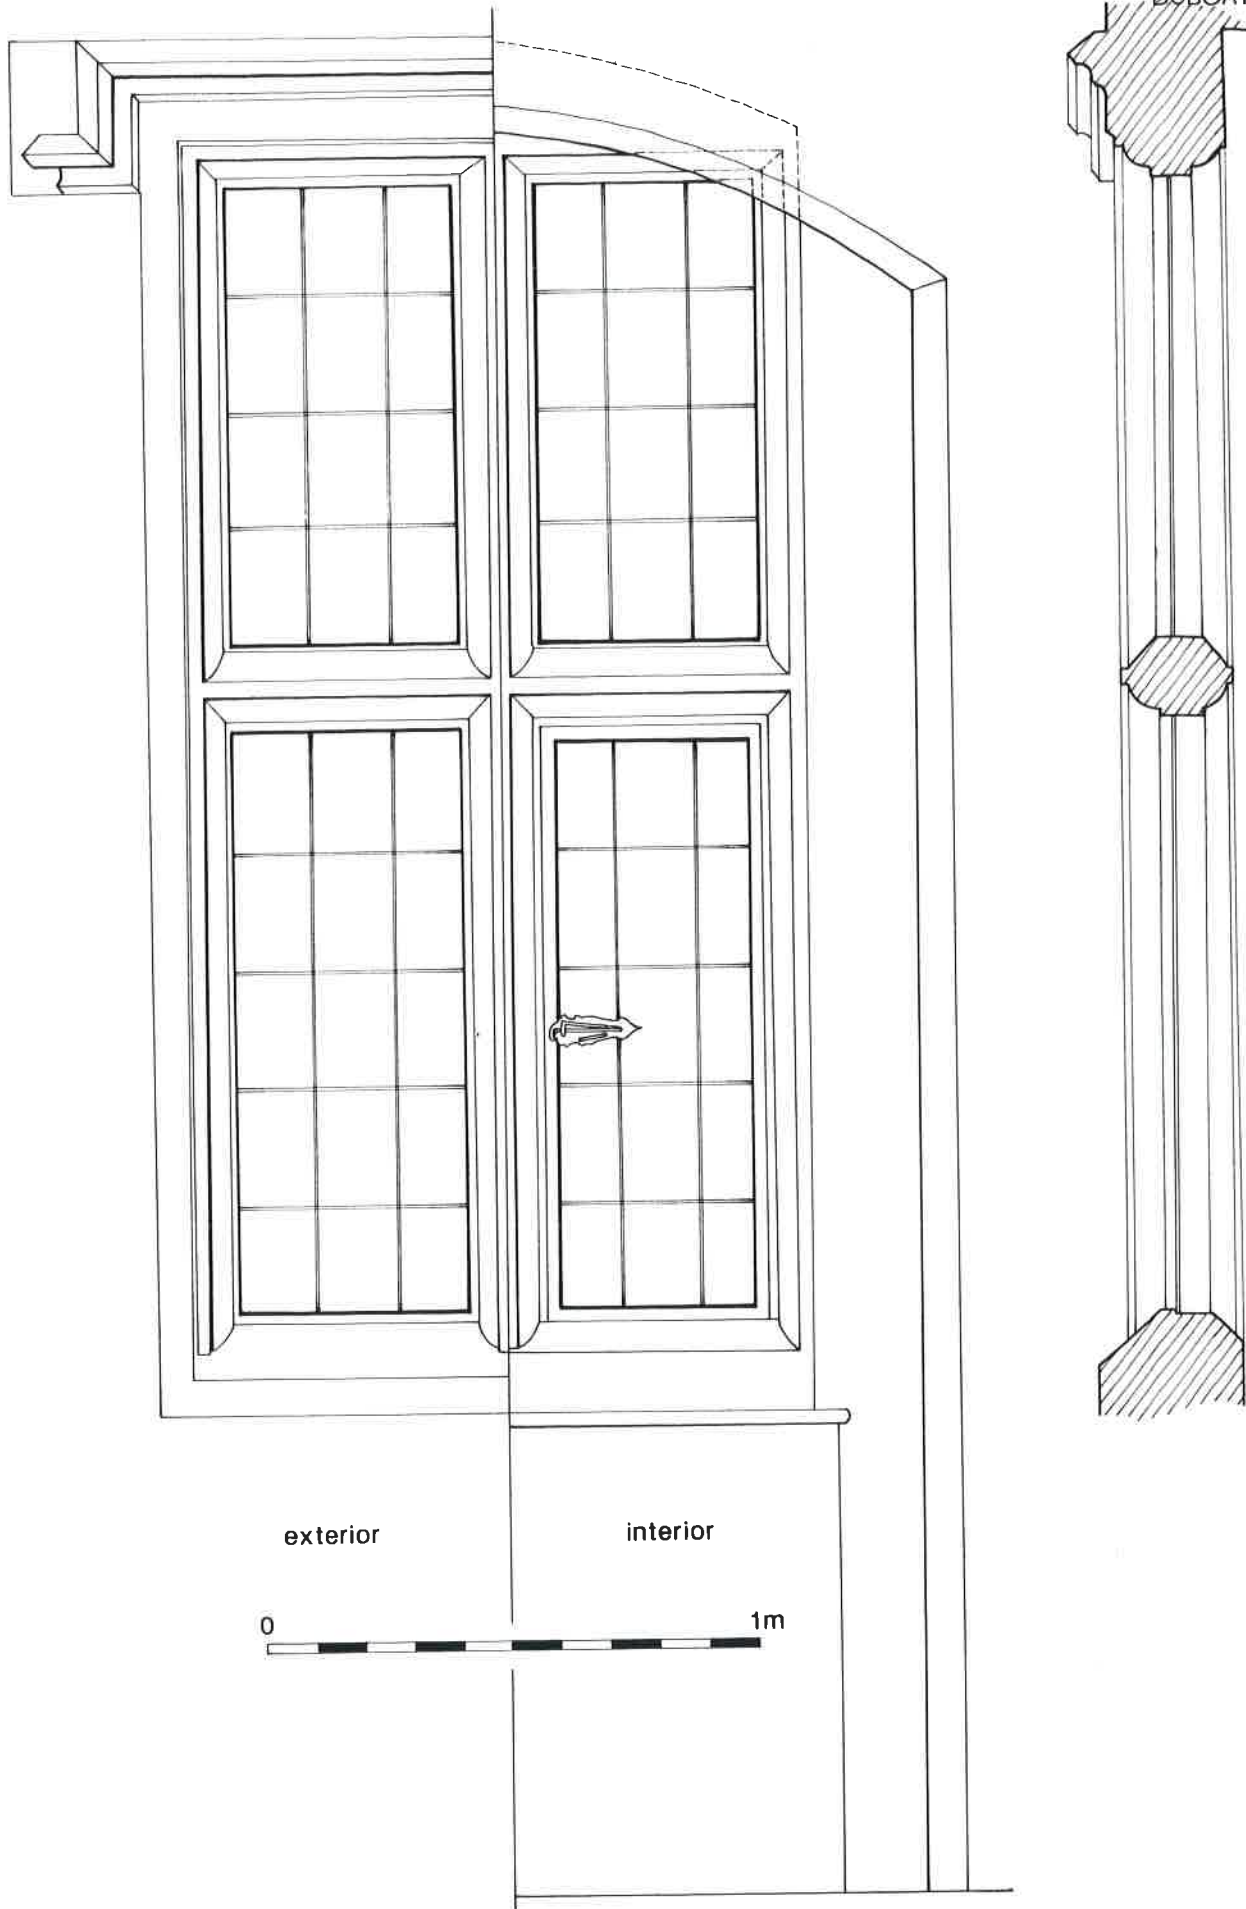
Figure 21: Window detail ; 2F/01, south-west wall

Two large limestone, ovolo-moulded cross-windows with splayed reveals and two centred rear-arches (see Fig.21) are located symmetrically to either side of a stone fireplace with moulded four-centred arch with spandrel decoration and stopped jambs (see Fig.17c). In each window, the lower light nearest to the fireplace represent opening casements. Each are of 15 panes, furnished with iron spring catches (Fig.14, type B) and quadrant stays (much corroded).

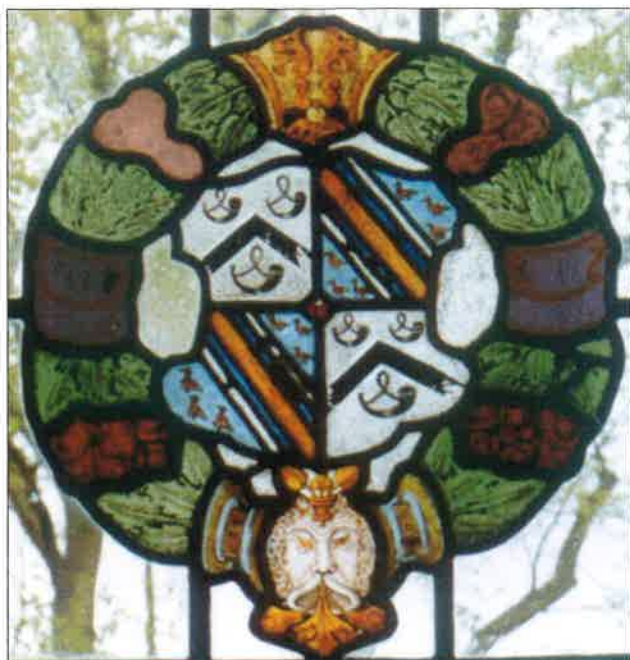
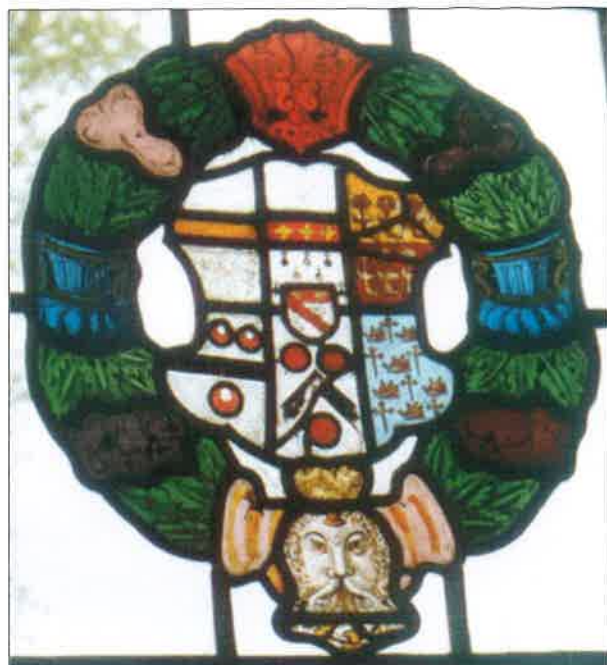
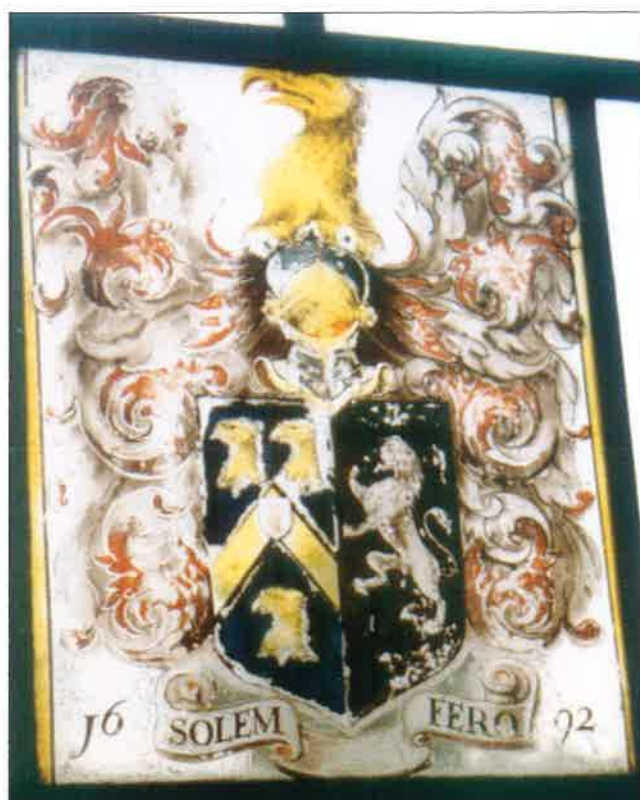
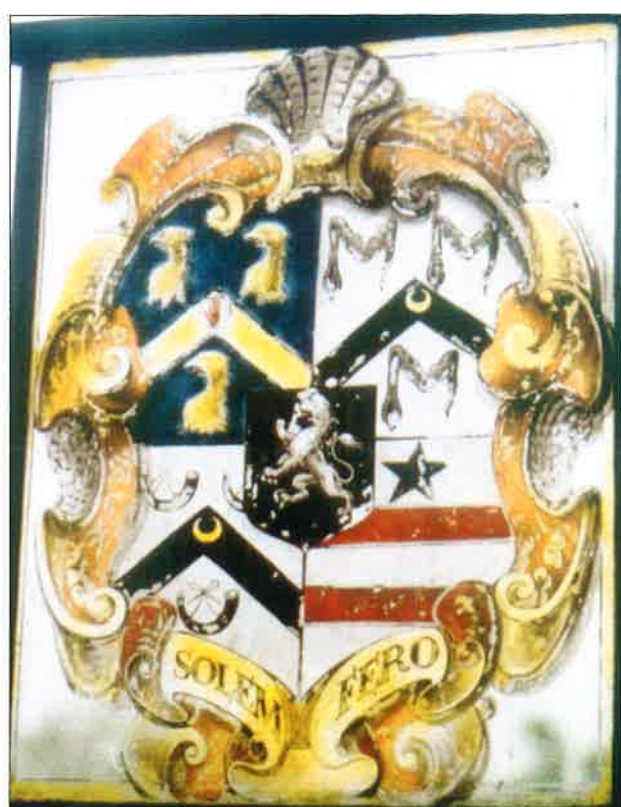
The windows of the upper level retain a number of panels of stained glass dating to the late 17<sup>th</sup> century - the panels within the north-east bay window contain the motto 'SOLEM FERRO' and the date '1692' (see Figure 25c). A full description of the stained glass panels is given in the Royal Commission field notes of 1911 included below as Appendix B.

**Figure 25:** Stained glass (a) + (b): Music Room, north oriel, (c) + (d): Music Room, east oriel

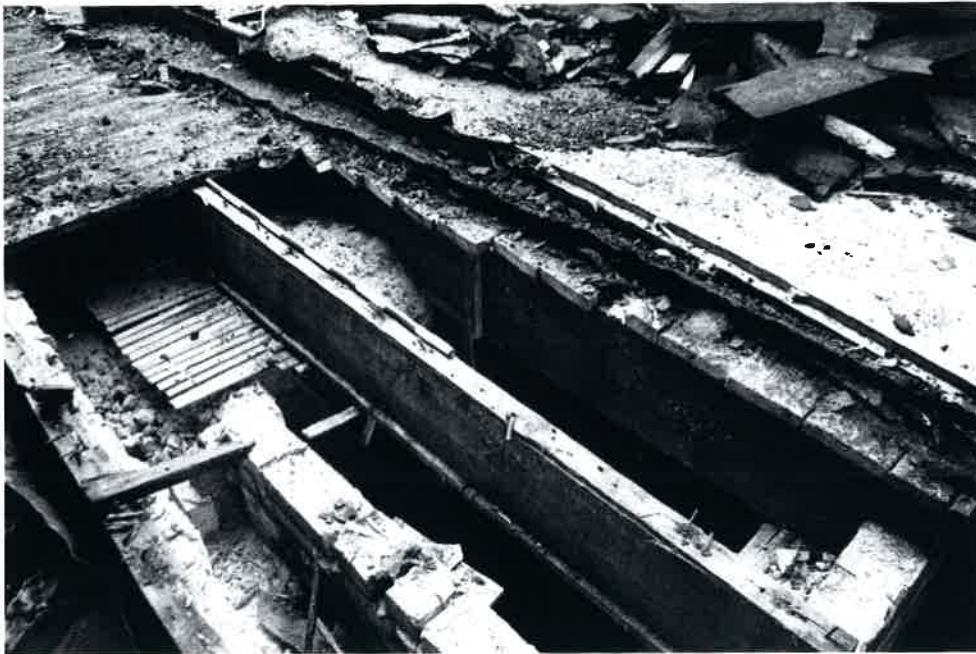
The roof covering had undergone repair evidenced by two clearly discernible phases of roofing felt (Fig.27), the second at a steeper incline than the first, and presumably added to alleviate problems of drainage. All modern roof coverings were removed and disposed of, the structural framework of the roof has been retained within the refurbished building.

**Figure 27:** annexe roof during dismantling showing successive layers of boards and roofing felt

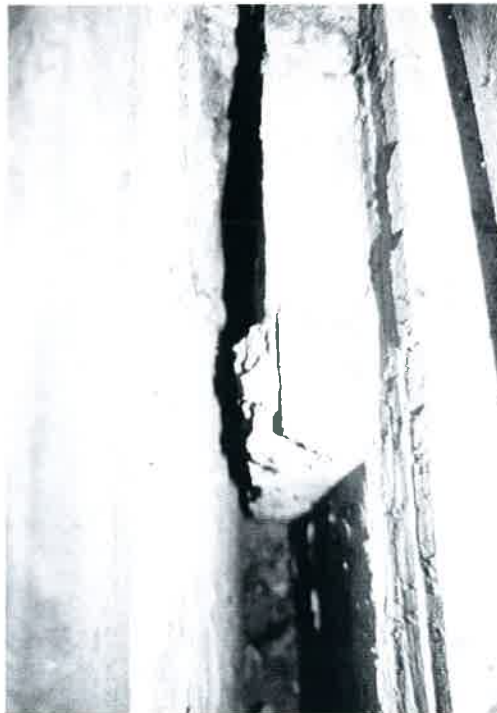
**Figure 28:** stub wall indicating western return of pre-1851 brick structure

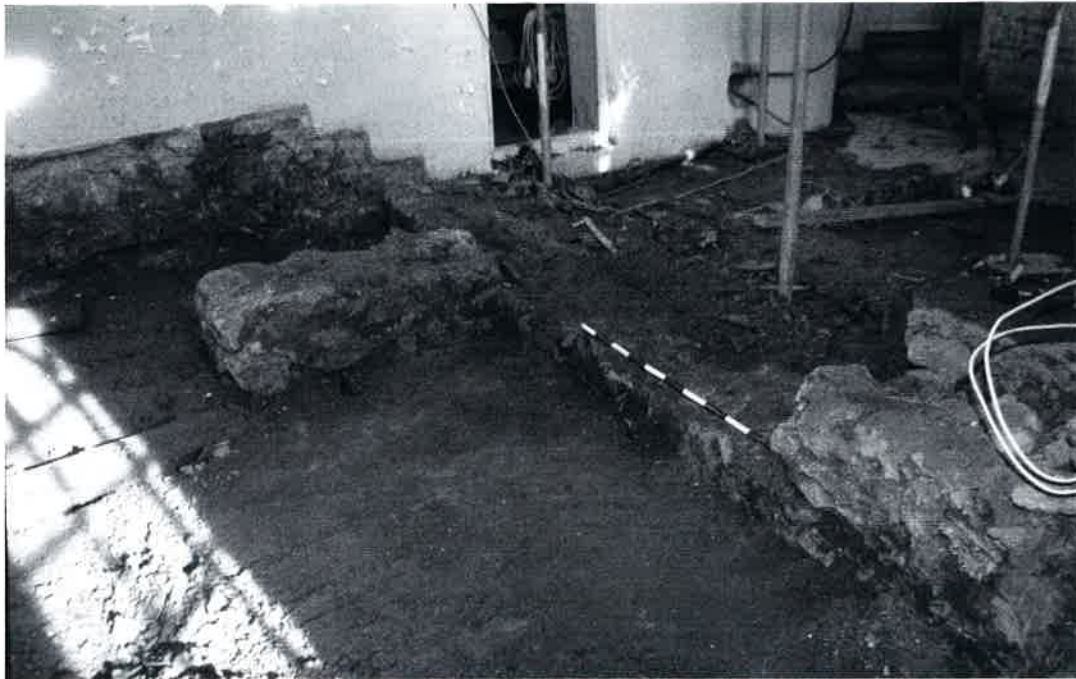
**Figure 29:** Annexe, reduced dig; detail of wall 1004 (centre-right) and perpendicular 'buttress' 1003 (left) (photo: OAU)

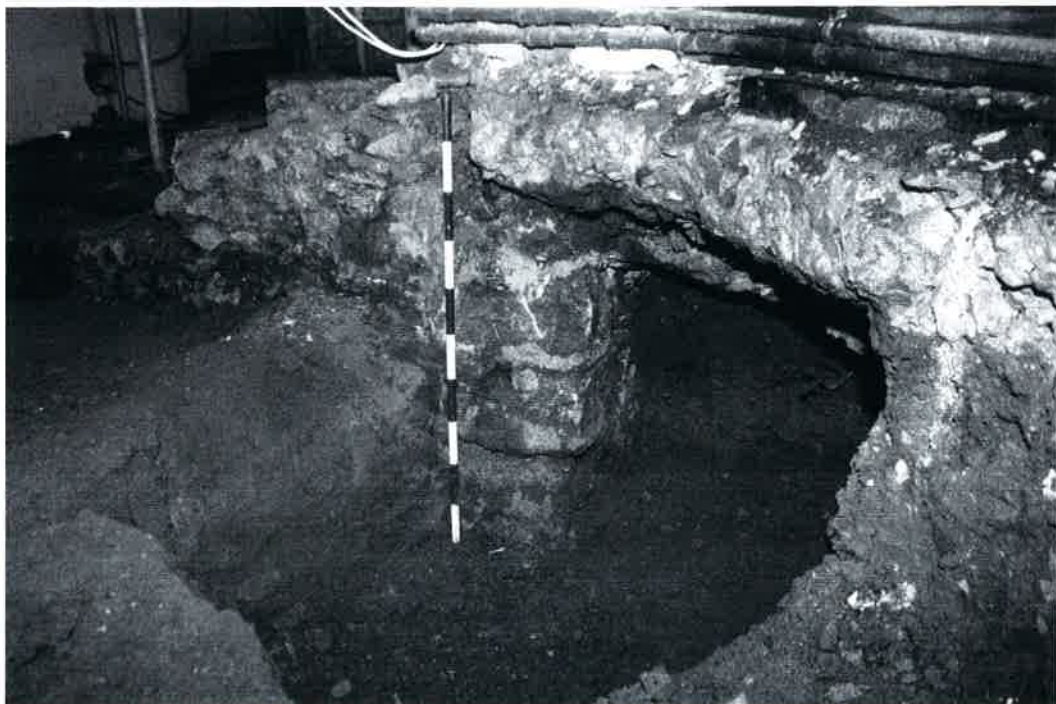
**Figure 30:** Annexe, reduced dig; detail of corner of wall 1004 and 1006 (photo: OAU)

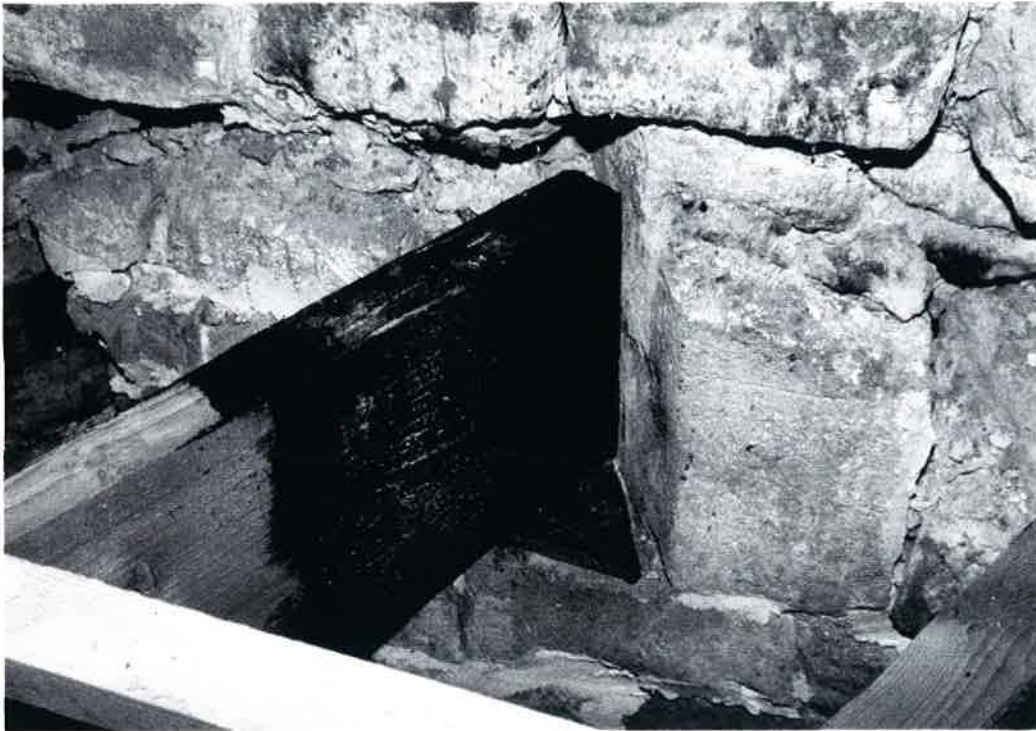
**Figure 35:** Ceiling joist of south-east corner turret housed within splay of former loop.

Figure 35), the base of the crenels being at a level of 107.625m OD . Externally, the form of the former loops was noted to be of standard cruciform type with circular terminals confirming a primary origin. The maximum level of primary stonework masonry was at a level of 107.90m OD, above this level the masonry was of mixed stone and brick construction, brick being extensively used as an internal facing.<sup>10</sup>

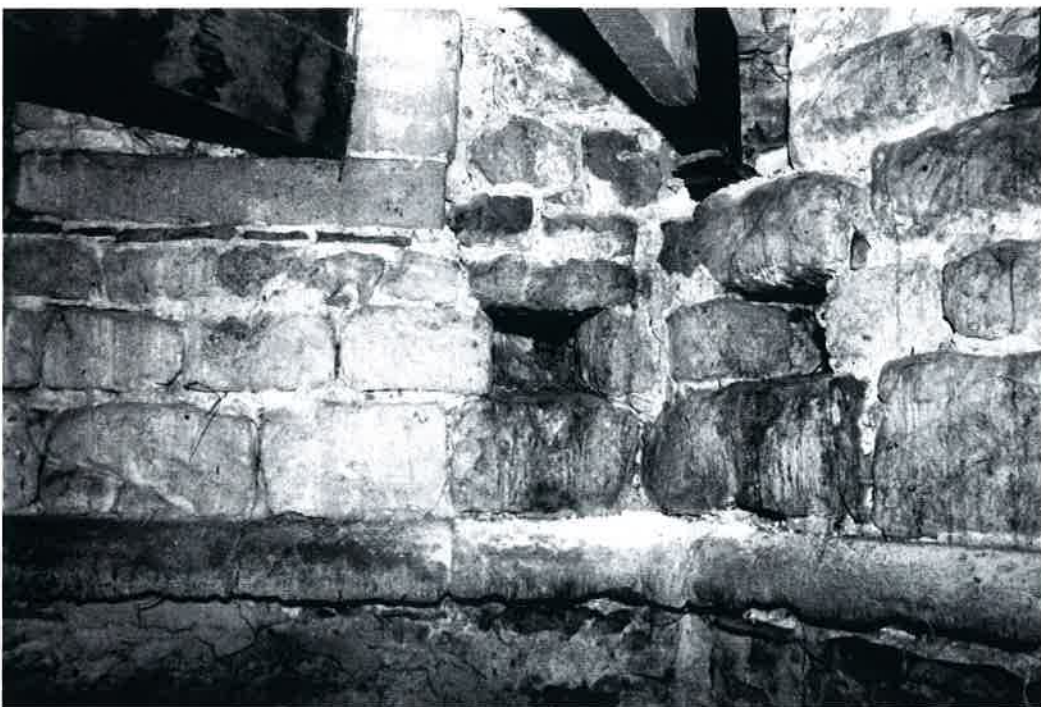
**Figure 36:** South-east corner turret: projecting stone string course below current roof level denotes former roof line; note ceiling joist (left) housed within splay of former loop.
