# Land near Cribbs Causeway Bristol

## Archaeological Watching Brief Report

Document Title: Land near Cribbs Causeway, Bristol

Document Type: Archaeological Watching Brief Report

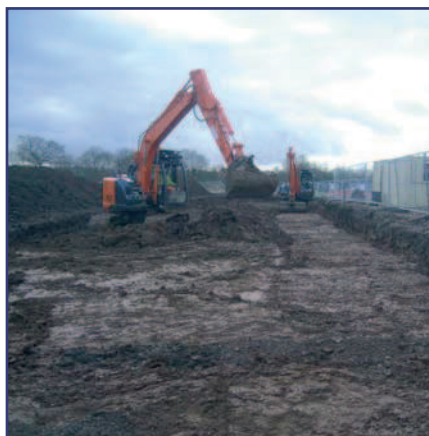
Front cover; Ground reduction on the site of the former mushroom farm
