Elsham STW Middlegate Lane Elsham

Archaeological Evaluation Report

OA East Report No: 1348 OASIS No: oxfordar3-124178

An Archaeological Evaluation at Elsham STW, North Lincolnshire

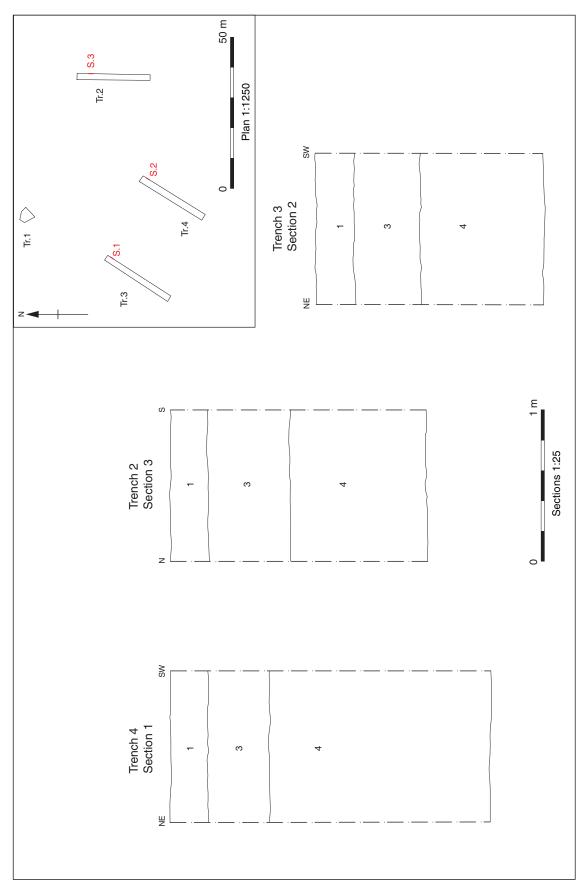
Figure 2: Trench layout and Sections 1, 2 and 3

3.3.1 The natural chalk geology was revealed at an average depth of 1.7m across the trench. No archaeological features were present throughout the trench (see plate 2). A previous levelling deposit of loose crushed white chalk rubble (5) interspersed with a dark orangey brown silty sand was excavated, measuring 0.9m in depth. Overlying this was a layer of densely compacted chalk rubble (4) 0.55m in depth. Topsoil was present across the trench, this consisted of a dark greyish brown silty sand, measuring 0.25m in depth (for section see fig. 2)

3.4.1 Natural was revealed across the trench at an average depth of 1.5m. No archaeological features were observed throughout the trench (see plate 3). Overlying the natural was a levelling deposit, measuring 0.8m in depth. This consisted of a crushed white chalk nodules with dark orangey brown silty sand (5) and was loosely compacted. Above this was a layer of crushed white chalk (4), which was densely compacted, which measured 0.45m in depth. Topsoil (1) was present across the trench, measuring 0.25m in depth. This was a dark greyish brown silty sand (for section see fig. 2).

3.5.1 The natural chalk geology was revealed at an average depth of 2.1m across the trench. No archaeological features were present throughout the trench (see plate 4). A levelling deposit of loose crushed white chalk rubble (5) interspersed with a dark orangey brown silty sand was excavated, measuring 1.45m in depth. A further levelling deposit lay above this, which was a densely compacted chalk rubble (4) 0.4m in depth. Overlying these deposit was topsoil, this consisted of a dark greyish brown silty sand, measuring 0.25m in depth (for section see fig. 2).

- 2.2.1 Three trenches were excavated measuring c. 25m long and 2m wide. A further trench, measuring 6.5m by 2m, was excavated, at which point further excavation was stopped due to health and safety concerns (see fig. 2).

3.1.1 The results are presented by trench, then chronologically (see Fig 2 for trench locations).

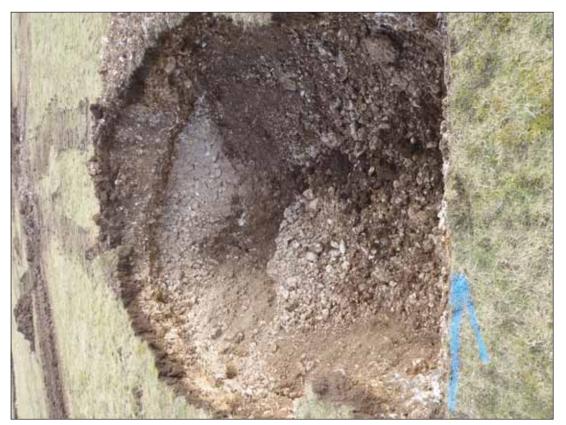
Plate 1: Trench 1

- 3.2.1 Natural geology was not reached during the excavation of this trench. The earliest deposit was a loose white chalk rubble (2), excavated to a depth of 3.9m. During the excavation of the trench the sides were continually collapsing. Overlying this was a dark greyish brown silty sand topsoil (1), measuring 0.2m in thickness.
- 3.2.2 The depth of the deposits and the loosely compacted nature of the deposits meant that the trench sides were collapsing into the trench as the machine was excavating. This restricted any entry and any meaningful excavation of the ground. A decision was made after consultation to halt the excavation of this trench on health and safety grounds (see plate 1).

4.1.1 No archaeological features were present in the excavated trenches. The land itself has been subject to several episodes of truncation and levelling. This is believed to have occurred when the land was used as an RAF airfield. Trench 1 is believed to be in the area that was subject to the disposal of build up material during the construction of the nearby water lagoons. The result of this levelling activity is that it is likely to have truncated the majority of any archaeological remains.
