Green Barn, Maris Lane Trumpington

Archaeological Evaluation Report

Green Barn, Maris Lane, Trumpington

Archaeological Evaluation

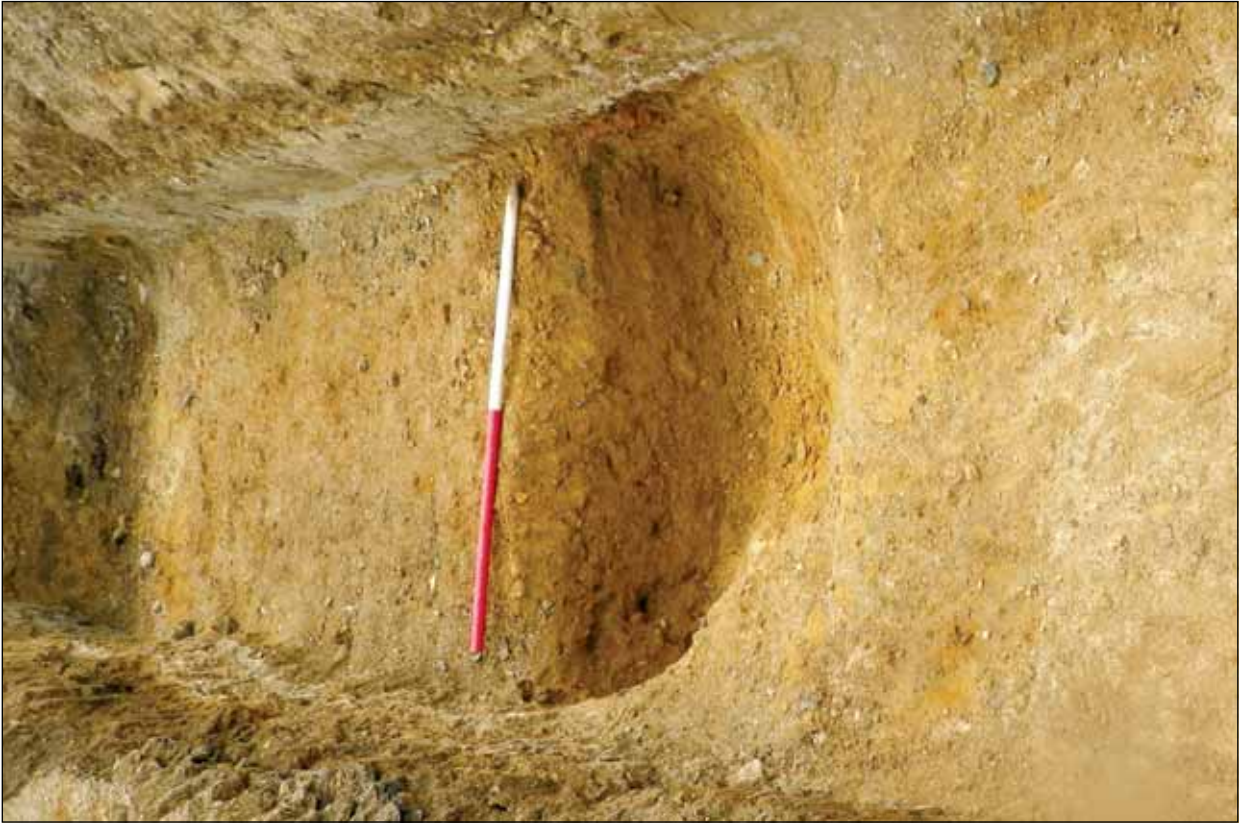
Plate 2: South-west end of trench from the North-east

3.1.1 The excavated trench (Figure 3, Plates 1 and 2) contained a single pit and modern surface both located at the south-west end of the trench. The natural marly chalk within the trench was overlaid by imported soils containing modern brick, mortar and other debris. The trench is described below and supplemented by trench/context information in Appendix A.

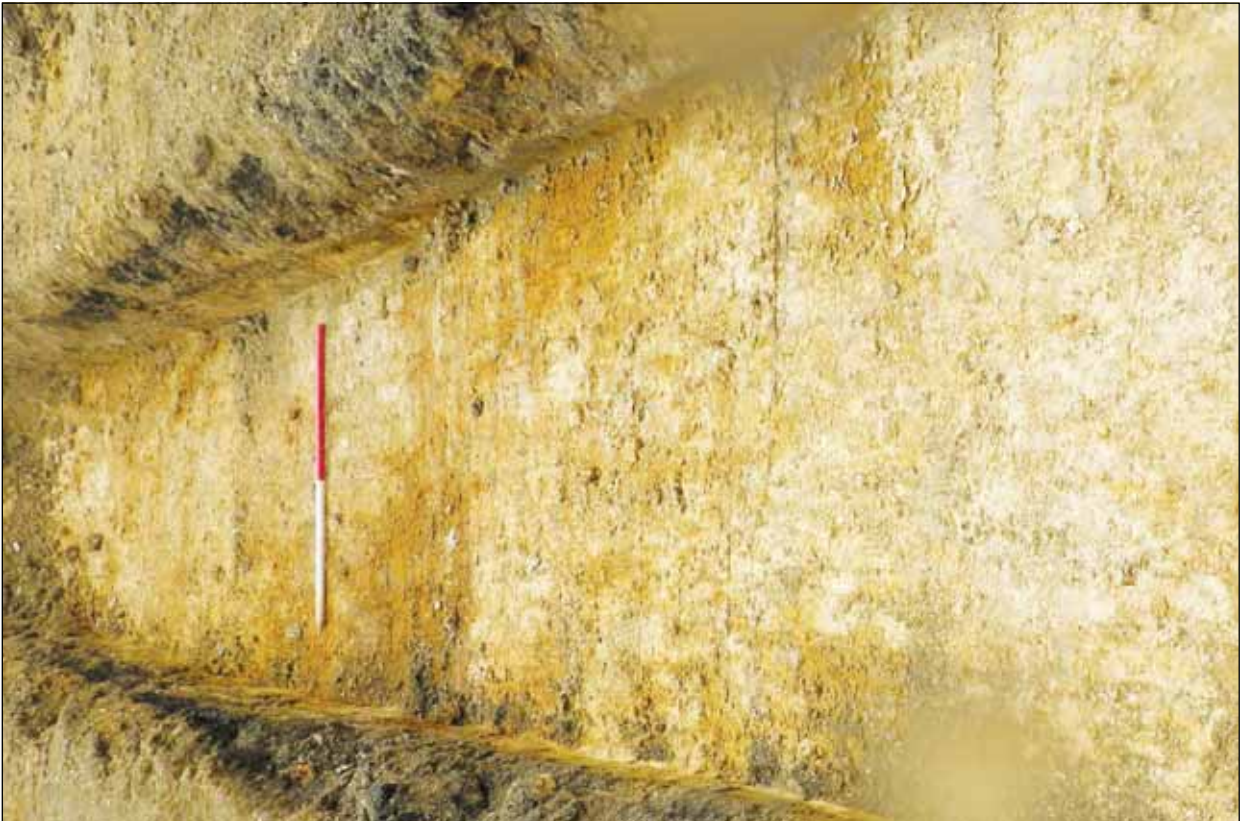
Plate 1: North-east end of trench from the south-west

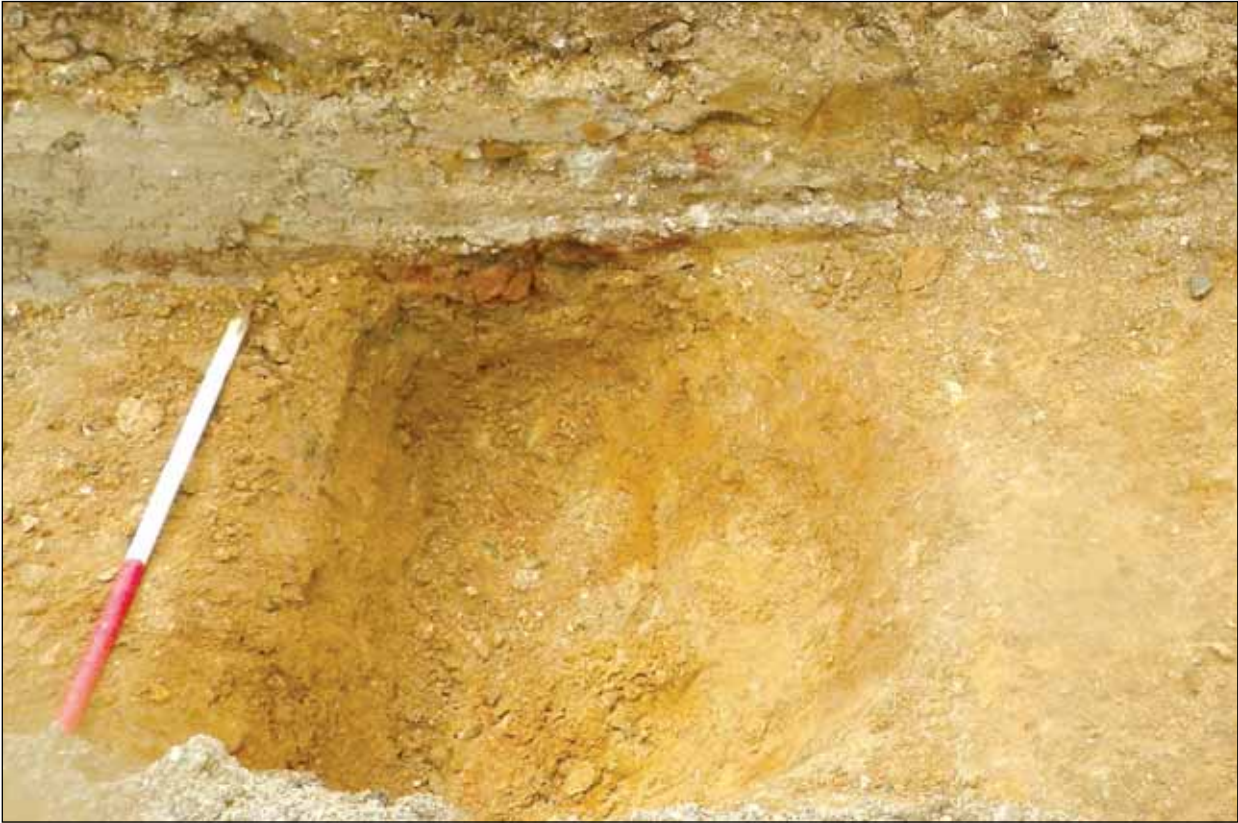
Plate 3: Pit 10, from the east

3.2.5 Pit 10 at the south end of the trench, truncated layer 5. This pit (Figure 3, Sections 1 and 2, Plates 3 and 4) was 2.80m long and 0.84m deep. The pit continued under both sides of the evaluation trench. The pit was filled with three layers; a light red-brown silt sand 0.13m deep (15), over which was a dark red silt clay 0.40m deep (11) that contained fragments of red brick, some of which were stamped "L.B.C" for the London Brick Company (founded 1900), along with pieces of modern machined iron components and washers. And finally a layer (0.34m thick) of white clay (12), presumably deliberately laid to cap the top of the pit.

4.1.2 The only features within the trench were a pit (10) and adjacent layer (5) both of which contained London Red Brick dating from 1900 onwards with no other earlier material present. As such these features will both date to the 20th century. Whilst it is possible that earlier features may have originally been located in the south-west end of the trench, the extent and depth of the modern pit would make their survival highly unlikely.

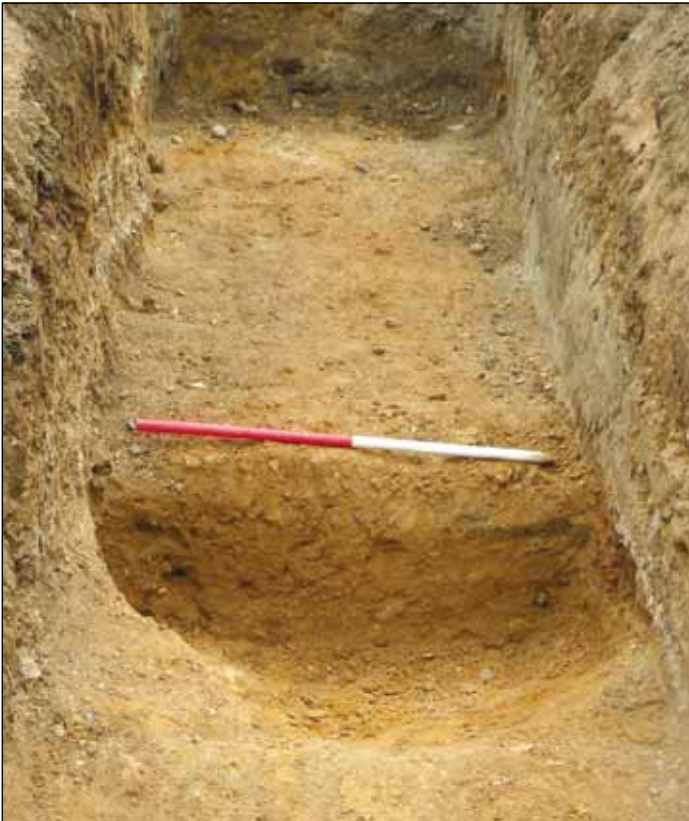
Plate 4: Pit 10, from the north-west
