The Talbot Hotel Oundle Northants

Desk-Based Assessment

OA East Report No: 1147
OASIS No: Oxfordar3-69051
NGR: TL 04066 88126

The Talbot Hotel, Oundle, Northamptonshire

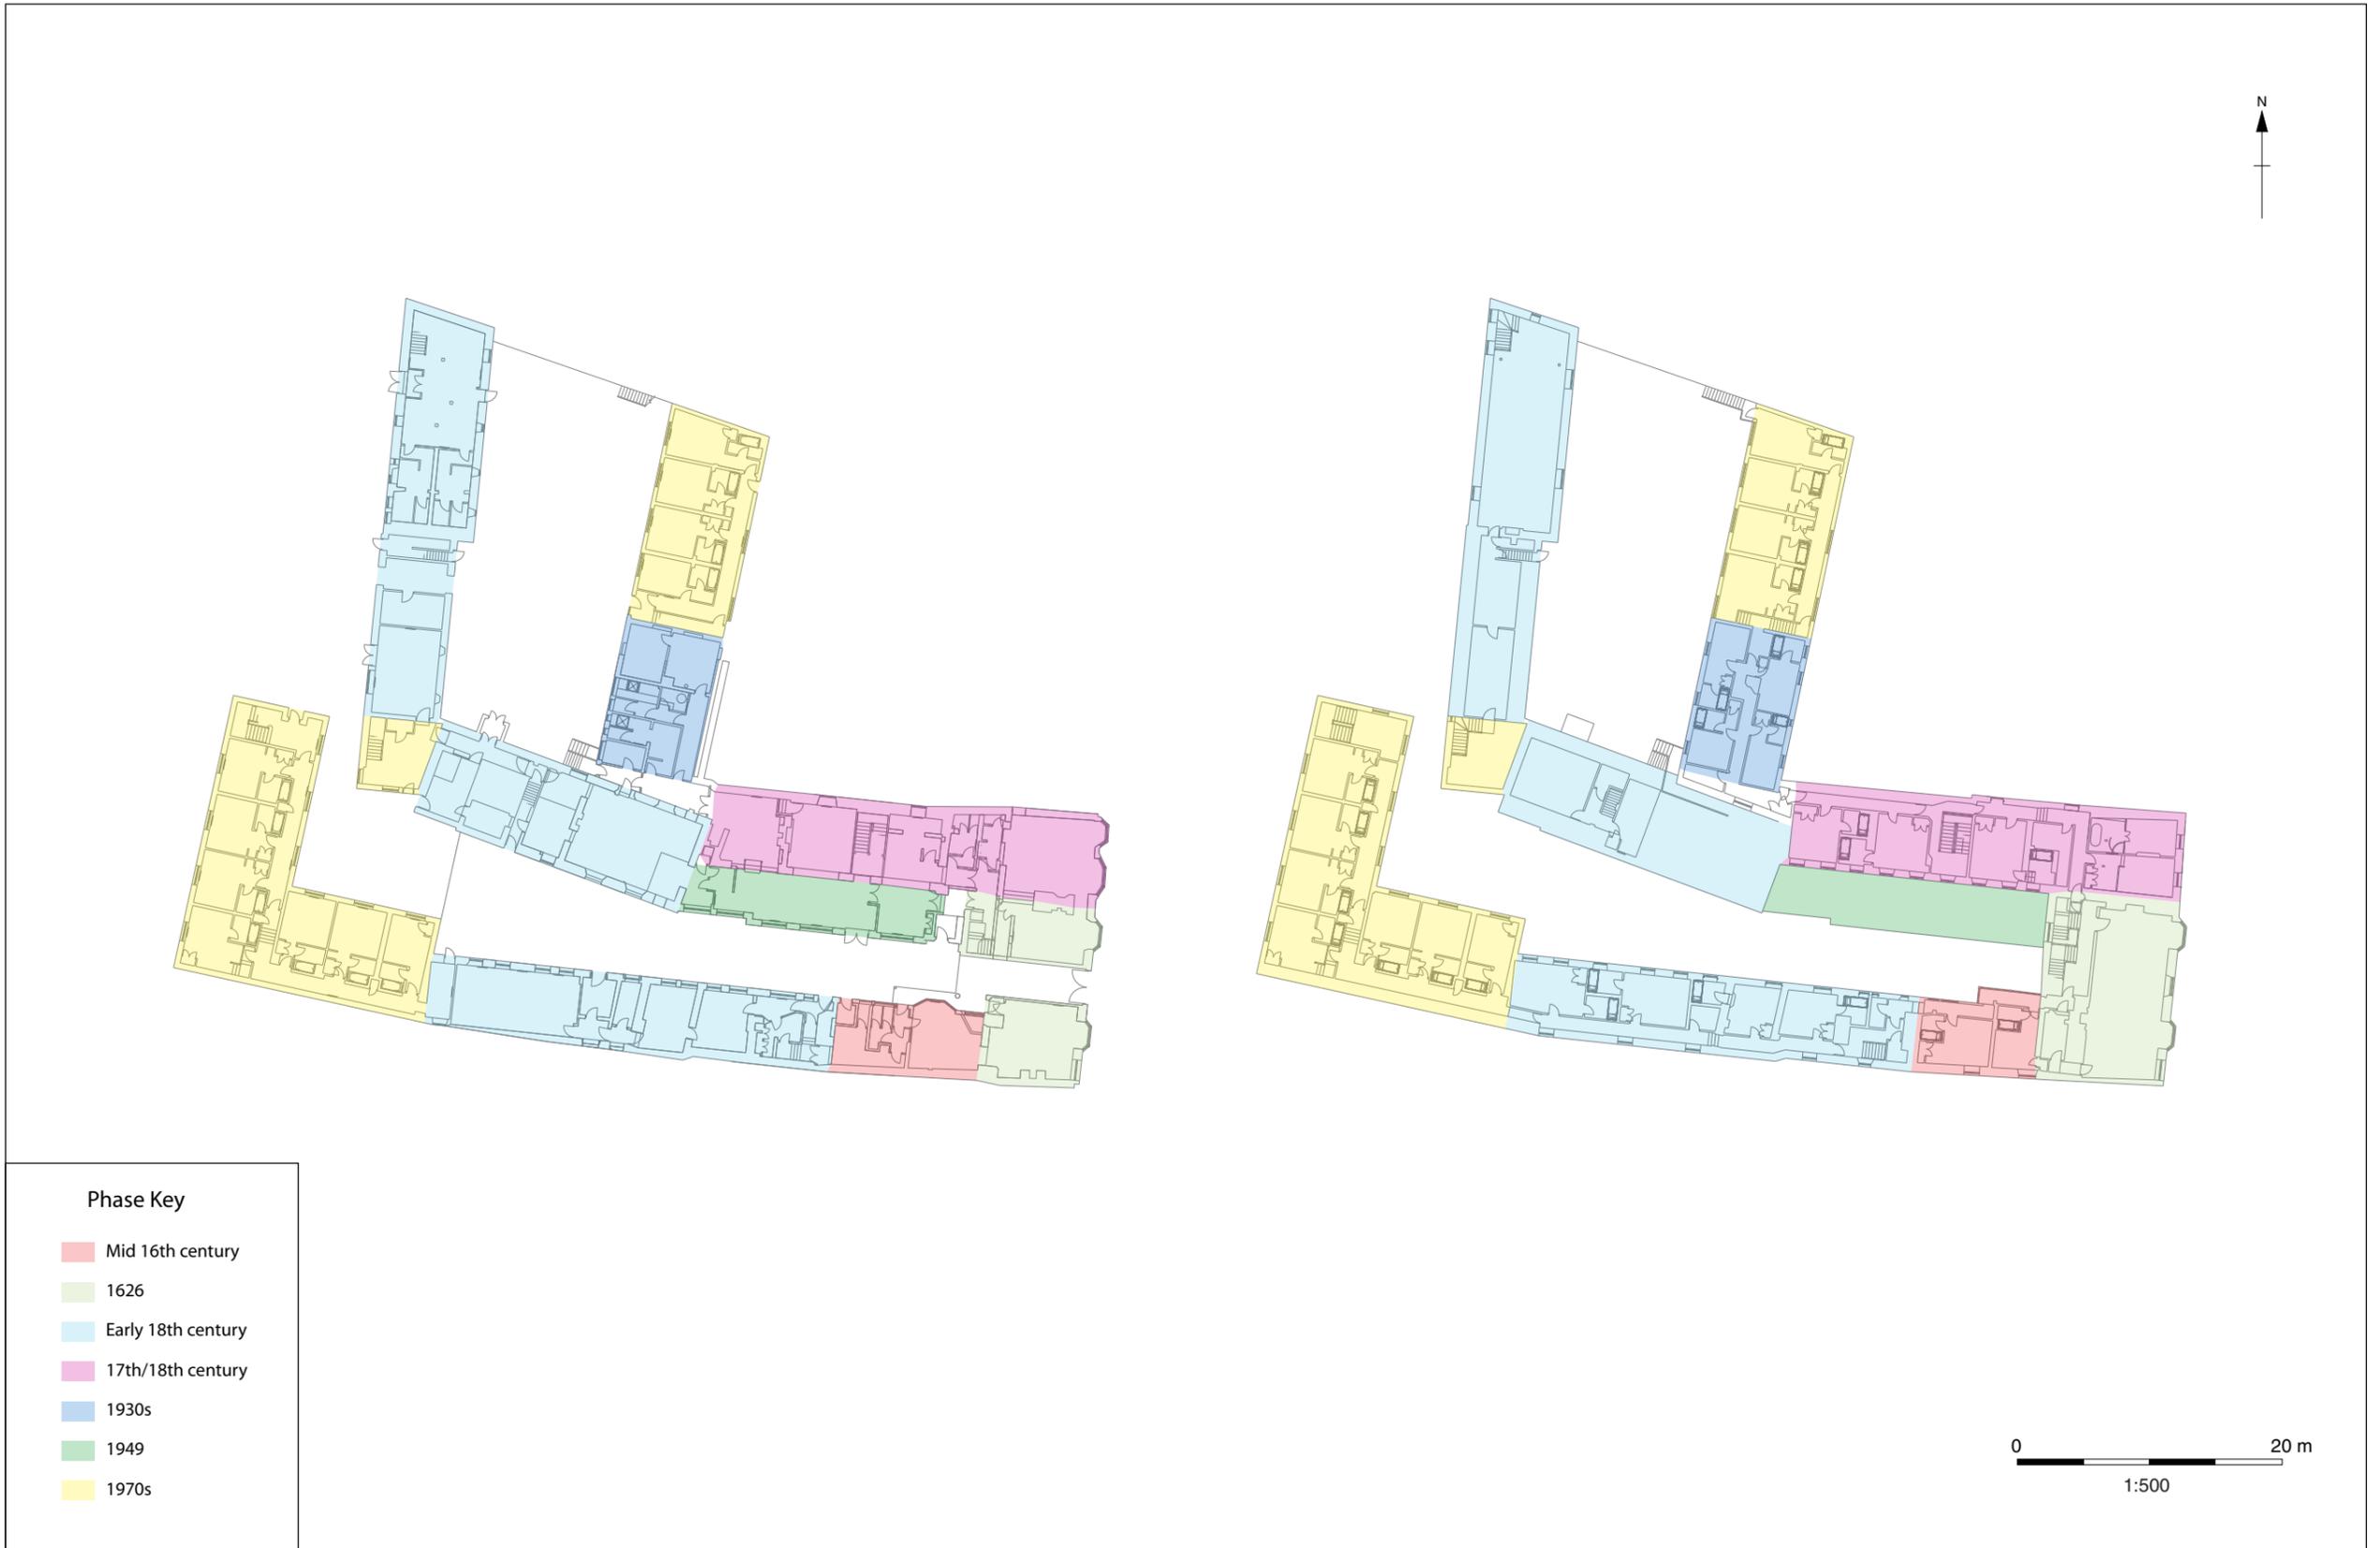
Figure 3: Ground and first floor plans of the Talbot Hotel with suggested phasing (data supplied by client)

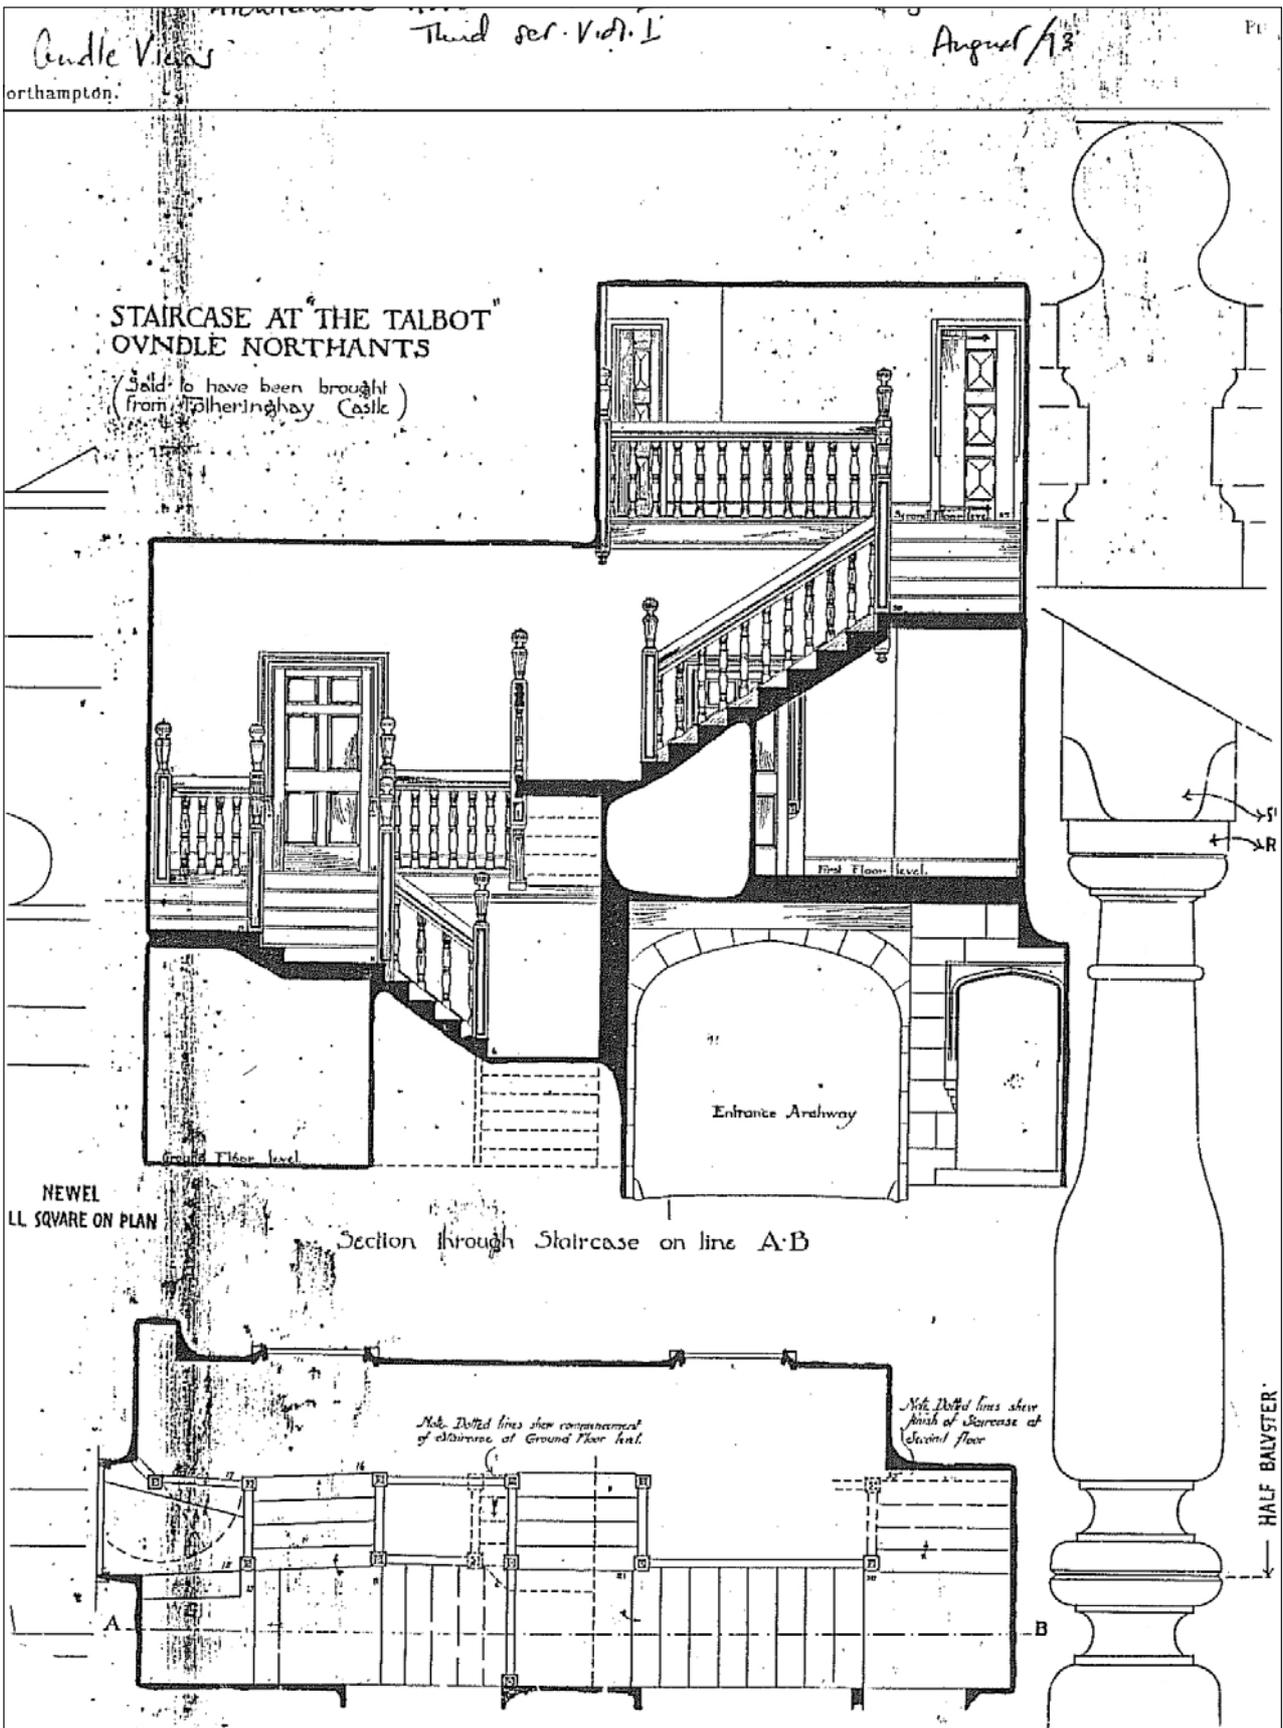
Figure 4: Architectural drawing of the staircase of the Talbot Hotel (from notes held in Oundle Museum), reproduced with kind permission from Oundle Museum

- 4.3.5 Much of the history of the hotel and what makes it attractive to visitors and historians alike is the suggestion that the stairs and windows viewed from the courtyard derive from the nearby Fotheringhay Castle. The stairs (plate 5) have moulded rails, turned symmetrical balusters and square newels with tall shaped finials and similar local examples have been recorded at Apethorpe and Kirby Hall. An architectural drawing was found during the research which shows a section through the staircase (Figure 4). The window facing into the courtyard (plates 6 and 7) has ovolo moulded members and is of the two orders (Gee, 1963). There is debate amongst historians as to whether this window came from Fotheringhay, although, it has almost certainly been re-used and is contemporary with and respects the layout of the staircase.

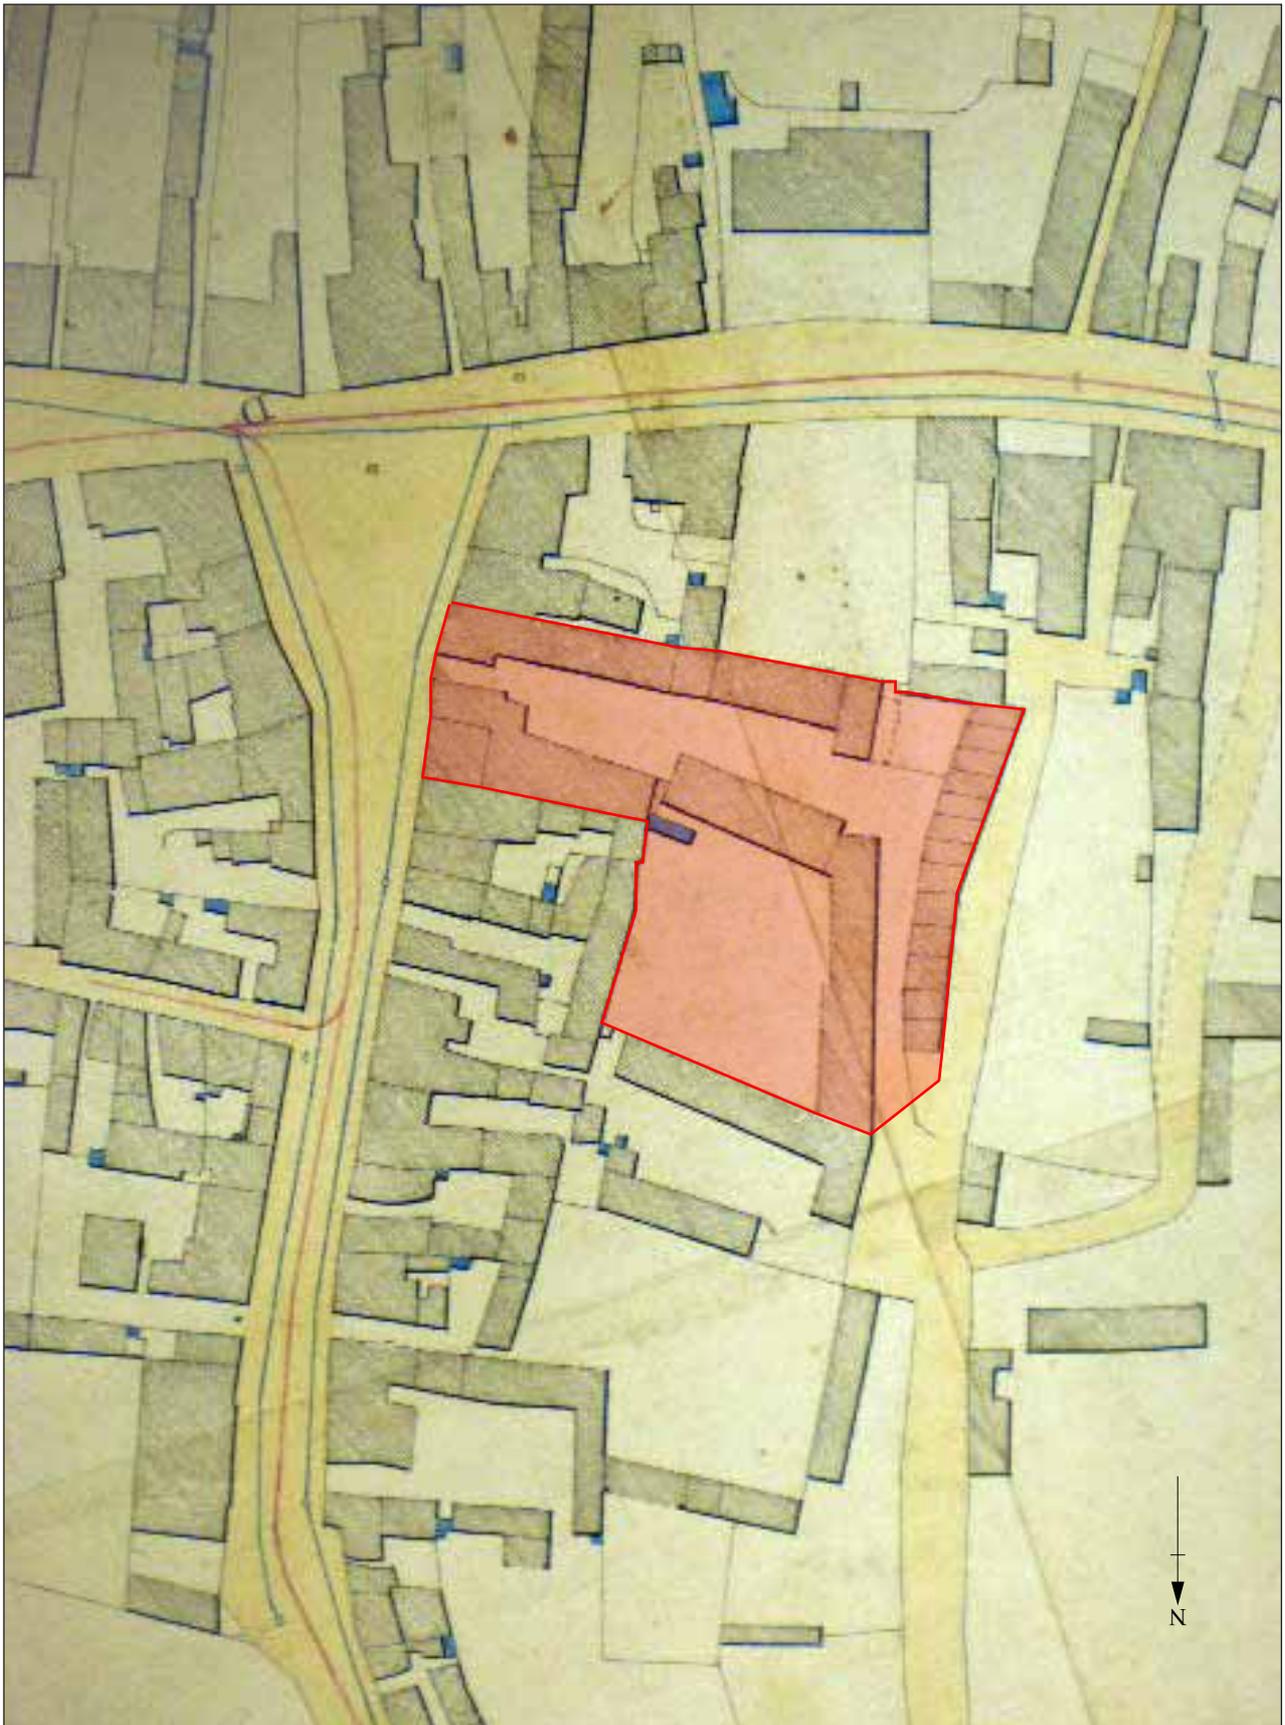
Figure 9: Sewerage and drainage map, 1877, showing study area in red (NRO MAP5949)

detail. There were no maps which date to the period of construction or which represents the site prior to the existing buildings. The first map to reveal the site in any detail is the town drainage map of 1877.

- 4.6.4 During the 1930s a plant room was built within the courtyard. Cartographic sources including the 1885 Ordnance Survey and 1877 drainage and sewerage maps indicate this new building did not replace any pre-existing structures. The extension was later converted into staff accommodation with the addition of bathrooms and bedrooms (client *pers. comm.*)

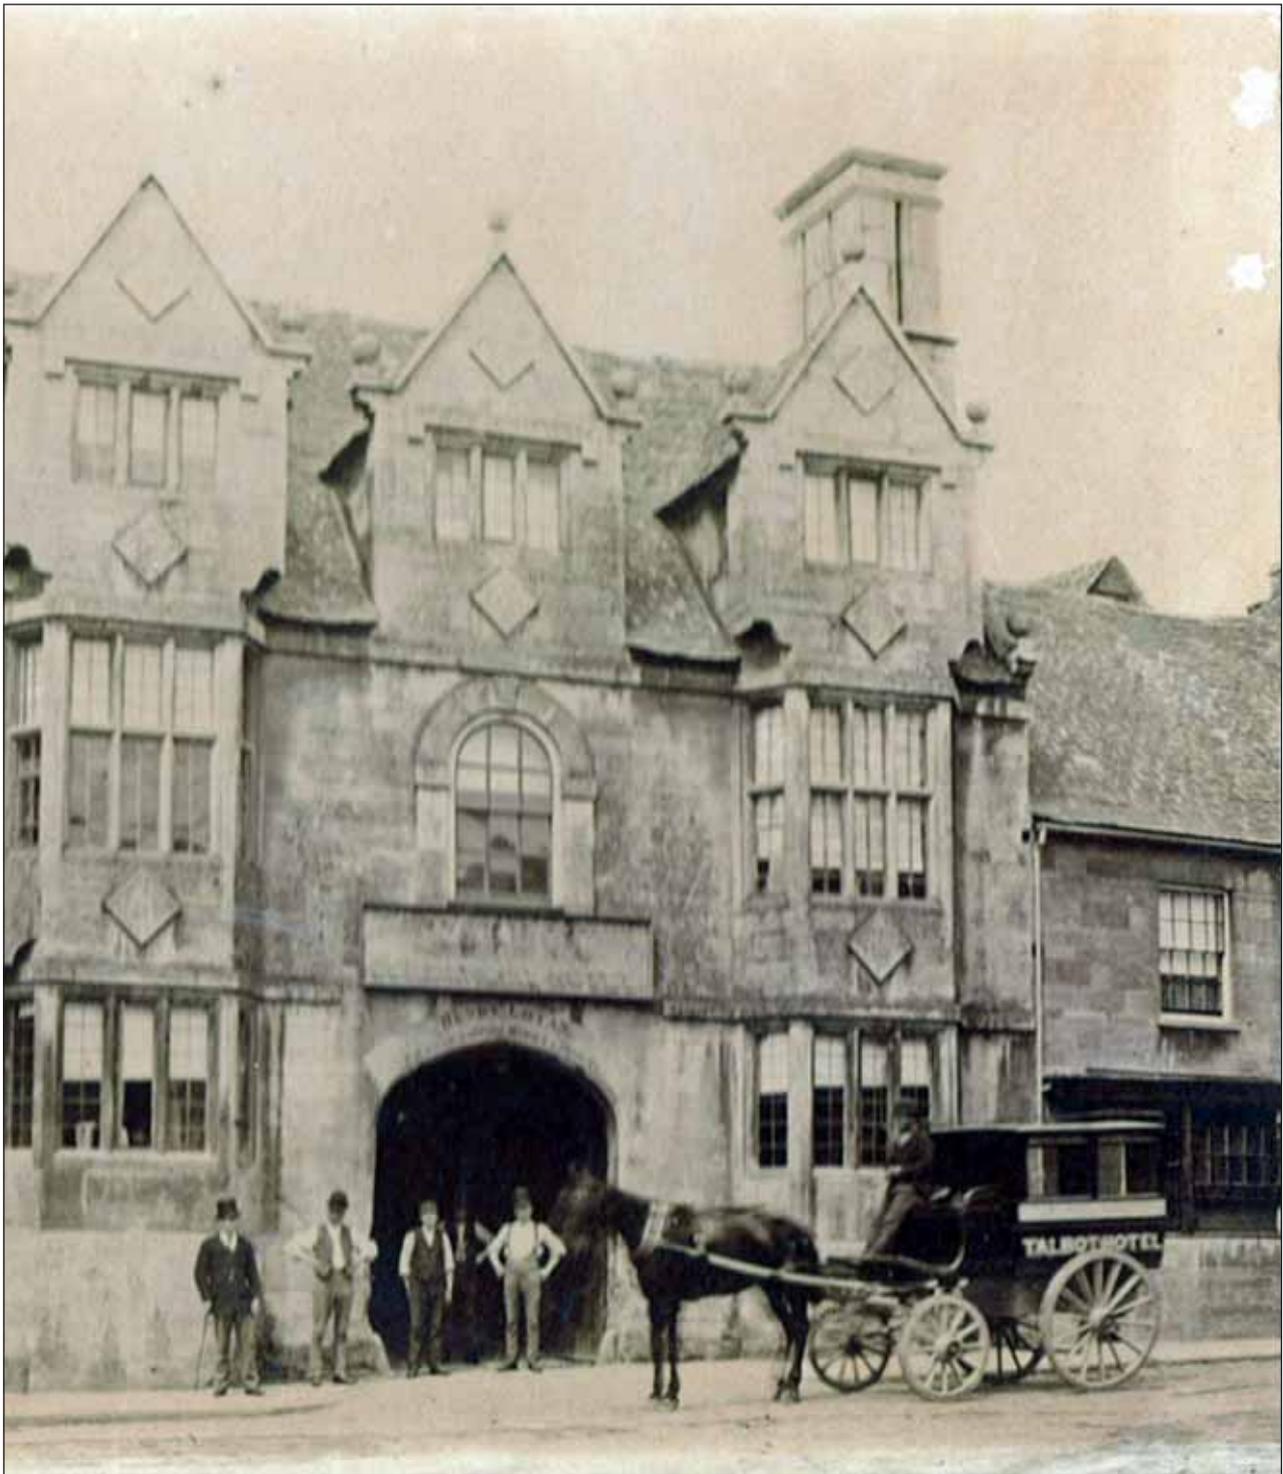
Figure 12: Photograph of Talbot Hotel with horse and carriage, c.1863 (from client)

- 4.5.8 The Talbot continued to prosper during this century and a regular service to the railway station ran from there. A photograph found during the research (Figure 12) shows a Talbot Hotel horse and carriage. Although undated, the name of Henry Lolan over the door indicates c.1863 – 1903.

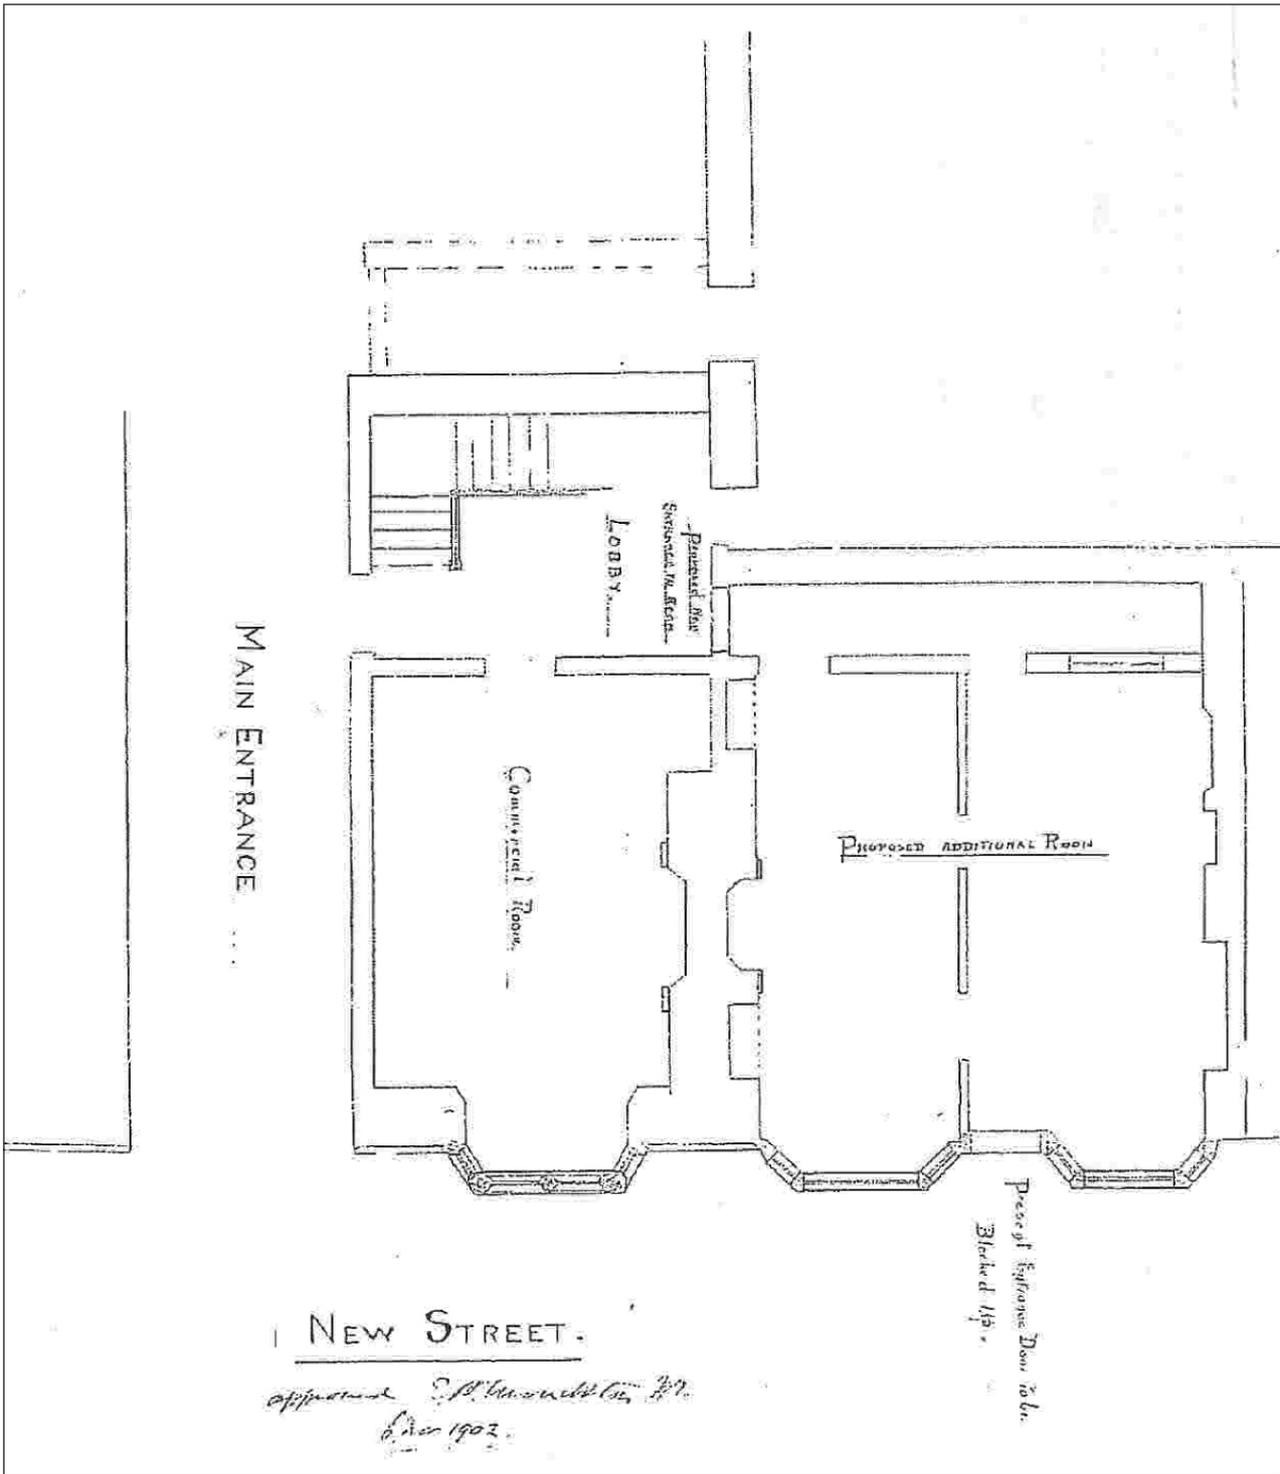
Figure 13: Architects plan for extension, 1902 (from J. Irving)

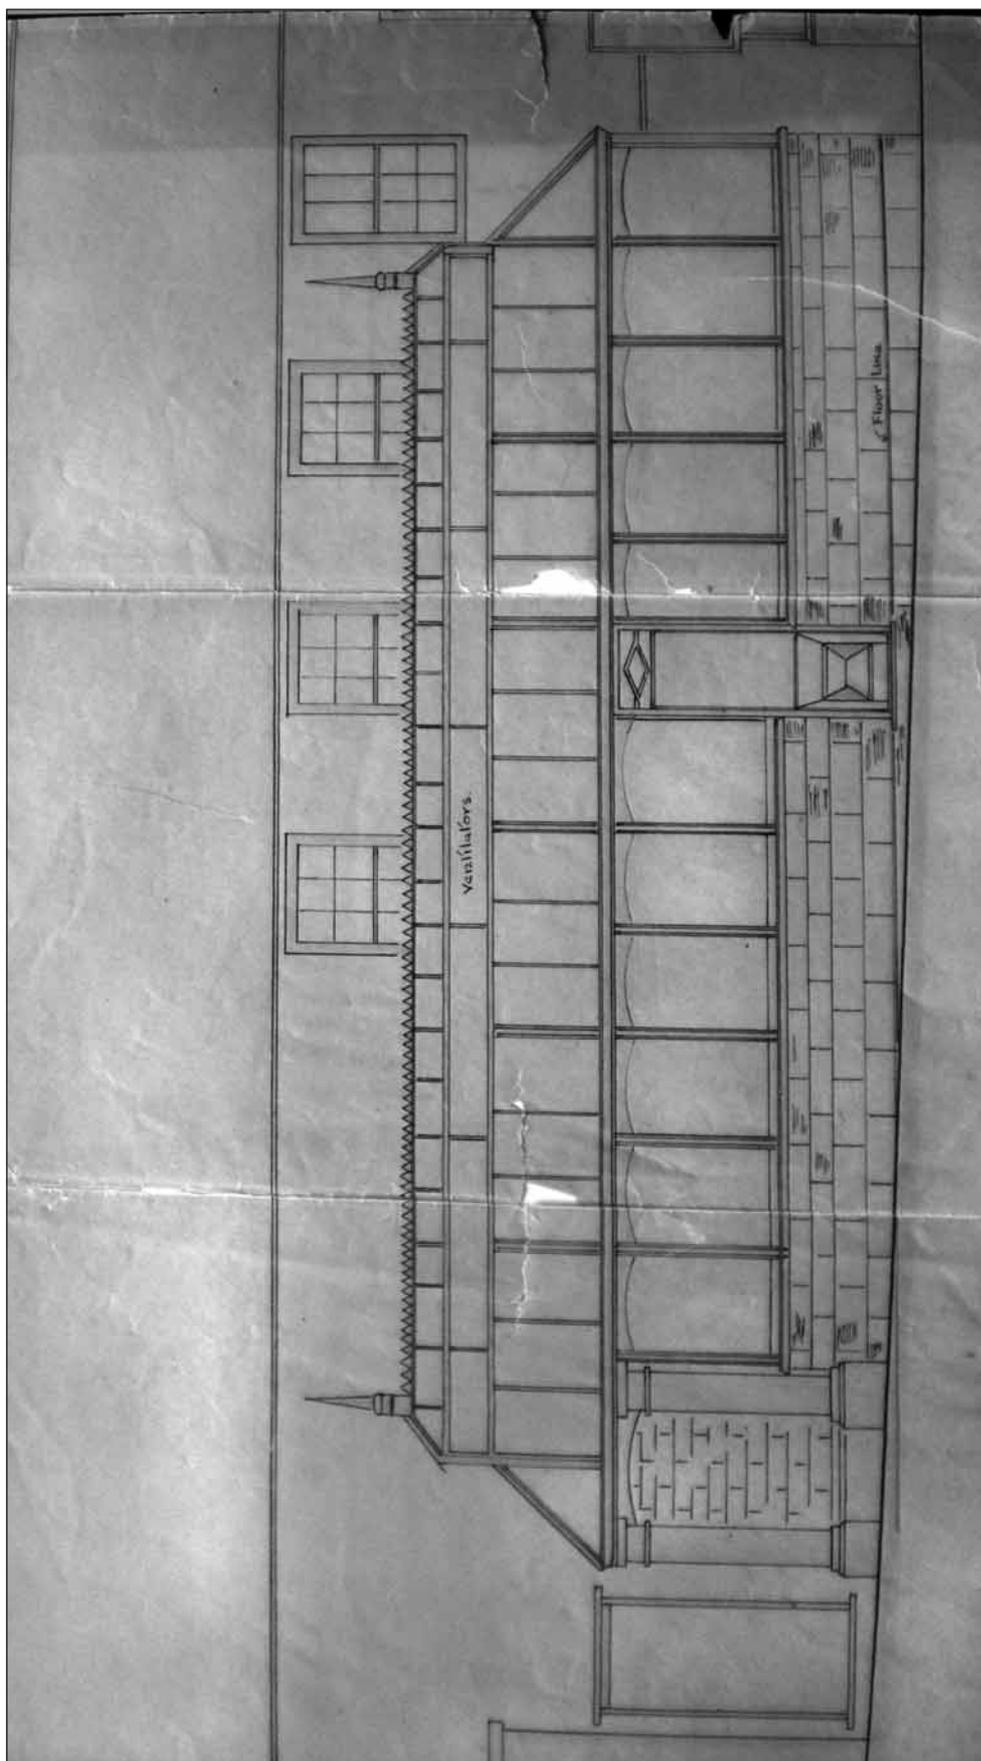
Figure 14: Architects drawing for extension to north wing within courtyard, 1917 (from J. Irving)

- 4.6.3 Another addition in this century was a single storey glass extension added onto the north wing, facing the courtyard around 1917. This extension was to form the residents lounge and became nicknamed “the icehouse” as icicles would form on the glass roof during the winter (J. Irving *pers comm.*). This addition on the northern wing, just inside the courtyard (on the right with New Street behind) was made mostly of glass on a brick plinth (Figures 14 and 15) It was later demolished and replaced by the current single storey building in 1949 (plate 13). An undated photograph (Figure 16) shows the corner of another structure (on the left) in the same position which juts forward too far to be the “icehouse” and may be an earlier structure. This image also shows what appears to be a glass shelter against the arch. It is understood that the reception “hatch” was once located on the left as you entered through the archway, where guests would check-in, this shelter may have been erected to offer protection from the rain. Figure 17, an undated image, shows the courtyard prior to any of these additions. Although undated, it was probably taken towards the very end of the nineteenth century, but certainly prior to 1917.

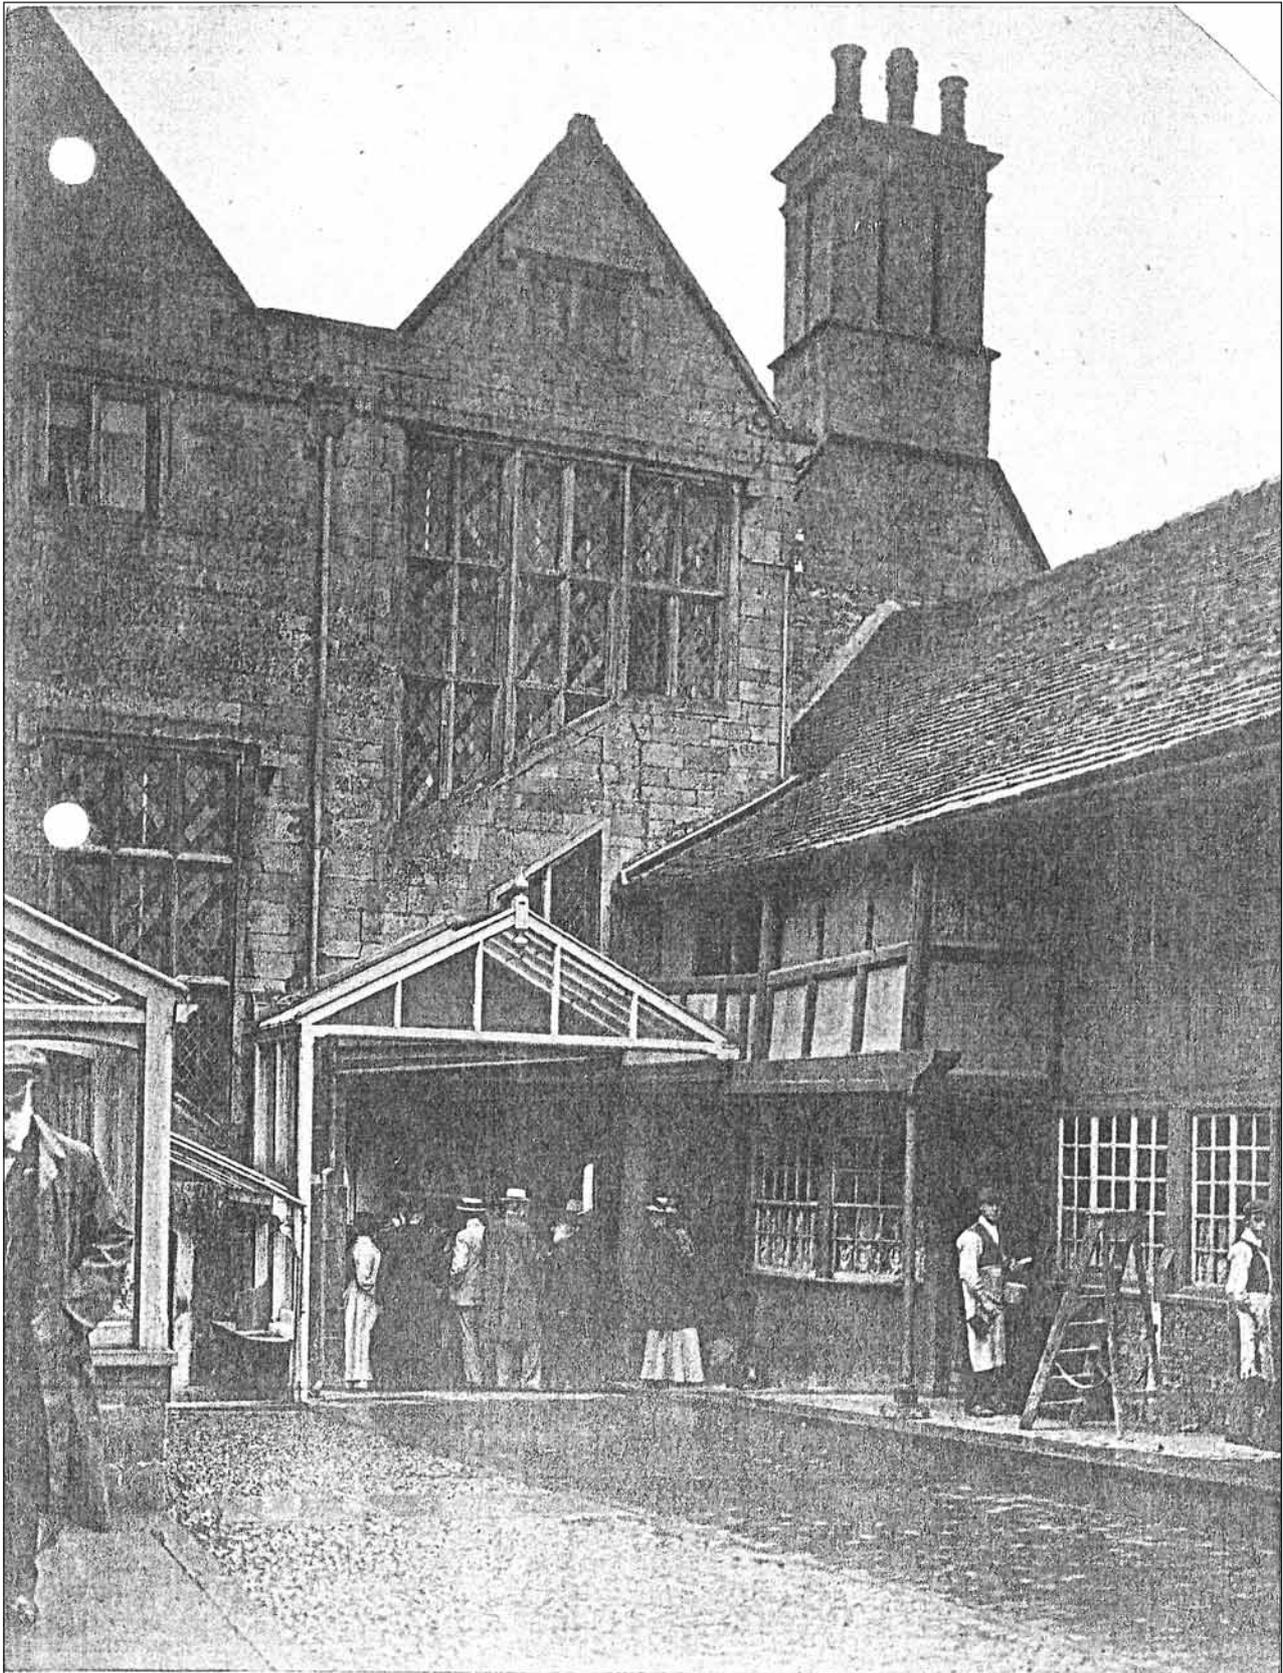
Figure 16: Undated photograph of courtyard showing “shelter” inside archway and corner of a conservatory building (left), prior to construction of 1917 “icehouse” (NMR OP.01832)

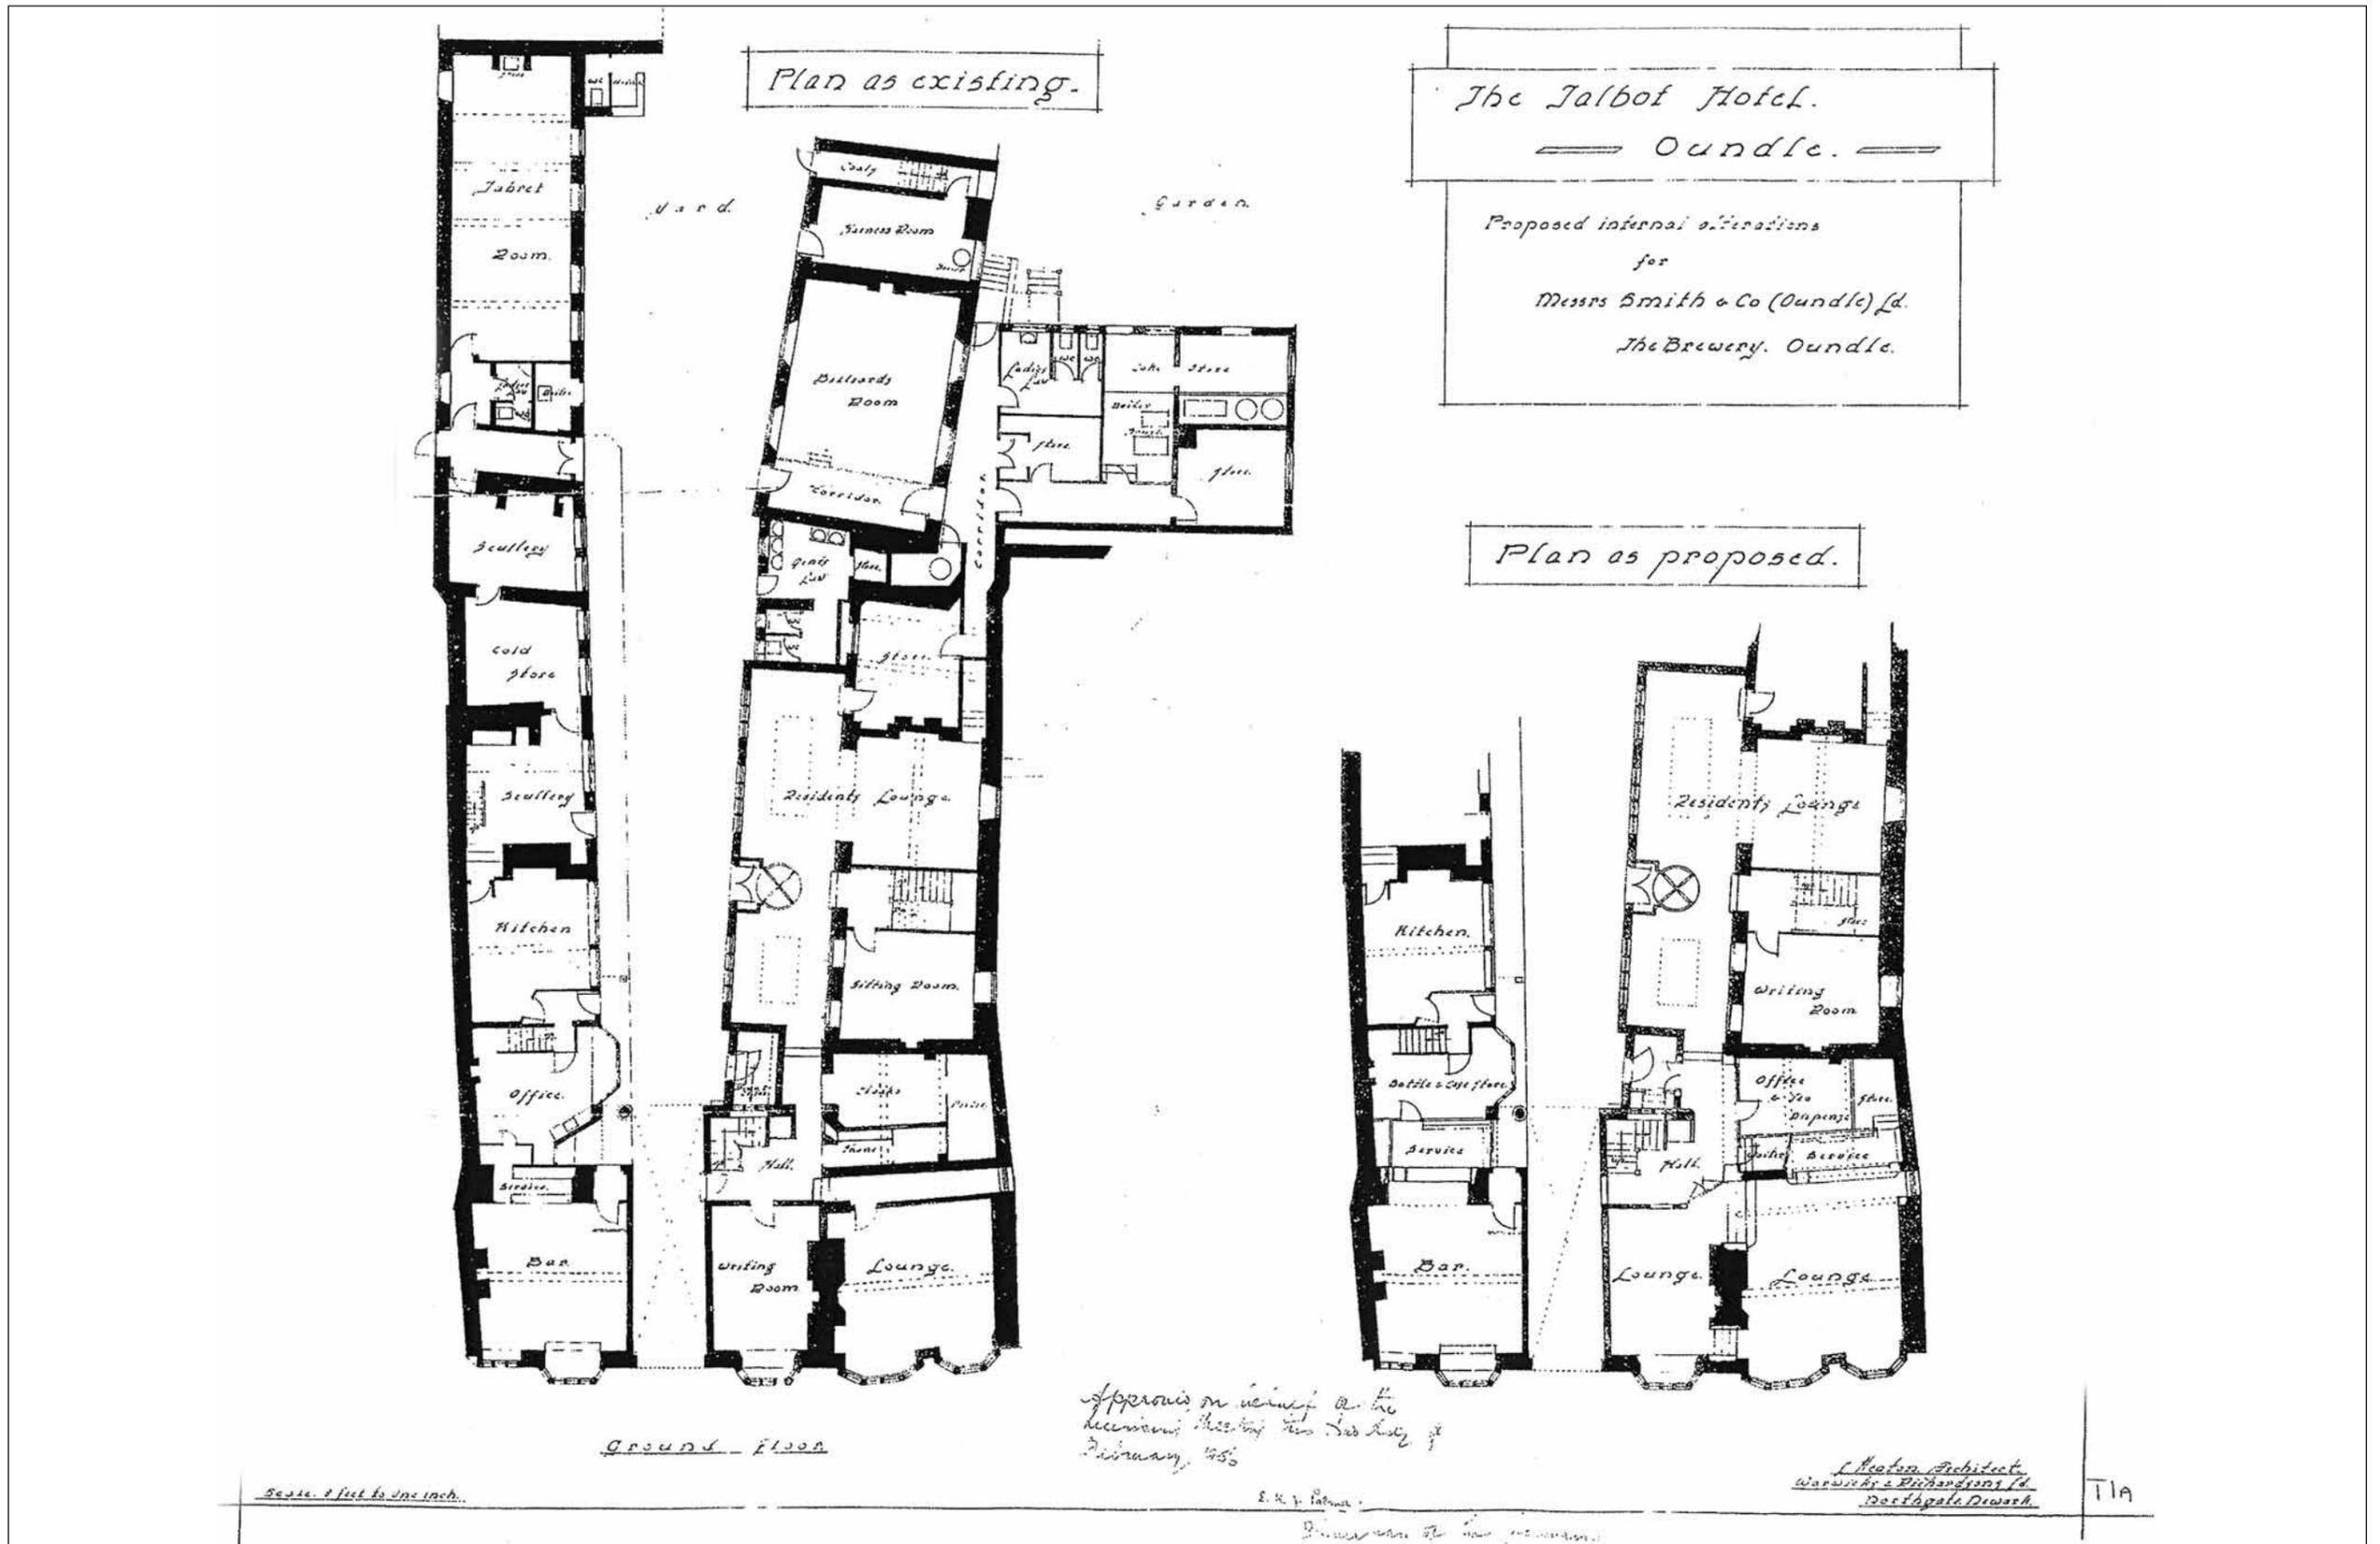
Figure 20: Architects plans of proposed alterations to the ground floor, 1956 (from client)

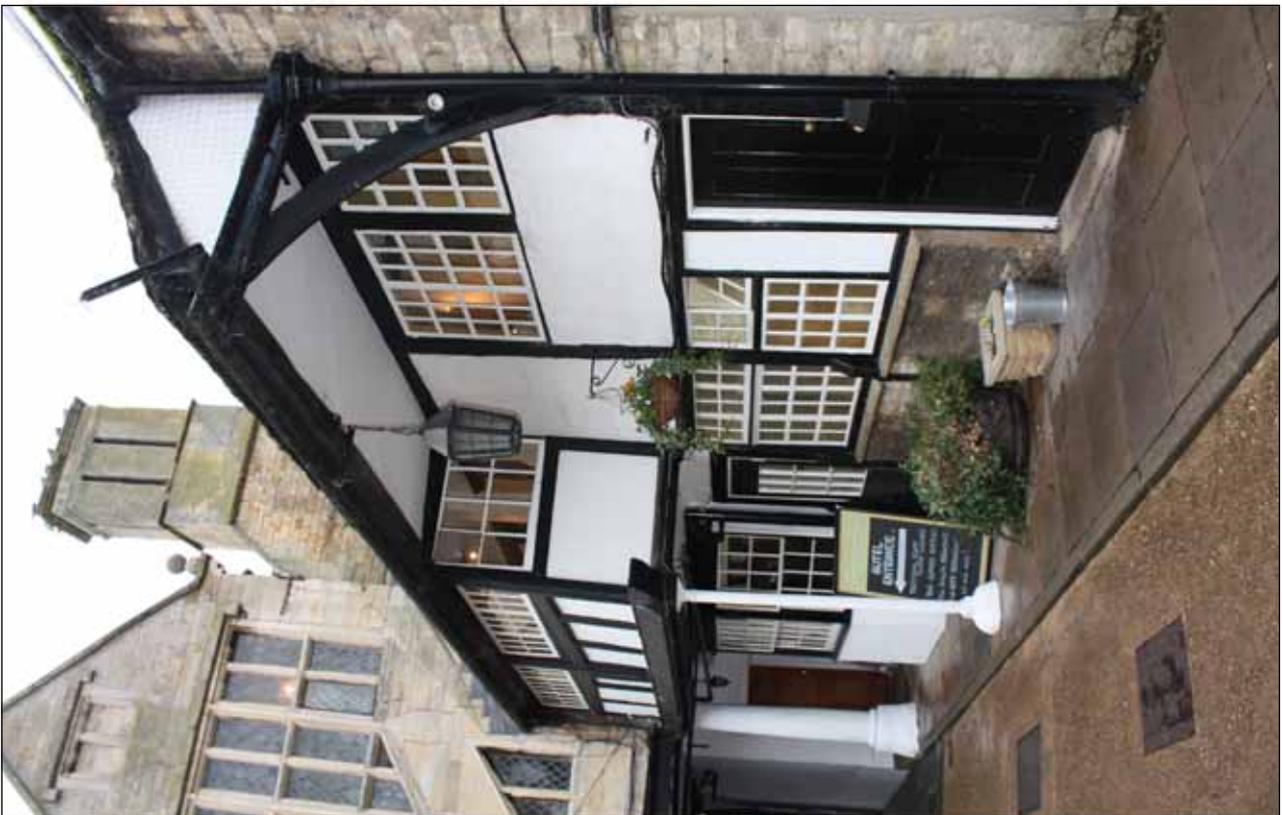
Plate 2: Timber-Framed building on southern wing (from courtyard)

- 4.2.3 Parker suggests that the later construction of the stone building on the street frontage may have shortened this range by two bays (Parker, 1989). It is therefore possible that this timber-framed range is surviving evidence of the pre-1624 redevelopment and pre-dates the second half of the sixteenth century when traditional vernacular buildings were replaced with stone.

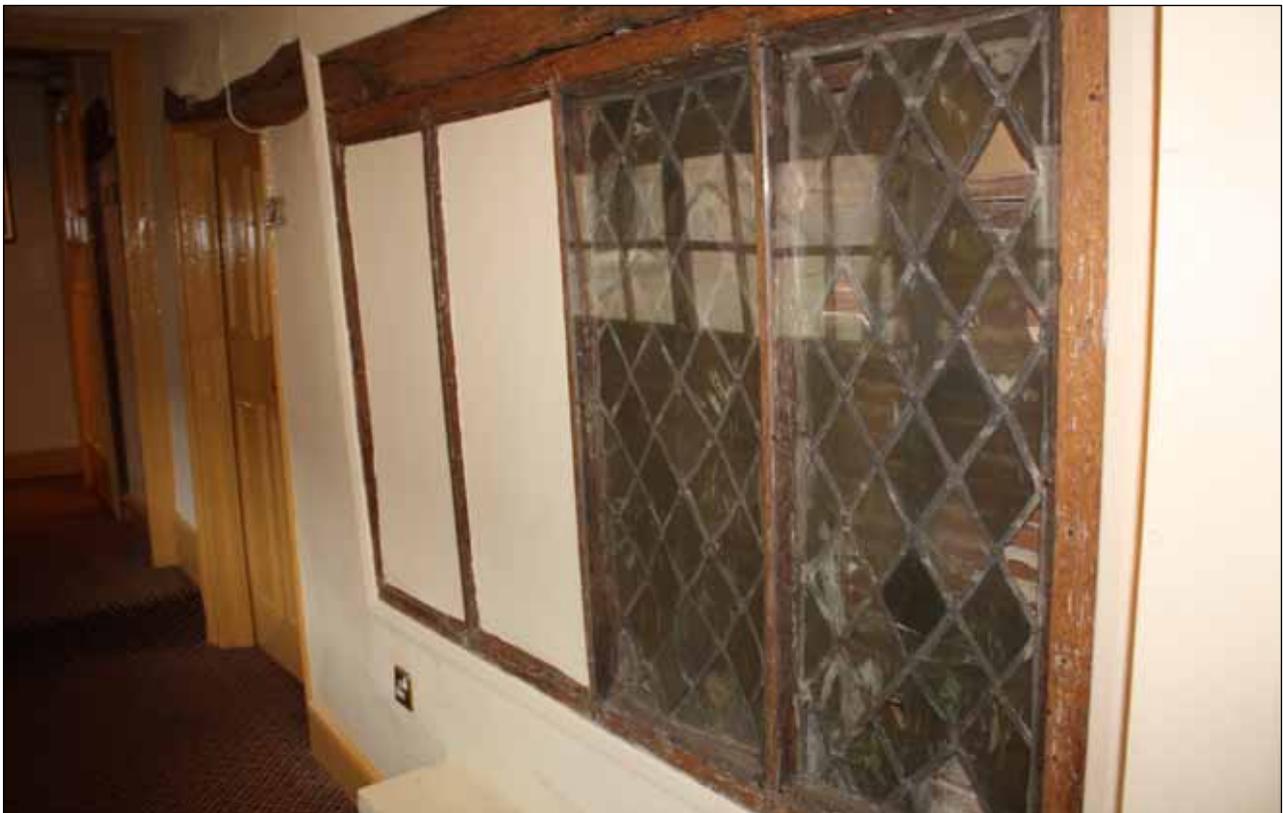
Plate 4: Window within the timber-framed range

- 4.2.4 From the first floor landing level an exposed leaded window with timber frame, plain mullions and jambs is representative of early 16th century window was noted (plate 4). A window in this location also suggests the later addition of this gallery area from where the photograph was taken.
