The Talbot Hotel Oundle Northants

Desk-Based Assessment

OA East Report No: 1147
OASIS No: Oxfordar3-69051
NGR: TL 04066 88126

The Talbot Hotel, Oundle, Northamptonshire

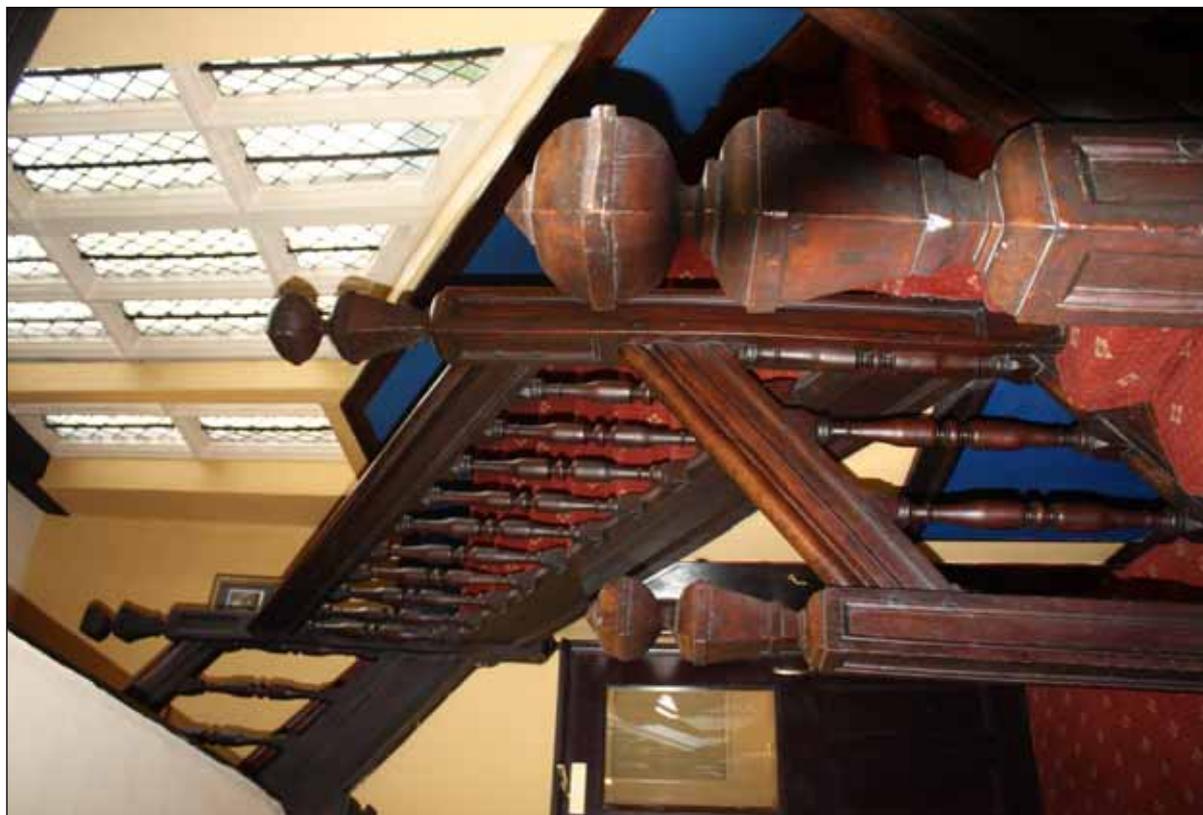
Plate 5: Staircase, thought to have derived from Fotheringhay Castle

- 4.3.5 Much of the history of the hotel and what makes it attractive to visitors and historians alike is the suggestion that the stairs and windows viewed from the courtyard derive from the nearby Fotheringhay Castle. The stairs (plate 5) have moulded rails, turned symmetrical balusters and square newels with tall shaped finials and similar local examples have been recorded at Apethorpe and Kirby Hall. An architectural drawing was found during the research which shows a section through the staircase (Figure 4). The window facing into the courtyard (plates 6 and 7) has ovolo moulded members and is of the two orders (Gee, 1963). There is debate amongst historians as to whether this window came from Fotheringhay, although, it has almost certainly been re-used and is contemporary with and respects the layout of the staircase.

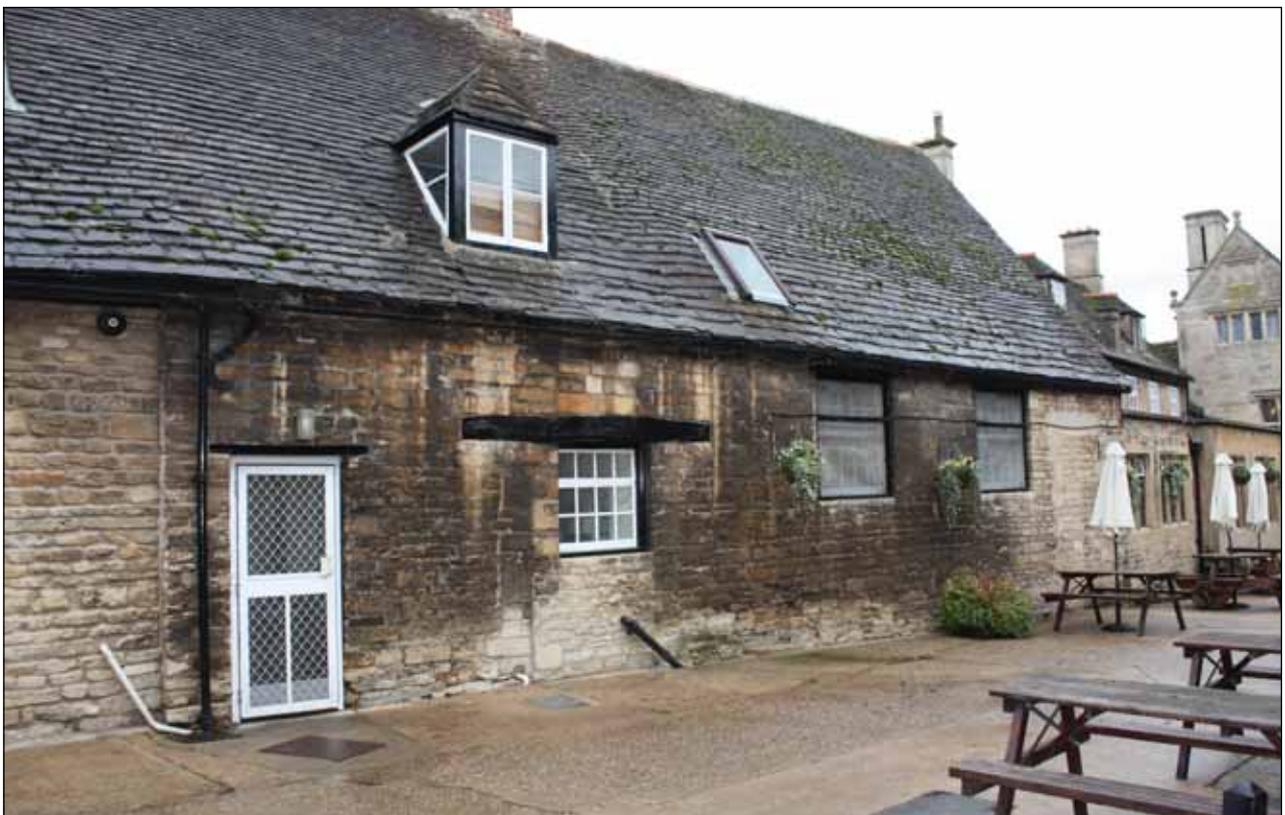
Plate 10: North wing, a former coachstore?

- 4.4.4 Opposite, on the northern range, is another stone building, also covered with Collyweston slate (plate 10). Although internal inspection was not possible at this stage, from the image of the external elevation, it is clear that this building originally had a wider opening and has had replacement windows and doors. Although it is difficult to be certain without further inspection, it is likely that this building stored coaches or carts, especially given its secure location within the courtyard.

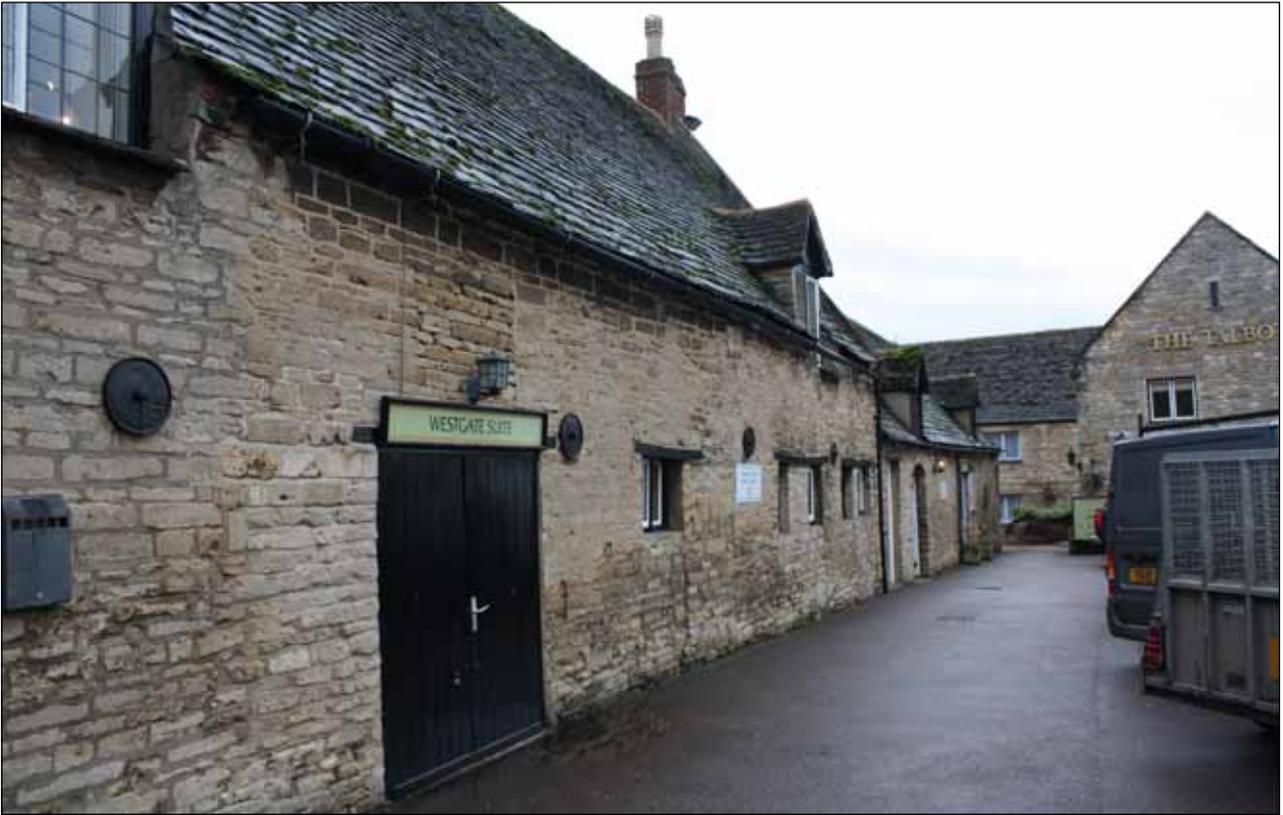
Plate 11: The Westgate Suite, former stables

- 4.4.5 At the rear of the site, now named “The Westgate Suite” is a two-phase range of buildings with dormers and small replaced windows (plate 11). This range appears to have been former stables. Again, access was not made during the brief site visit, however from this elevation it was clear that there had been much wider openings originally which have been blocked up and smaller windows inserted. If these buildings were stables associated with the inn, they would be accessed from the rear via Drummingwell Lane which was a right of way to the inn from the seventeenth century. Also, evidence has indicated that the inn had more land associated, probably to the rear and may have been the location of further outbuildings and fields.
