Withern Eight House Row

Archaeological Watching Brief Report

Client: Anglian Water

OA East Report No: 1574

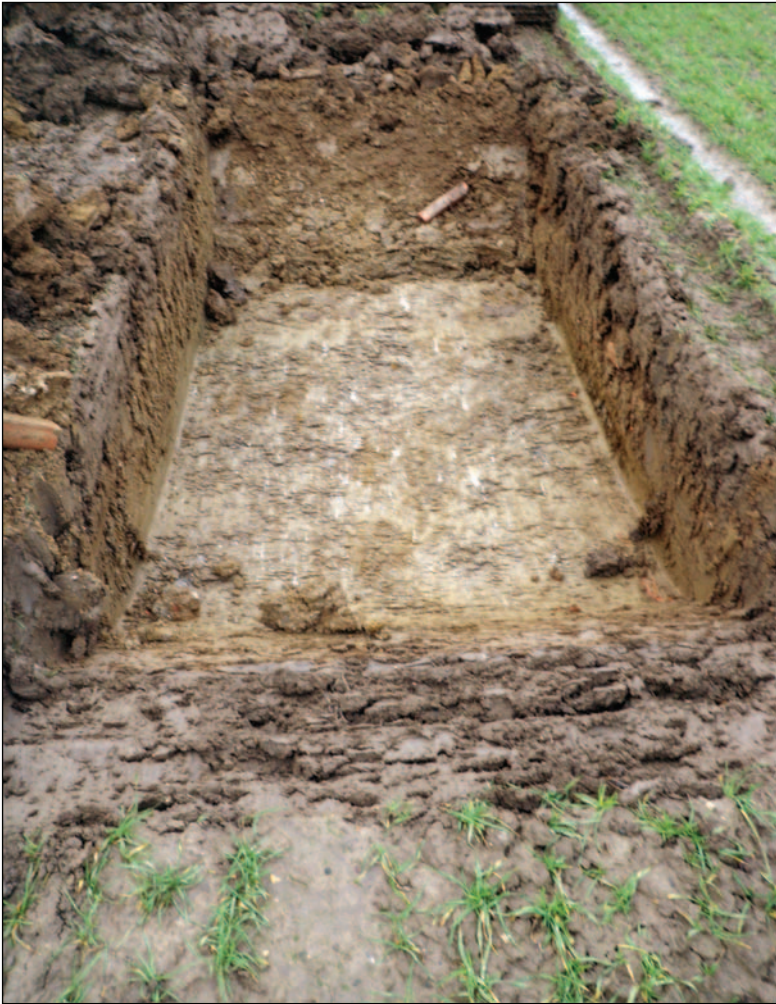
- 4.2.2 Reception pit 1 had a depth of 0.6m before encountering natural geology. The geology was overlain by 0.35m of mid yellowish brown subsoil which was in turn overlain by a dark greyish brown topsoil with a depth of 0.25m

- 4.2.4 Modern field drains were present in both reception pits and no archaeology was observed. The pits were then backfilled to be re-excavated when needed by the contractor.

Plate 1: Reception Pit 1

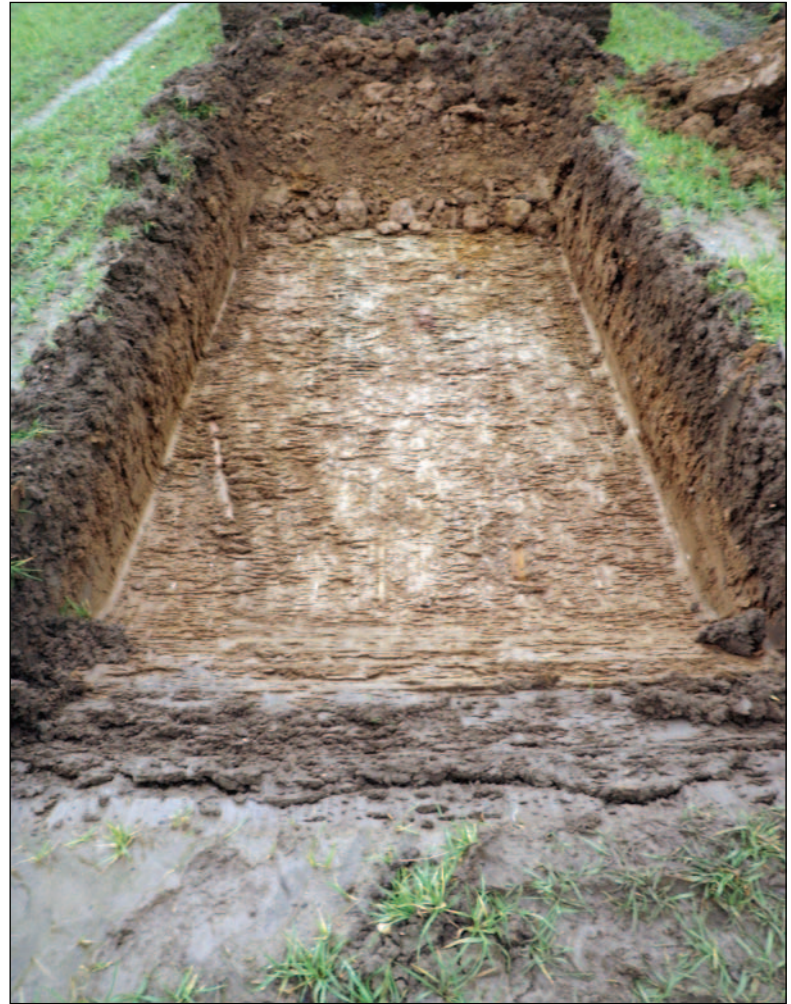
- 4.2.3 Reception pit 2 had a depth of 0.5m before encountering natural geology. The geology was overlain by 0.25m of mid yellowish brown subsoil which was in turn overlain by a dark greyish brown topsoil with a depth of 0.25m.

Plate 2: Reception Pit 2

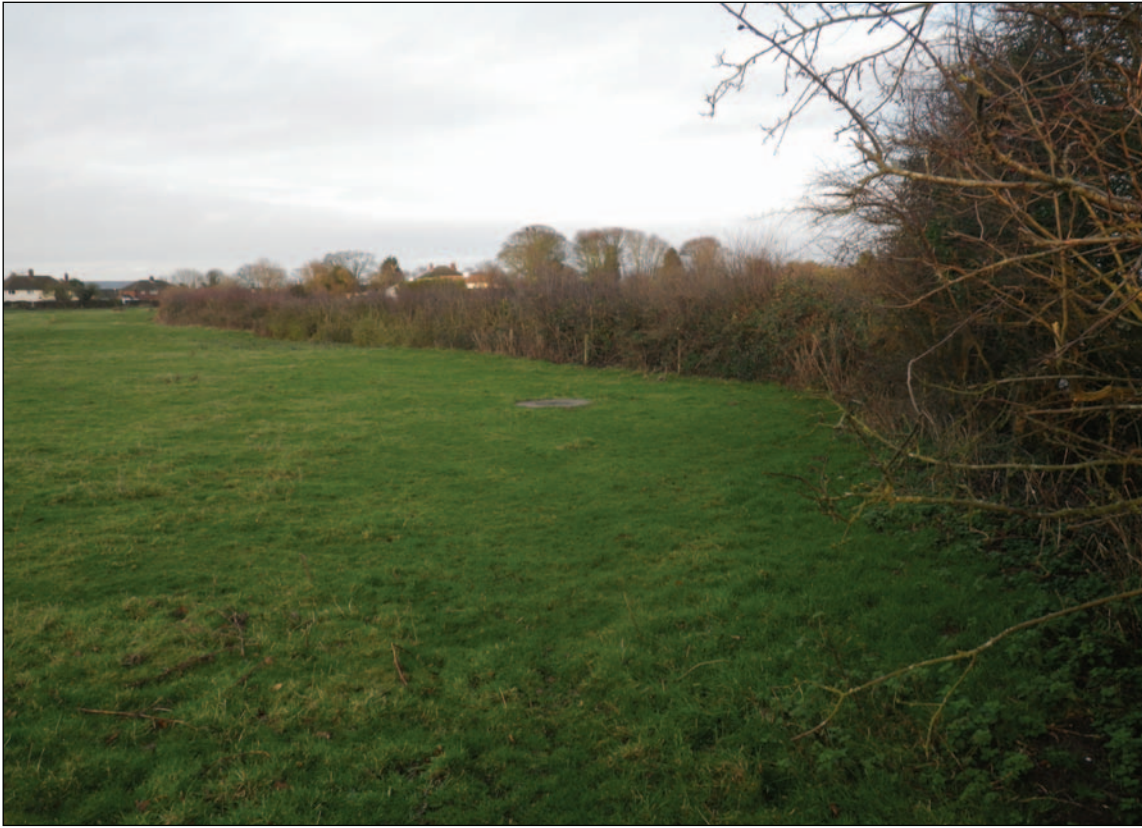
Plate 3: Field with earthworks, showing location of valve

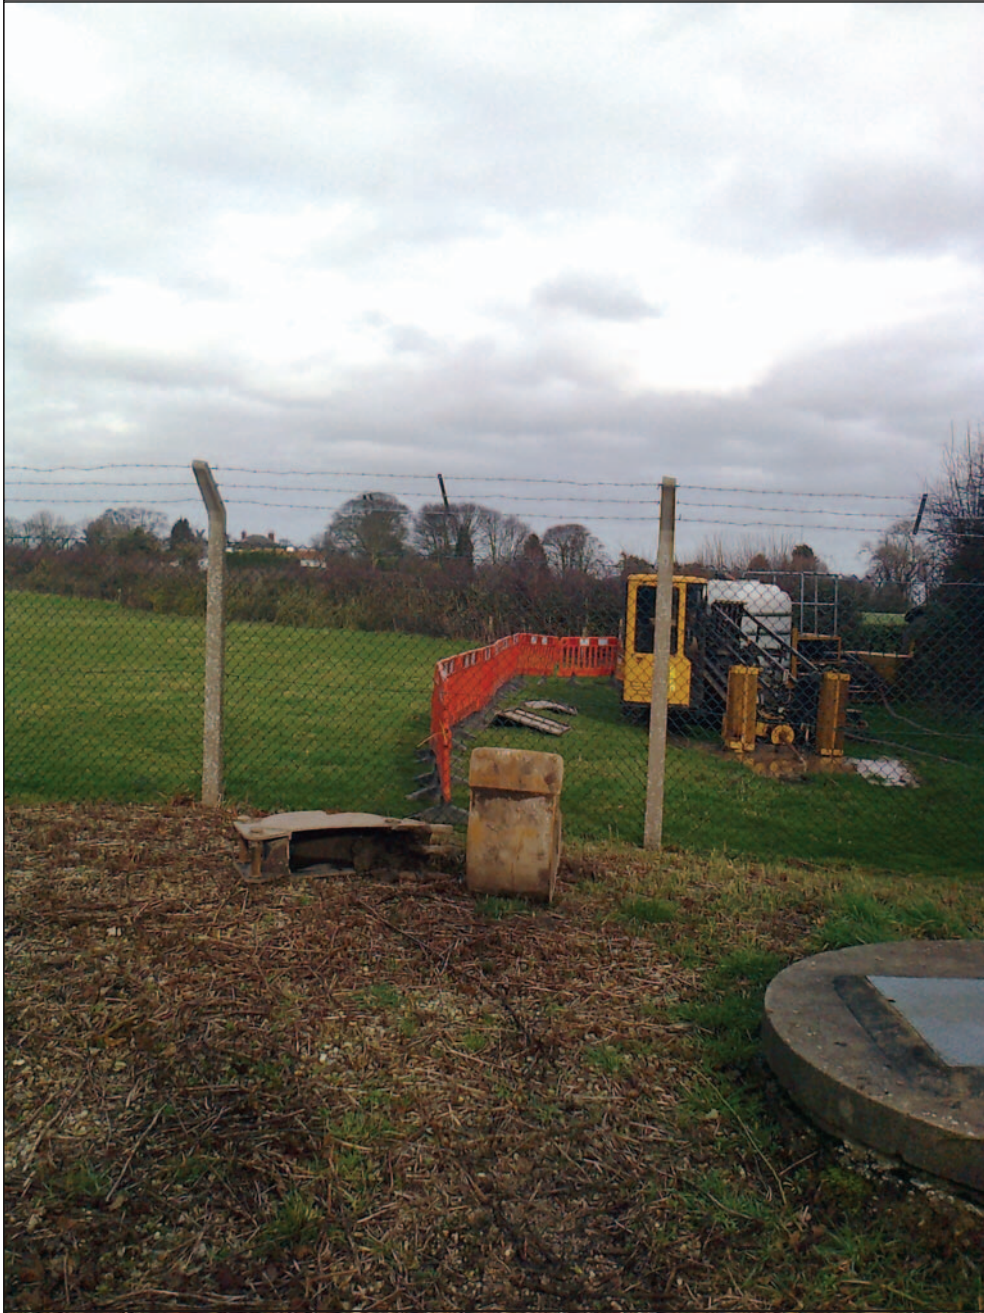
Plate 4: Work under way in Earthwork Field.
