Hill House Farm, Dullingham

Archaeological Evaluation Report

April 2017

OA Report No: 2074

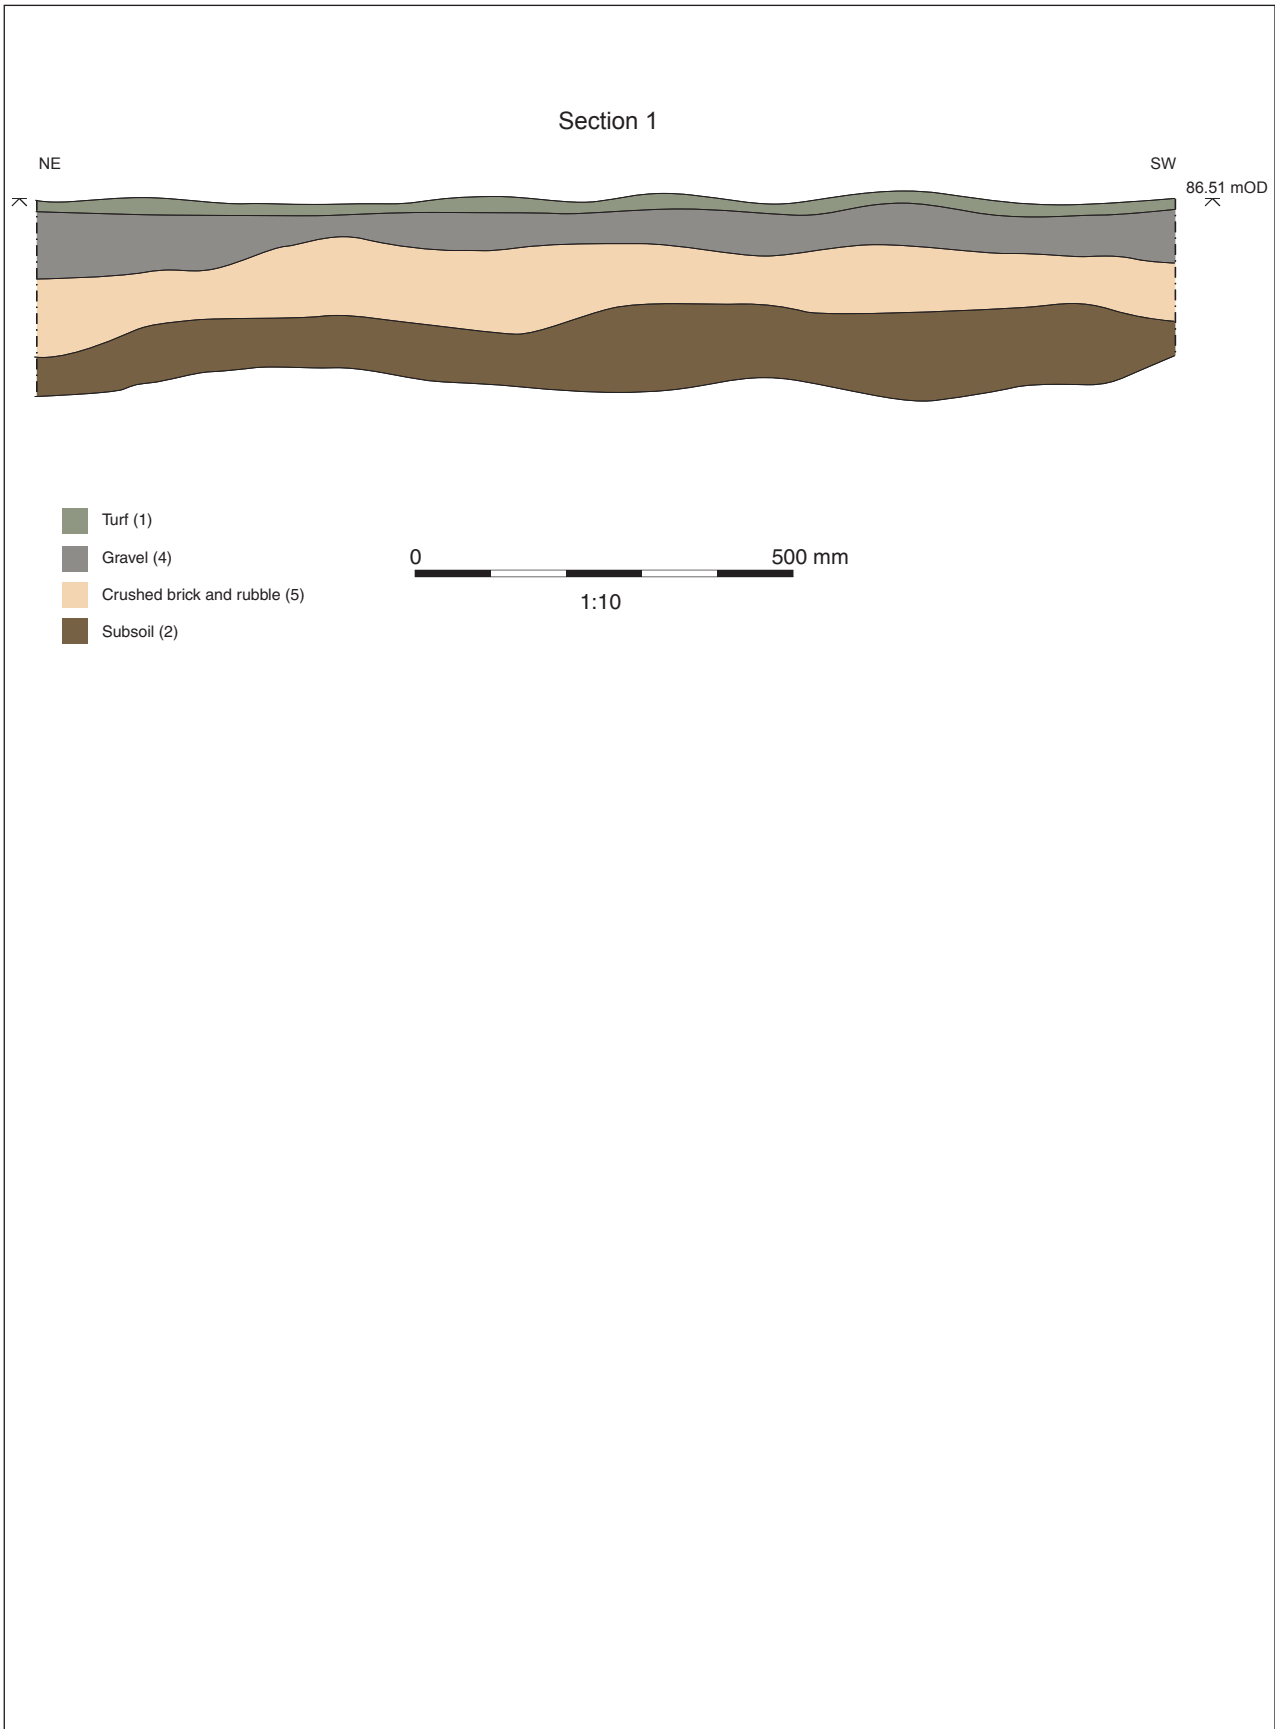
Figure 3: Section through Trench 1

3.4.2 A reddish brown silty subsoil (2) 0.15m thick ran across the trench. This was overlain by a layer of crushed brick and rubble (5) 0.16m thick, acting as a bedding layer for an early modern yard surface. The yard surface itself (4) consisted of gravel 0.09m thick and contained a number of modern metal artefacts, including a horseshoe and chain links (Fig.3 Section 1, Plate 2).

4.3.2 Trench 1 contained a gravel surface laid over a bedding layer of brick rubble. As this was only just below the modern ground surface and was located immediately in front of an existing barn this was likely to be an early modern yard surface relating to the barn.

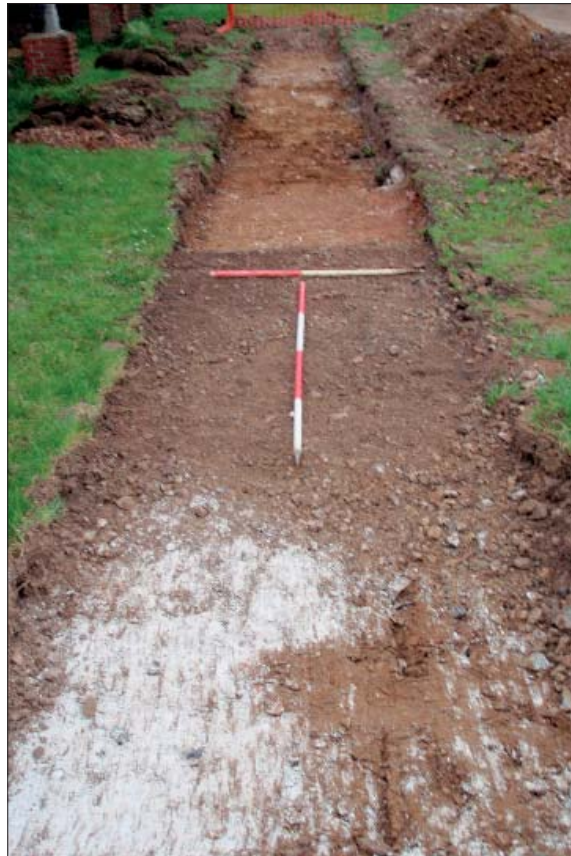
Plate 1: Trench 1, looking north-east

3.4.1 Trench 1 was located in front of a barn in the north-west corner of the development area. It was 20m long and had an average depth of 0.28m and aligned north-east to south-west (Fig.2, Plate 1).

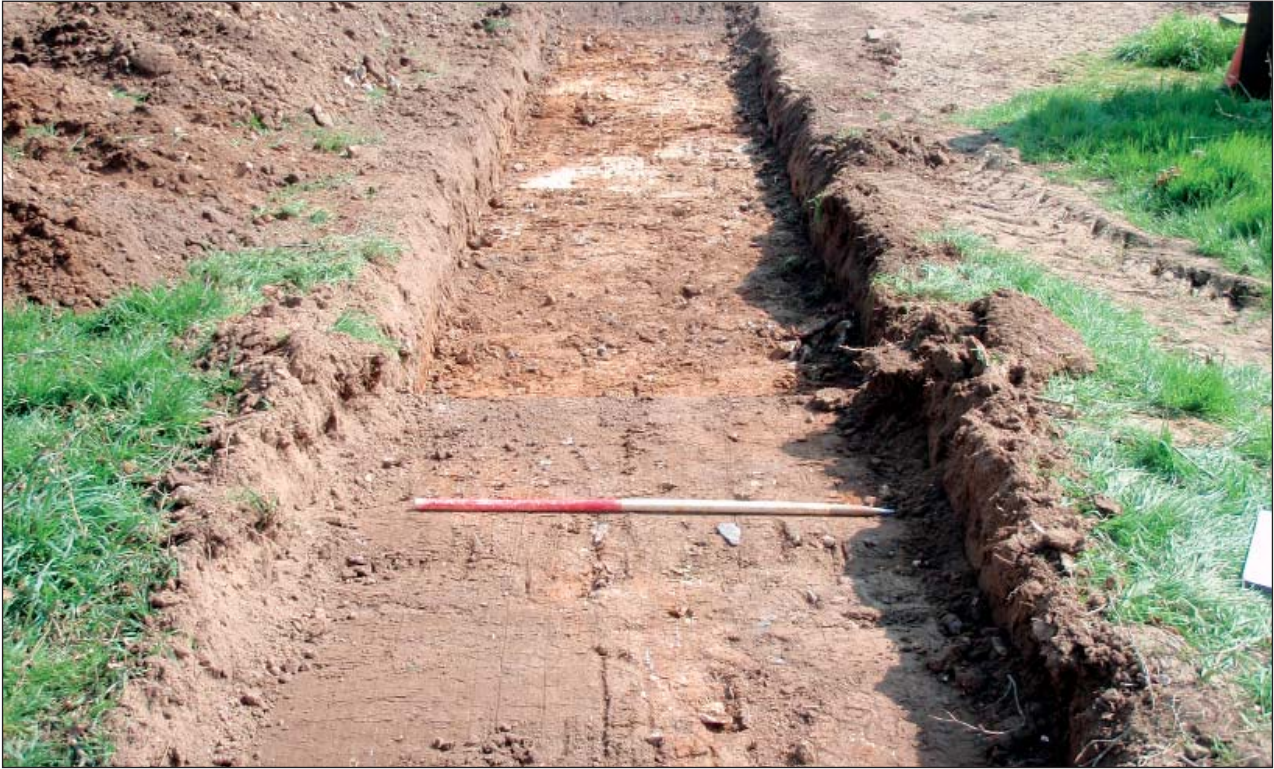
Plate 3: Trench 2, looking east

3.5.2 Trench 2 located between the other two trenches aligned just off east to west. The trench was 10m long and averaged 0.42m deep, with subsoil (2) with a maximum thickness of 0.2m and topsoil (1) up to 0.3m thick (Fig.2, Plate 3).

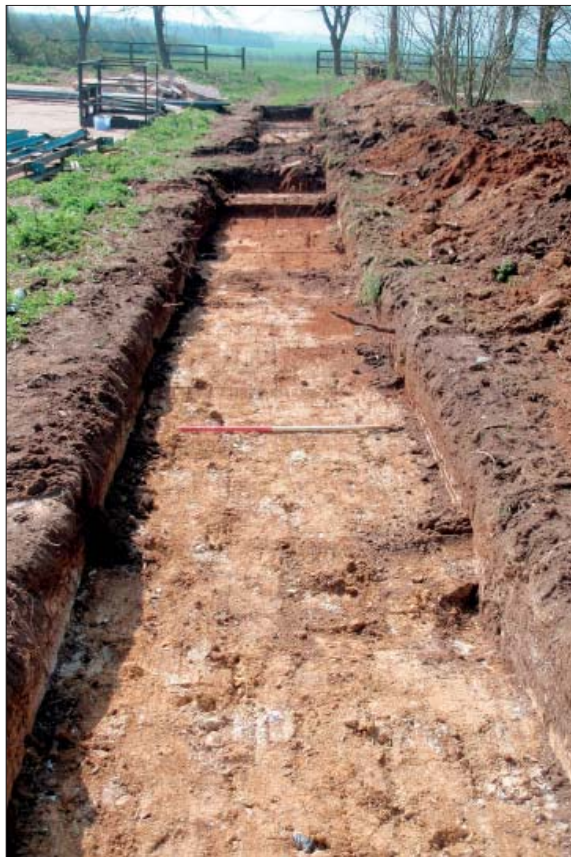
Plate 4: Trench 3, looking south-west

3.5.3 Trench 3 was located on the western edge of the development area in the south-west corner. It was 30m long and had an average depth of 0.52m, on a north-east to south-west alignment. The subsoil (2) had a maximum thickness of 0.37m and the topsoil (1) of 0.28m. Two modern services lines crossed the trench at right angles and there was considerable root disturbance from a number of trees throughout the trench (Fig.2, Plate 3).
