# An Archaeological Evaluation St Leonard's Hospital Sudbury

## Archaeological Evaluation Report

March 2016

**Client: CgMs on behalf of  
PJ Livesey**

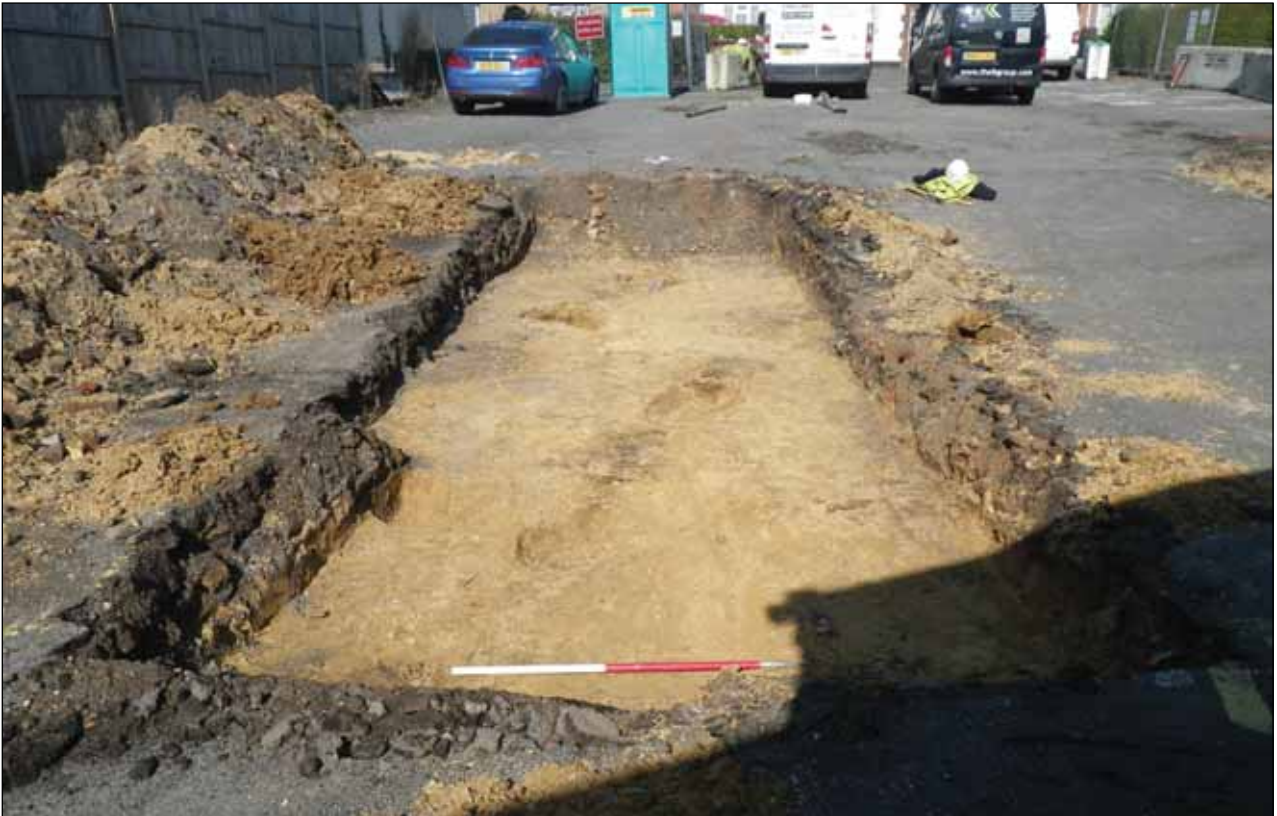
Plate 1: Trench 1, view north-northeast

#### ***8.3m x 2.6m***

- 3.2.1 Due to probable live electrical services, this trench was positioned slightly to the south of the original plan, perpendicular to Burroughs Piece Road.
- 3.2.2 Natural geology of fine clayey sand was encountered at a depth of up to 0.4m. A number of irregular glacial features filled by very firm mid-brown clayey silt were visible (Plate 1), apparently oriented down the natural slope. These were excavated by hand to confirm their nature and were typically 0.2m deep although this varied.
- 3.2.3 The area may have been truncated as there were no soils present. Two layers (0.2m thick) of modern block paving lay immediately upon the natural sand across the trench. A further 0.2m of tarmac made up the surface.
- 3.2.4 No archaeological features were found.

- 4.1.2 Soil had evidently been stripped from Trenches 1 and 3 prior to laying of the block paved surface, but the surface slope and the levels within Trench 2 (which was on grass with surviving soils) suggests little underlying natural sand was removed.

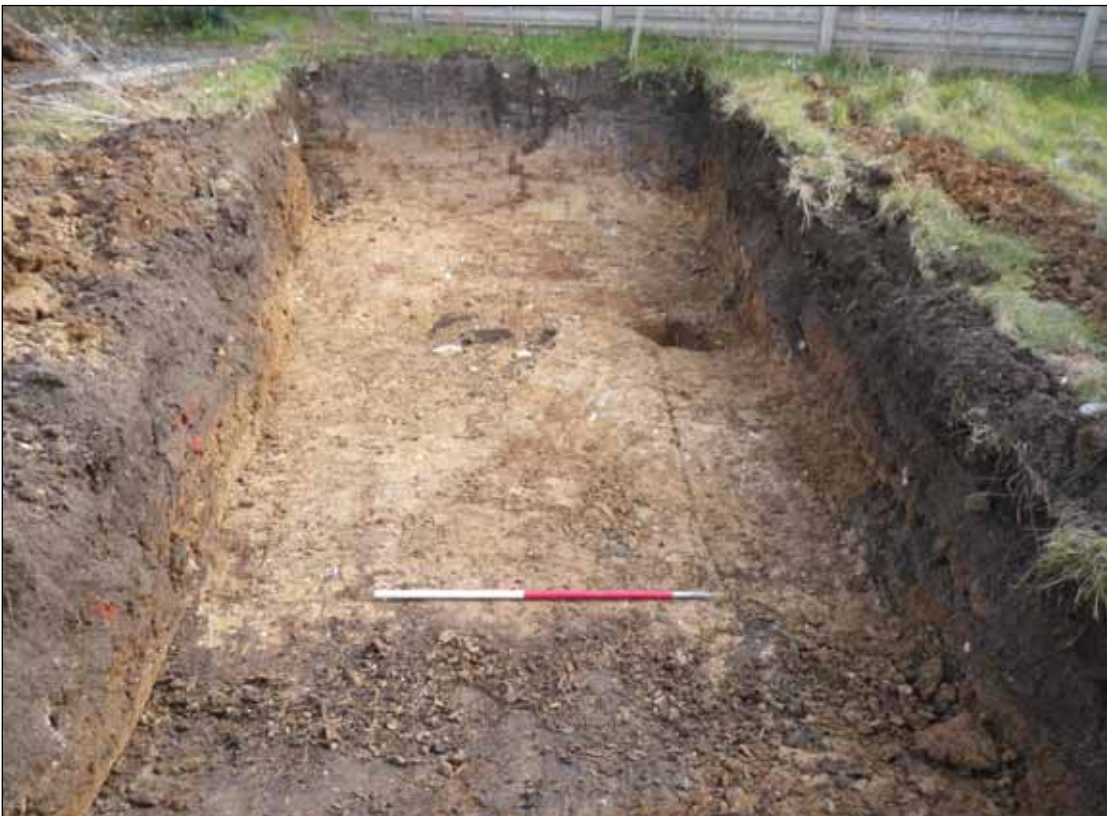
Plate 2: Trench 2, view northeast

#### ***7.1m x 2.2-3.1m***

- 3.3.1 In order to work around the concrete barriers securing the northern site access, Trench 2 was positioned diagonally across a grassy area in the northeast of the site, between a concrete surface, the tarmac-surfaced car park and a concrete shed.
- 3.3.2 Natural clayey silts were encountered at a depth of 0.65-0.8m. A thin linear streak of darker silt, angled down the natural slope (i.e. to the southwest) proved to be a variation in the natural.
- 3.3.3 Subsoil (0.3m thick) survived, with 0.4-0.5m of topsoil and turf overlying it. The topsoil thickness varied, probably due to dumping of material during the period when the hospital was in use. Only modern brick/tile and asphalt were found within the topsoil.
- 3.3.4 No archaeological features were found.

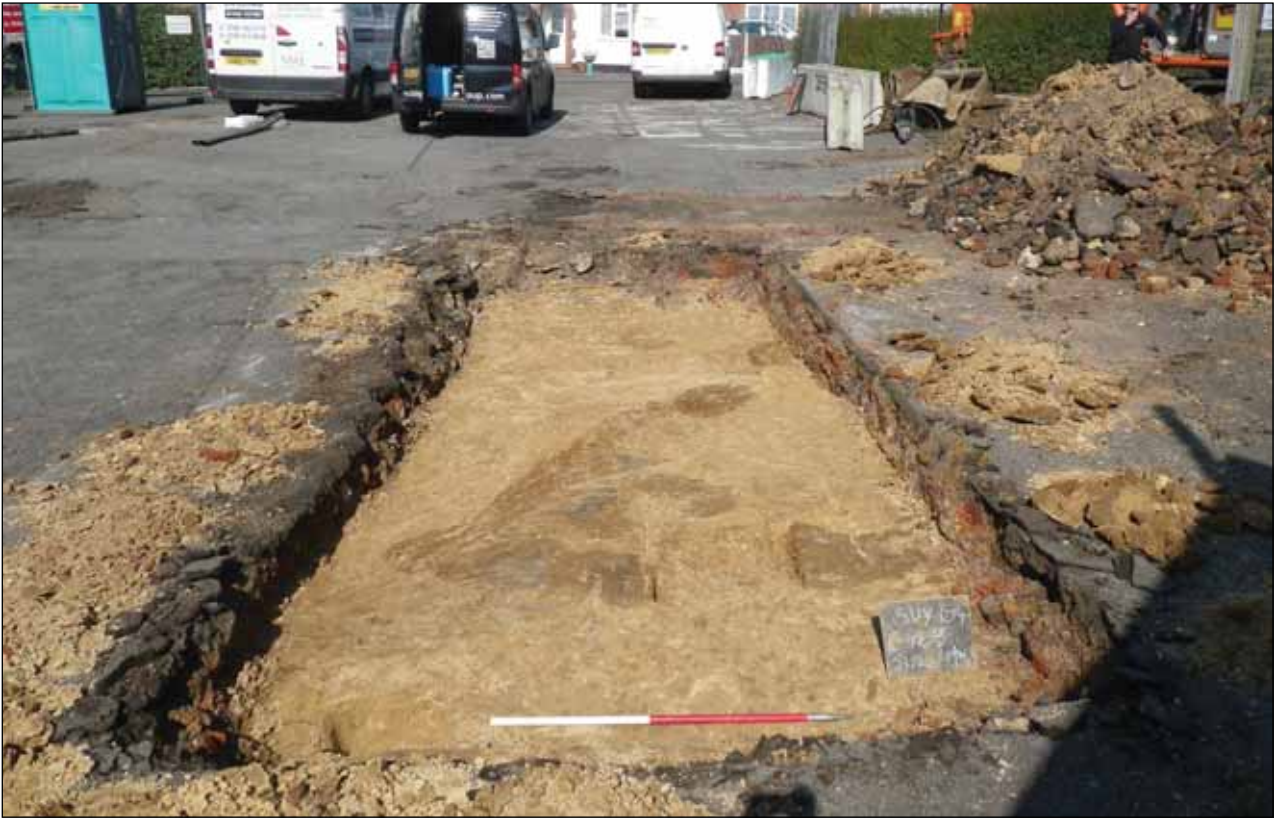
Plate 3: Trench 3, view north-northeast

#### ***6m x 2.6m***

- 3.4.1 It was not possible to position Trench 3 aligned east-west across the car park in the north of the site, as per the original trench plan, due to the probable presence of buried services. Instead a small trench was excavated 5m east of Trench 1.
- 3.4.2 Natural clayey sand with similar irregular glacial features to Trench 1 were found at a depth of c.0.3m. No soil was present. Two layers of block paving and a layer of tarmac lay directly upon the natural sand.

3.4.3 No archaeological features were found.

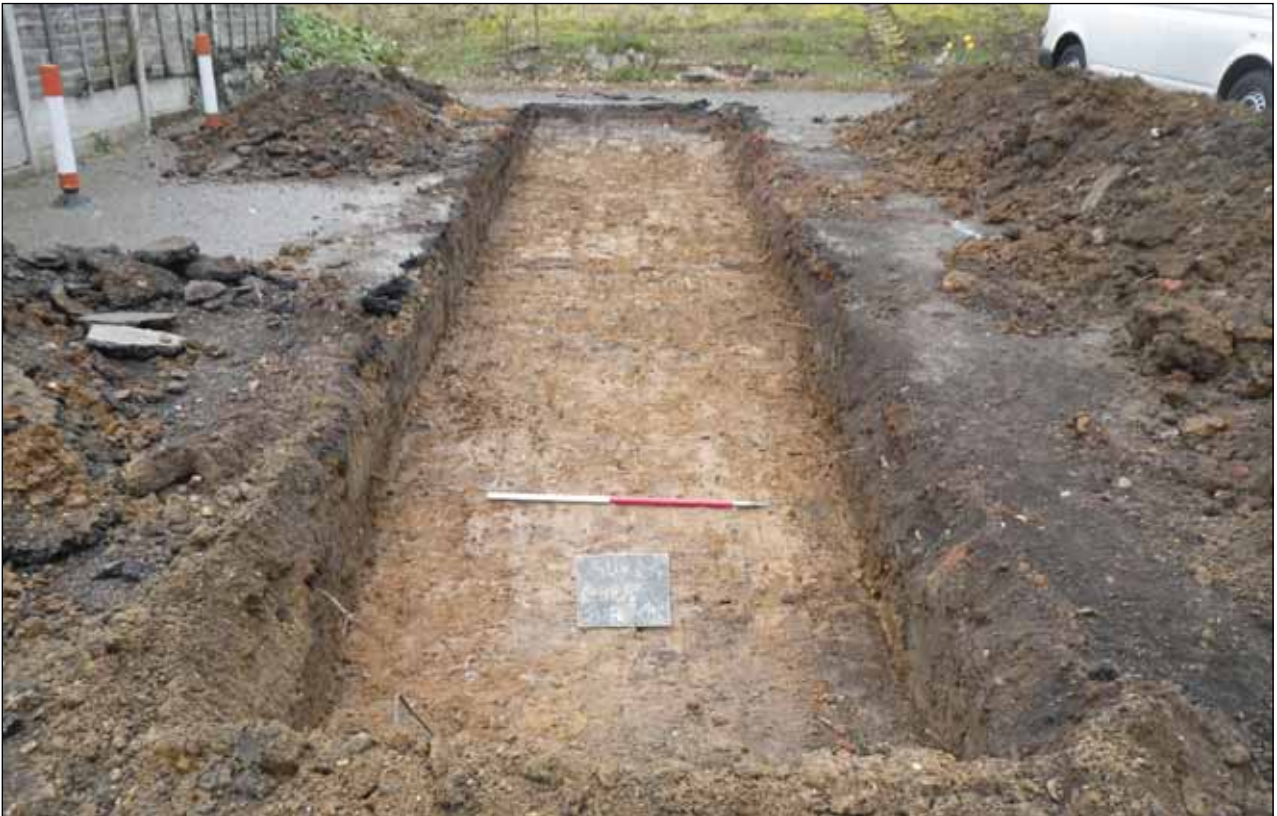
Plate 4: Trench 4, view north-northeast

#### ***9.6 x 2.2m***

3.5.1 This trench was broken out of tarmac within a car park on the south side of the hospital, aligned north-south, parallel with the western boundary.

3.5.2 Depth varied from 0.4m at the northern end to 0.6m at the southern end as the tarmac surface had been levelled relative to the natural geology of clayey silt and flint gravel.

3.5.3 A heavily compressed band of soil survived to a thickness of up to 0.35m across the southern half of the trench. At the northern end of the trench this was truncated to 0.2m thick.

3.5.4 Overlying the soil was a layer 0.21-0.25m thick comprising imported sands and gravels. This was a make up for the tarmac surface which was 0.1m thick.

3.5.5 No archaeological features were found.

- 4.1.3 Trench 4 showed a small amount of truncation due to levelling for the southern car park. A steep bank to the north between the car park and the hospital buildings was evidently built up ground. At Trench 5, a good covering of subsoil and topsoil preserved the natural gravels.

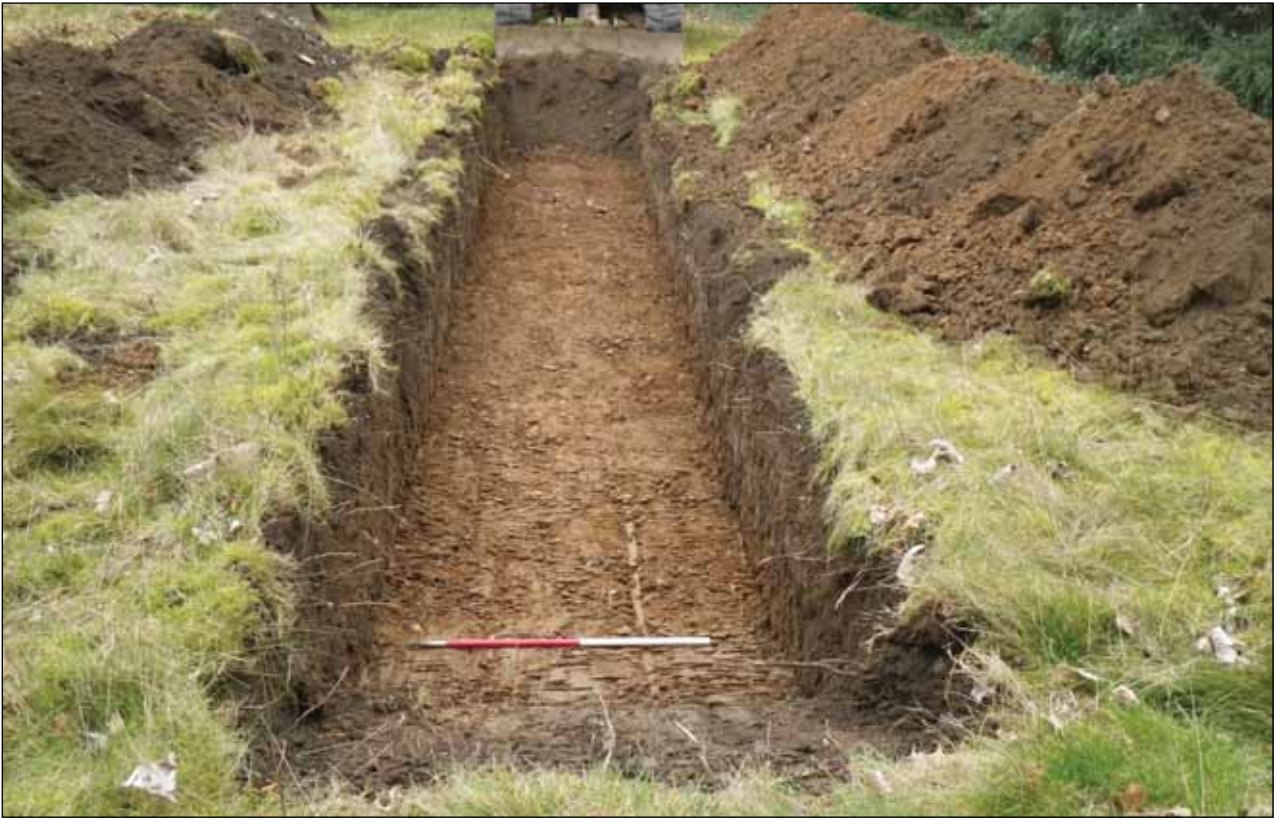
Plate 5: Trench 5, view east

#### ***10.8m x 1.8m***

3.6.1 This trench was positioned on a grassy area between the car park and the site's southern boundary.

3.6.2 Natural sands and gravels were encountered at a depth of 0.75m, although this was slightly over cut by the machine to a total depth of 0.9m.

3.6.3 Overlying the gravel was a layer of clayey sand perhaps 0.15m thick with no clear lower horizon to the gravels. This may represent some colluvium or a continuation of the natural deposits seen in the other trenches at higher elevations.

3.6.4 Subsoil survived with a thickness of 0.3-0.35m. Topsoil and turf 0.25-0.3m thick overlay the subsoil.

3.6.5 No archaeological features were found.
