Archaeological Investigations
into the Deterioration of
Stonework within the
Dining Room at
Anglesey Abbey House
Cambridgeshire

Excavation Report

January 2010

OA East Report No: 1158

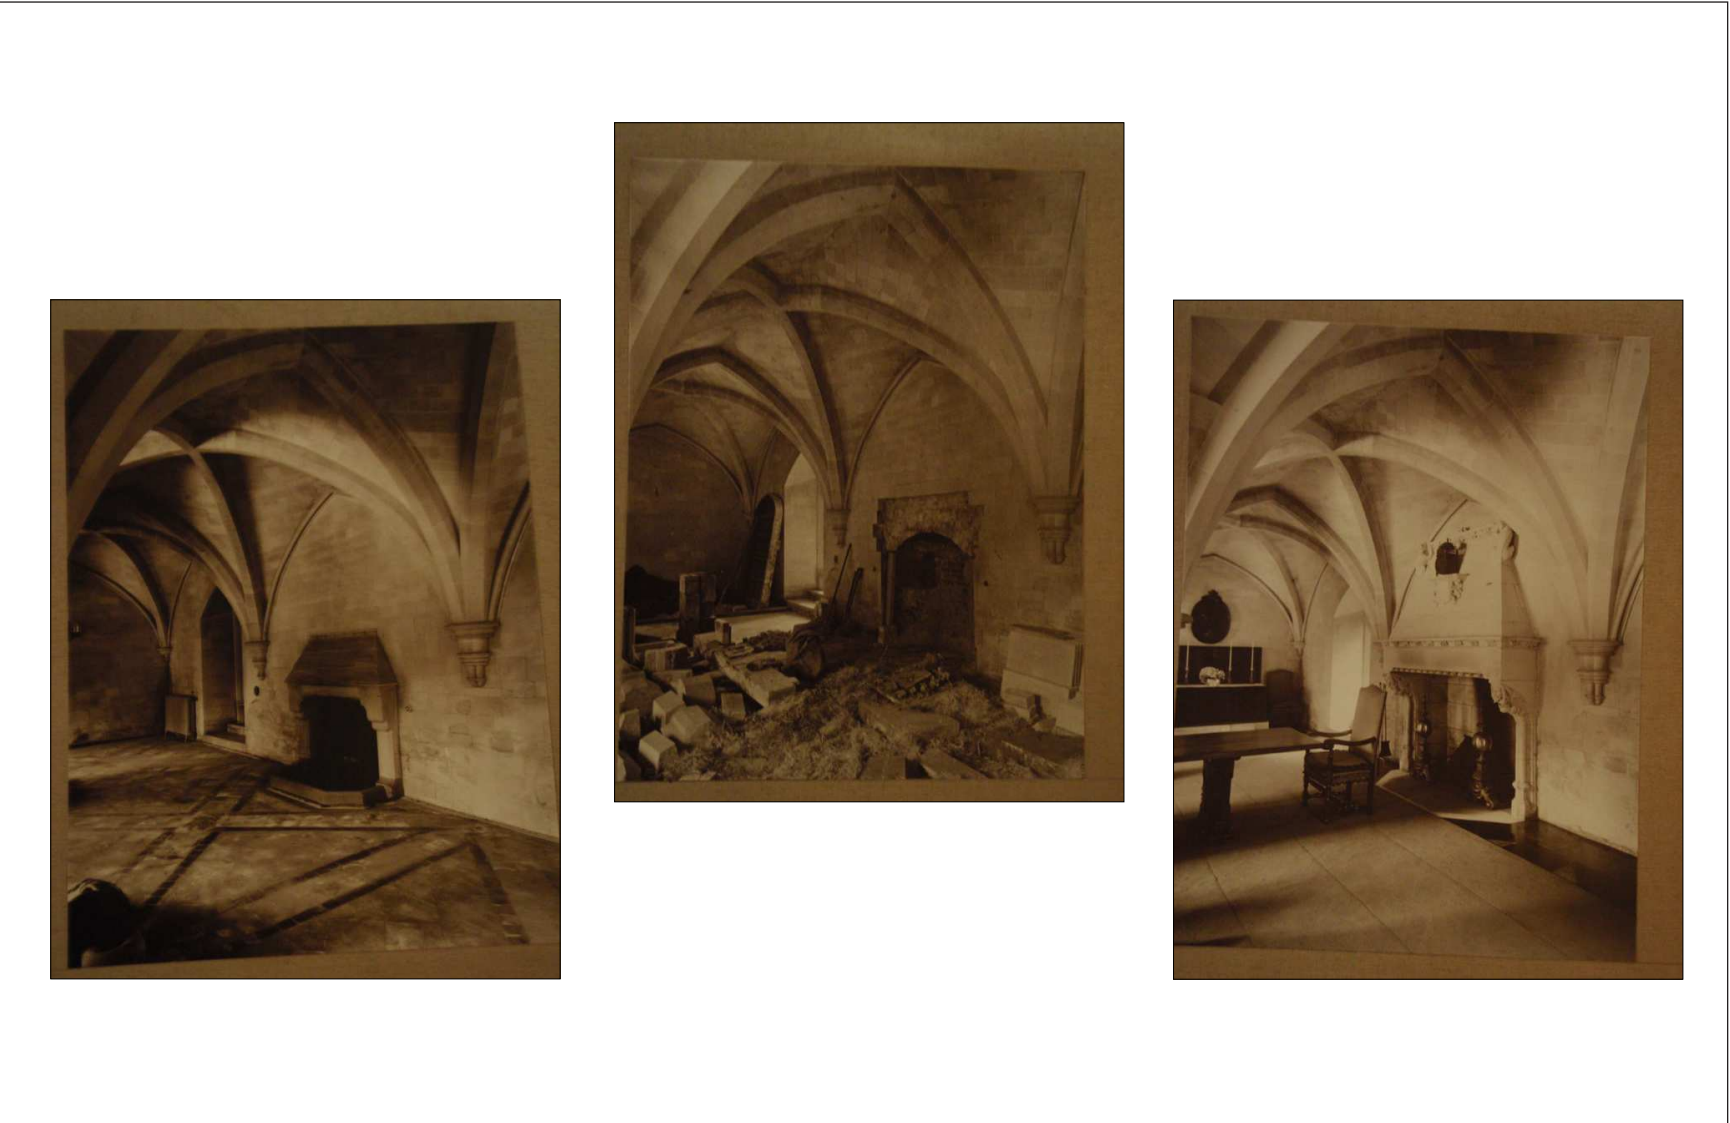
Figure 4: Photographs taken before, during and after renovation in the dining room by Lord Fairhaven in the 1930s (reproduced with kind permission from the National Trust)

- 4.1.4 The current floor was then laid sometime after this in the late 19th century, presumably by Reverend Hailstone. Lord Fairhaven then took over the house in 1926 (www.nationaltrust.org.uk). It is well documented that during his occupation of the house, Lord Fairhaven undertook some dramatic renovations which included changing the location of the main entrance to the house and other internal alterations. Images of the replacing of the fireplace in the dining room before, during and after the work can be seen in Figure 4.

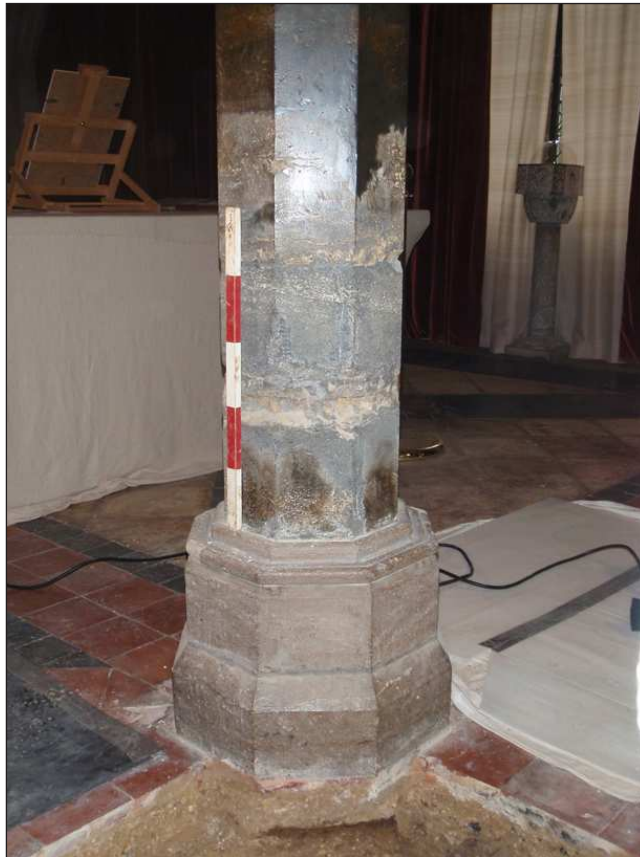
Plate 1: Column under investigation within dining room

Anglesey Abbey house is converted from the remains of an Augustinian Priory and the present dining room is in the medieval undercroft. The vaulting for this undercroft is supported on two pillars. In recent years some spalling of these pillars has been observed which may be caused by rising damp. The purpose of this archaeological investigation was to help identify the cause of spalling by excavating on one side of the foundations of one of the pillars, below the present modern floor and specifically to locate a possible raised water table.

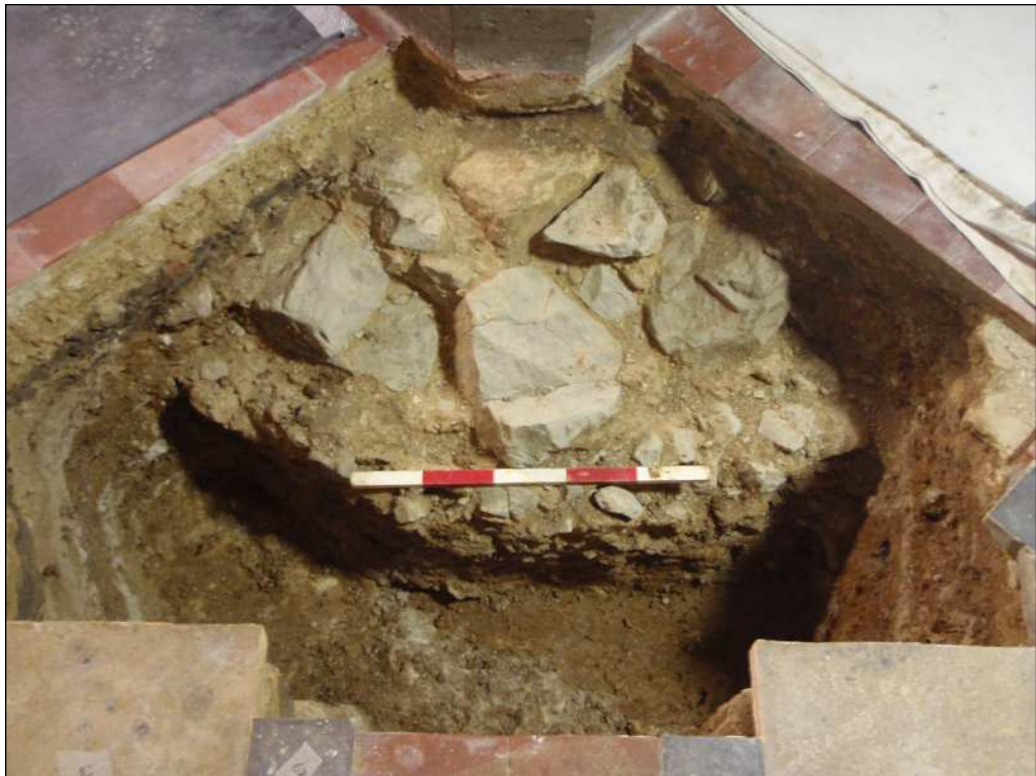
Plate 4: Excavated foundations

- 4.1.1 The excavations at Anglesey Abbey have shown that the foundations were constructed upon a layer of crushed stone with large cut (?) blocks of local clunch (plate 4). The materials used in the construction of the abbey have been locally sourced (Barnack stone, Alwaton marble) and the nearby village of Burwell, less than 4.5 miles to the north east has a number of documented quarries and produced clunch right up to the end of the twentieth century. The foundations for the pillar appear to go no deeper than 0.40m below the current floor surface. The depth/location of layer 10 (a compacted, firm redeposited natural chalk) shown within the section (Figure 3) corresponds with the base of the foundations and represents the level of construction of the building. Beneath this level is a dark orangey brown layer (11) which is likely to have been an imported subsoil used to fill a much larger area into which the abbey was built. It is evident from standing outside of the building that the ground level inside is at least 0.50m lower, suggesting a “cut” was made for the building, possibly as the soils were unsuitable to build directly onto. Excavation ceased at the level of truncated natural geology (13) which was further recorded by auger survey (14 and 15) to a depth of 1.0m. Layer 13 was a very silty soft, deposit and had been truncated by the construction cut for the building.

- 4.2.1 This investigation has revealed the original foundations of the calefactory from the thirteenth century abbey. It has shown the foundations to be 0.40m below the current room floor level and constructed using local clunch and supported by a large padstone of Barnack limestone.
- 4.2.2 Although this excavation did not reveal the source of water which may be causing damp within the column above, it is not conclusive that it is not present at a higher level
