Former Riding School
(ASU Building)
Queen Elizabeth
Barracks
Church Crookham
Hampshire

**Historic Buildings
Investigation and Recording**

**Former Riding School (Former ASU Building)
Queen Elizabeth Barracks, Church Crookham**

Historic Building Investigation and Recording

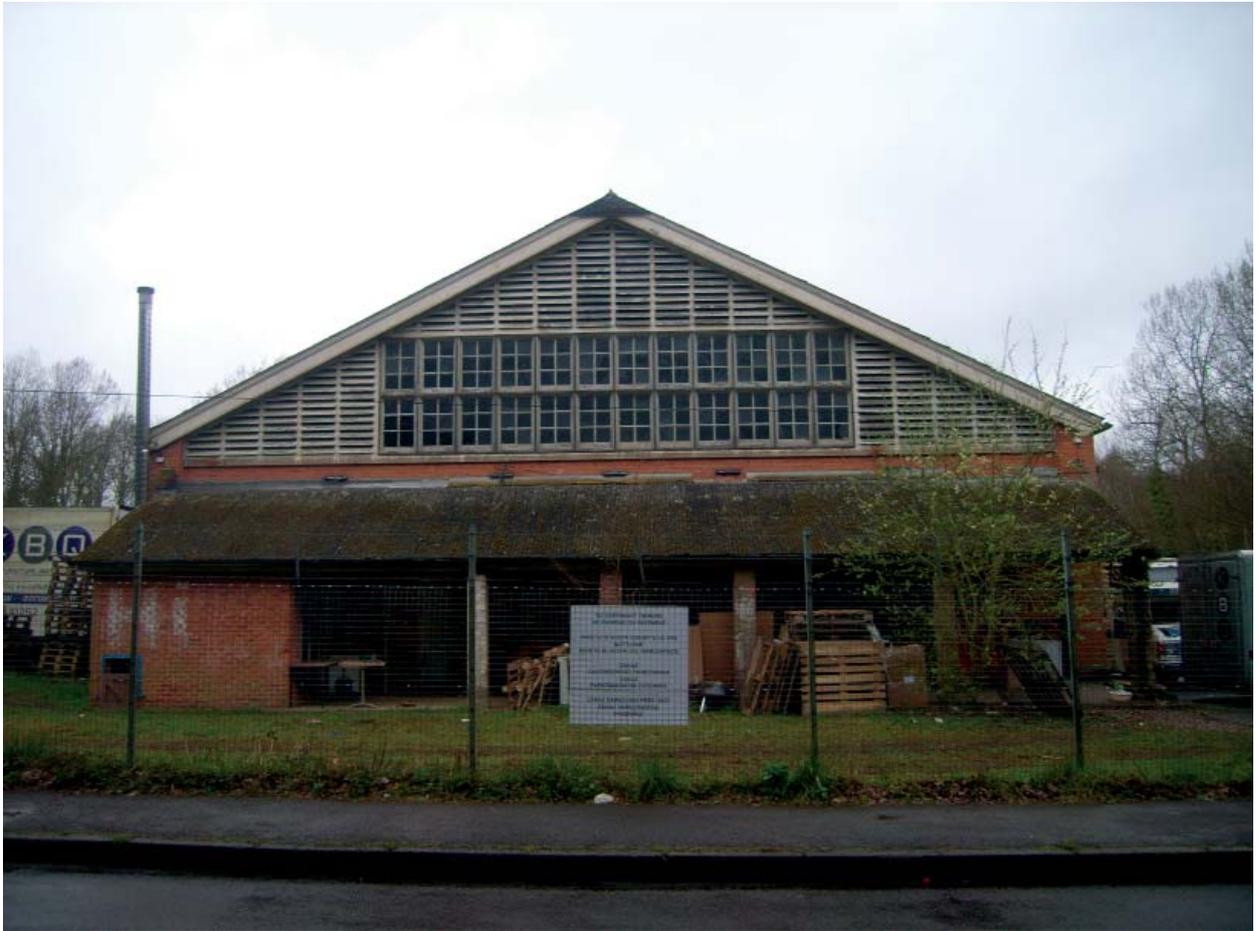
Plate 1: East elevation (taken in 2011)

- 3.1.7 The *east elevation* (Pl. 1-3) faces the main road passing the building and it is dominated by a very large gable end formed from fixed timber slat-vents and 24 timber windows (two rows of 12). Each window has six fixed lights and the whole bank of windows is set on a stone sill. Above the gable is a moulded bargeboard and the windows are now set behind metal security grilles.

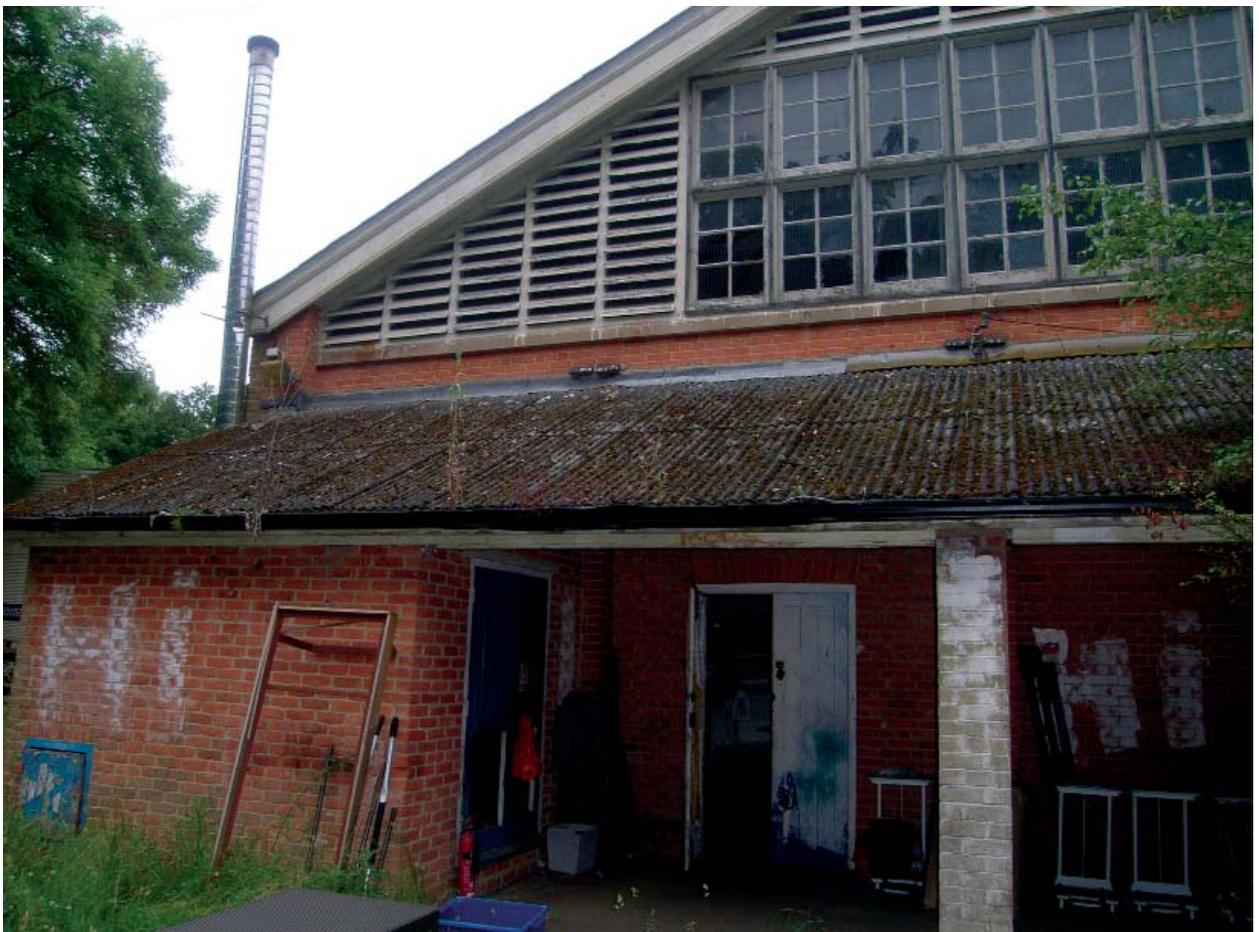
Plate 2: South half of east elevation

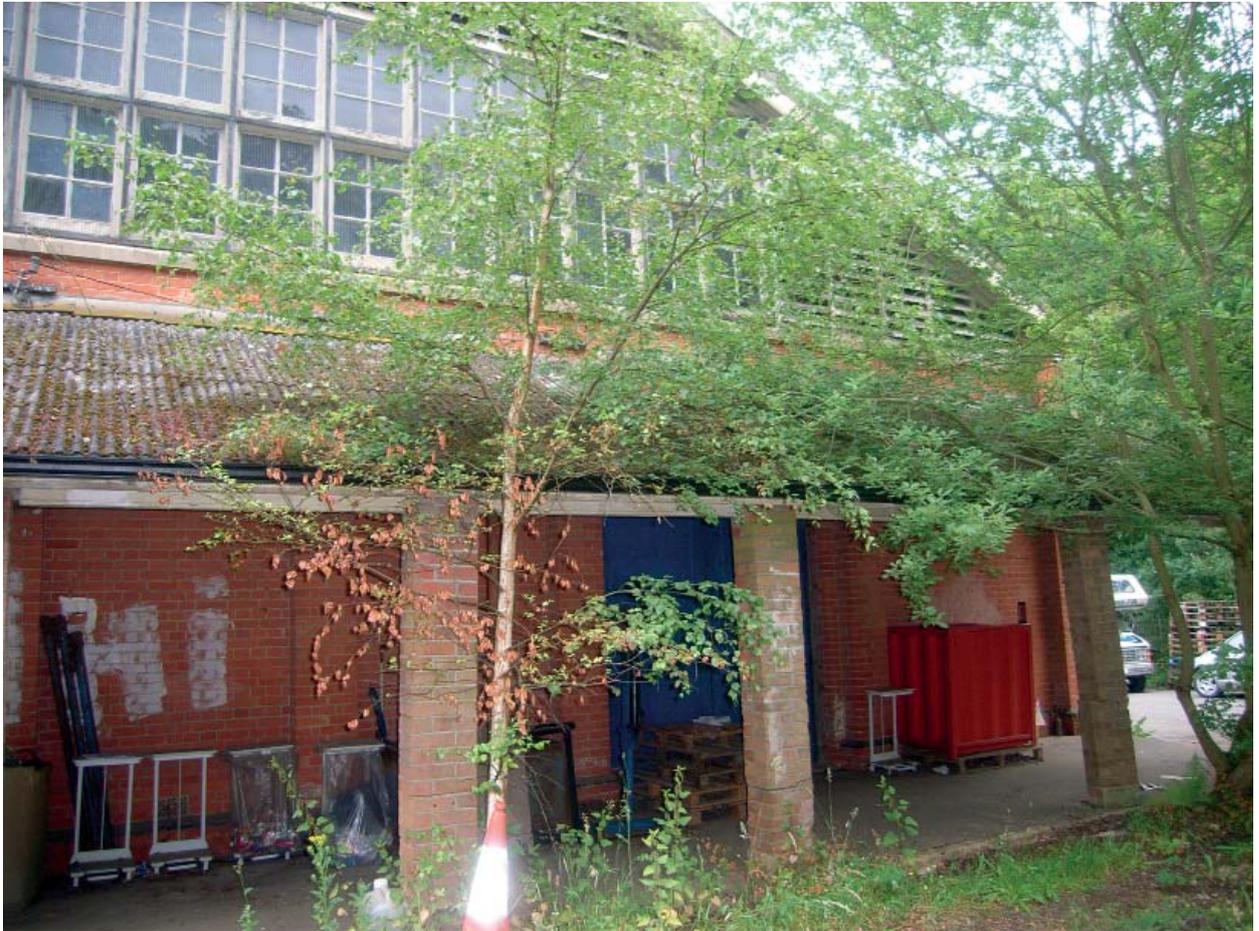
Plate 3: North half of east elevation

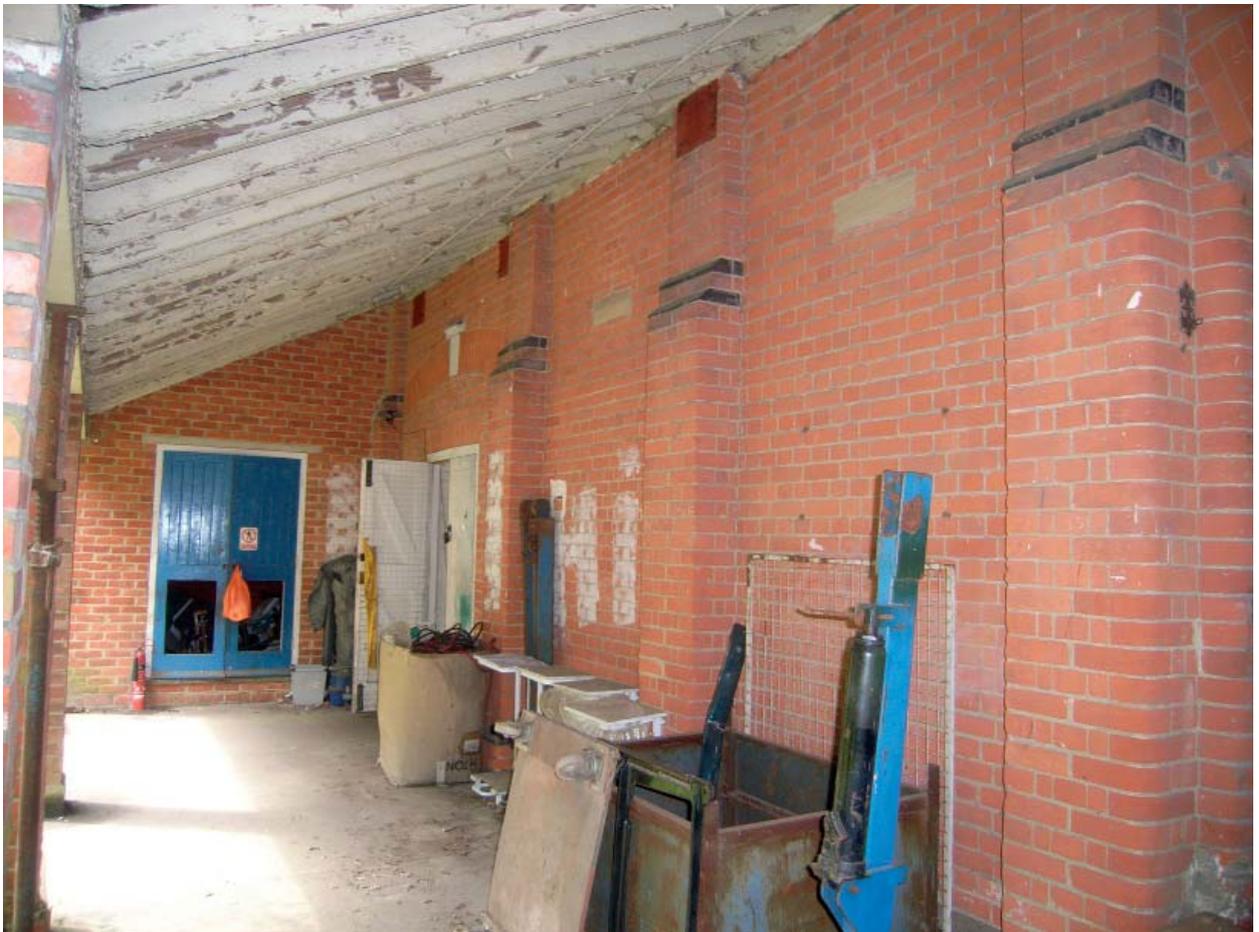
Plate 4: East elevation detail

- 3.1.9 Beneath the pentice there are five buttresses within the primary brick wall and these diminish in depth with black brick shoulders (Pl. 4). There is a primary set of double doors (vertical planks) towards the north end of the wall beneath the pentice (Plate 5) with good quality segmental-arch brickwork above which extends the full width of the bay between buttresses and with a stone key-stone. The jambs of the doorway have bullnose edges and the doors would have slid sideways on the internal side of the wall. Towards the southern end of this section of wall (adjacent to the boiler room) there is another bay with a full width segmental brick arch but this bay has been partially infilled with secondary brickwork and a smaller set of double doors (Pl. 6). This doorway leads into a partitioned room that is currently used as a vehicle workshop. Evidence inside the building confirms that this opening formerly also had a pair of sliding doors.

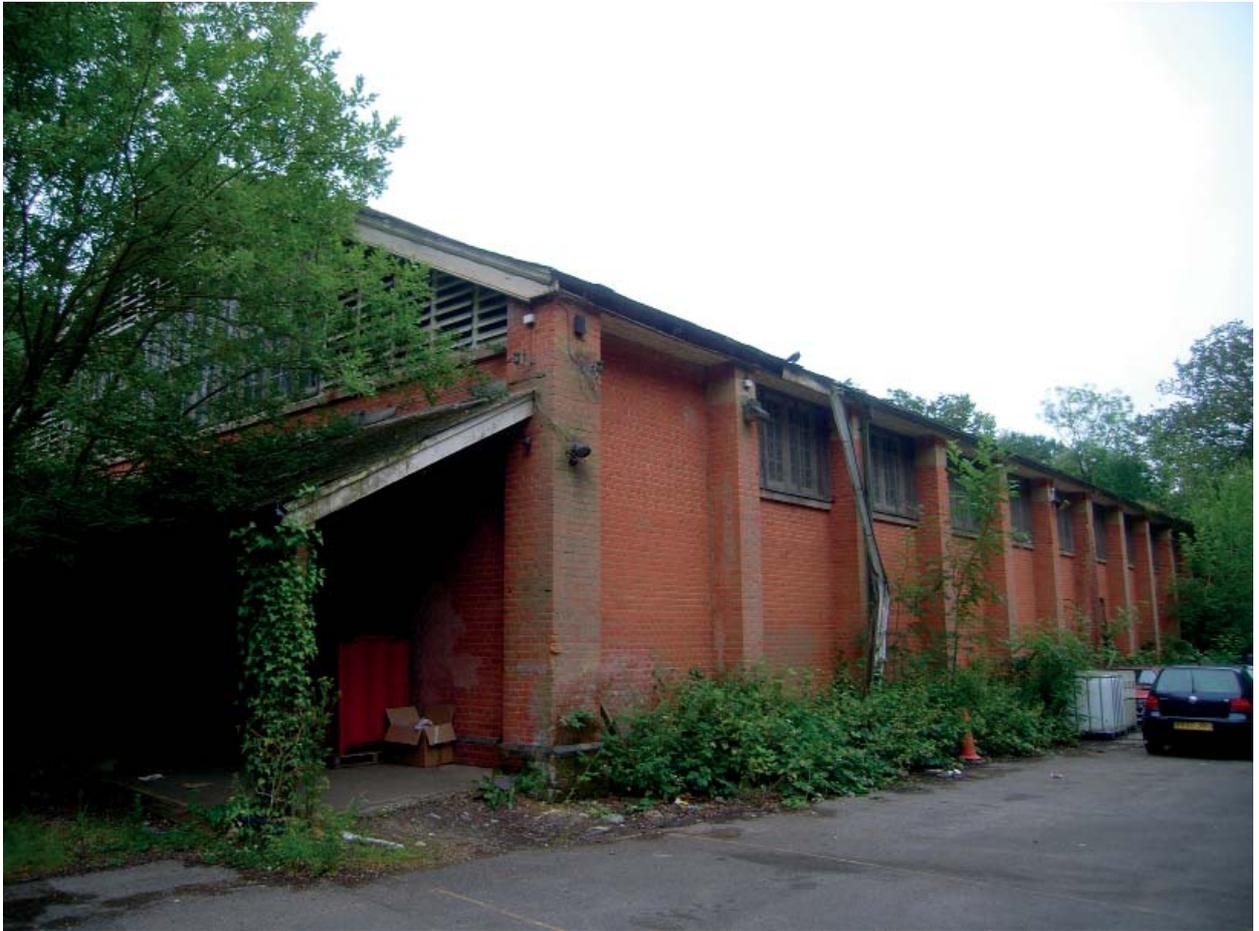
Plate 7: Exterior from north-east

- 3.1.2 The building is orientated east-to-west and the main long *north and south elevations* are each divided into 16 regular bays by large brick piers or buttresses (c.50 cm²) which support the deep overhanging eaves above (Pl. 7-8). The eaves are c.5.2 m above the ground level, (although this varies slightly with the slope of the ground) and they comprise a timber soffit with distinct criss-cross patterns of holes drilled for ventilation (Pl. 10). Each main buttress (other than those at the corners) incorporate a large stone block towards their top which would have supported the ends of each truss. The arrangement of fenestration in the north and south elevations is similar to each other with large, high windows, just below the eaves in each bay other than those adjacent to the gable ends. In each bay there are three, fixed 12-light timber windows with stone sills (Pl. 10).

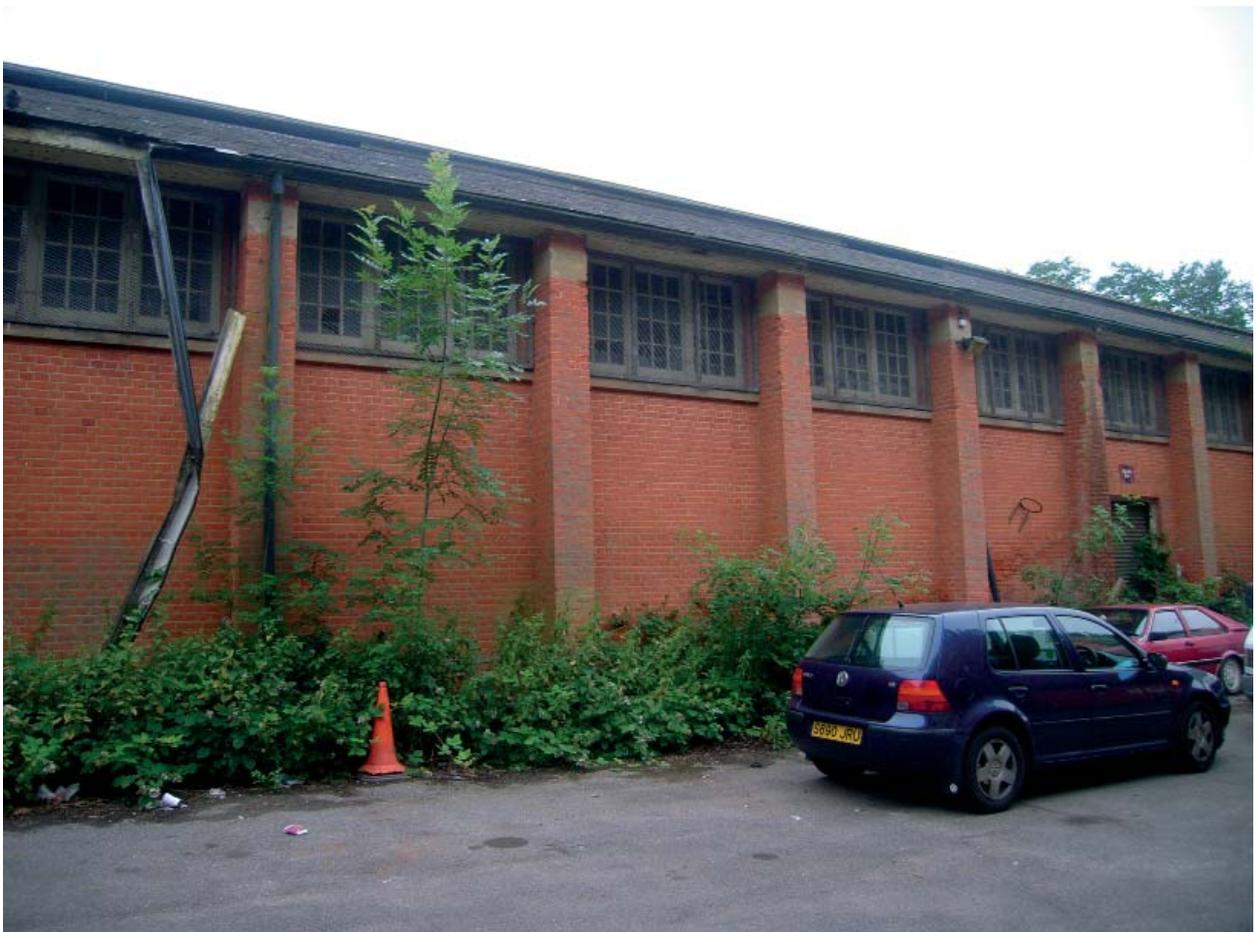
Plate 8: North elevation

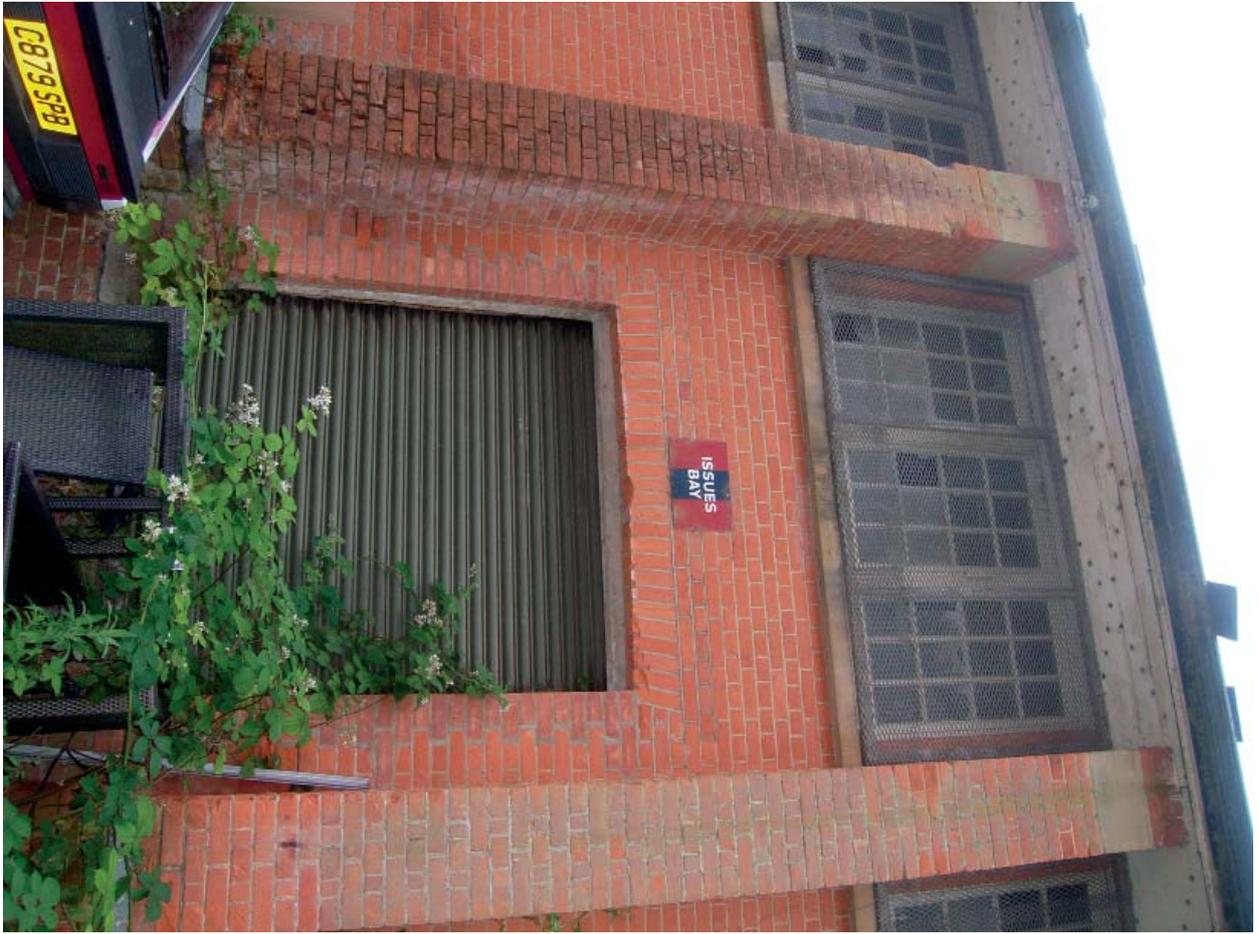
Plate 9: Inserted loading door in north elevation

- 3.1.3 In the north elevation three doorways have been inserted relating to the secondary use of the building as a storehouse (Pl. 9). Each of these is double width with a square-headed, gauged brick lintel and reformed brick jambs. Two of them also have a later 20th-century roller shutter set immediately above the doorway on the inner face and a raised loading platform which trucks could pull up to. The roller shutters were almost certainly secondary to these doorways and replaced previous storehouse doors. One of the doors with the roller shutter is in the 7th bay from the east and above this opening there is a sign saying 'issues bay' while just to the west of the centre of the elevation (9th bay from east) there is another similar doorway a sign above it for 'receipts bay'. Each sign has a distinctive (military?) form with two red vertical stripes either side of a central black stripe. Towards the west end of the north elevation there is another doorway with similar lintel and sill as the others but here the earlier double doors survive instead of the later roller shutters. This door was largely obscured by vegetation.

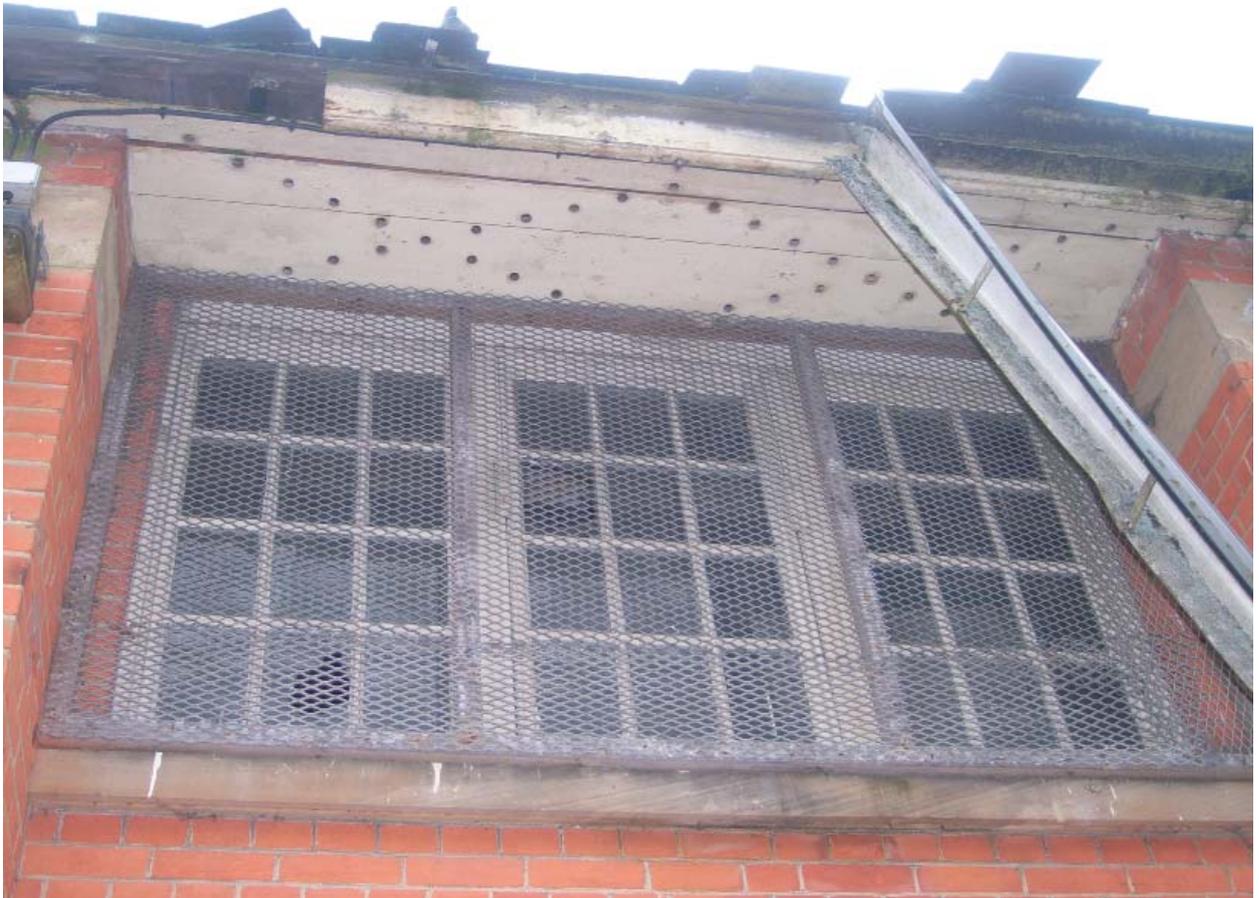
Plate 10: Typical window in north elevation

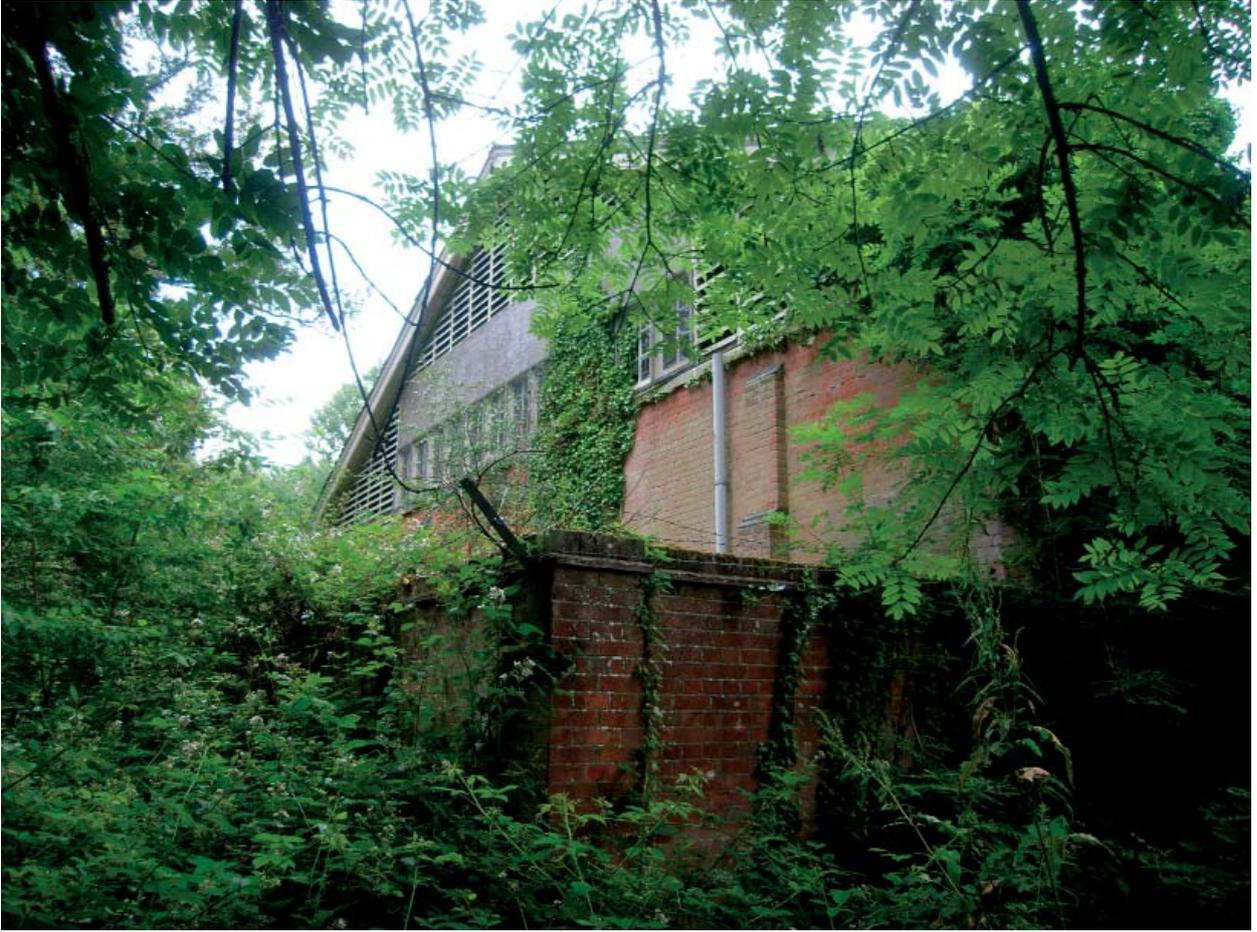
Plate 13: West elevation

- 3.1.12 The *west elevation* is dominated similarly to the east elevation by a large gable end with fixed timber slat vents, a long bank of windows and bargeboards (Pl. 13). Below the gable the elevation is constructed of brick but the lower half is obscured by a secondary brick wall which appears to enclose a small yard although access was not possible into this area. This elevation is supported by brick buttresses, similar to those in the east elevation, which extend up to a point just below the sills of the bank of windows. These buttresses diminish in depth towards the top with a blue, sloped brick shoulder just above the mid point and there is another shoulder at the top of the pier.

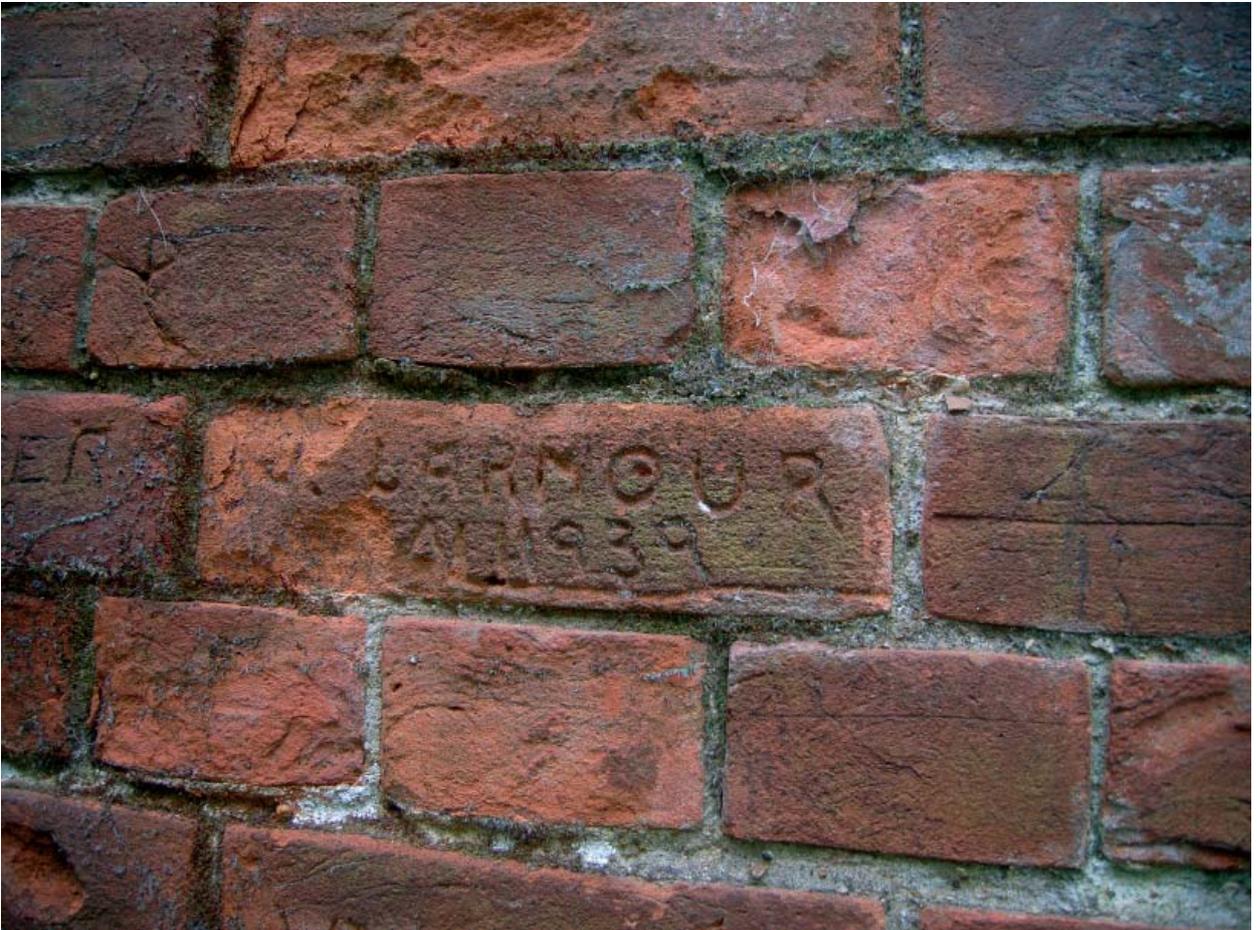
Plate 14: Graffiti on east wall

- 3.1.11 Along this wall there are numerous names and dates scratched informally as graffiti (Plates 14-16). These are mainly from the 1980s but there are some from the mid 20th century (1952, 1956) and even one faint date which appears to be 1901.

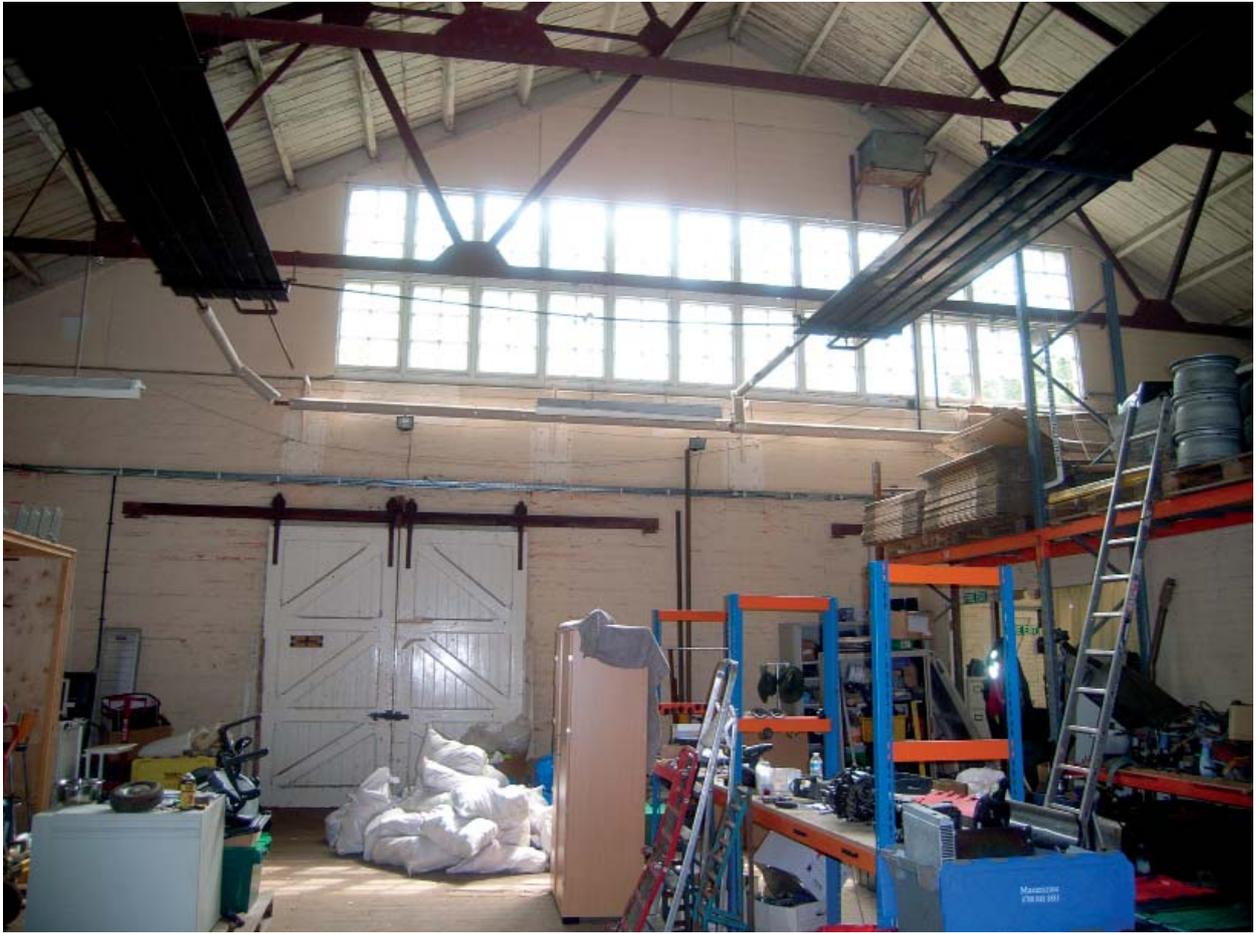
Plate 17: Internal face of east wall

- 3.2.2 The primary *sliding doors* at the east end of the building are 2.9 m tall and with good quality detailing such as chamfers to each brace and vertical rail (Pl. 17-18). The doors are set on a steel rail across the top of the opening and it is interesting to note that the same type of rail is also set above the door towards the south end of this (eastern) wall confirming that this opening also had similar sliding doors prior to being replaced by the current smaller doors. Either side of the main doorway there are upright, triangular, steel stanchions fixed to the floor although their purpose is unclear.

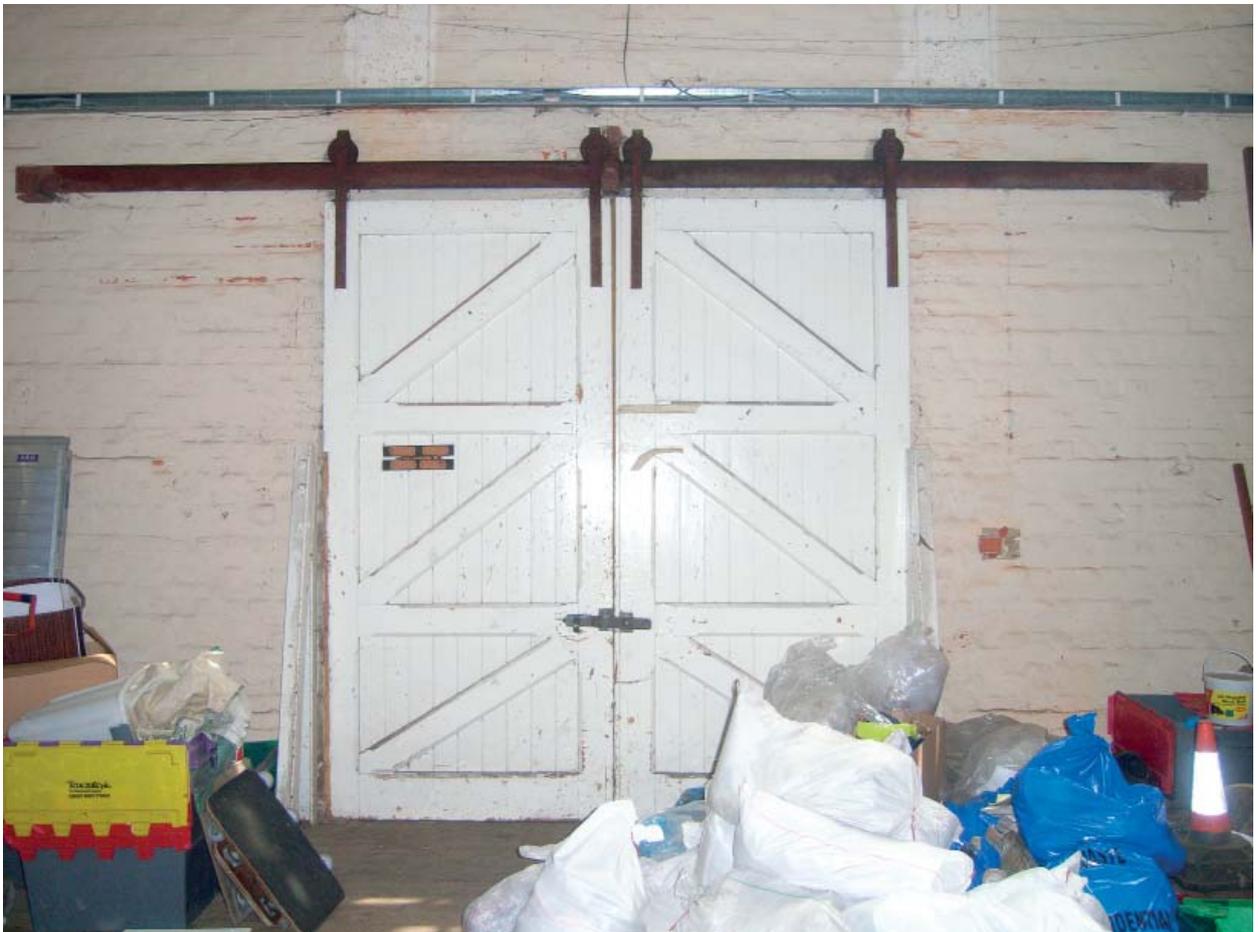
Plate 18: Doors in east wall of building

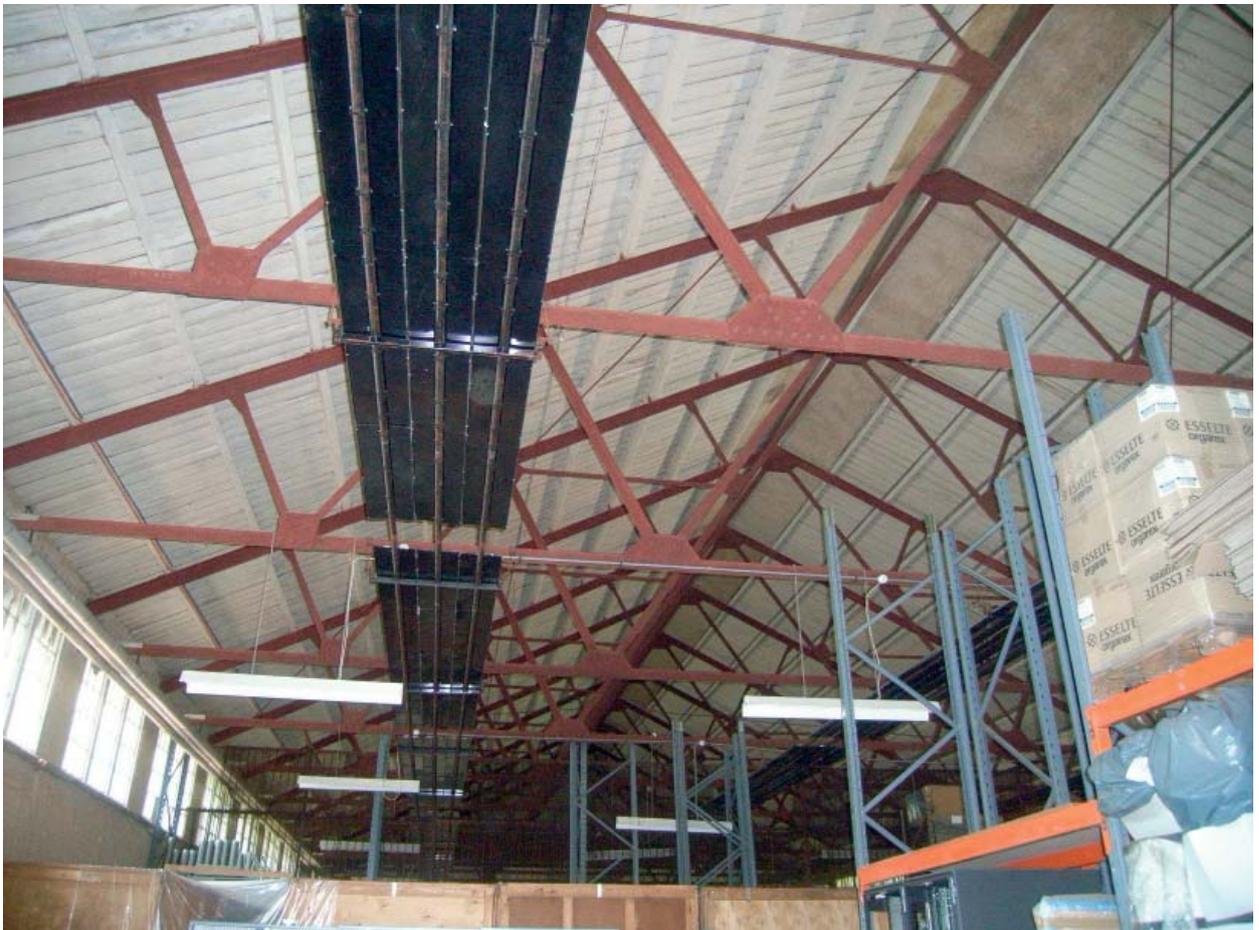
Plate 22: General view of roof from east end

- 3.2.5 The primary *roof* of the Riding School survives and comprises 15 metal trusses typical for large-span buildings of this type from the first half of the 20th century (Pl. 22-26). The form of the trusses is suggestive of a slightly later date than 1900 but it seems inconceivable that they would have been replaced relatively soon after the building's original construction so they must be primary. The trusses are formed from flat-section and L-section steel lengths; the flat section members act in tension while the L-section members act in compression. The members of each truss form an open triangle to the centre and with a series of struts to each side with connecting plates at the intersections. There are nine softwood purlins to each slope lying on the back of the principal rafter with small steel bracket supports.

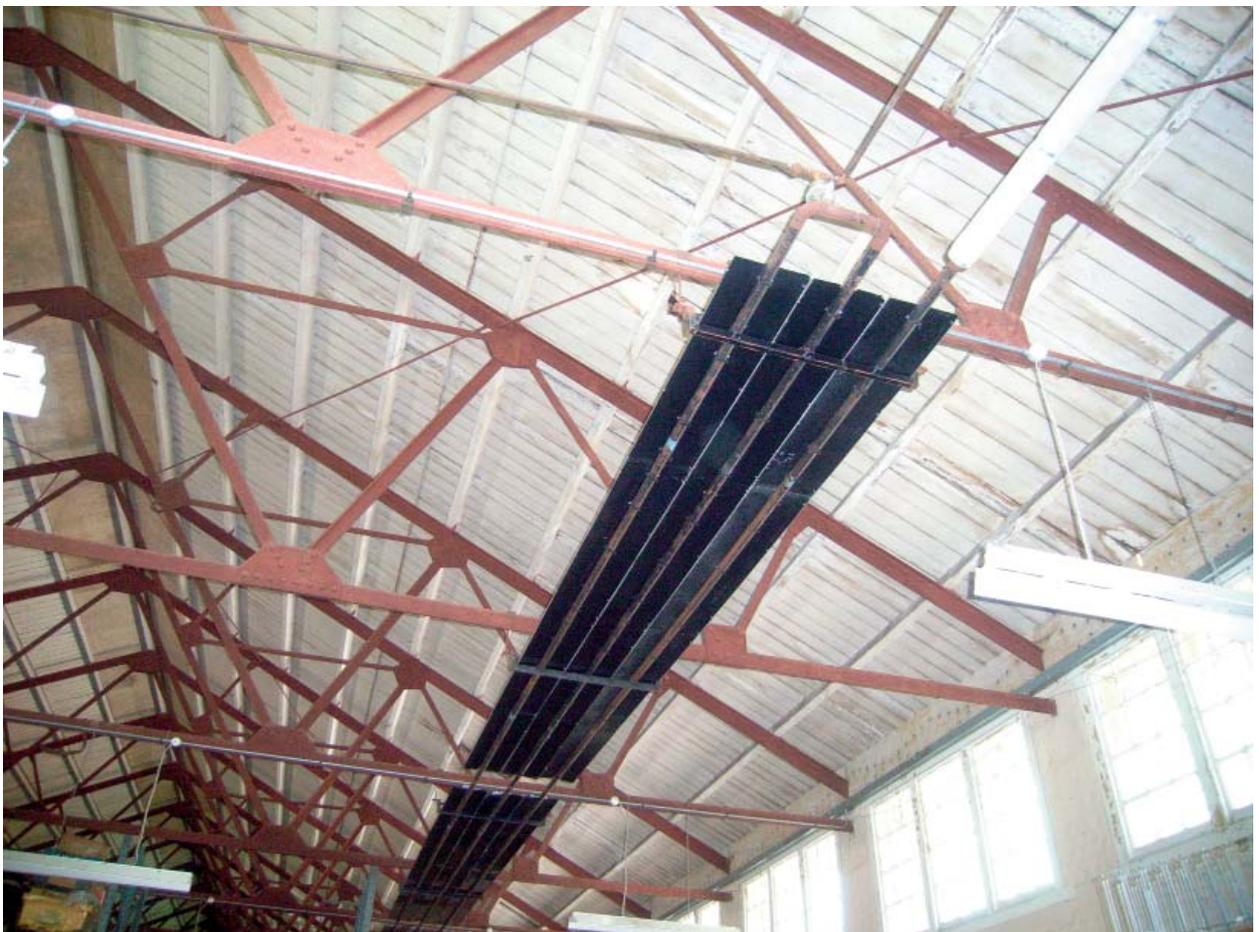
Plate 24: Heating racks on roof

- 3.2.8 Three sets of *heating pipes* extend along the length of the building, suspended just beneath the tie-beam of each truss (Pl. 24). Each of these comprises three hot water pipes grouped together and set immediately beneath black, sheet metal plates that would have helped to reflect the heat from the pipes down into the room. At each end of the building there are lateral pipes against the wall and at the east end the pipes connect to the boiler room. This heating system was almost certainly added when the Riding School was converted (1940s?) and it is interesting to note that OA has recently noted a similar type of system in a railway carriage shop at the Old Oak Common depot in West London. This railway building was constructed in the mid 1930s and the heating system was intended to help dry the painted carriages.

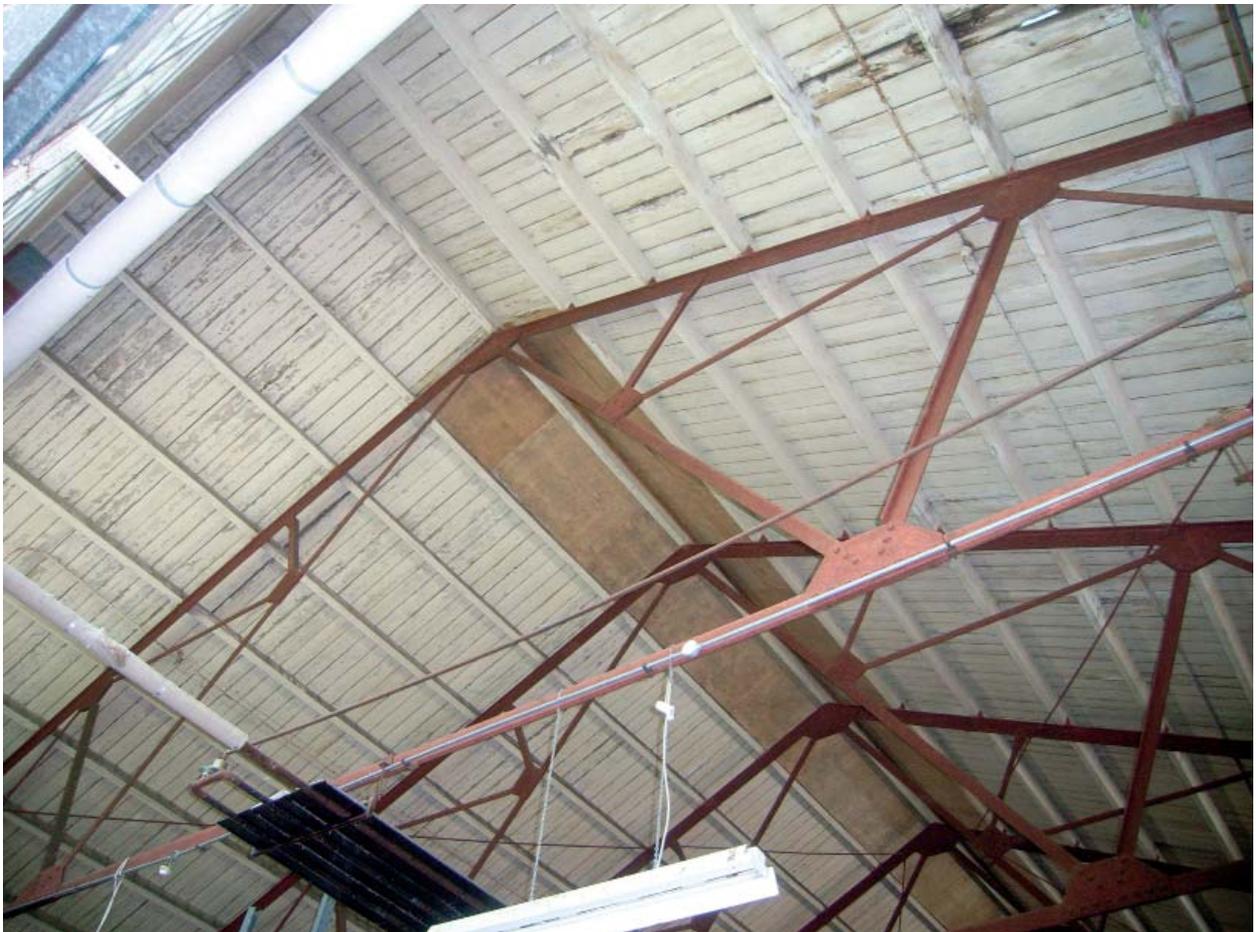
Plate 26: Typical roof truss

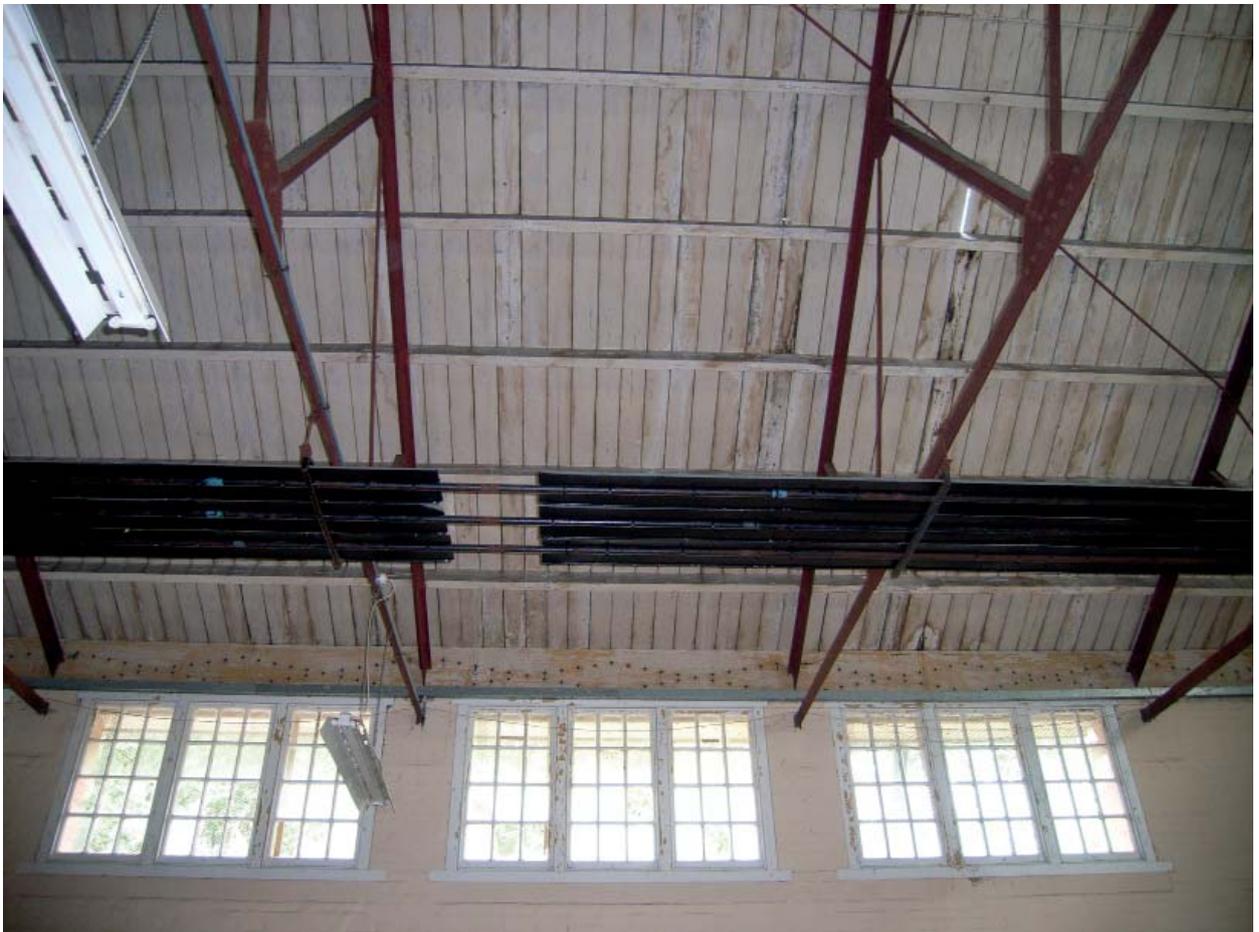
Plate 28: Roof detail

- 3.2.7 At the eaves there is a fascia board which hides the ends of each truss and there is a criss-cross pattern of small ventilation holes drilled in this board similar to the pattern in the external eaves board noted above (Pl. 28). Presumably when it was a riding school the

building would have had a moist atmosphere and ensuring adequate ventilation would have been important.
