The Garden Building Lincoln College Oxford

Historic Building Investigation and Recording

April 2013

Client: Stepnell Ltd for Lincoln College, Oxford

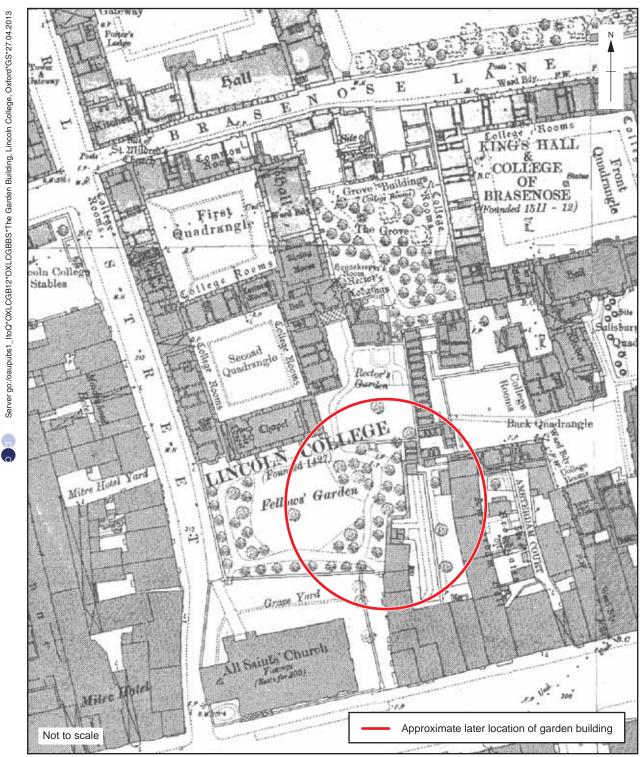
Figure 2: 1876 town plan, showing approximate later location of garden building

- 2.2.2 The Fellows' Garden was established in c.1808 by the demolition of a number of buildings on the east side of Turl Street known as Rotten Row and it is clearly shown on the Ordnance Survey 1:500 Town Plan of 1876.

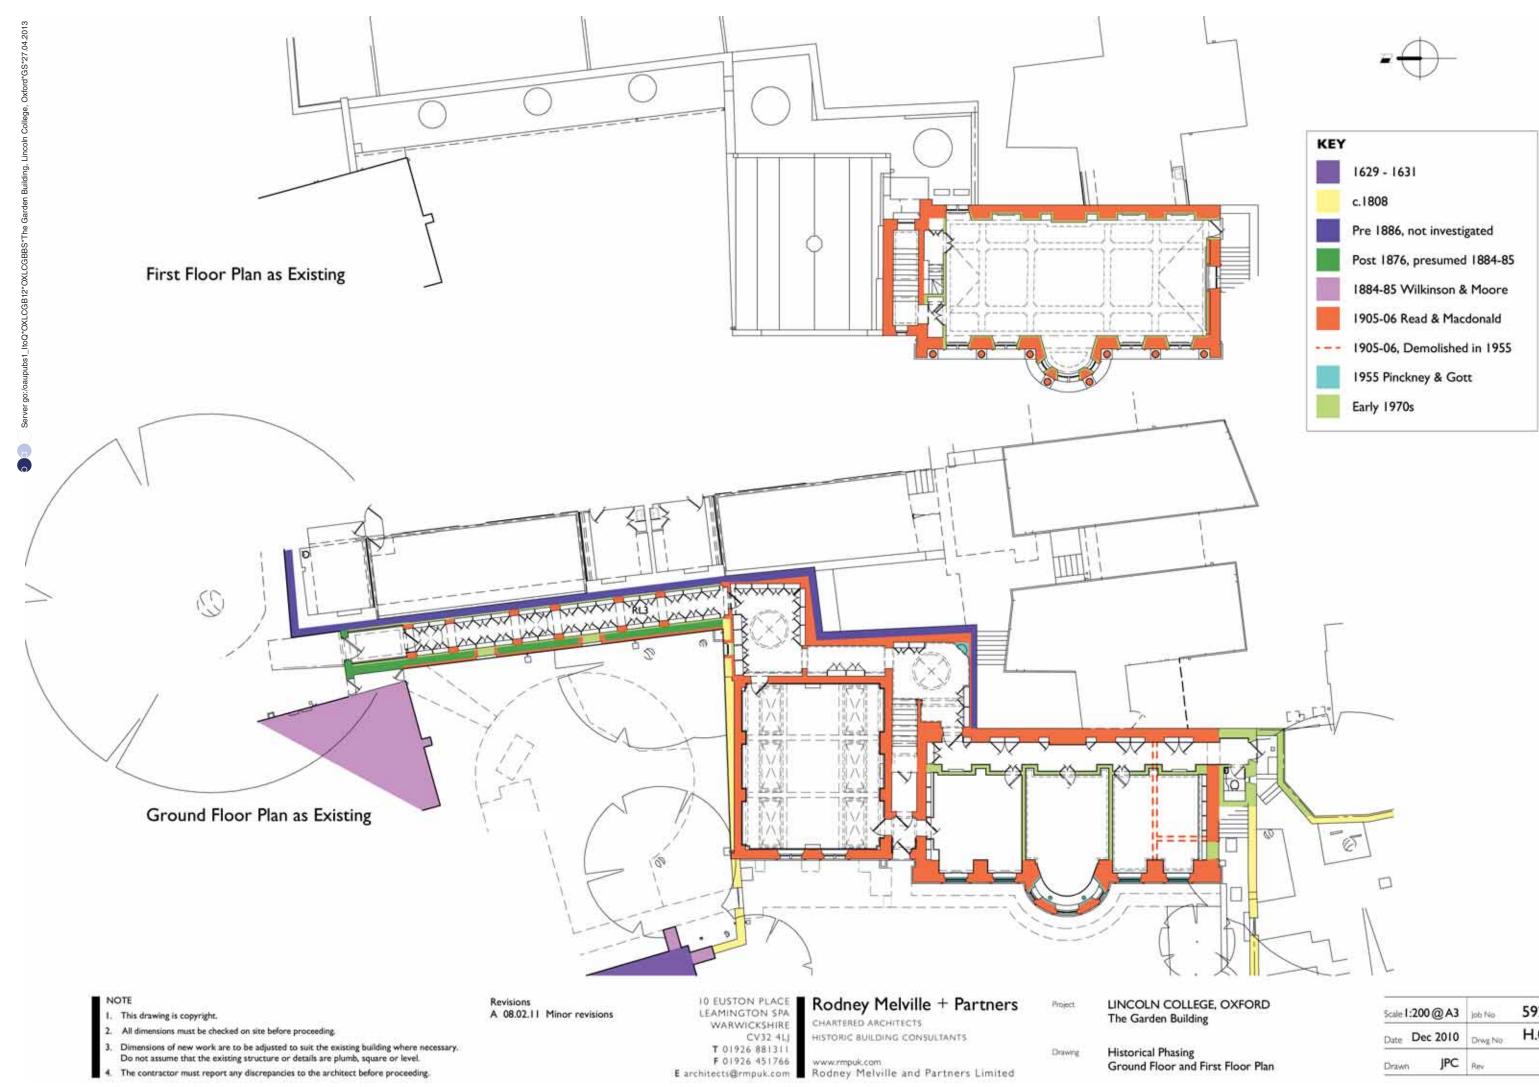
Figure 3: Phased floor plans taken from 'A History of the Garden Building Lincoln College, Oxford' by Rodney Melville & Partners

- 2.2.4 The new building comprised two distinct blocks separated by a flight of stairs up to the first floor and connected by a corridor at the rear. To the south was the two storey main block which housed the Modern or Junior Library on the ground floor together with the Senior Library above while to the north was the single storey Lecture Room.

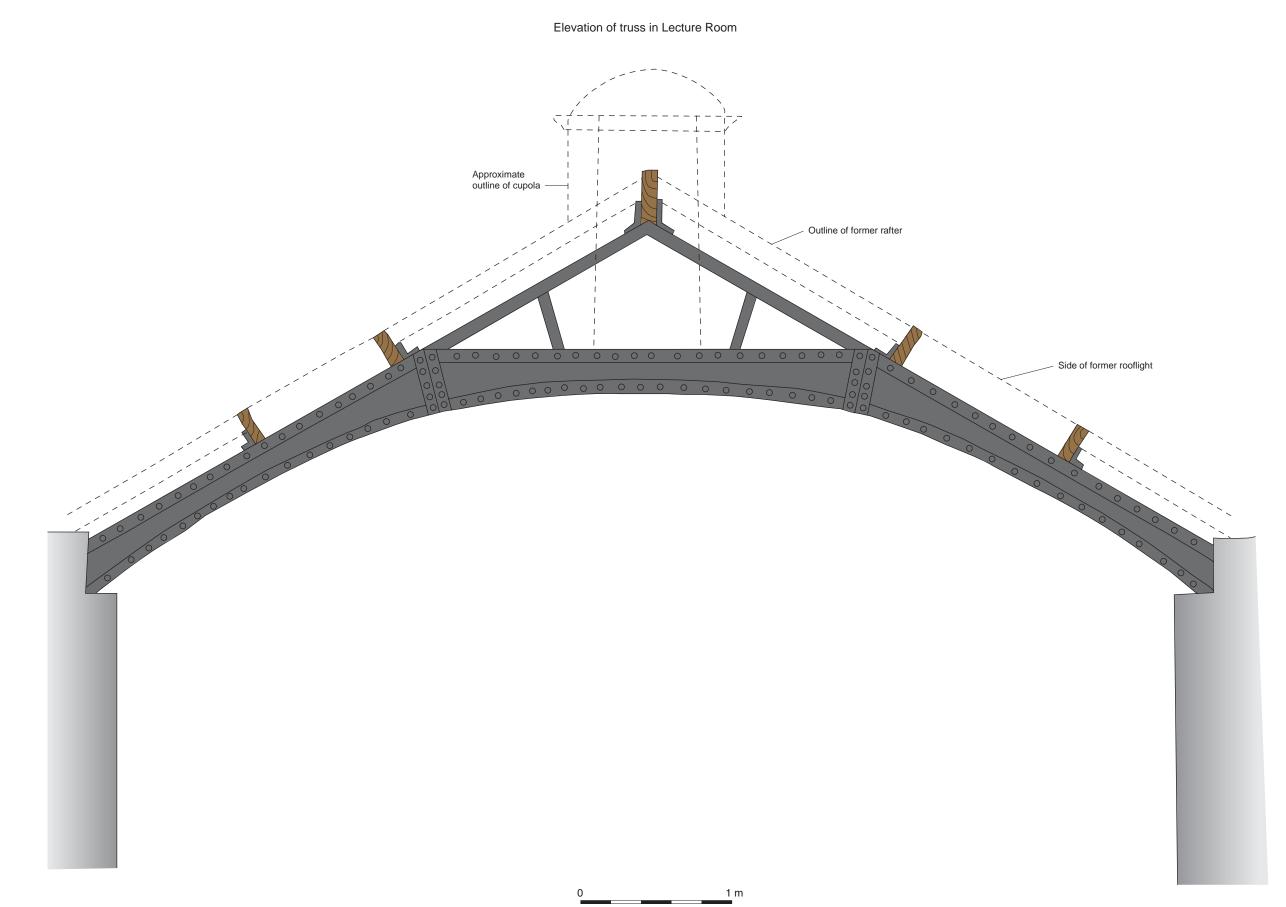
Figure 5: Section through roof of Lecture Room

3.3.11 The arched outline of two curved trusses are visible in the ceiling, clad in boarding, beneath the main sloped ceiling which is painted a light pink colour. Recording was undertaken during the dismantling of the roof and this revealed valuable evidence relating to the construction of the trusses. The two trusses are formed from steel with softwood purlins (x 2), rafters and cladding around the arches. The principal rafters are formed from two coupled lengths of L-section steelwork although only one of these extends up above the uppermost purlin to the apex. The two purlins each rest on a small steel bracket on the top of the principal rafters and there is a similar steel bracket at the apex securing the ridge piece. The underside of each truss is formed from an arched steel band (16 cm wide x 1 cm tall) which is encased in softwood cladding and with a steel flange between the band and the rafter. There are two small raking steel struts in the uppermost section of the truss formed from L-section steel.

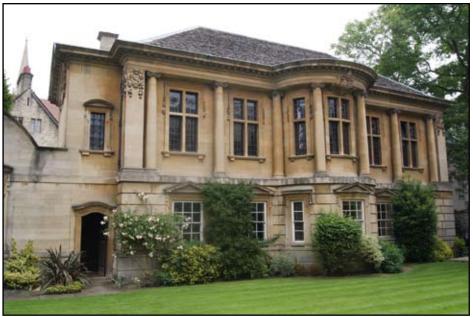
Plate 1: West side of Main Garden Building from Rector's Garden

- 3.2.2 *Main range front*: The main building's front (west) elevation has a rusticated ground floor beneath a first floor articulated by Ionic columns set between square-plan columns (or antae) at the edge of the elevation. The central bay of the elevation is a large bow with flat roof and at the centre of this is a carved-stone Lincoln College crest which is draped over the entablature. The elevation is also adorned with various other garlands and motifs (described by Pevsner as 'very sparingly used') including beneath lugs to the architraves of the upper windows and above inverted lugs to the lower windows. A mitre is incorporated into to the garland on the side of the northern *anta* (a Greek corner pilaster), just below the capital while on the west face is a garland incorporating the Lincoln Imp. There is a pelican in the corresponding anta at the southern end of the elevation.²

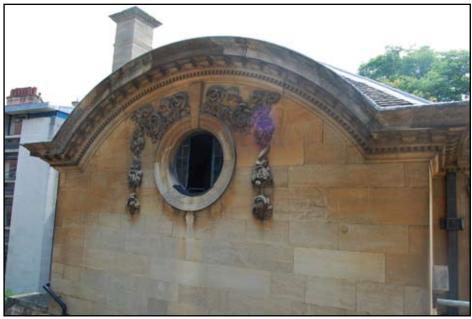
Plate 3: North face of main Garden Building

- 3.2.5 The upper part of the north face of the main building is visible above the single storey block and this largely plain ashlar wall includes a large bulls-eye window in the segmental arch gable with an elongated keystone, moulded surround and garlands to each side. It is interesting to note that the lower section (c.1.2 m) of this wall is constructed from coursed, roughly dressed stonework in contrast to the much finer ashlar above. This distinction is clearly simply due to this area being entirely hidden from view, behind the gable and roof of the single storey range, rather than it being indicative of an earlier structure forming the base of this wall.

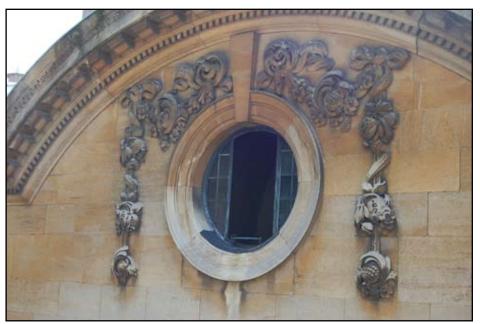
Plate 4: Bulls-eye window and garlands in north side of main Garden Building

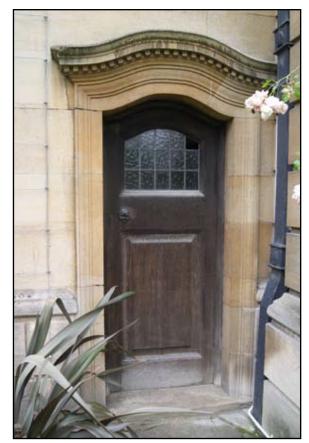
Plate 5: Main door in west wall

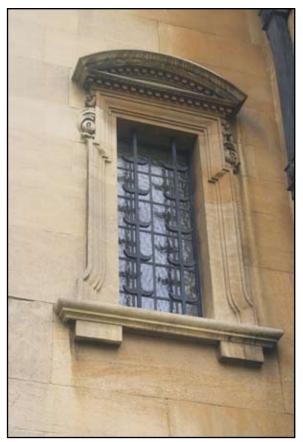
Plate 6: First floor window in west wall

- 3.2.3 There are five main windows to each floor, together with two further flanking windows at each level of the bow. The upper windows have stone mullions and transoms as well as plain lugged architraves and stone sills supported on plain brackets. The ground floor windows are beneath pediments and these are secondary windows replaced in the 1950s to allow more light into the lower library. The replacement windows are 6-over-6 sashes to the main lights and 3-over-3 sashes to the side lights in the bow. Early views of the building confirm that the original lower windows had stone mullions similar to those on the upper floor but they were lower and did not have transoms.

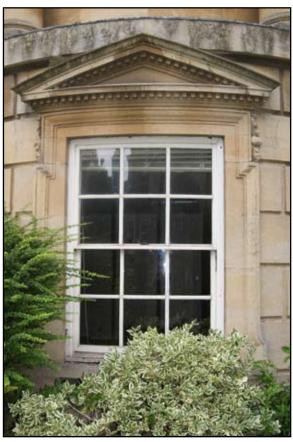
Plate 7: Replaced ground floor window in west wall

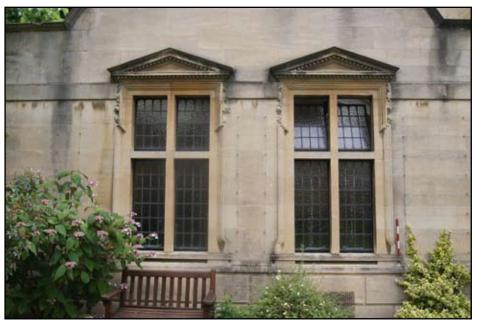
Plate 11: Windows in west wall of former lecture room

- 3.2.8 The west elevation of the former lecture room is again of fine ashlar and there is a low rusticated plinth beneath sill level. There are two stone mullion-and-transom windows and the first floor string at the base of the *piano nobile* in the main building is carried through this elevation at the head of the windows. Directly above this are pediments above the windows and a plain segmental arched gable. The two windows again have inverted lugs to the architraves and garlands above these.

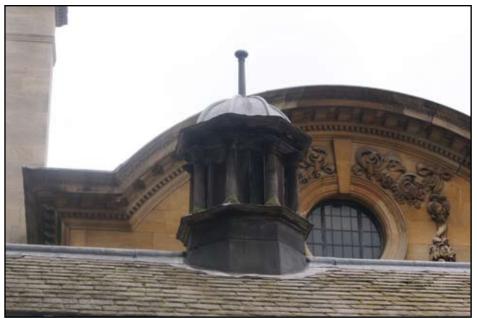
Plate 13: Cupola on roof of former lecture room

- 3.2.7 This louvre is octagonal in plan and with a domed, lead covered roof with a projecting pinnacle at its centre. The louvre has timber doric columns around its edge which encircle a square plan metal duct that carries air from inside the building. Observations were made during the demolition of the roof and this confirmed that the louvre was set on an octagonal, lead-lined timber box on top of the primary rafters and that the dome was constructed with very short timber rafters. It appears that warm air from inside the building would have gathered at the top of the louvre and then dissipated from narrow gaps in the structure just beneath the dome.

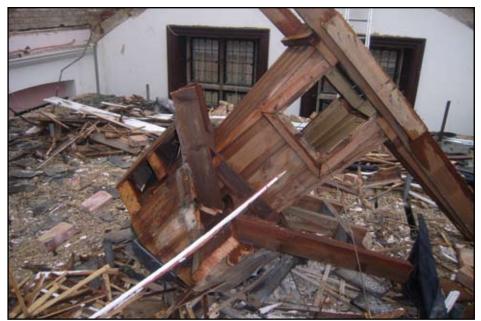
Plate 17: Ex-situ cupola structure during demolition

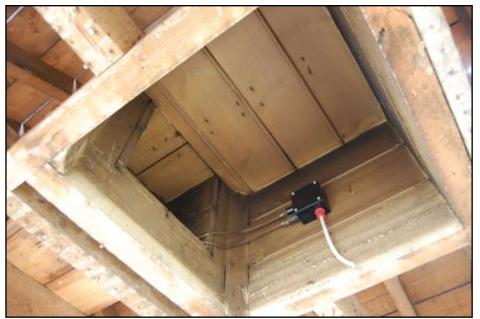
Plate 45: Underside of duct in ceiling of lecture room

these ducts had a covering to the ceiling (presumably a metal grille) but these had been removed prior to the current work. The central duct extends vertically and tapers in section up to the louvre on the ridge of the roof whereas the two flanking ducts connect to a horizontal duct along the spine of the building which links to the main vertical duct. All these ducts are clad in tongue and groove boarding.

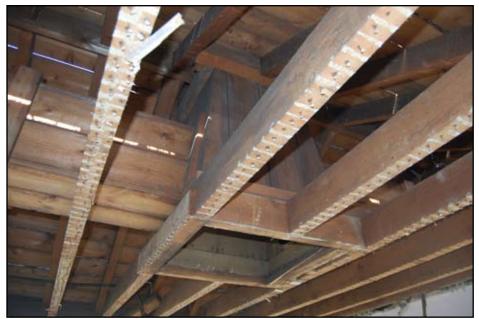
Plate 46: Duct in ceiling

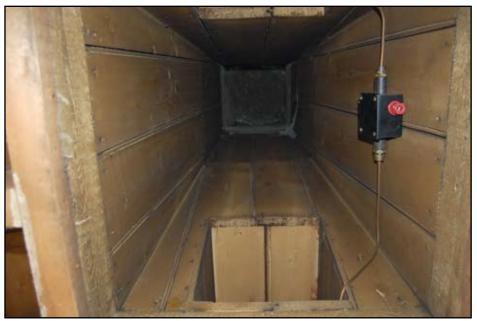
Plate 47: Vertical duct rising to cupola

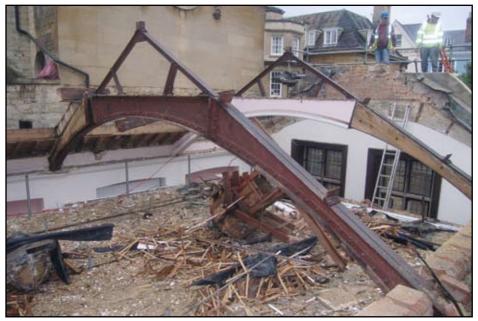
Plate 48: Roof of former lecture room during dismantling

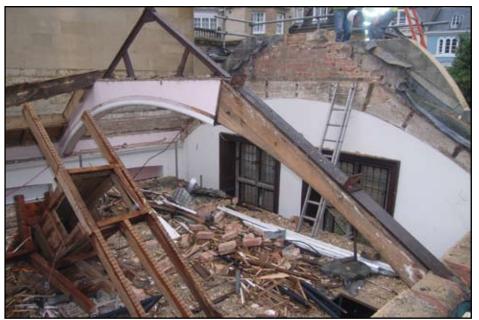
Plate 49: Roof of former lecture room during dismantling

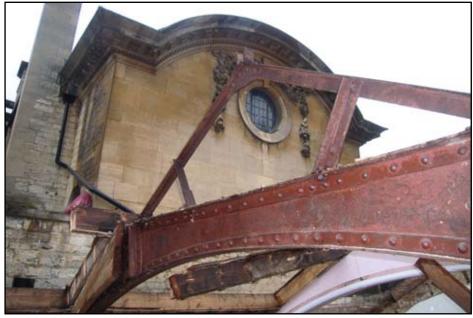
Plate 51: Truss in former lecture room

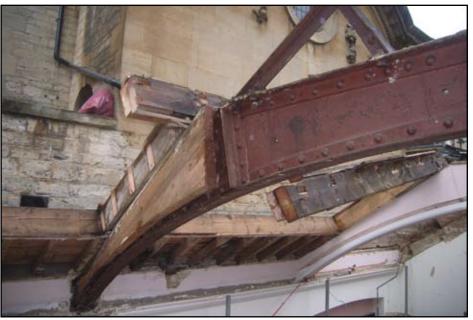
Plate 52: Truss in former lecture room

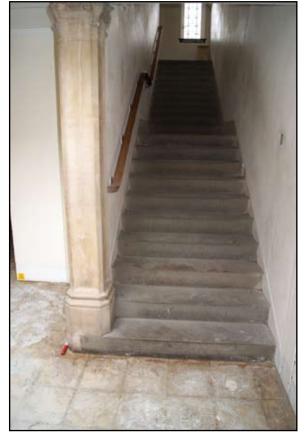
Plate 61: Stairs between main building and former lecture room

- 3.3.19 The staircase is a single flight of stone steps between the two ranges and there is a single handrail on the south side. The stairs are illuminated by a bullseye window in the east wall and by a leaded light casement window at the head of stairs. The foot of the stairs is decorated by a square stone column with decorative capital.

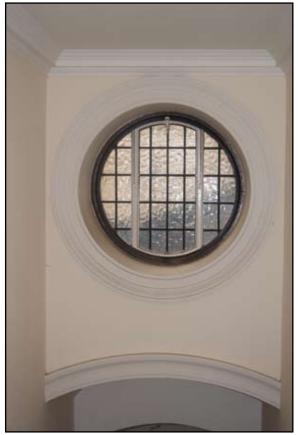
Plate 63: Bulls-eye window above stairs
