Manor House, 2 Main Street, Coveney

Archaeological Evaluation Report

October 2017

Client: E Palmer & Sons Limited

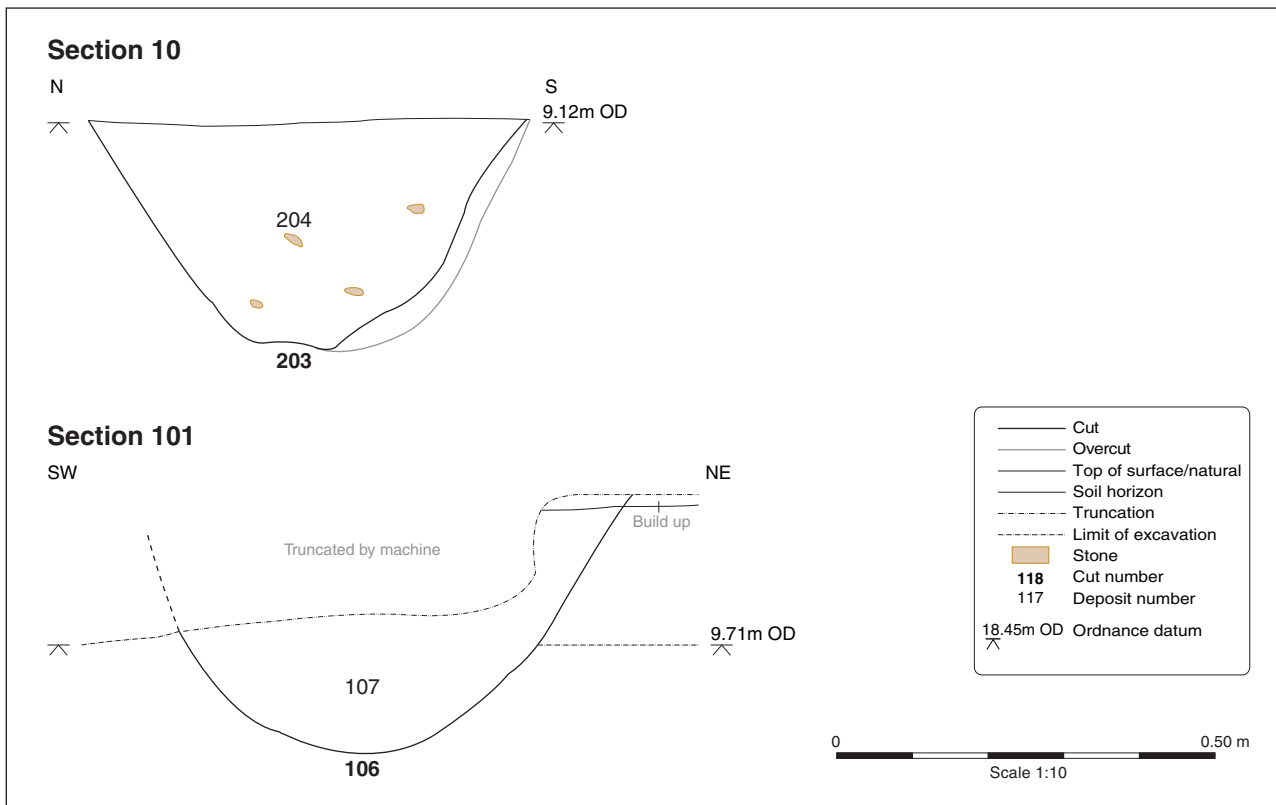
Figure 3: Selected sections

- 3.4.2 Ditch **106** was the southernmost feature in the trench. The ditch was aligned north-west to south-east, perpendicular to Main Street. It measured 0.45m wide and 0.34m deep, and had steeply sloping sides with a concave base (Fig. 4, Section 101; Plate 4). The ditch was filled with a single deposit (107) of mid grey silty clay that contained four fragments of broken field drain (884g) and six pieces of post-medieval to modern tile (199g). The ditch is a continuation of ditch **207** in Trench 2.

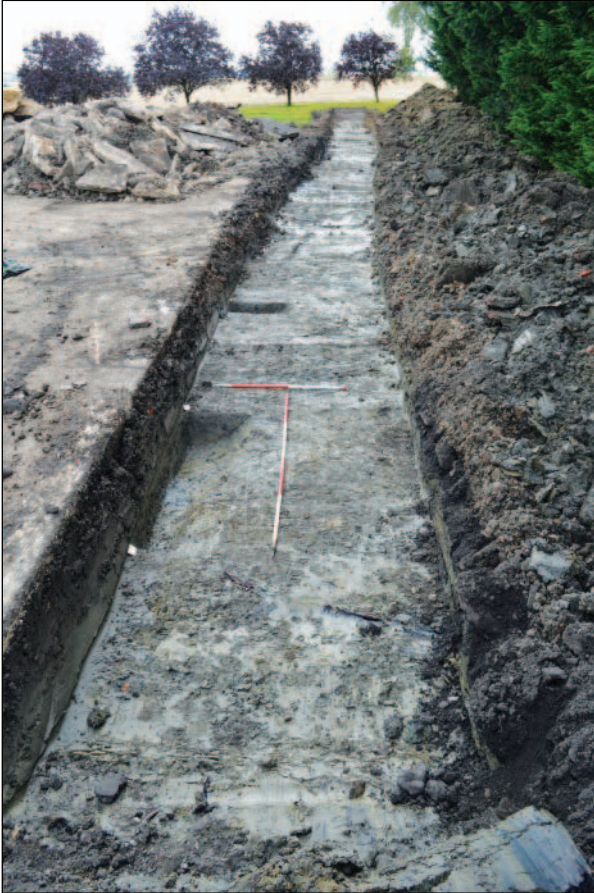
Plate 1: Trench 1, viewed from the north-east

- 3.4.1 Trench 1 (Plate 1) was located in the west of the site, in the yard area of the Farm parallel to the Main Street. This trench revealed five distinct features, all of which were sealed by made ground deposits and the patchy subsoil.

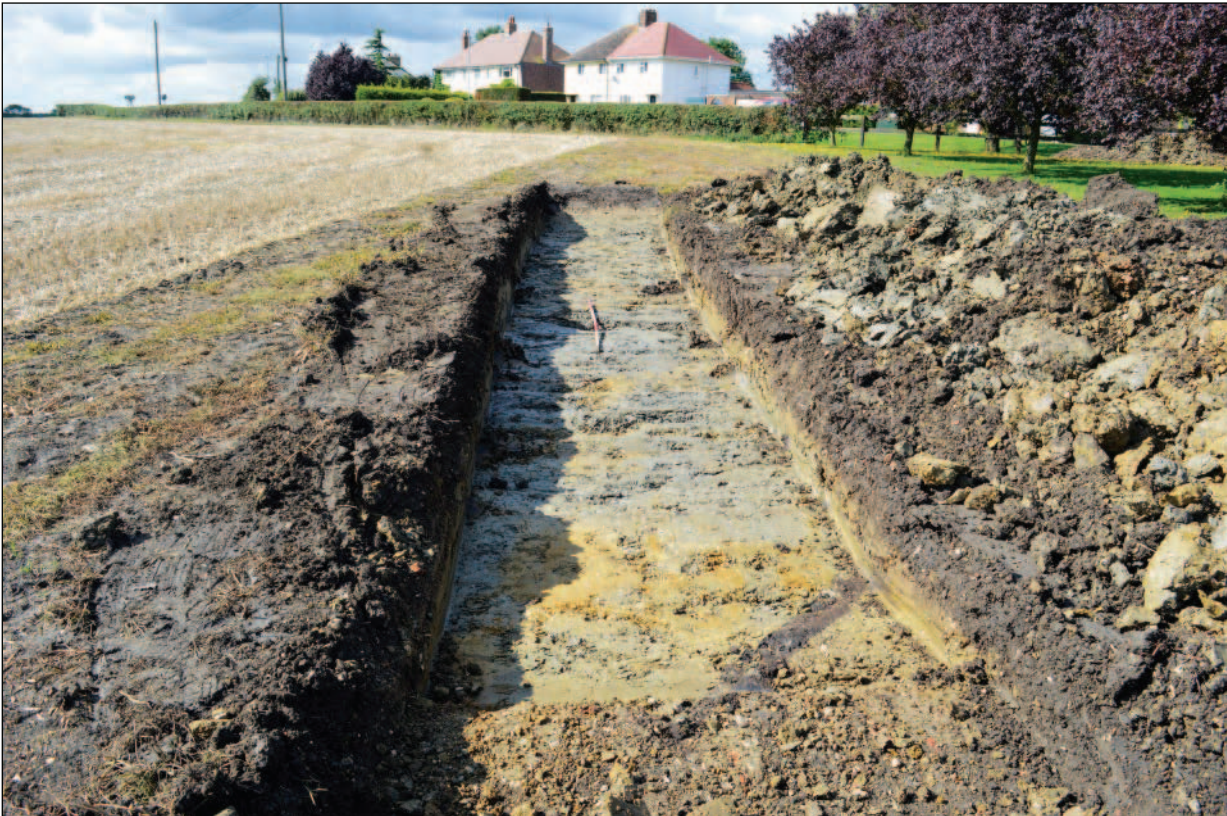
Plate 3: Trench 3, Viewed from the east

- 3.3.1 Archaeological features were present in Trenches 1 and 2 (Fig. 3); these are described below. Trench 3 (Plate 3) was devoid of any archaeological features and had a single north-west to south-east aligned modern field drain at the eastern end.

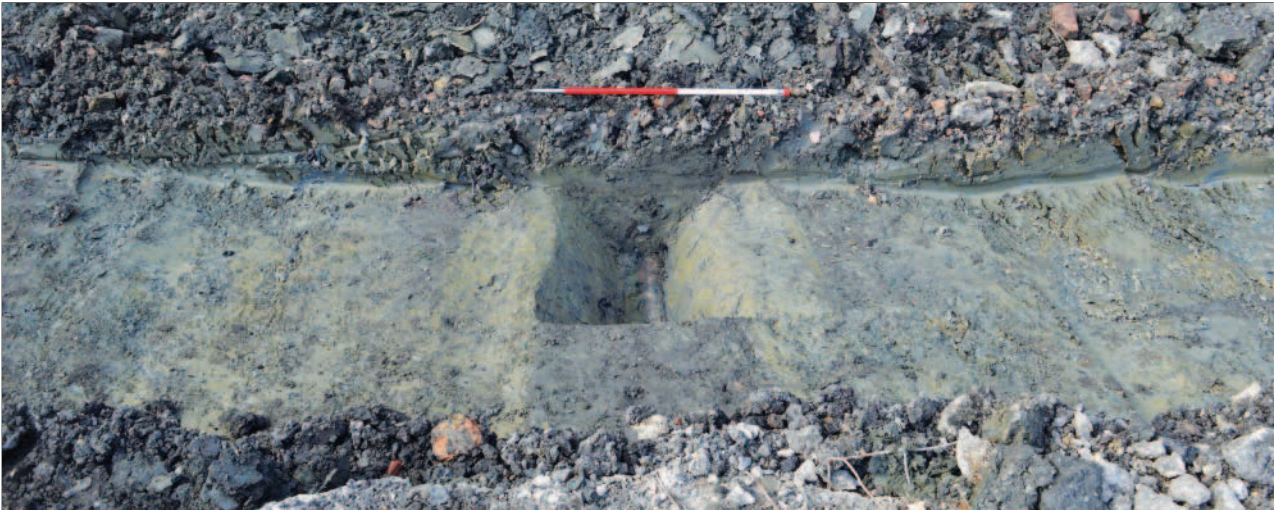
Plate 5: Feature 110, viewed from south-east

- 3.4.4 Ditch **110** was located to the north of ditch **108**, and shared the same alignment as ditches **108** and **106**. The ditch measured 0.75m wide, 0.50m deep and had steep sides

and a concave base (Plate 5). The ditch held an intact 0.10m diameter (4 inch) clay field drain at the base of the cut, and was filled with mid grey silty clay. Five fragments of post-medieval to modern tile and brick were recovered from the fill of the ditch (160g).

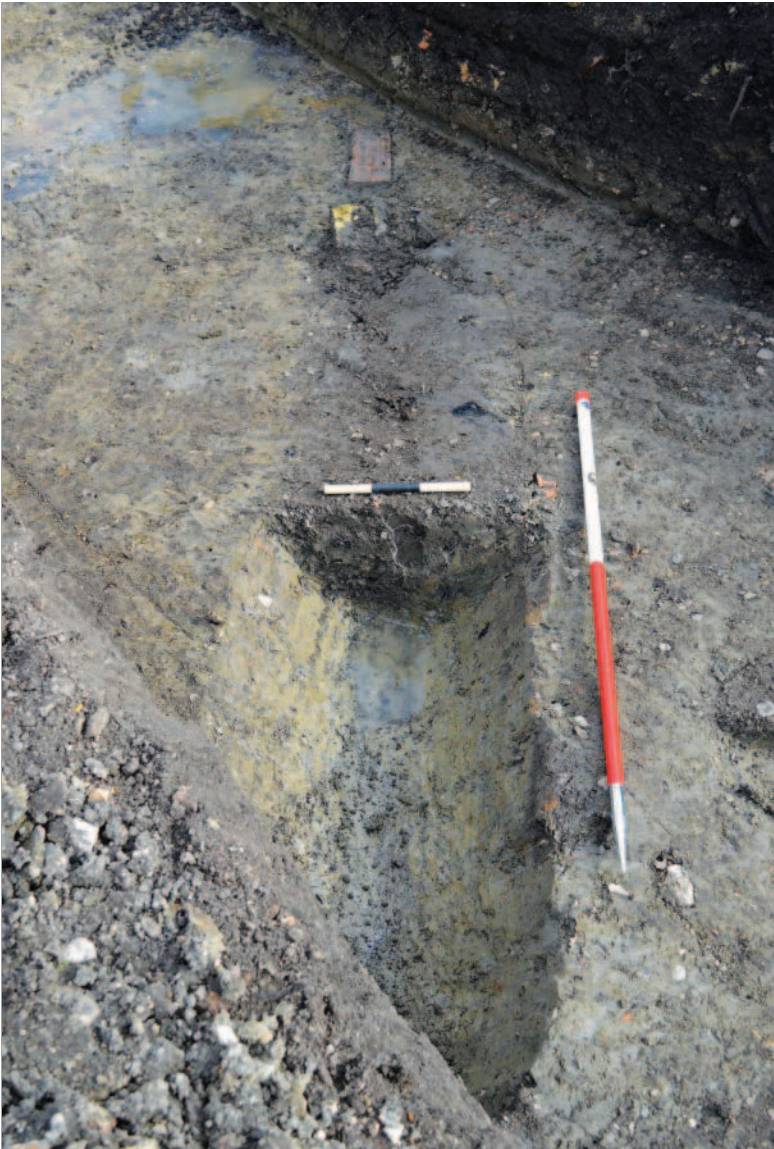
Plate 6: Feature 203, viewed from the north

- 3.5.2 Ditch **203** was located at the eastern end of the trench and was aligned north-west to south-east, perpendicular to Main Street. The measured 0.58m wide, 0.30m deep and had steep sides and a flat base (Fig.4, Section 10; Plate 6). The ditch was filled with a single deposit of mid grey silty clay (204) which yielded a stem fragment of 19th century clay tobacco pipe (2g) and a single sherd of 19th century white refined earthenware pottery (4g). The ditch is a continuation of ditch **108** in Trench 1.

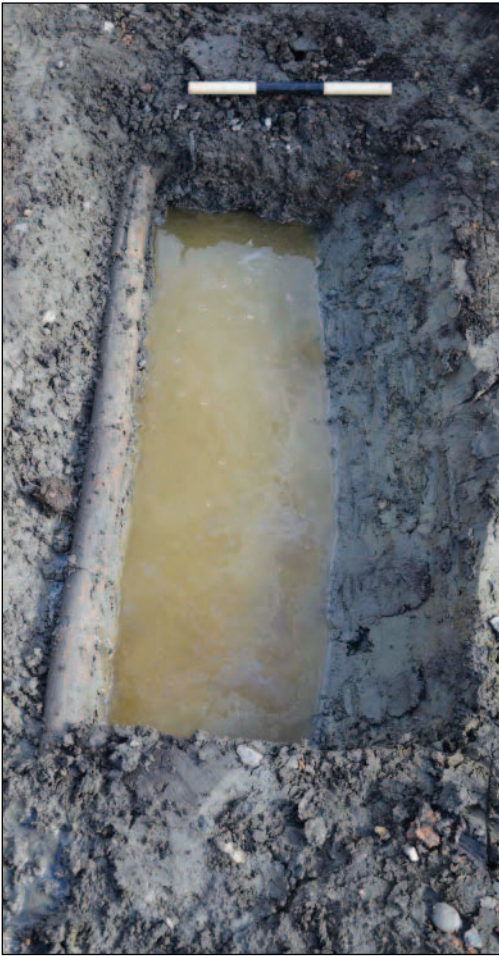
Plate 7: Feature **207**, viewed from the north-west

- 3.5.4 Toward the centre of the trench was ditch **207**. The ditch was 0.5m wide, 0.2m deep and had moderately steep sides and a V-shaped base (Plate 7). The ditch held an intact 0.05m diameter (2 inch) clay field drain, and was filled with mid grey silty clay (208). The ditch is a continuation of ditch **106** in Trench 1.
