A Medieval Moat at Crows Parlour, Fowlmere Cambridgeshire

Archaeological Watching Brief Report

OA East Report No: 1759

A Medieval Moat at Crows Parlour, Fowlmere, Cambridgeshire

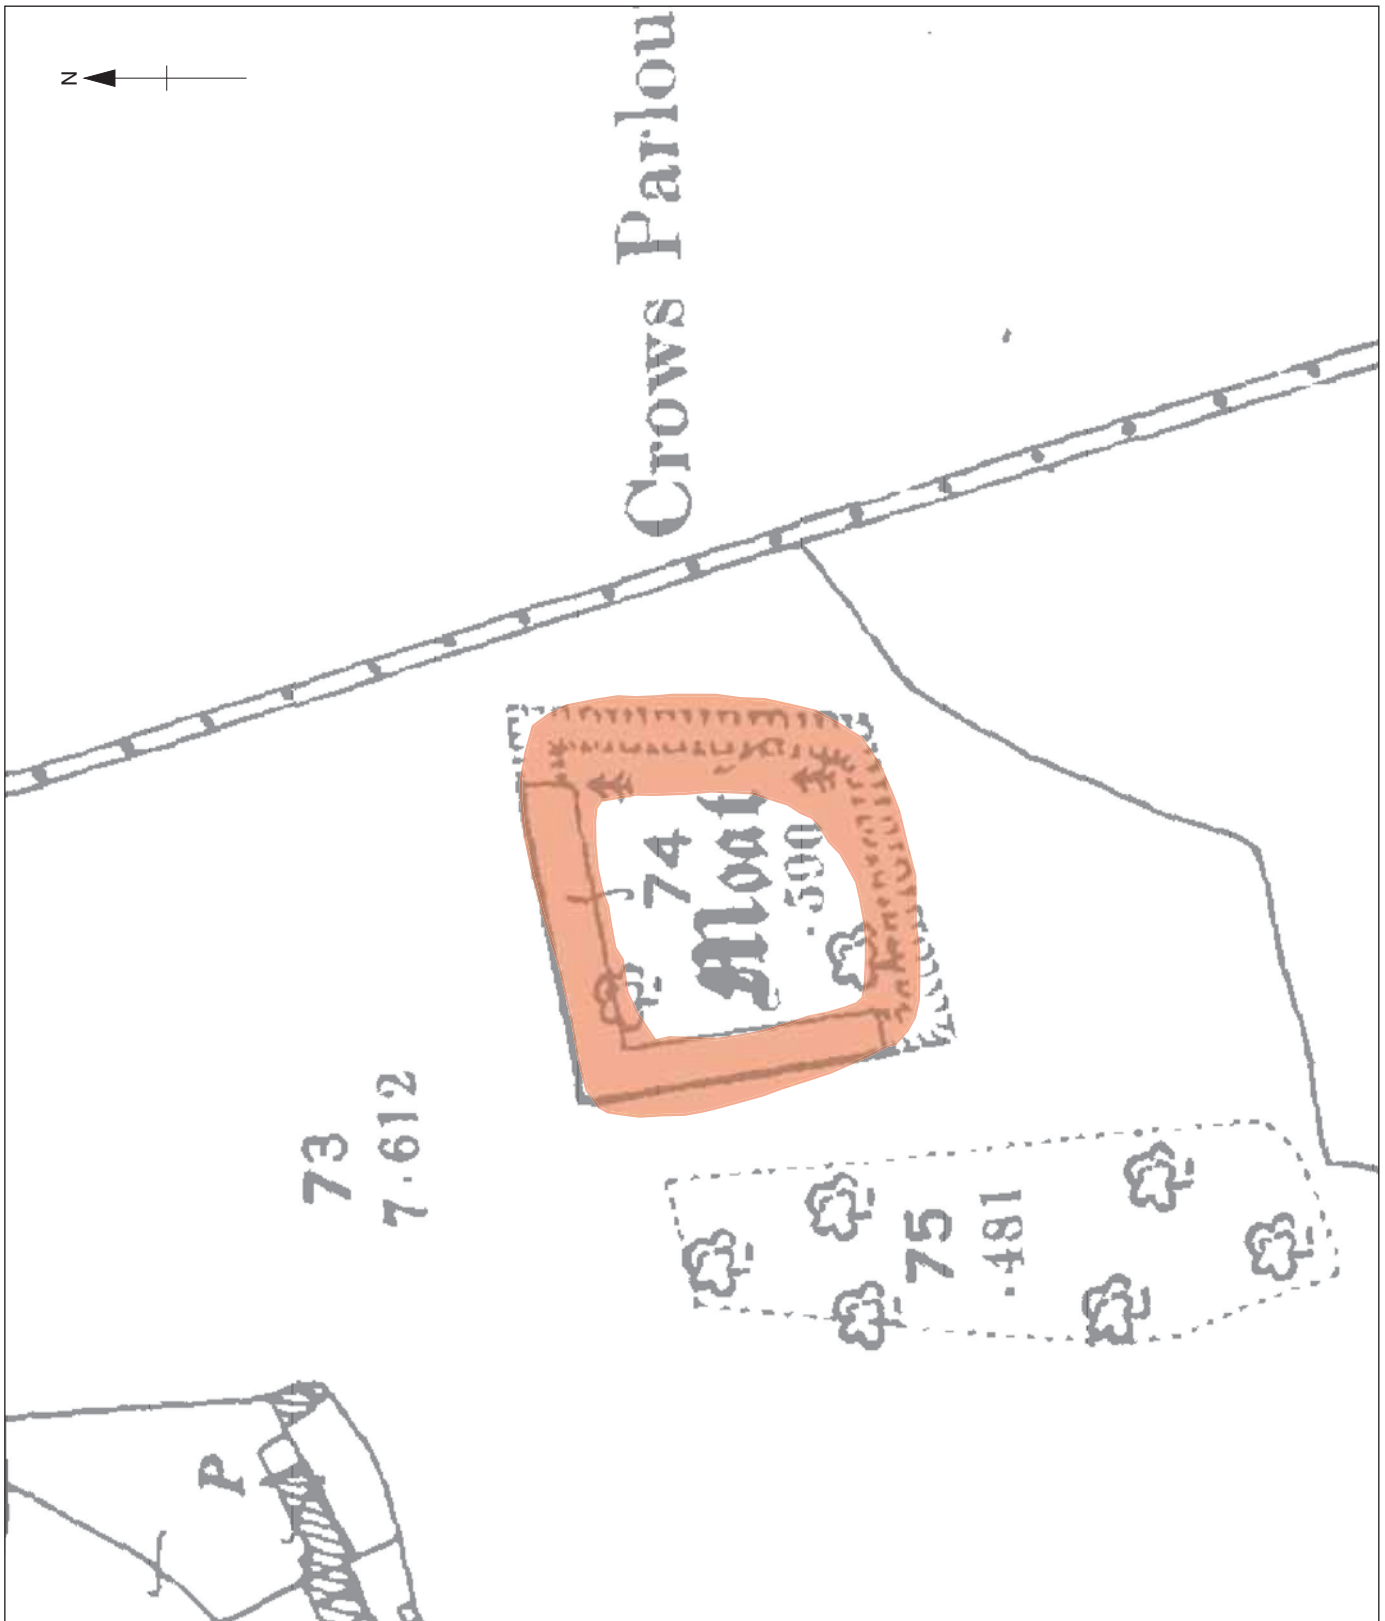
Figure 4: Plan of reconstructed moat overlain on 1903 OS map (Scale 1:1000)

- 4.1.1 The archaeological monitoring has formed part of an agreed programme of works to undertake a (partial) reconstruction of the moat by removing rubbish dumped in the ditch during the 20th century. Along the northern and eastern side of the moat the reconstruction is accurate to the original form. Subsequent boundary changes, however, have meant that the south-west corner now lies outside the plot, which has meant that the reconstructed moat is narrower at this point than the outline of the moat shown on the Ordnance Survey map of 1903 (Fig. 4).

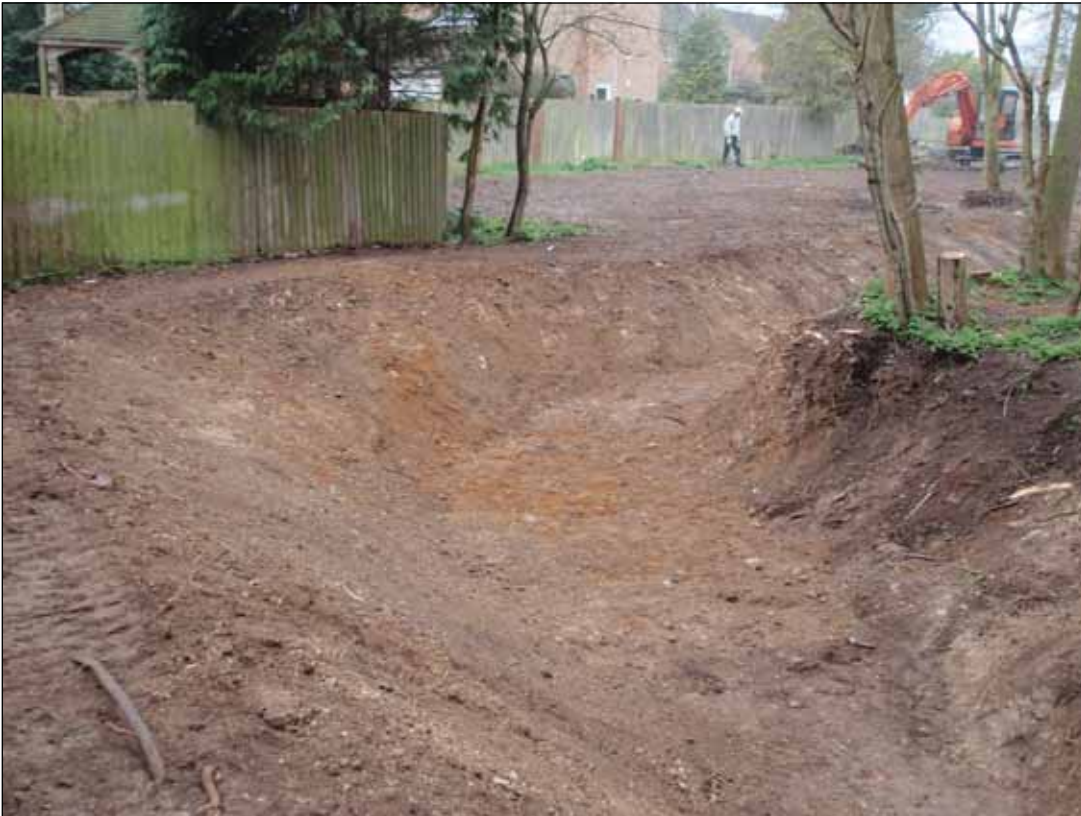
Plate 3: South-eastern corner after works, viewed from south-west

3.3.2 The rubble from the southern arm element of the south-eastern corner of the moat was excavated by mini-digger. Observations recorded that no archaeological deposits were exposed at this point, largely due to the presence of modern boundaries extending within the monument.

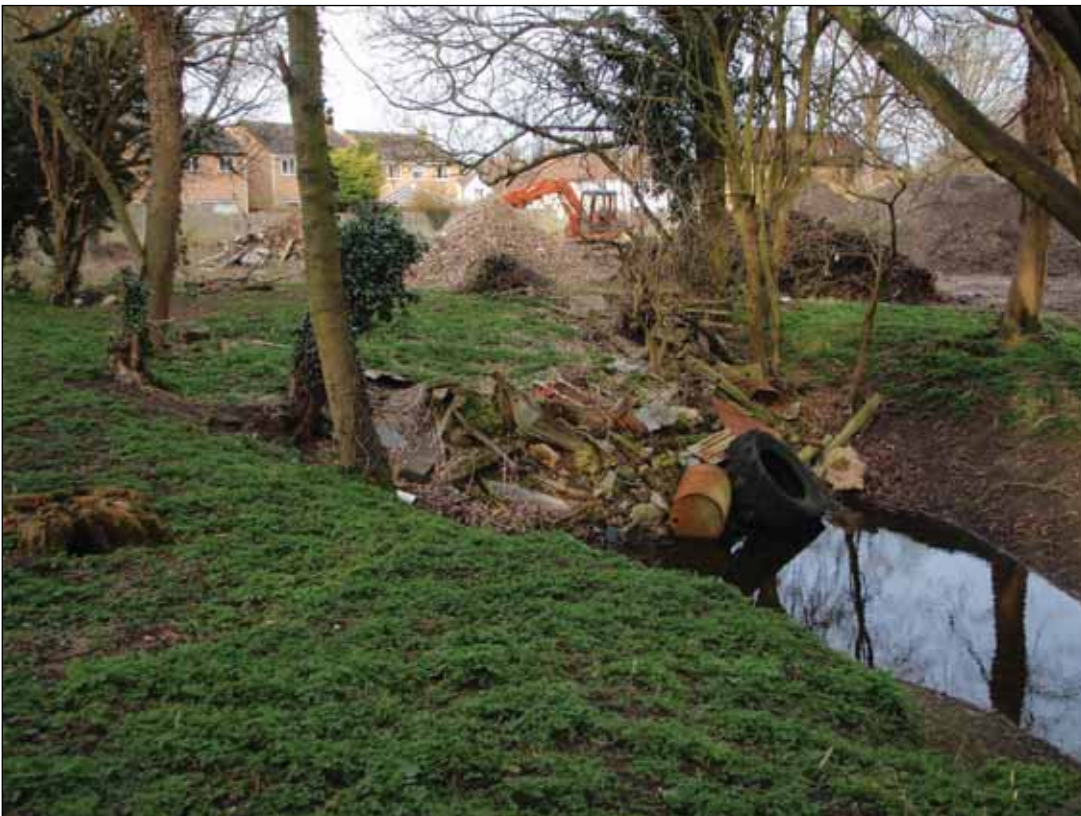
Plate 4: Western arm before works, viewed from west

3.4.2 The deposits that were removed on this arm consisted of a mixture of dark greyish brown clayey silt with brick and mortar rubble (4). No finds other than 20th century objects were observed.
