Mill Road Cemetery Mortuary Chapel; an Archaeological Observation

Archaeological Watching Brief Report

November 2016

OA East Report No: 2005

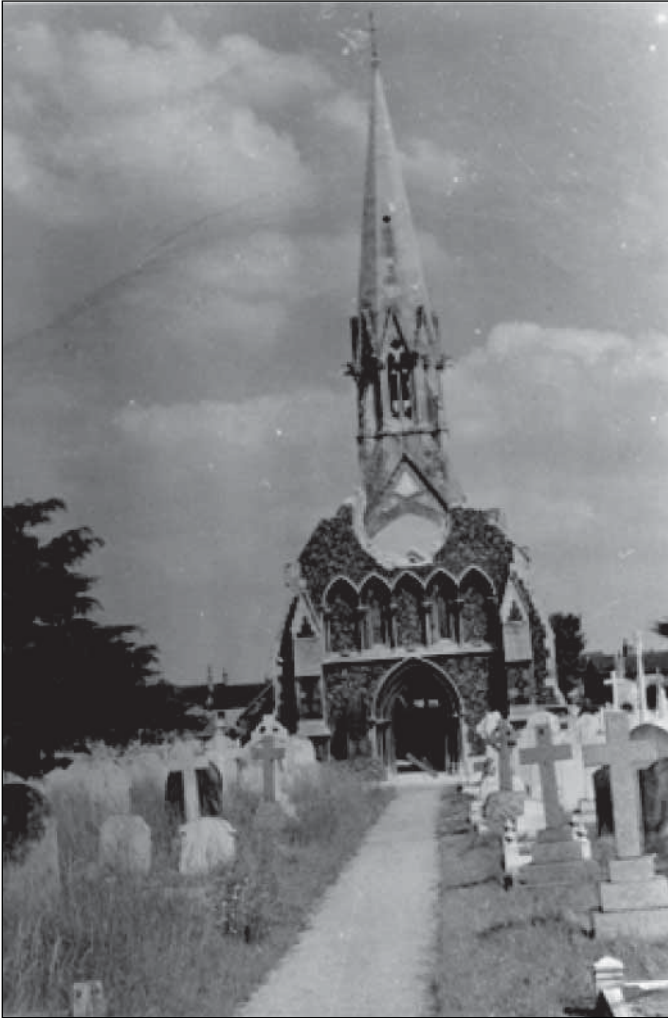
Plate 1: The Mortuary Chapel during demolition, viewed from the west. Courtesy of the Cambridge Collection

Plate 1: The Mortuary Chapel during demolition, viewed from the west. Courtesy of the Cambridge Collection.

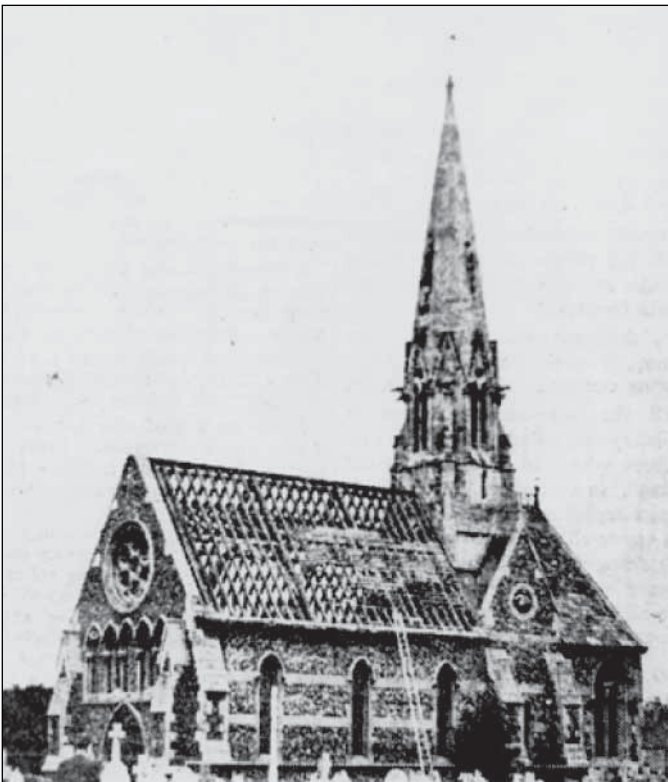
Plate 2: The Mortuary Chapel during demolition, viewed from the south

Plate 2: The Mortuary Chapel during demolition, viewed from the south.

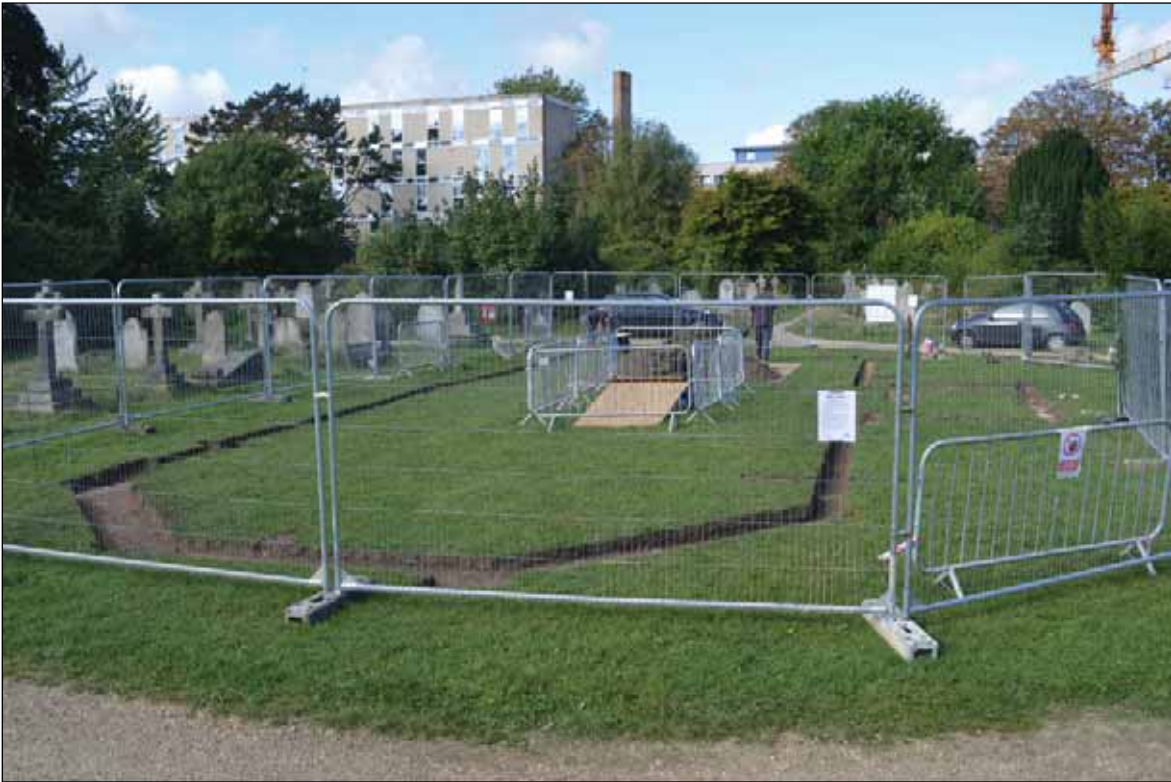
3.4.1 The uncovering of the foundation was positioned over the foundation of the apsidal eastern end of the chapel. It revealed a wall foundation 0.10m below the present ground surface. This wall was 0.98m wide, with an internal brick facing, a core of mortar with flints and an exterior of flints with mortar.

Plate 3: Overview of the chapel foundation trenched. Viewed from the east

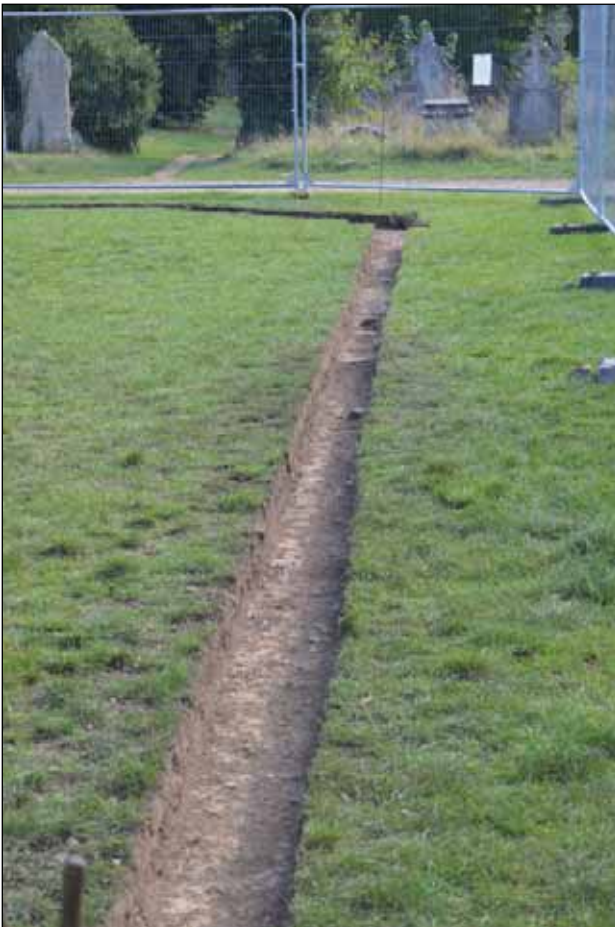
3.5.1 This excavation here revealed the southern wall of the church and associated buttress, which was located 0.19m below the present ground surface. The buttress was just over 1m wide and extended 1.22m from the outside surface of the wall. The exterior of this buttress was faced with brick, and had a mortar core. It was noted by the contractors that the buttress had become separated from the wall, most probably due to the weight of the tower.

3.6.1 This revealed the western wall of the chapel 0.12m below the ground surface. Again a rubble and brick foundation was encountered. This foundation had an average width of 0.95m

Plate 4: Southern wall foundation. Viewed from the west

- 4.3.1 During the uncovering of the southern wall foundations it was noted by Messenger Conservation Ltd that the buttresses that once existed to the north and south of the chapel showed signs of movement at foundation level.
- 4.3.2 The wall foundations and buttresses had splayed slightly at this point. There is a possibility that this movement could have been caused by the extra weight of the larger and more extravagant tower that was erected.
- 4.3.3 The original Scot plans showed a smaller less ornate tower. The added weight of a larger redesigned structure probably necessitated the buttresses to be added soon after the tower had been erected.
- 4.3.4 This could also be a contributing factor to why the life span of the building was so short lived. The addition of the much heavier tower could have caused the foundations to move causing the chapel to become unsafe relatively quickly.

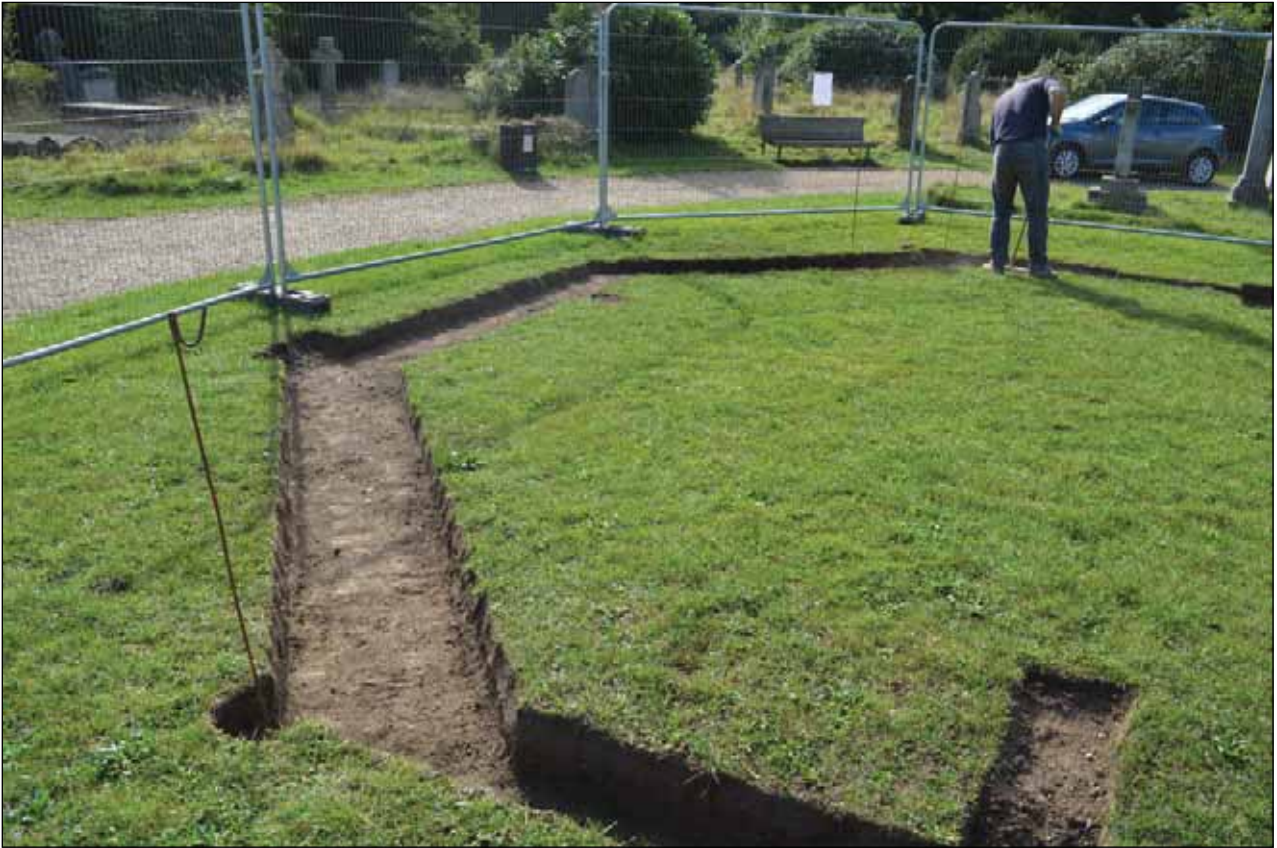
Plate 5: The eastern apsidal end of the chapel. Viewed from the north

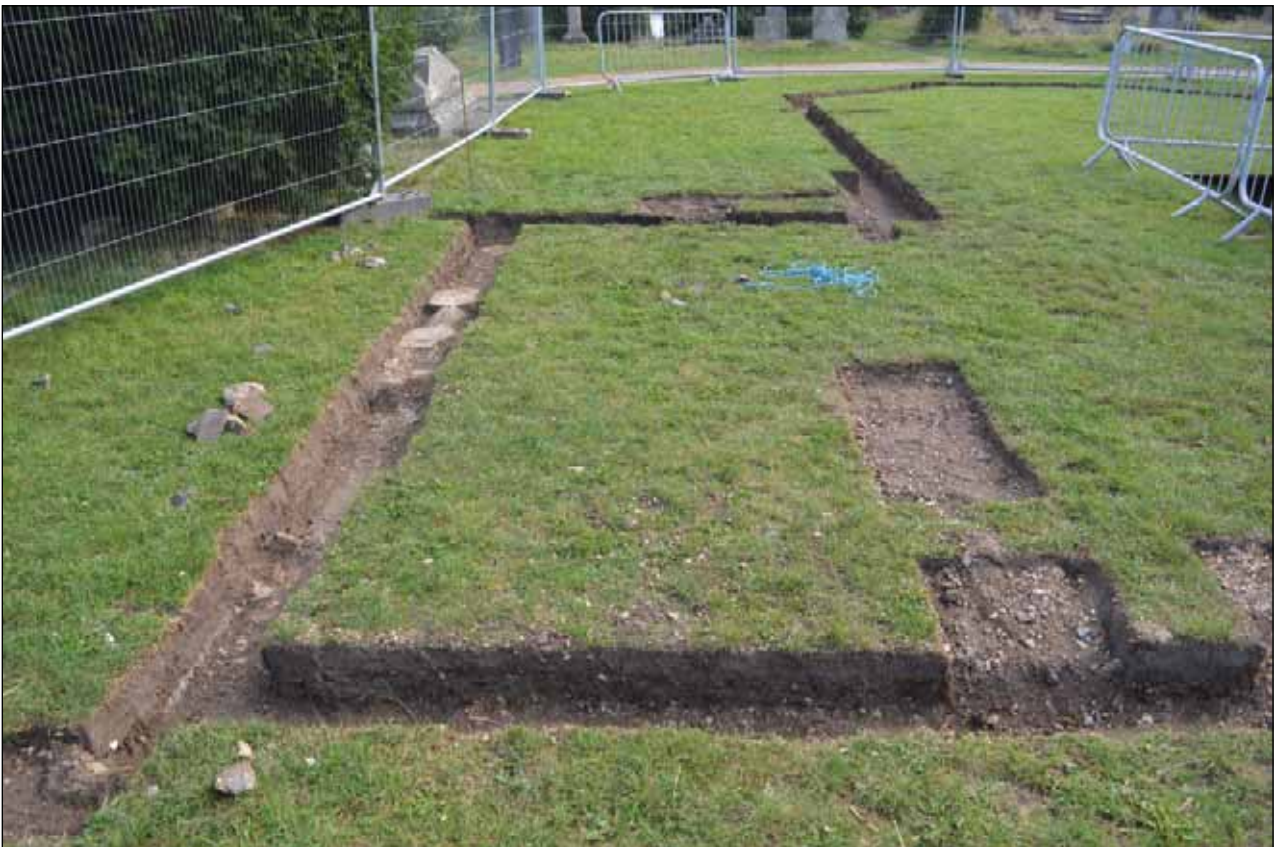
3.3.1 The foundations of the northern end of the chapel north end of the chapel were linear in plan with a width of 0.95m and were uncovered at approximately 0.20m below the turf line. These were in good condition and consisted of a rubble and brick foundation.

3.3.3 A projected area to the north was also uncovered (plate 6). This was first discovered in the test pit evaluation of 2009 (TP1) and was thought to be a separate room located on the north wall of the chapel..

Plate 6: Chapel foundations uncovered. Viewed from the west

- 4.2.1 On the north side of the chapel a protruding room was shown to have a lower floor level than the rest of the chapel. This had resulted in the survival of at least 0.96m of wall which had been faced internally with brick and flint. Set into this was a window, the base of which, as well as part of the architrave survived. The floor surface of this area may have survived.

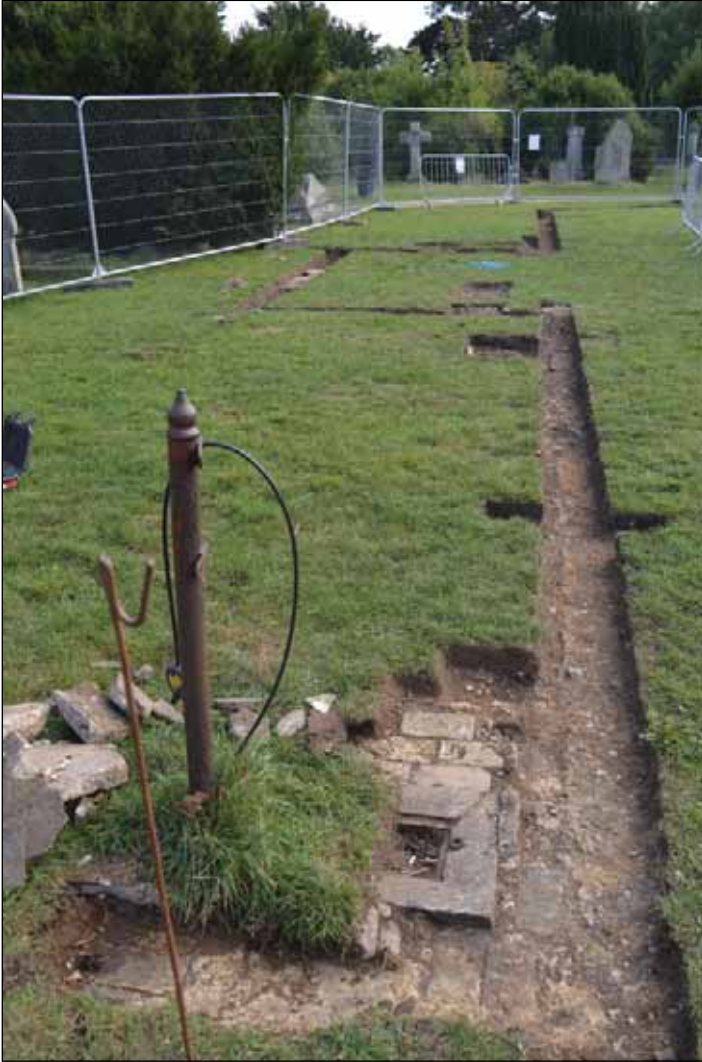
3.3.2 Truncation had been caused to the foundations in the north-west corner by a later foul water drain and post (Plate 7).

Plate 7: The northern wall foundation. Viewed from the west

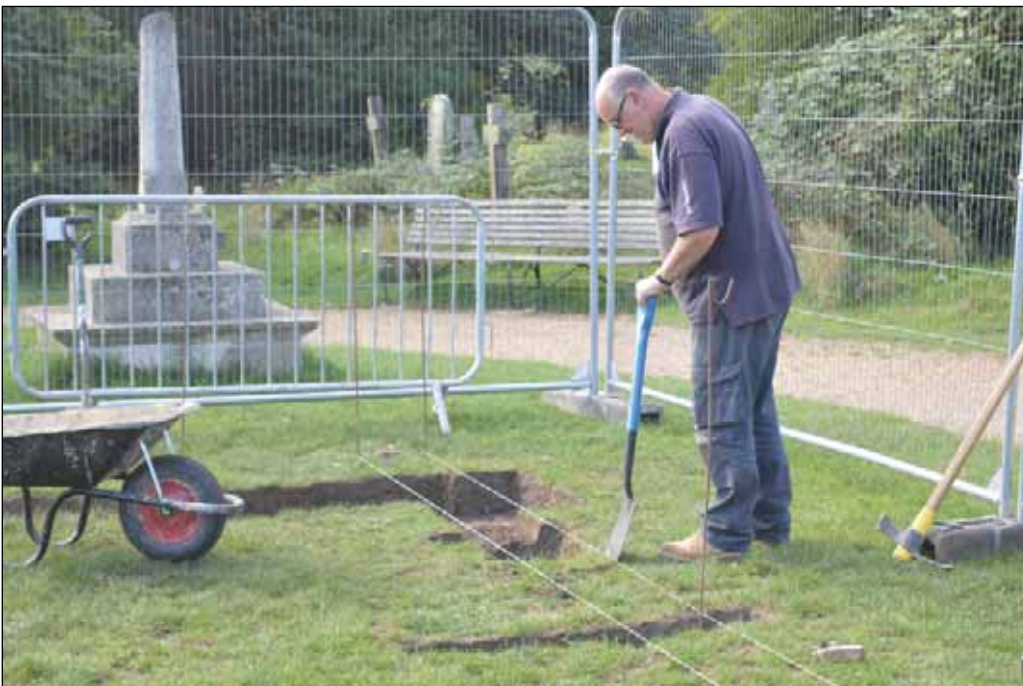
Plate 8: Excavation of the north-western corner of the chapel building

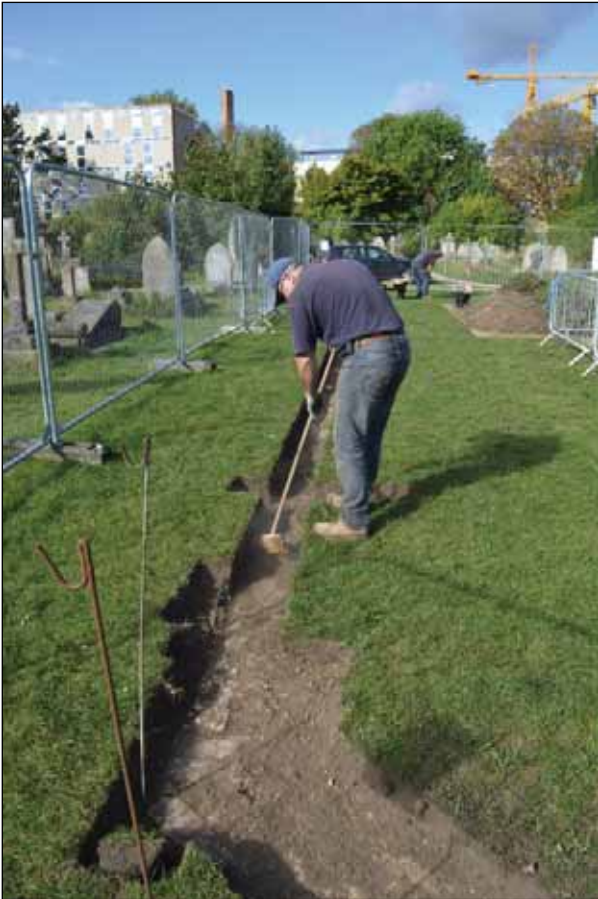
Plate 9: Cleaning the southern wall foundation trench

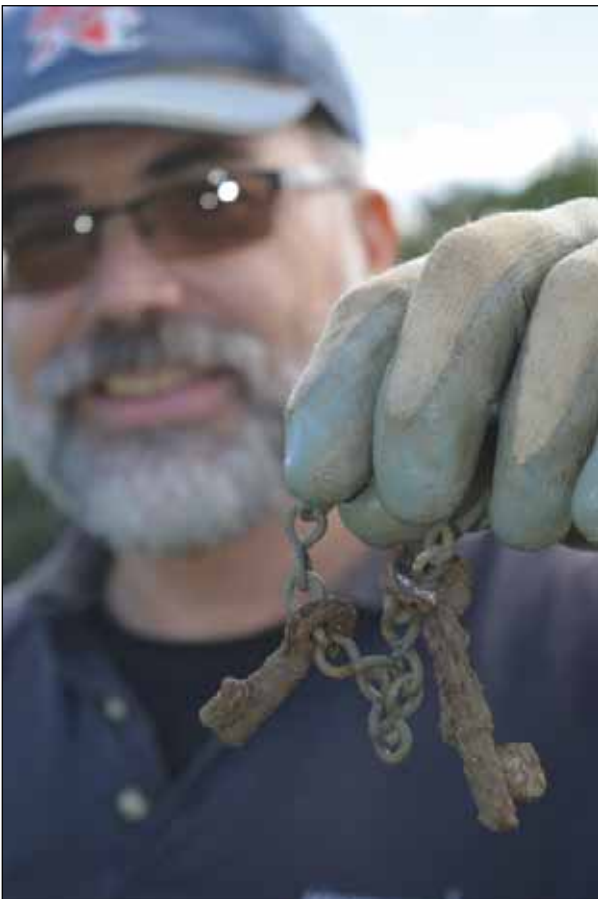
- 3.7.4 Iron cast rotary key with an oval bow, circular section stem and a rectangular bit with a cleft to front and back; a hole once existed at the end of the stem. From its size, probably for a door. Length: 65mm, Height (at bit): 20mm, Thickness: 7mm, Weight: 24.2gms.

- 3.7.5 Iron cast rotary key with an oval bow, circular section stem and a rectangular bit with a cleft to front and back; a hole once existed at the end of the stem. From its size, probably for a casket or cupboard. Length: 40mm, Height (at bit): 7mm, Thickness: 4.3mm, Weight: 15.4gms.

Plate 10: Keys to an internal door of the Mortuary church
