Site/Project Name: **Horley Park House, Banbury**

Site Code: BAHOPH09

Site/Project Type: Watching Brief

HORLEY PARK HOUSE, BANBURY (OXFORDSHIRE)

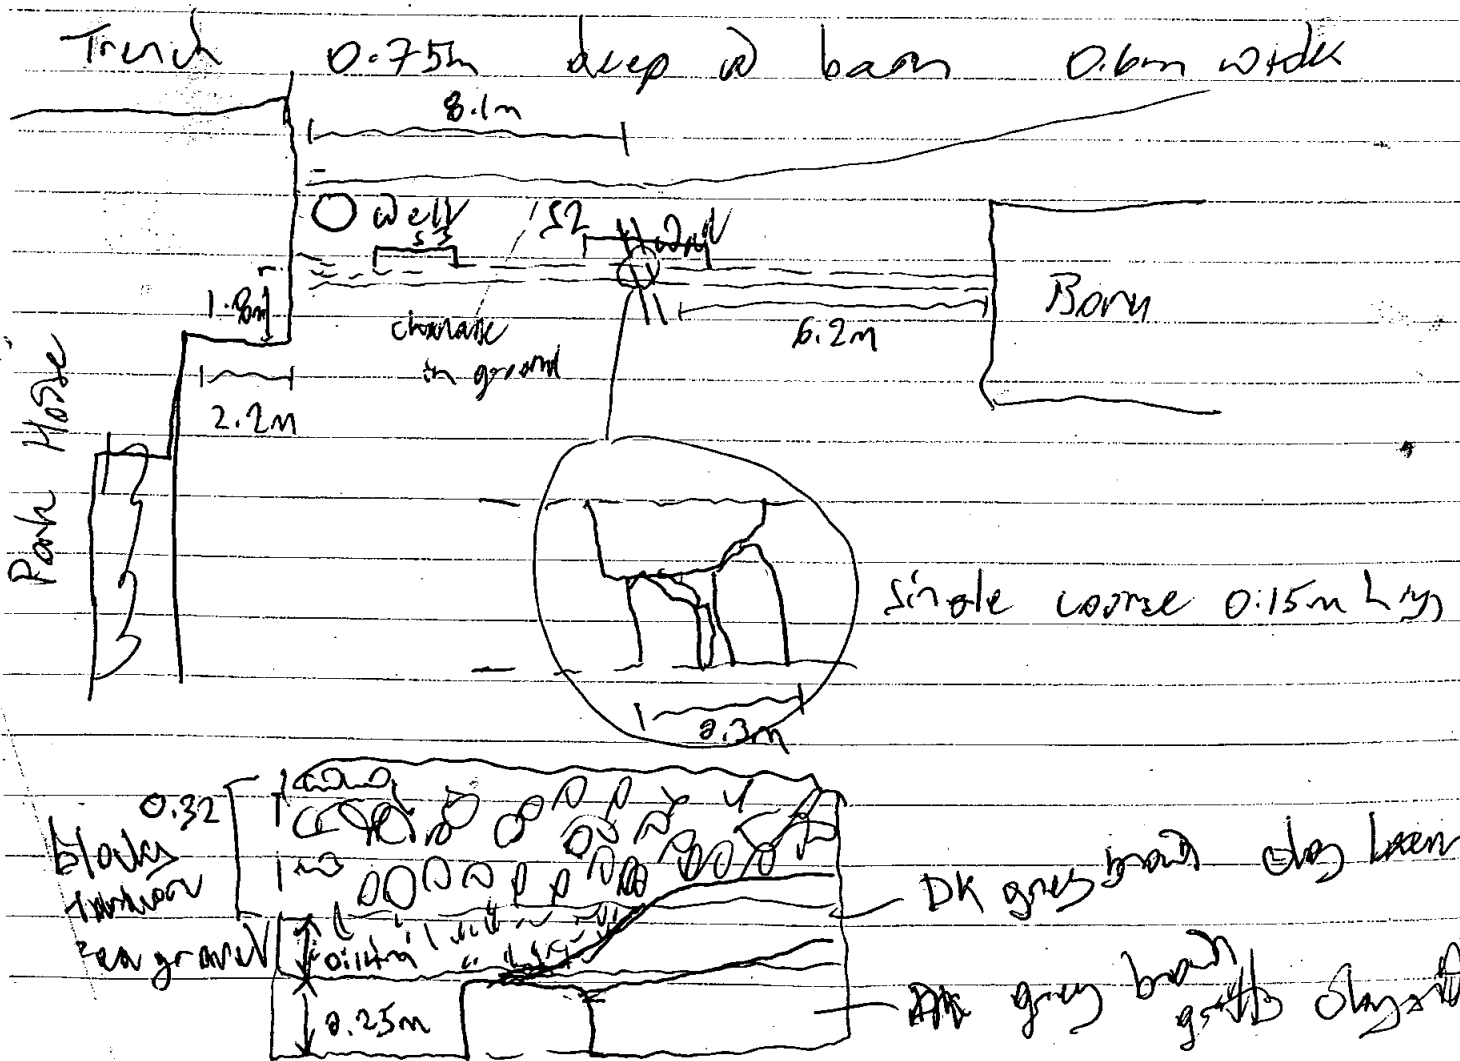
Section 2

Approx 18m length of 0.6m wide by 0.75m deep.

Service trench from rear extension of house to centre of barn.

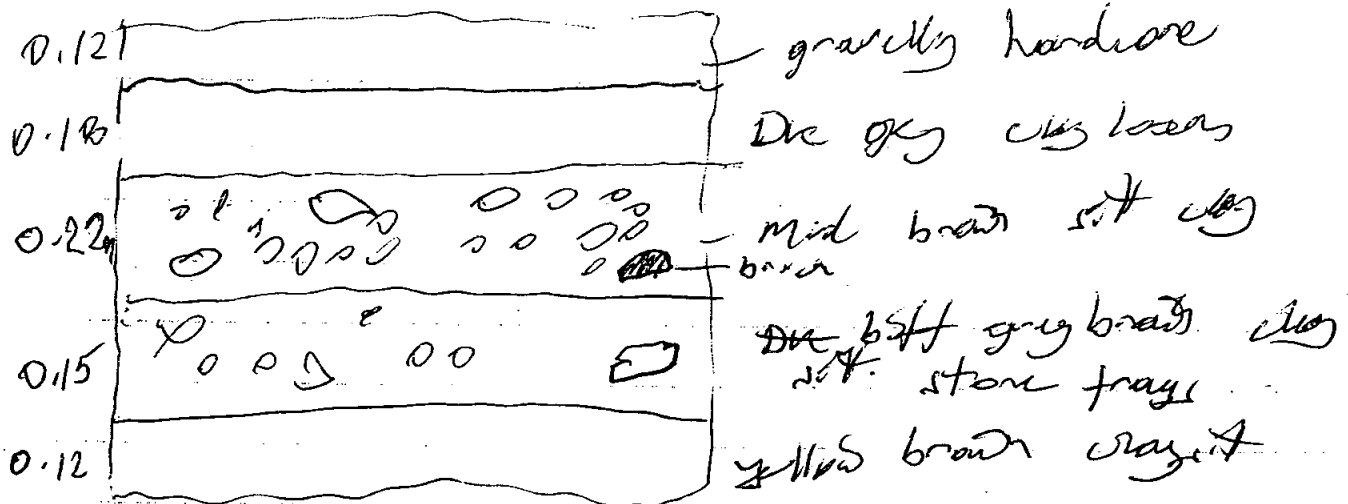
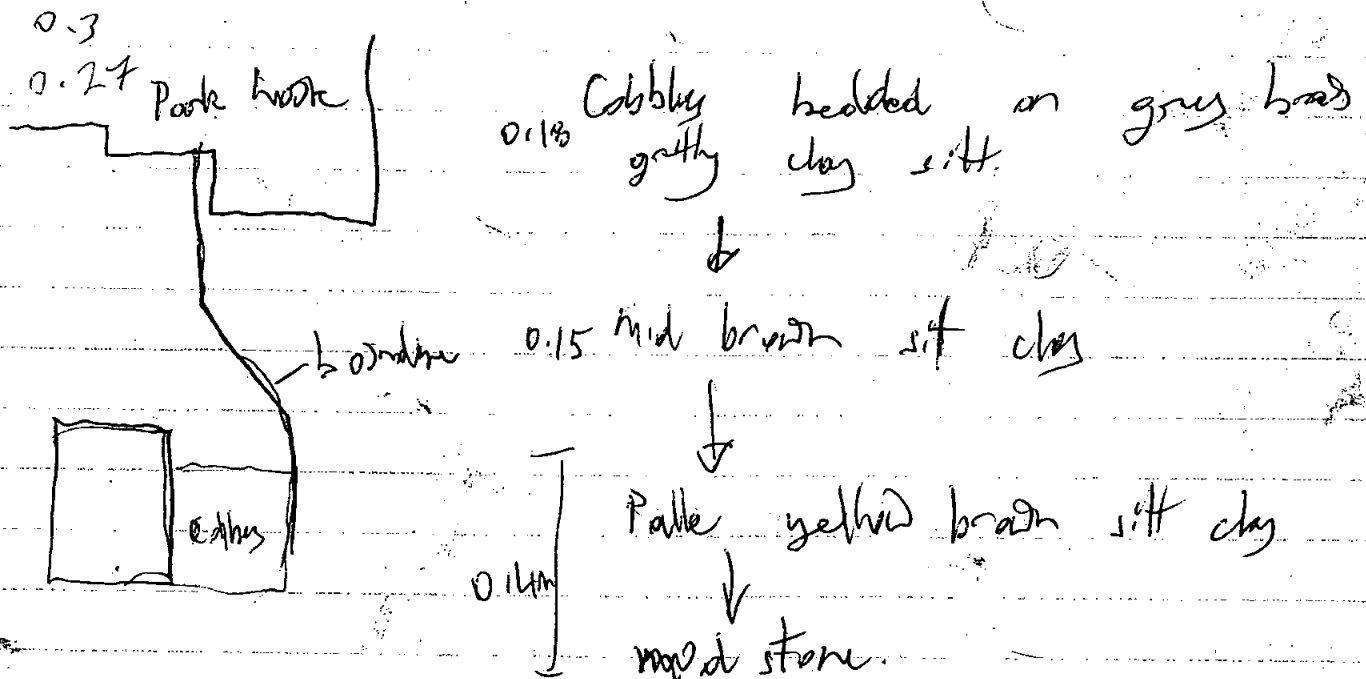
*Service trench open underpinning pit down
dig outside west gable wall.*

Depth of house 0.9m

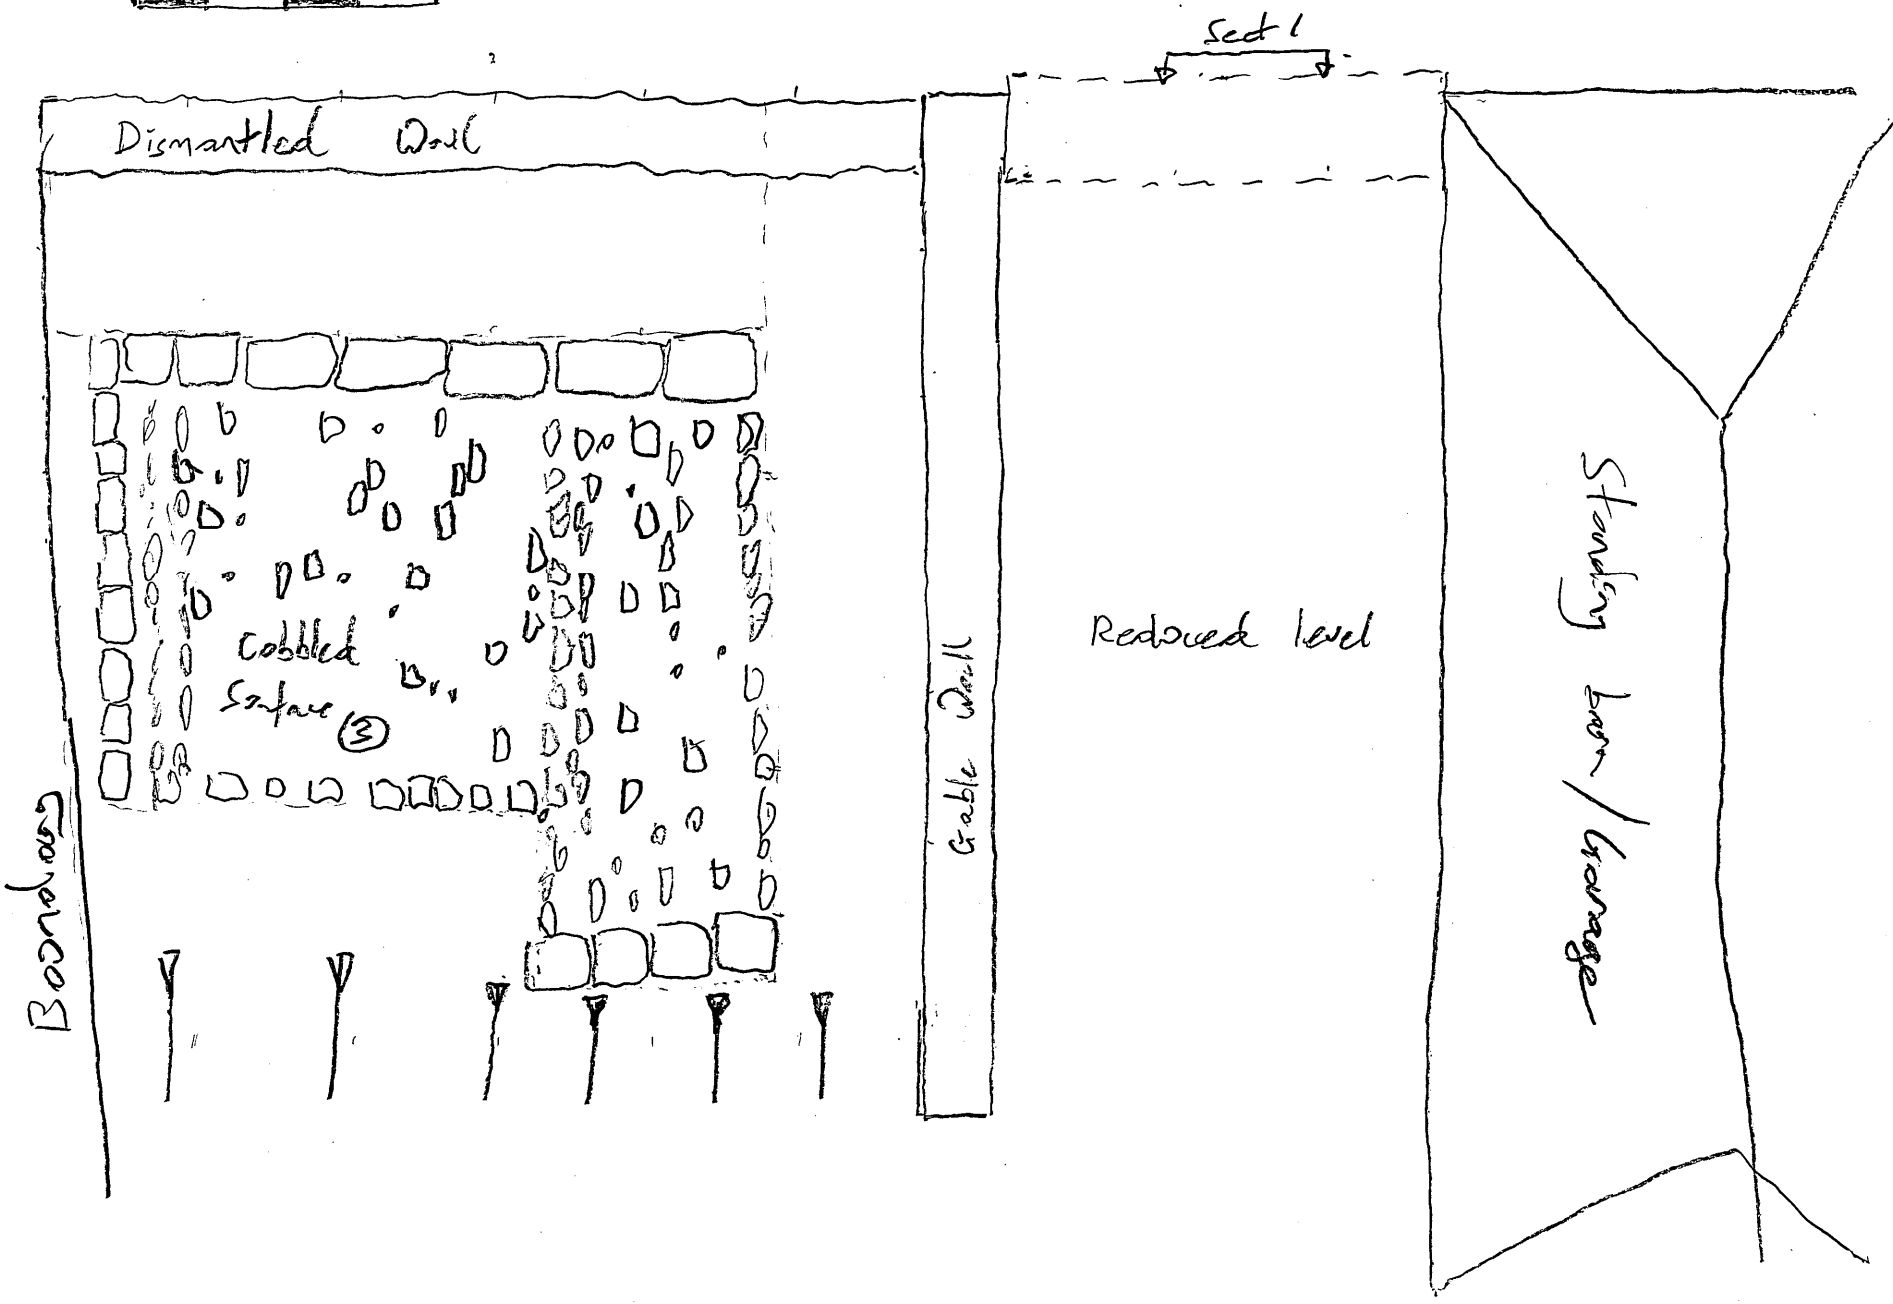
BAHOPH 09
Plan 1
Scale 1:50

Ground to NE of barn cleared exposing a cobbled (yard?) surface (3)

Cobbled (yard?) surface
Edges bordered by big blocks
centre smaller blocks.
All edges rounded/smoothed by wear.

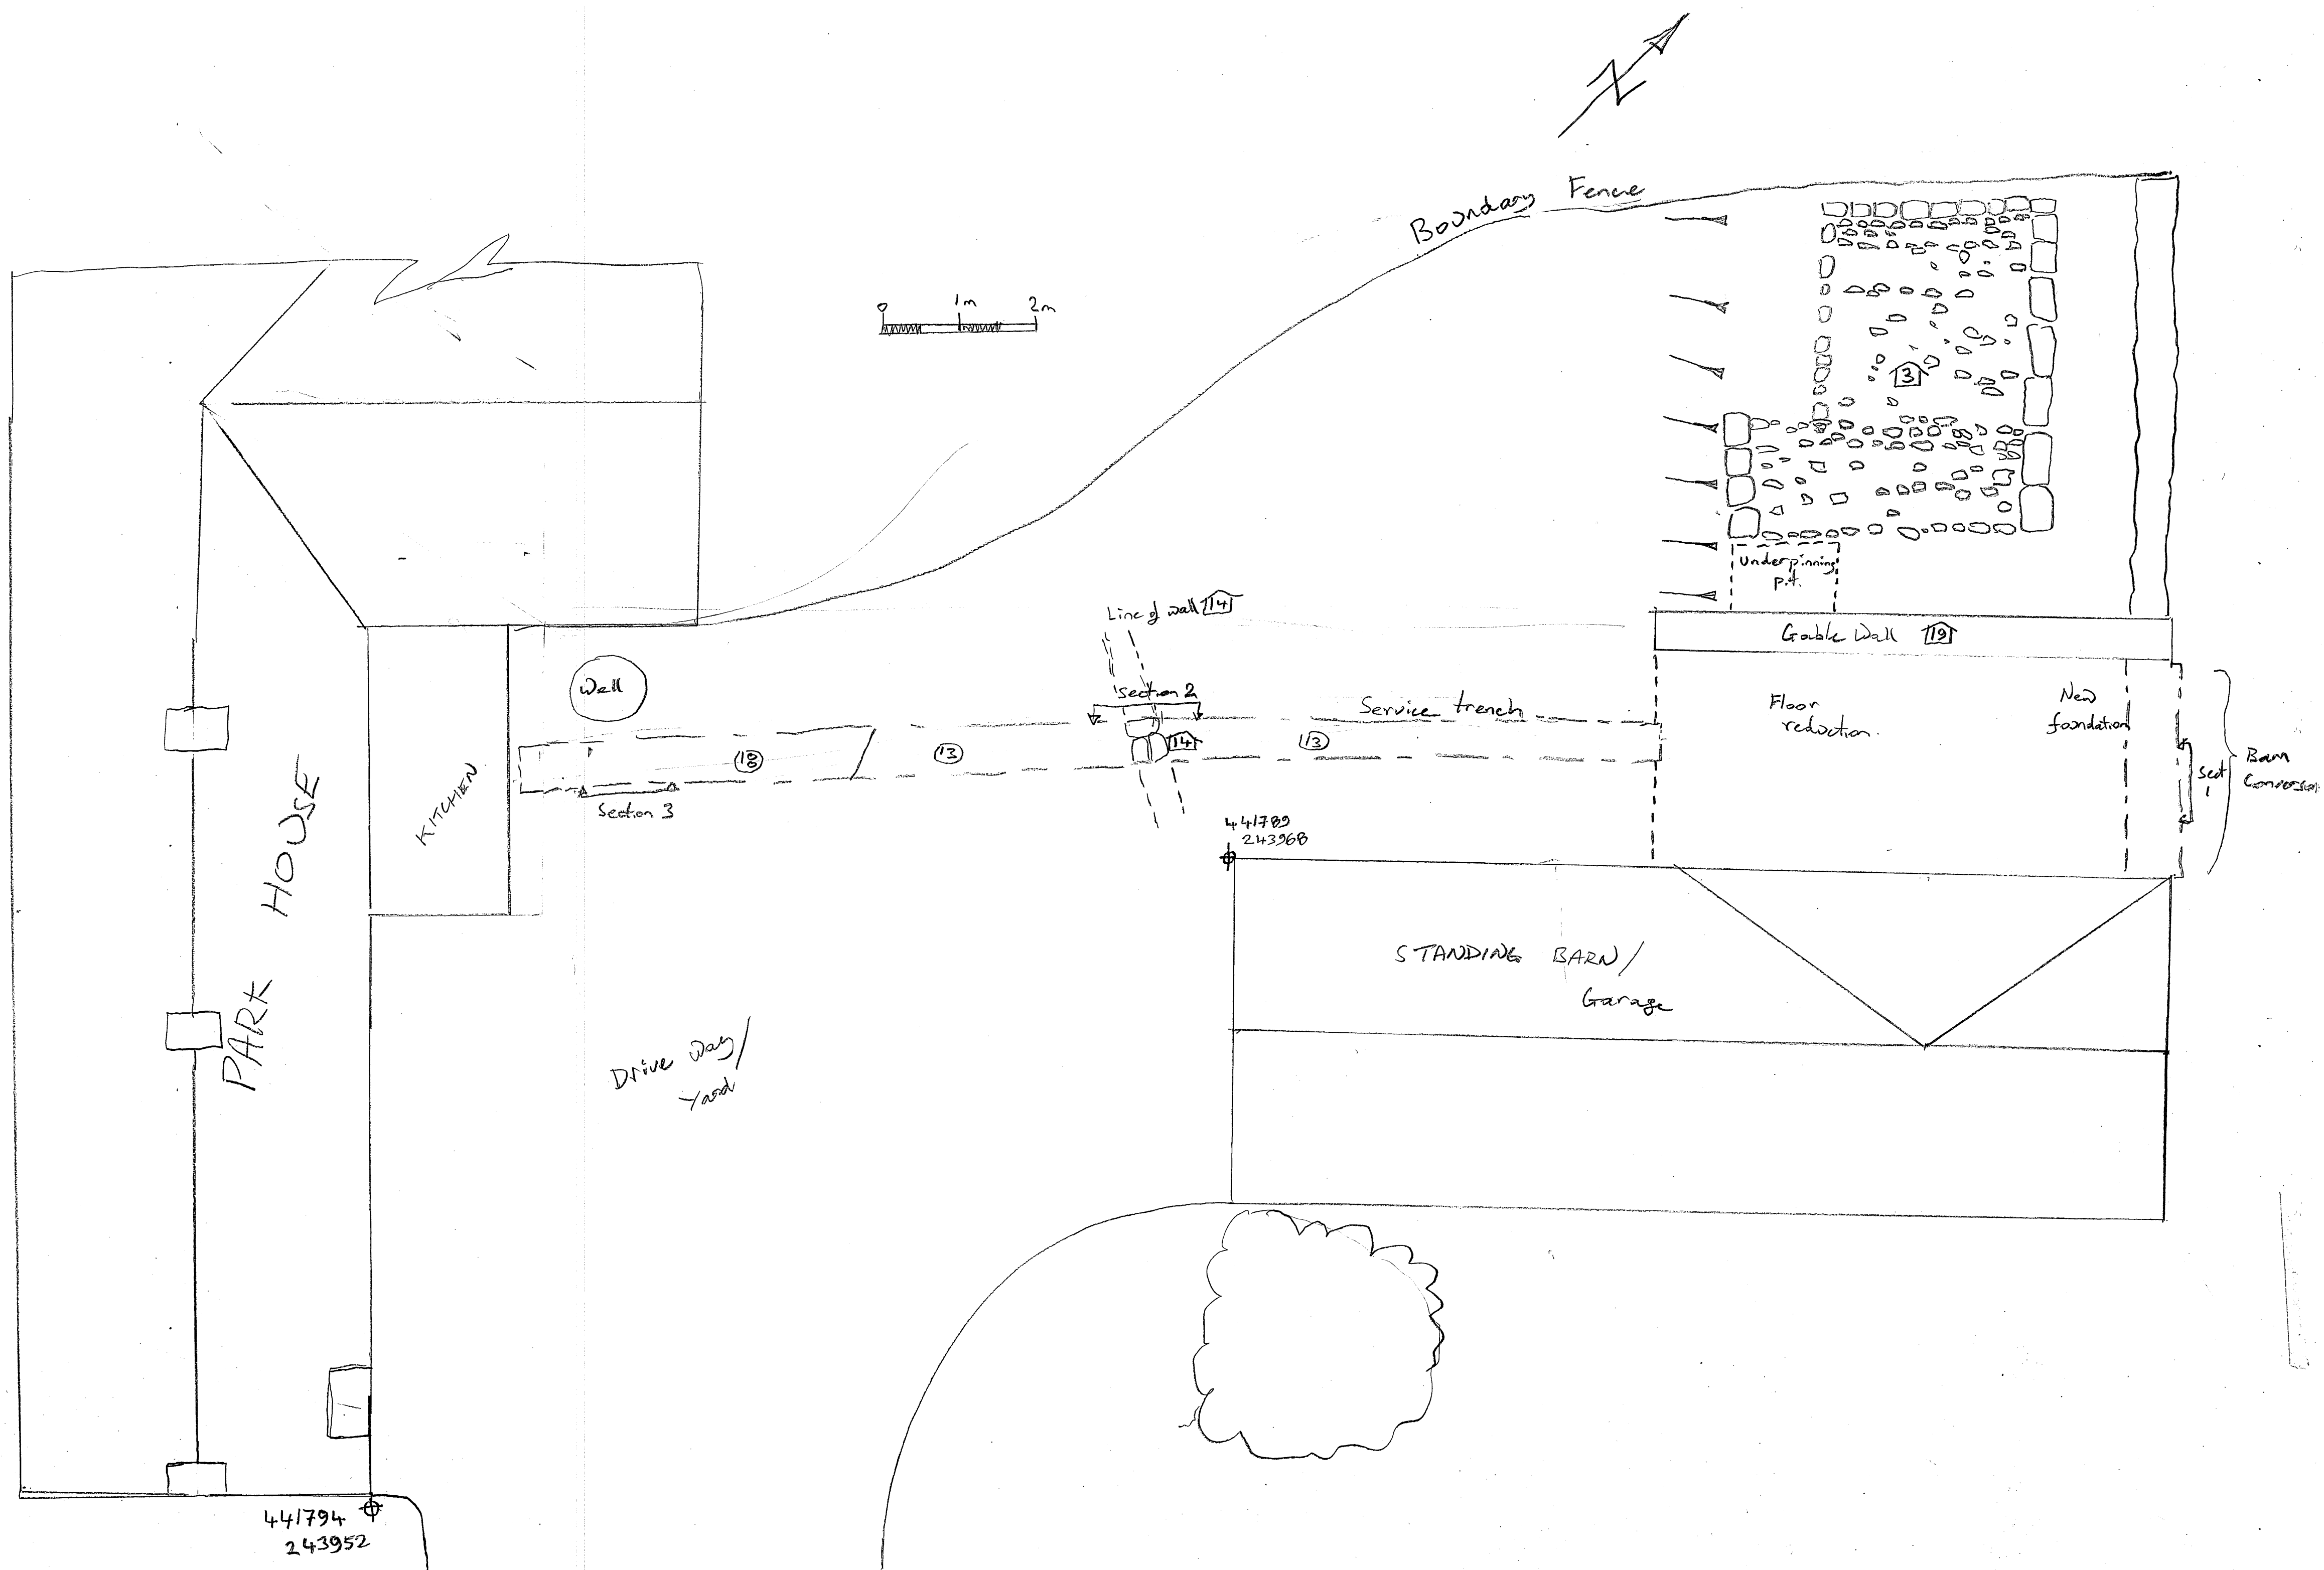
BAHOPH 09
Plan 2
Scale 1:50

Bedding layer for stone slab
floor 5/4

Dumping, bonfire heap above cobbles modern

BANBURY HORLEY HORTON LANE
PARK HOUSE BARN CONVERSION
BAHOPH 09
