Bushett Farm Great Bardfield Essex

Archaeological Evaluation Report

OA East Report No: 1910
OASIS No: oxfordar3-244812
NGR: TL 67288 28355

Archaeological Evaluation

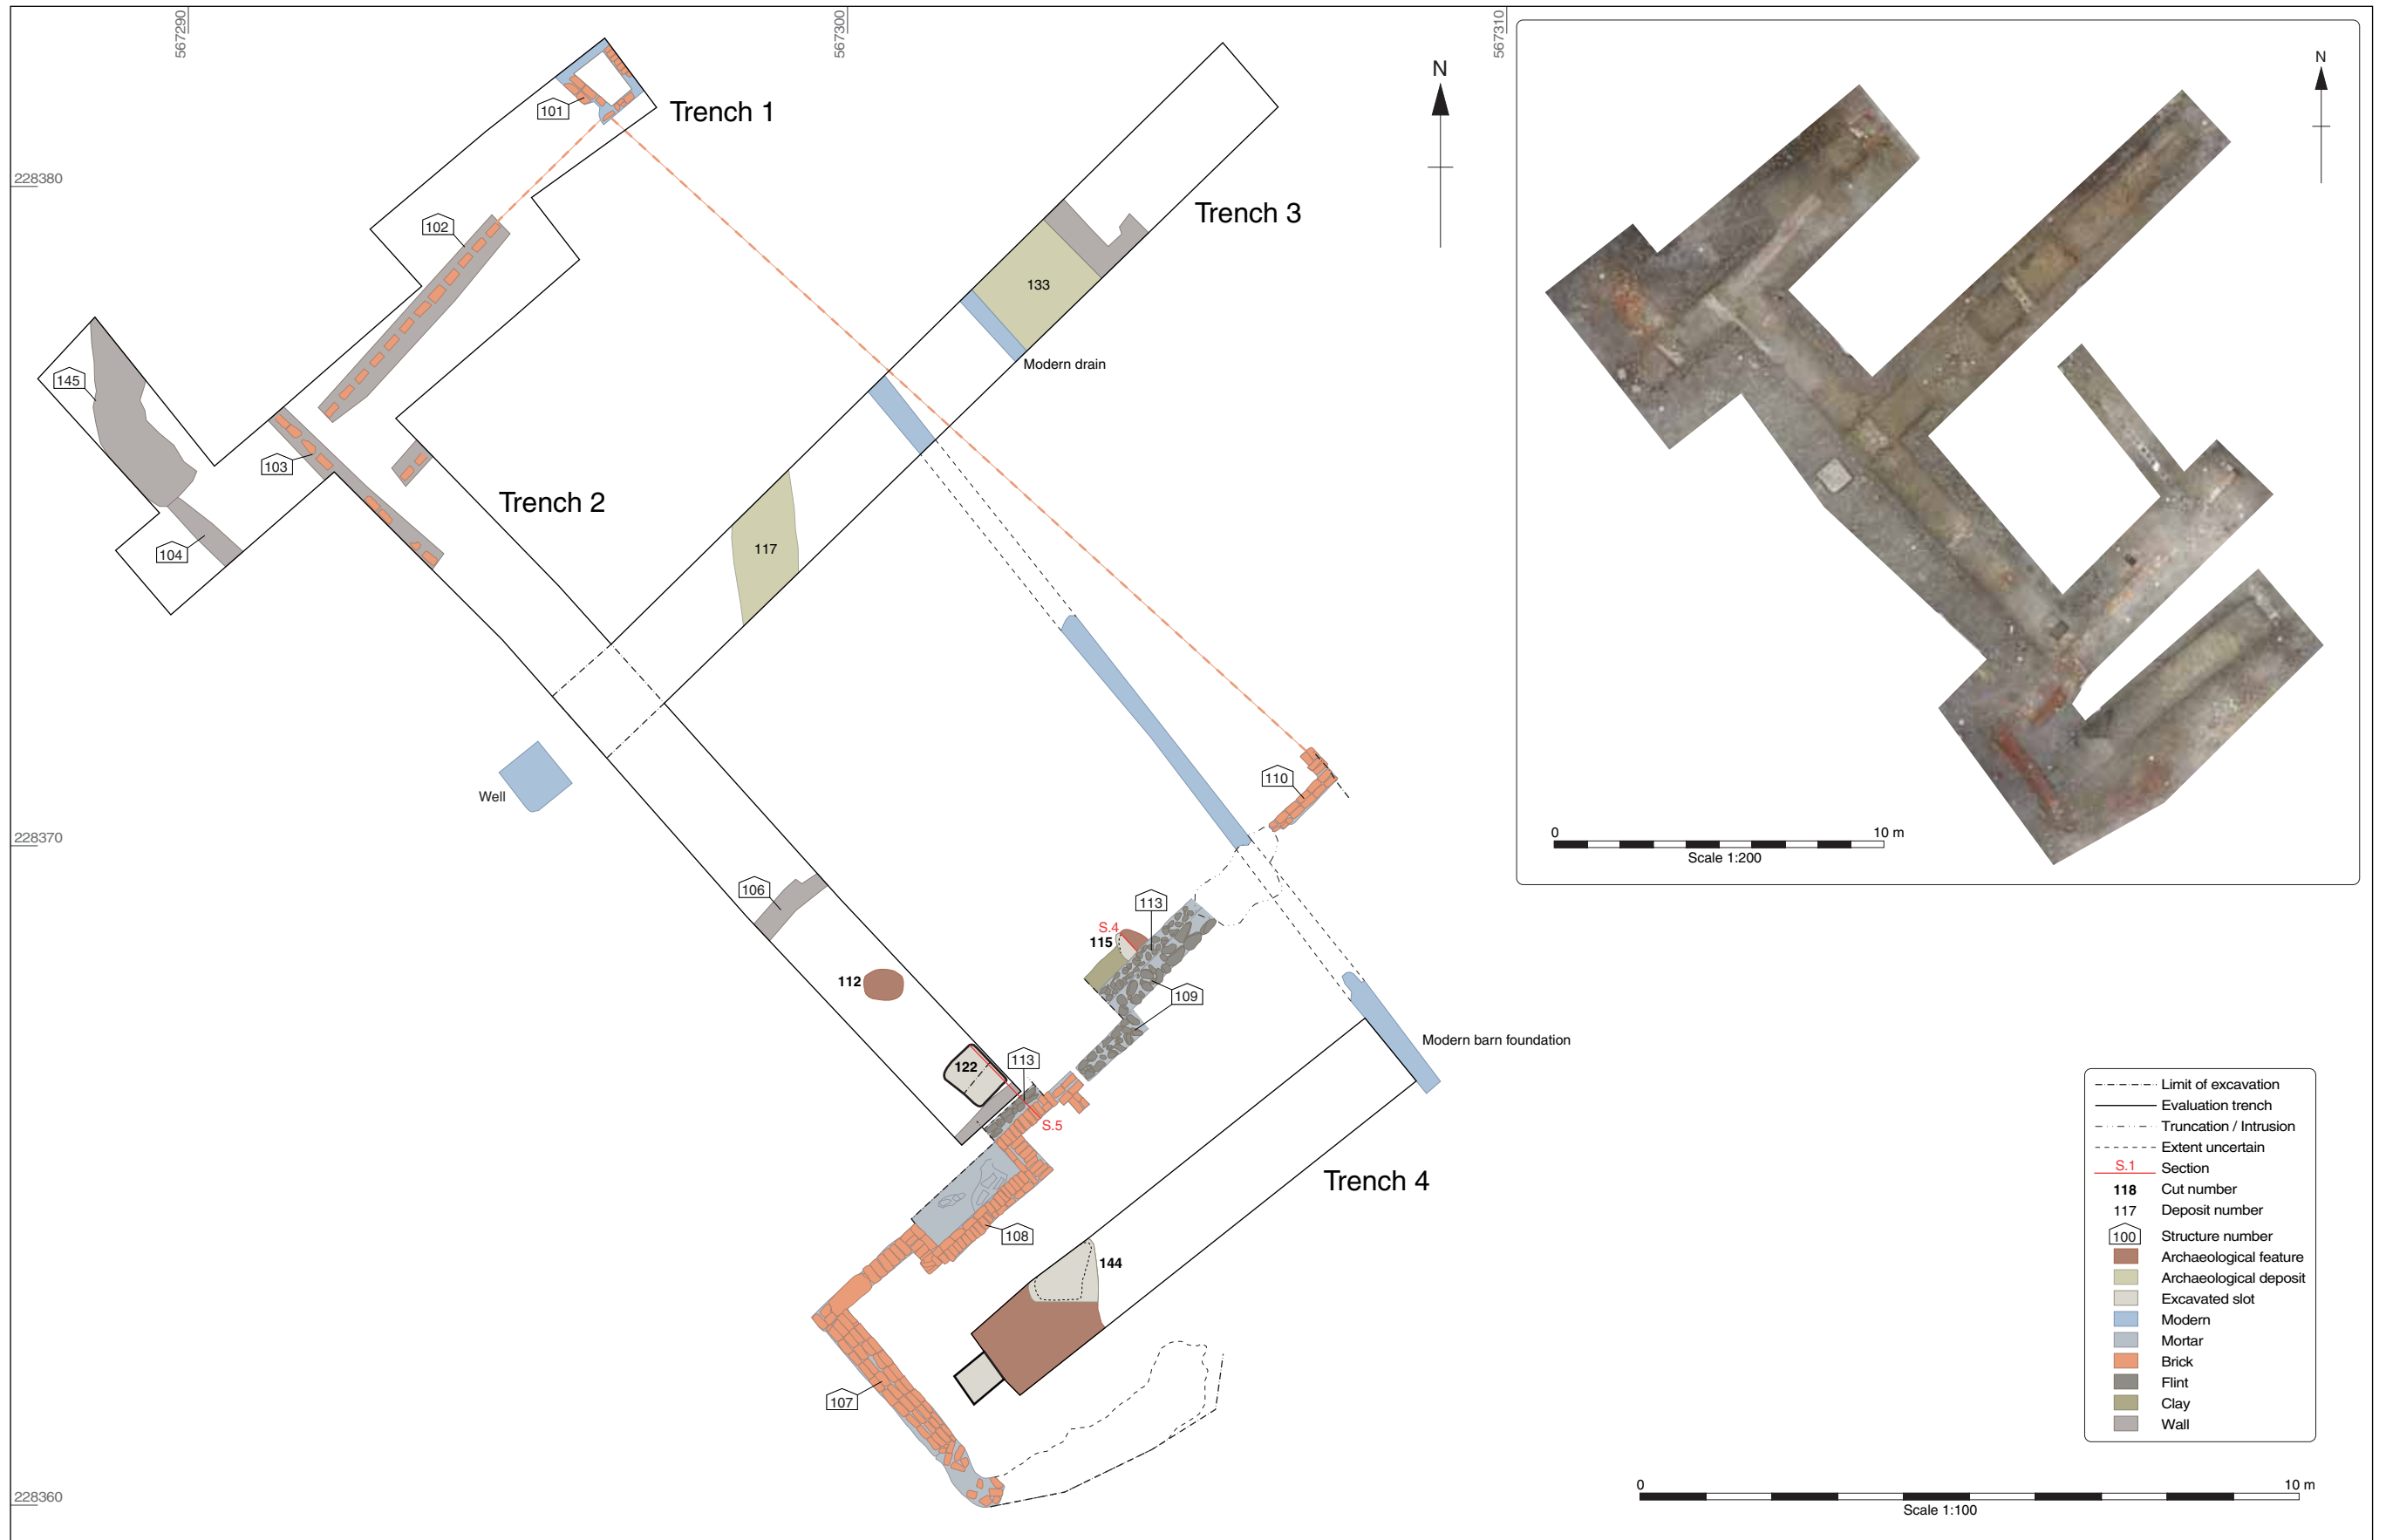
Figure 2: Plan of trenches and rectified photograph

3.1.1 The results are presented below by trench. A total of four trenches (Fig. 2) were targeted on specific areas of the foundations of Bushett Farm.

Trench 1 (Fig. 2)

Trench 2 (Fig. 2)

Trench 3 (Fig. 2)

Trench 4 (Fig. 2)

- 3.1.16 Modern features seen within the evaluation area all relate to the barns that were erected on the site. These consisted of foundations made from cast concrete blocks that were aligned south-east to north-west and truncated the probable front foundation of the manor house (Fig. 2).

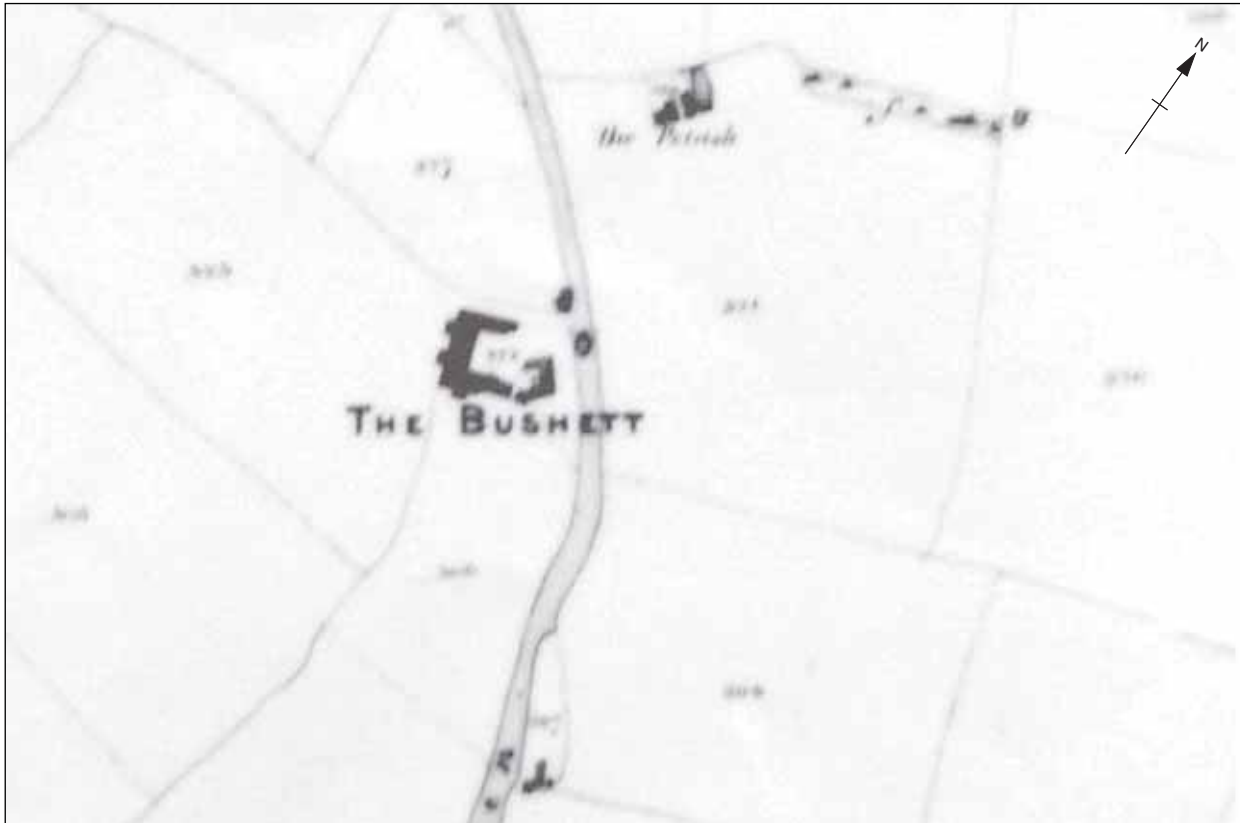
Figure 3: 1835 Tithe map and 1941 sales particulars (Essex County Record Office).

- 1.3.3 The following is a summary of the History of the site taken from the Heritage Statement by Beacon Planning (2012).
- 1.3.4 The farm was acquired by Guy's Hospital in the early 18th century and underwent substantial alteration, including the construction of the listed barn that still stands. The farm appears on the parish map of 1755, the Tithe map of 1835 (fig 3) and the O/S map

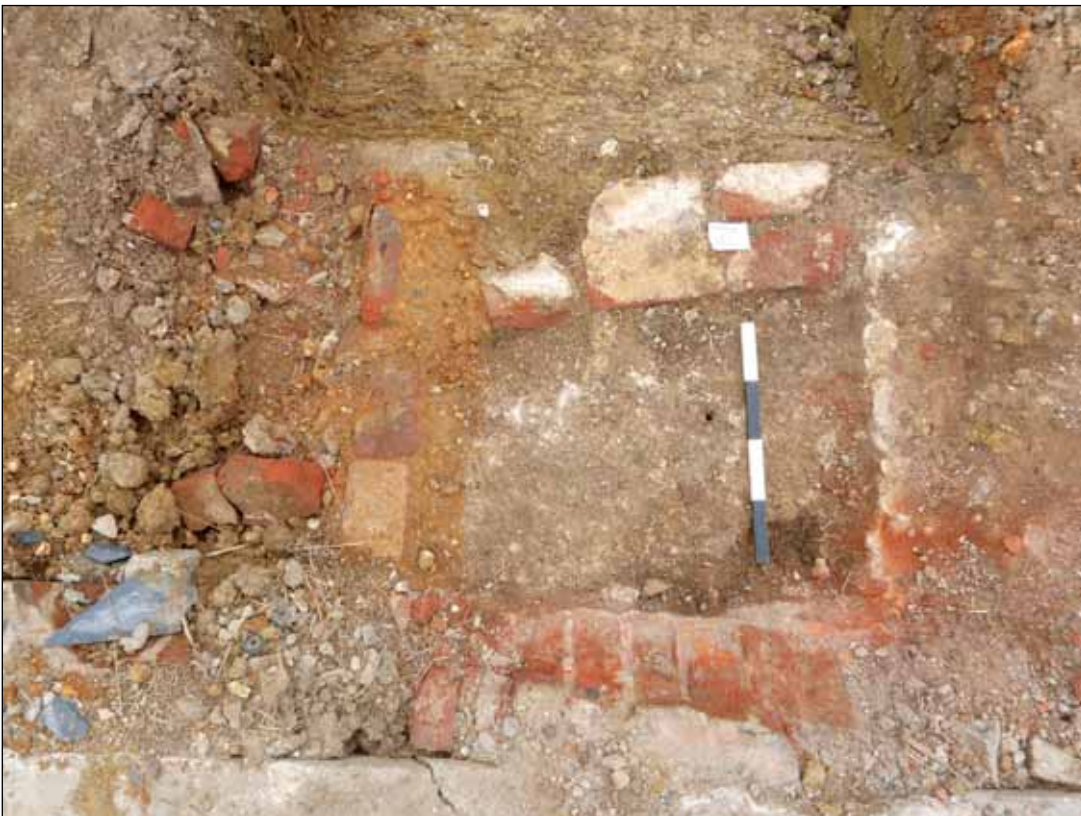
Plate 2: Foundation 101 viewed from the north-east

3.1.3 Trench 1 measured 10.2m and had a maximum width of 2.2m. It was located at the northern end of the evaluation area and was orientated south-west to north-east. A small section of a foundation wall (**101**) was recorded at the north-west end of the trench. Two courses of 18th century bricks were recorded on a north-west to south-east alignment. These were laid end to end with the bed of the brick uppermost. Although only a small remnant of the front foundation remained it aligned with the southern return of the front wall of the building (Plate 2).

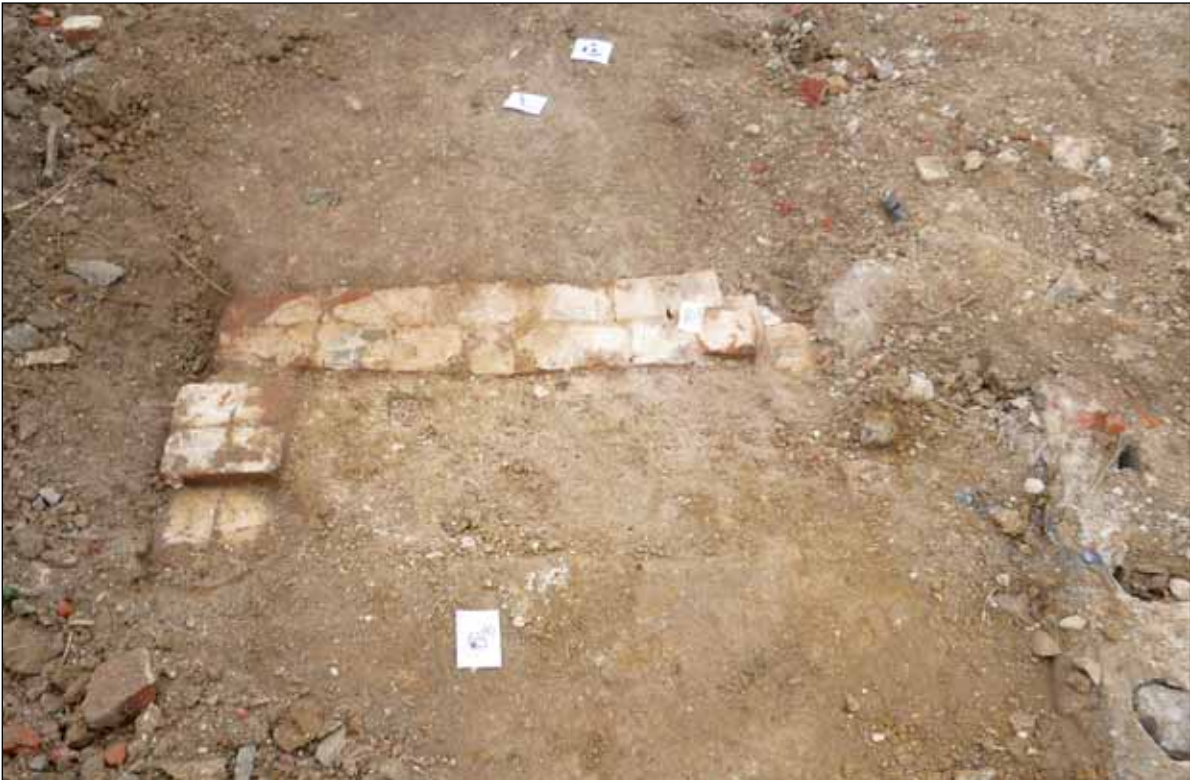
Plate 3: Return of wall 110 viewed from the north-west

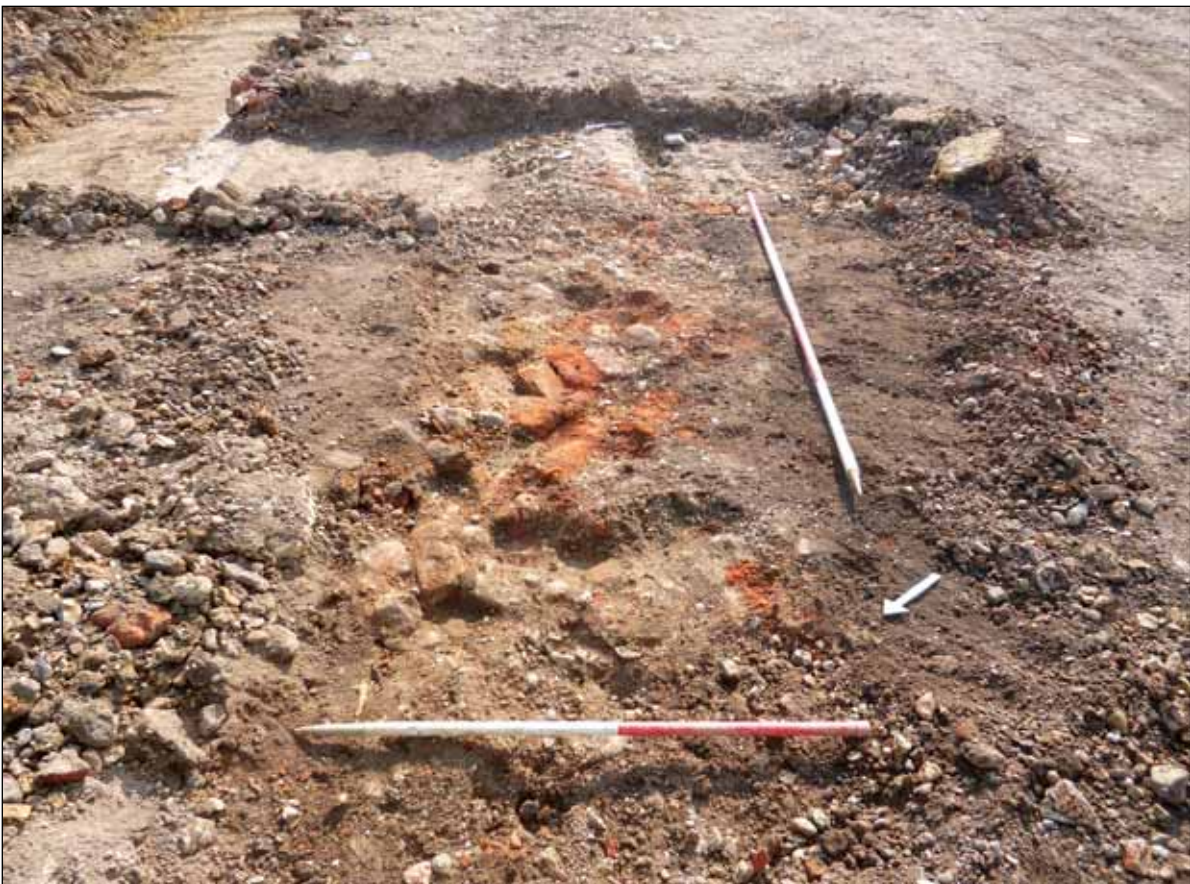
Plate 4: Continuation of the rear wall of the building viewed from the north-east

3.1.4 Another small section of wall **104** (Plate 4) was seen at the western end of Trench 1. This was of a similar construction and date. It had at sometime been covered by cobbles and gravel forming a yard surface for the cattle pens situated to the rear of the building. When compared to historic plans the position of this section of wall corresponds with the rear wall of the building. This area was subsequently extended slightly towards the north-west, where a continuation and turn of the wall (**145**) was noted.

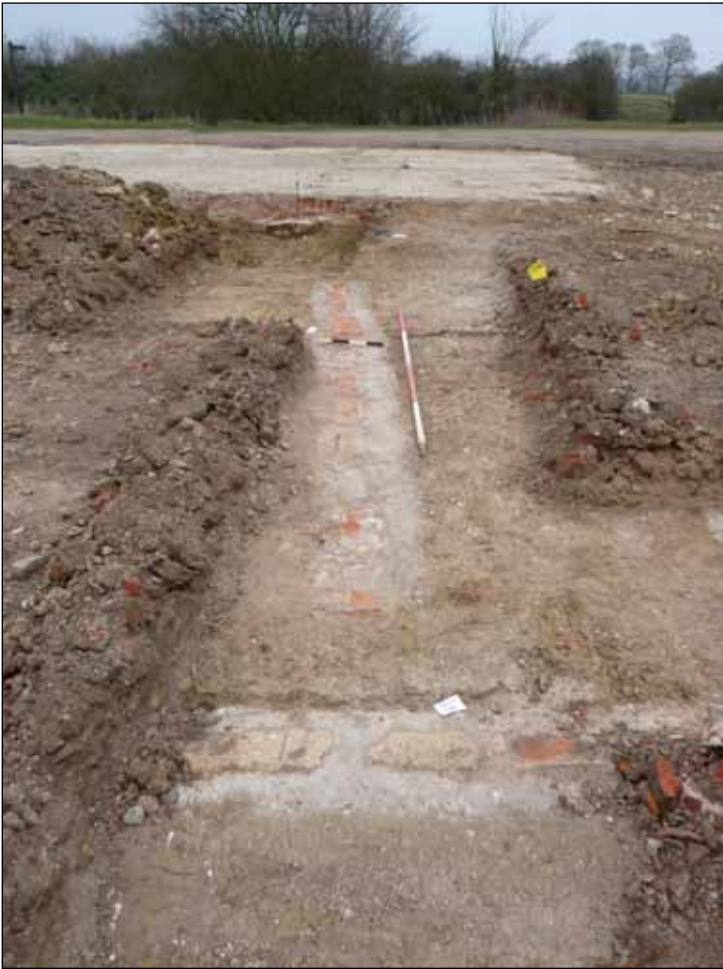
Plate 5: Internal walls **102** and **103** viewed from the west

3.1.5 Two further walls (**102 & 103**) relating to a 19th or 20th century phase of internal alteration were recorded in Trench 1. These were at right angles to each other and, according to a former owner, formed a scullery that was constructed for farm workers who occupied the northern end of the building. The walls were constructed of brick laid within a concrete foundation. A similarly constructed wall was seen in the northern end of Trench 2 (Plate 5).

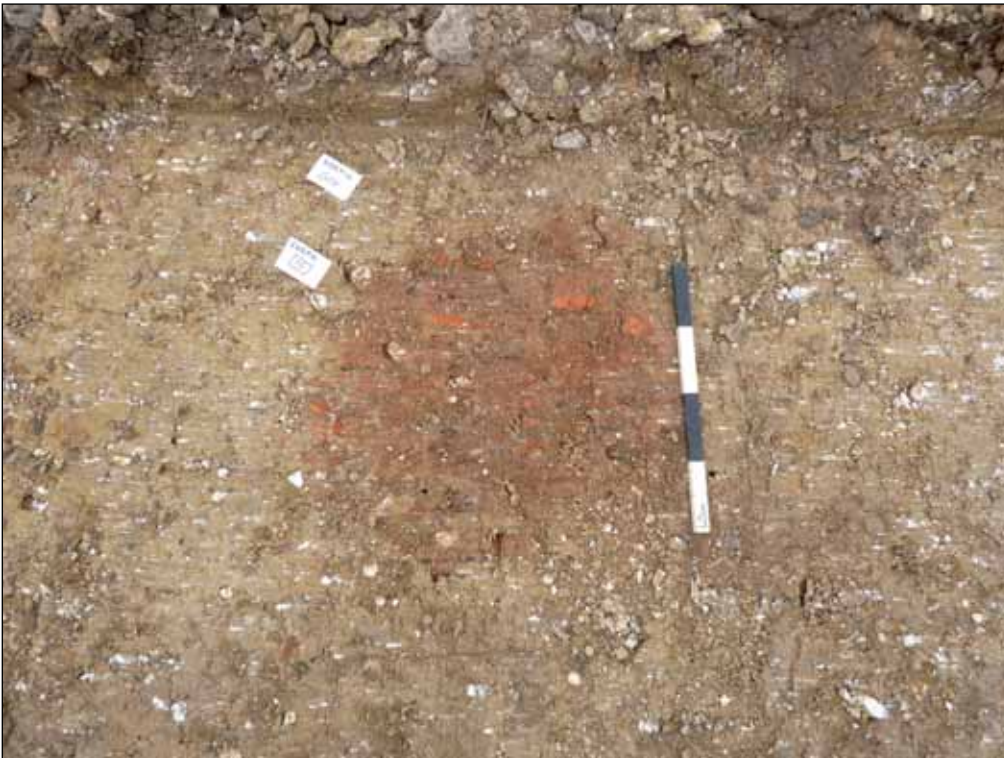
Plate 6: Hearth **112** viewed from the west

- 3.1.8 Two surfaces were also recorded at the southern end of Trench 2. A hard packed clay (123) was overlain by a thicker clay (122), the latter is thought to be the surface used for bedding a brick internal floor.
- 3.1.9 Evidence of an external yard or garden area was also revealed centrally in Trench 2 where an area of silty brown clay differed from the areas of compacted grey clay that had been deposited and compacted within internal areas of the building (Plate 8).
- 3.1.10 A small circular feature (**112**) containing ceramic building material that had been subjected to heat was recorded toward the south-eastern end of the trench (Plate 6). This feature may be the remnant of a hearth.

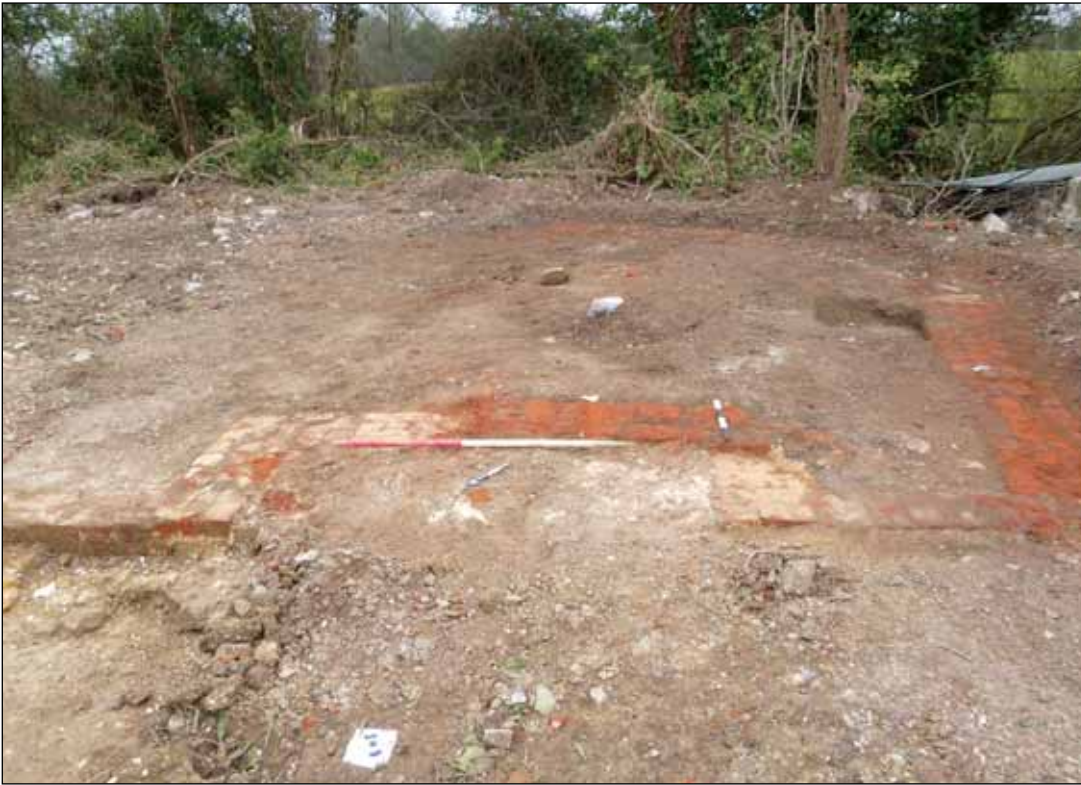
Plate 7: Later chimney **108** base, viewed from the north-west

3.1.7 A flint wall (**113**) was noted at the south-eastern end of the trench (Plate 8). This probably related to an early phase of the building and to one of the wings. Adjacent to this was the base of a chimney stack (Plate 7) that had been added at sometime during the 18th or 19th century. This feature truncated an earlier wall (**107**) that may have been constructed as a garden or perimeter wall (Plate 9).

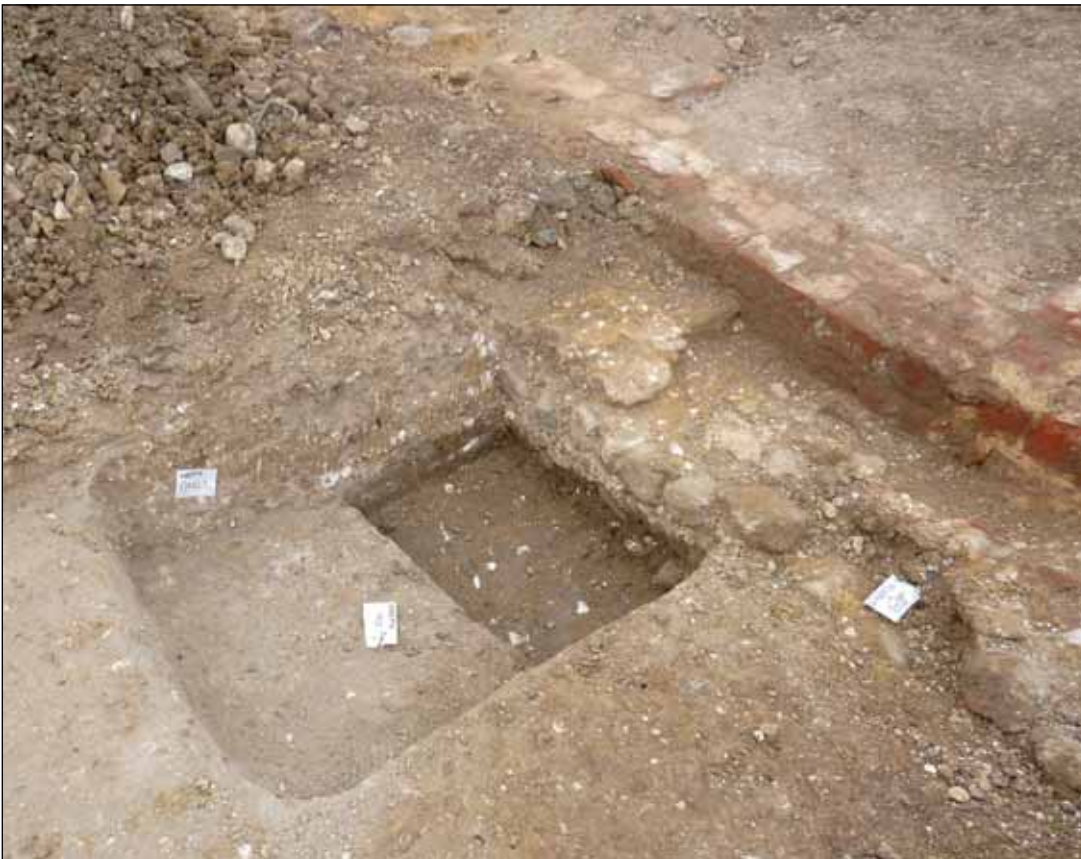
Plate 8: Flint wall **113** and surfaces **122** and **123** viewed from the west

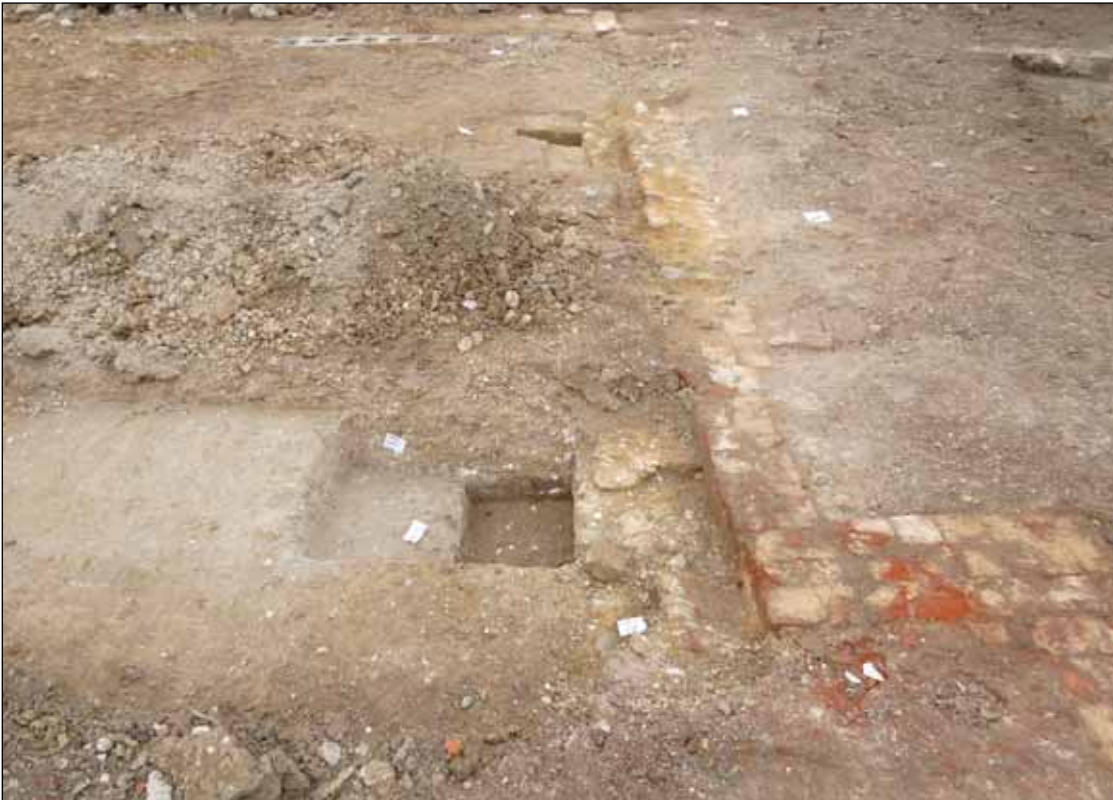
Plate 9: The southern wall **108** of the building viewed from the west

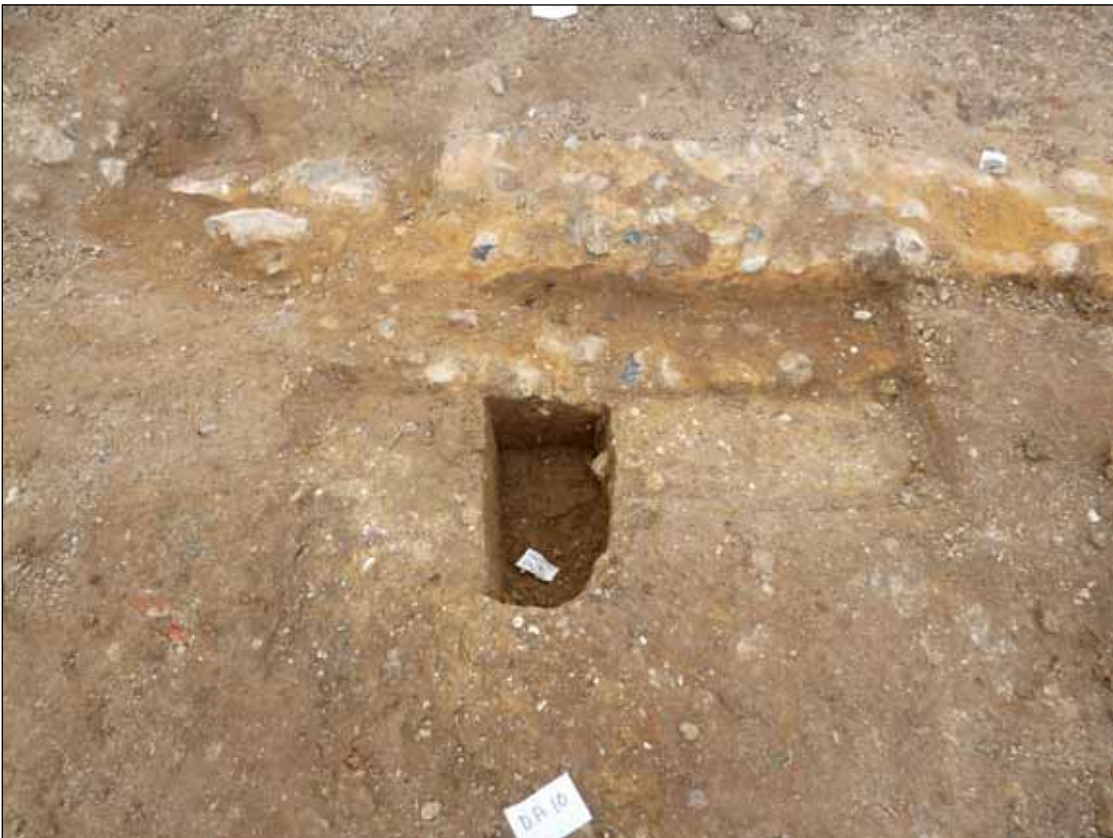
Plate 10: Post hole **115** viewed from the north-west

- 3.1.14 A number of features were visible on or just below the surface. A post hole **115** was noted adjacent to an early phase of flint wall (Plate 10) at the southern end of the building. No datable material was found within its fill but it is assumed to be related to an earlier timber phase of the building. The probable corner of the house (**110**) was seen close to the rubble heap, this turned north and aligned with the brick feature (**101**) seen on Fig 2.
- 3.1.15 A well survives that can be seen on historic maps of the site. This would have been sited in a garden or yard located between the two wings that extended from the rear of the building. The well retains water, is circular and constructed from red brick. The well head is of modern concrete with a cast concrete cover. A depth of 6.8m was recorded.

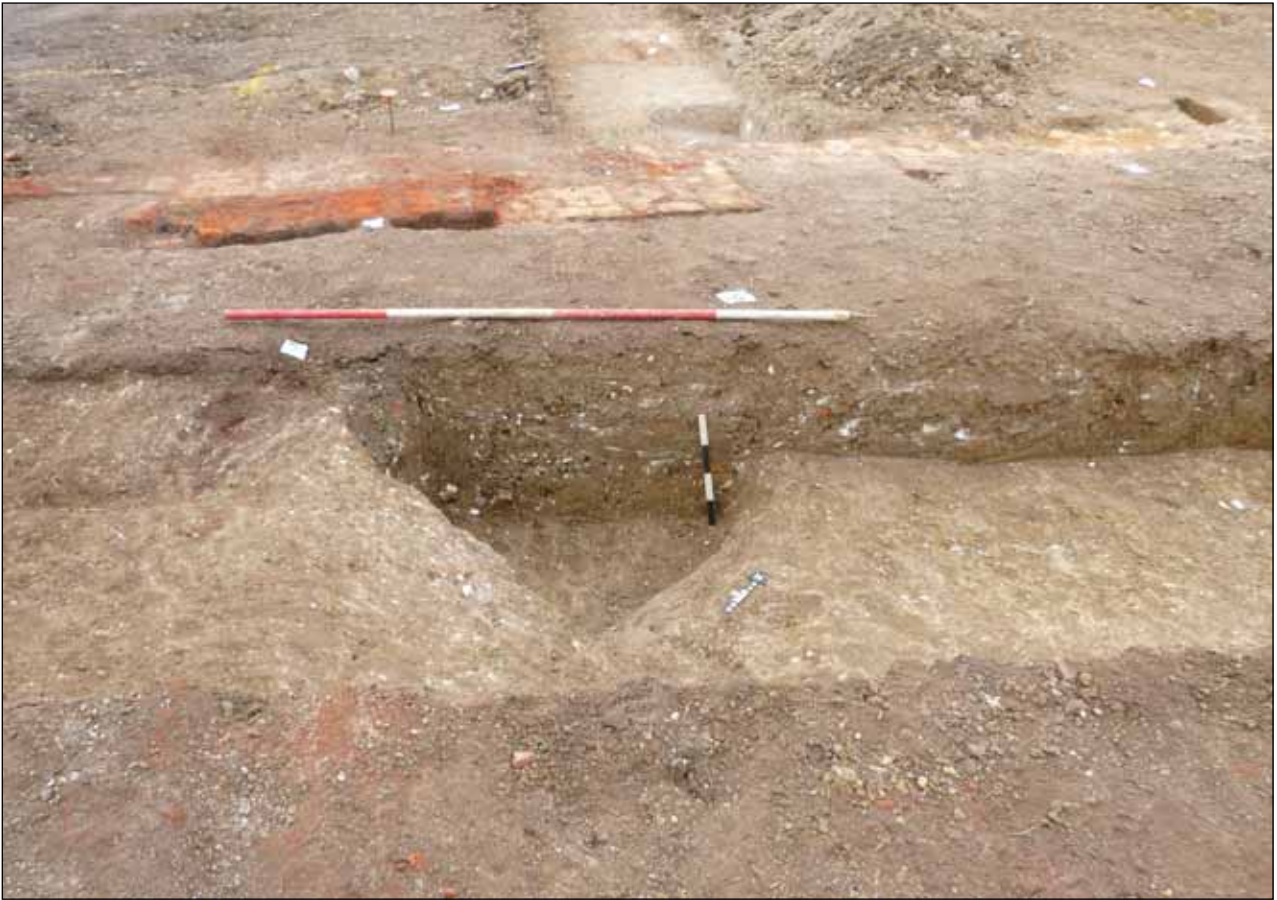
Plate 11: Pit/ditch **144** viewed from the south-east

- 3.1.13 Trench 4 was located to the south of the building in an area that would have been external. The trench measured 7.4m by 1.2m and was orientated south-west to north-east. A large ditch or pit (**144**) was recorded at the south-west end of the trench (Plate 11). This was partially excavated and contained animal bone and pottery dating to the late 13th to the mid 16th century. This feature was sealed by a chalky layer of silty clay material (139).
