Steeple Bumpstead
Flood Alleviation Scheme,
Steeple Bumpstead,
Essex

**Archaeological
Watching Brief Report**

OA East Report No: 1451

Watching Brief

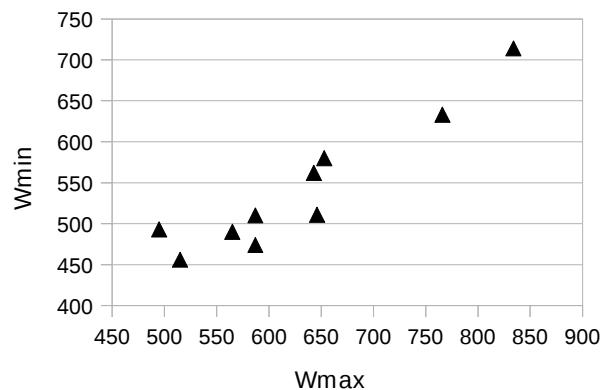
Chart 1: Size of cattle horncores (mm)

- 3.11.1 Twenty fragments of animal bone were recovered from the watching brief, with 18 fragments being identifiable to species. Identifiable bone was recovered from two contexts, consisting almost entirely of long and medium horned cattle horncores. Aside from horncores, context 2 also contained cattle and horse metatarsi from animals standing 1.64m and 1.47m at the shoulder respectively. A cattle mandible from an animal aged 1 ½ to 2 ½ years of age was also recovered from this context. Fifteen horncores were recovered from contexts 2 and 4 (10 being intact). Two of these are classed as 'long horned' animals with the remainder being 'medium horned' (Armitage 1976). Morphological analysis of measurable horncores suggests the majority (5) of the medium-horned animals were females, with four bulls or steers also being present. Chart 1 shows the sizes of the horncores as a group and also suggests a predominantly female sample, with the two long horned (morphologically male) animals being clearly separate at the top end of the range. Few butchery marks were present while the large numbers of horncores suggests the assemblage represents tanner's or lawyer's waste.

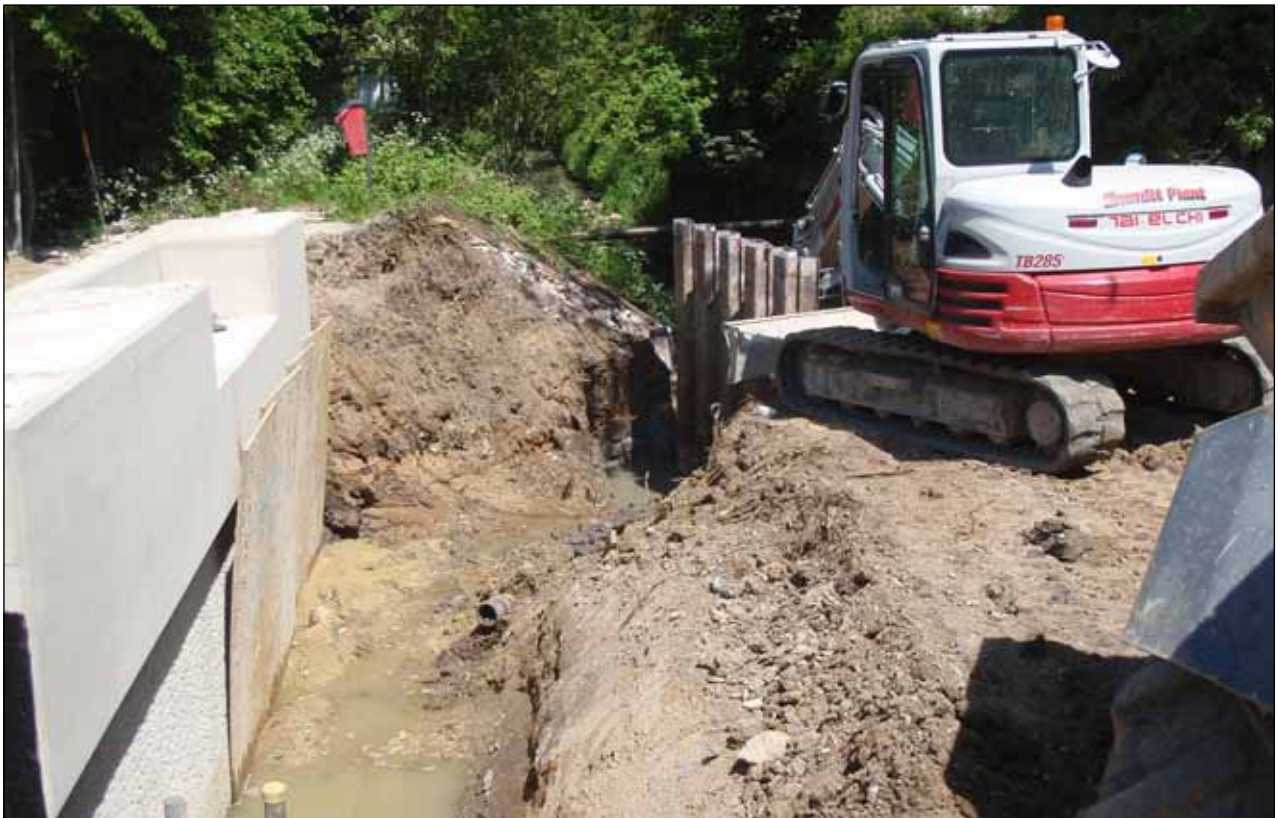
Plate 1: Crescent Bridge excavations

- 3.2.1 Piling works were observed on the 7th March and 26th April 2013 (Plate 1). The works comprised excavation by auger of a series of boreholes 0.45m in diameter on either

side of the Bumpstead Brook. The boreholes identified the below ground deposits to consist of natural chalk (context 6) at approximately 10m below ground level (bgl), overlain by orange and yellow brown gravels (context 5) to approximately 7m bgl. These deposits were overlain by uncompacted dark grey and brown sandy silt with some chalk and flint gravel (context 2 – each different archaeological deposit receives a context number) to just below the surface, where recent made ground (1) was encountered.

- 3.2.2 A visit was also conducted at this location in advance of the replacement of Crescent Bridge on the 3rd May 2013 when the foundations were excavated. This confirmed the ground conditions encountered in the previous visit. The modern made ground (context 1) was found to be 0.8m thick.
- 3.2.3 No surviving palaeoenvironmental deposits that might have contained macro-botanical remains, or lacustrine (lake) deposits, were observed and no finds were recovered.

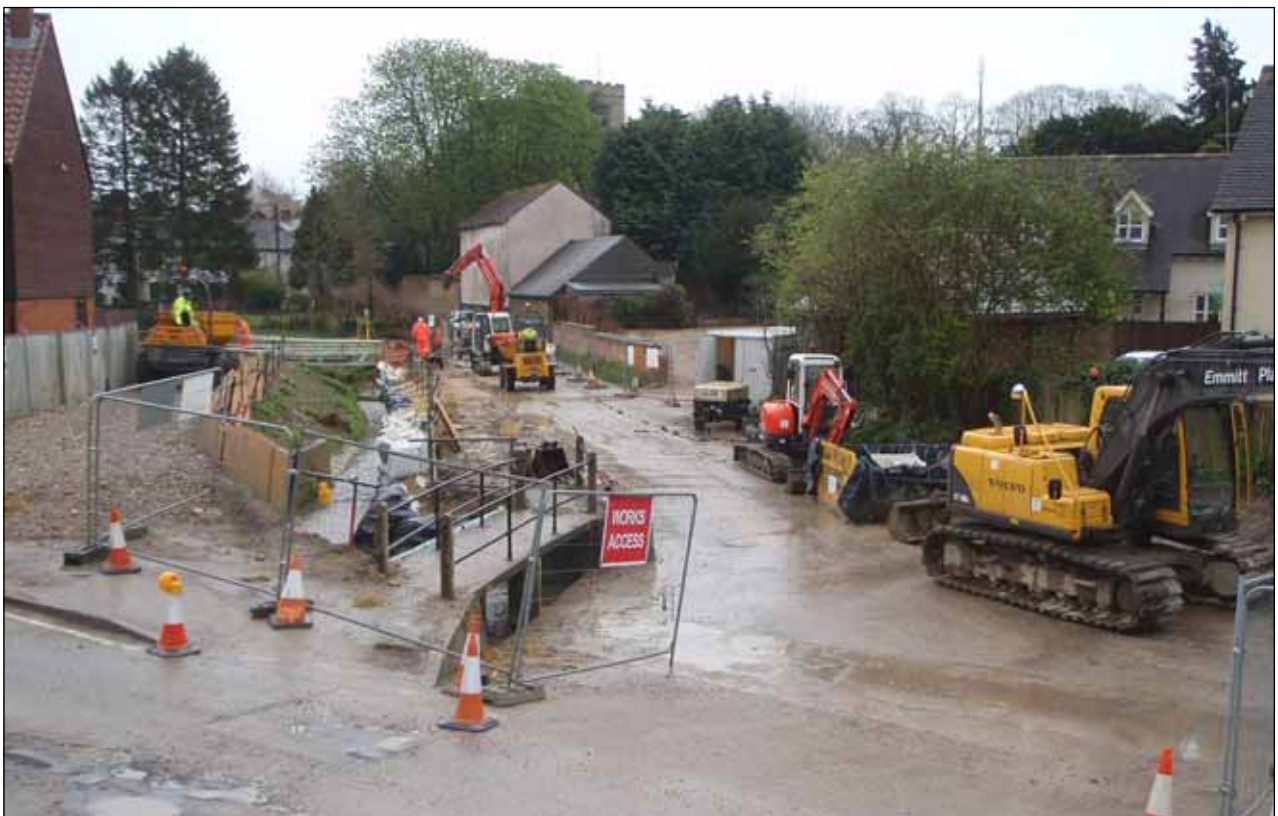
Plate 2: Excavations at Church Street Ford

- 3.3.1 Piling works were observed on the 26th April 2013 (Plate 2). The works involved the excavation by auger of a series of boreholes 0.45m in diameter down to the depth of the natural chalk on either side of the Bumpstead Brook. The deposit sequence was found to be the same as that encountered at Crescent Bridge, described in section 4.2.1 above.
- 3.3.2 Further excavations were observed along the line of the brook at the ford on the 20th June 2013. Yellowish brown sands and gravels (context 5) were observed below a dark grey sandy silt (context 2).
- 3.3.3 No surviving palaeoenvironmental deposits that might have contained macro-botanical remains, or lacustrine (lake) deposits, were observed and no finds were recovered.

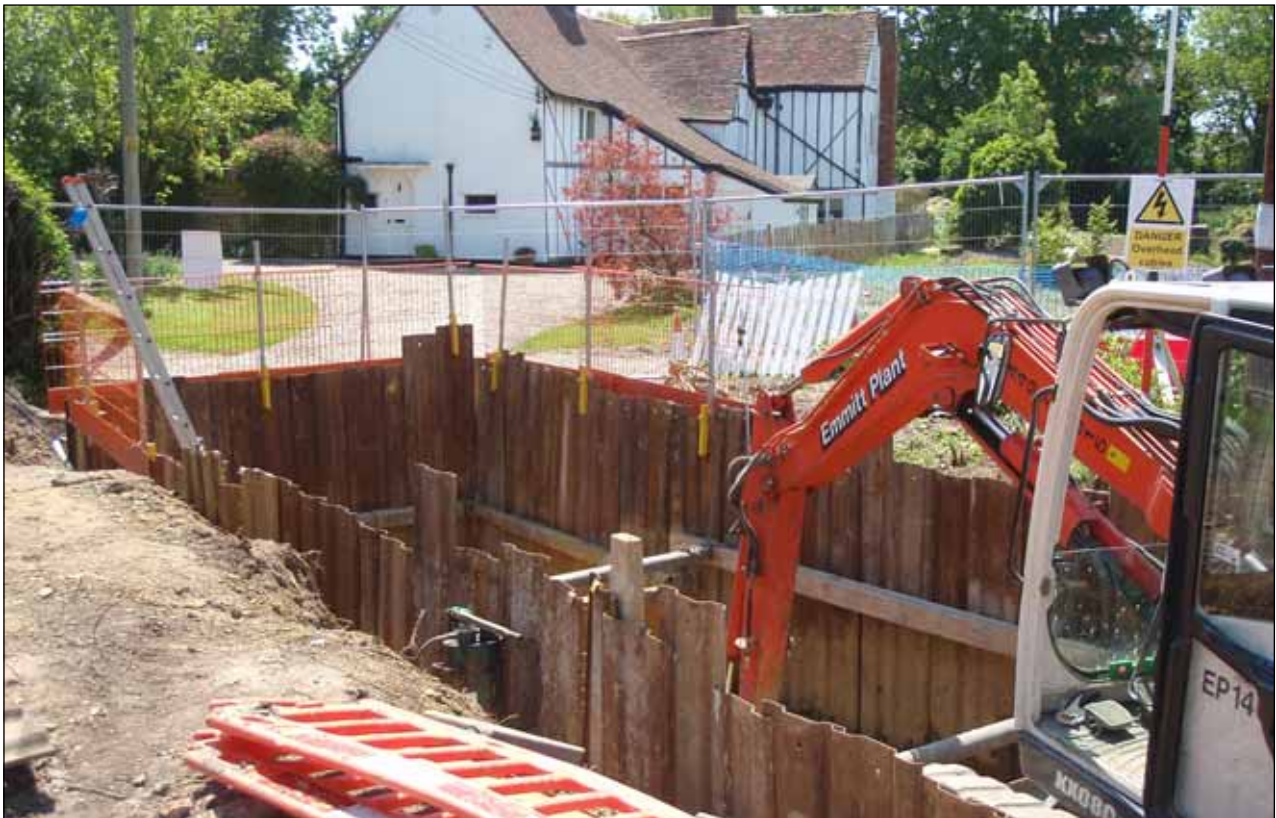
Plate 3: Tanyard Bridge excavations (with old tanyard in background)

- 3.4.1 A large excavation was observed on the 5th June 2013 on the east side of Bumpstead Brook at the Old Tanyard (Plates 3 and 4). This was undertaken in advance of replacement bridge building works, affecting an area measuring 12m x 5m. The deposit sequence was found to comprise orange and yellow brown gravels (context 5) to a height of 59.28m OD, overlain by uncompacted grey sandy silt with some flint gravel (context 2). The upper silt also contained occasional 18th to 19th century bricks and tile fragments (Plate 9; not retained) extending up to a height of 60.53m OD. This was overlain by recent made ground (context 1) to a height of 60.95m OD, capped by concrete to the present surface, at a height of 61.2m OD.

- 3.4.2 A large split wooden tree trunk (not illustrated) was found at a depth of 60.53m OD in the uppermost part of the grey silt. It was 3m long and 0.6m wide and lay level in the grey silt (context 2) with its flat side uppermost. Its long axis lay on a north-west to south-east orientation, in the northern end of the excavation, so that it lay across the path of the brook. Three smaller timbers were also recovered, also not retained, from the silt adjacent to the split trunk (Plate 10). These elements appear to have been relatively recent as they were found within the uppermost river silt close to the interface with the overlying (modern) made ground. No evidence was found that these were associated with the tanning deposits, which were located at a c.0.8m deeper level (see below) and it is likely that the trunk had been used as an informal ford across the brook (see Discussion).

- 3.4.3 The excavation was extended 4m to the north-east along the southern bank of the Bumpstead Brook on the 3rd and 4th July 2013. Yellow brown silty sandy gravel

(context 5) was observed at the base of the excavations. Overlying this deposit, from a height of 59.87m OD, was a 1m-thick layer comprising very dark grey silty sandy gravel (context 4). This deposit was notable for the quantity of horncores, other animal bone fragments (see 4.11 below) and post-medieval tile fragments; the latter not retained. Part of a 19th century leather boot was also recovered. The deposit thinned to the north-west towards the line of the Bumpstead Brook. Overlying this, from a height of 60.87m OD, was a 1.4m-thick layer of made ground (context 1) consisting of light brown silt with some gravel.

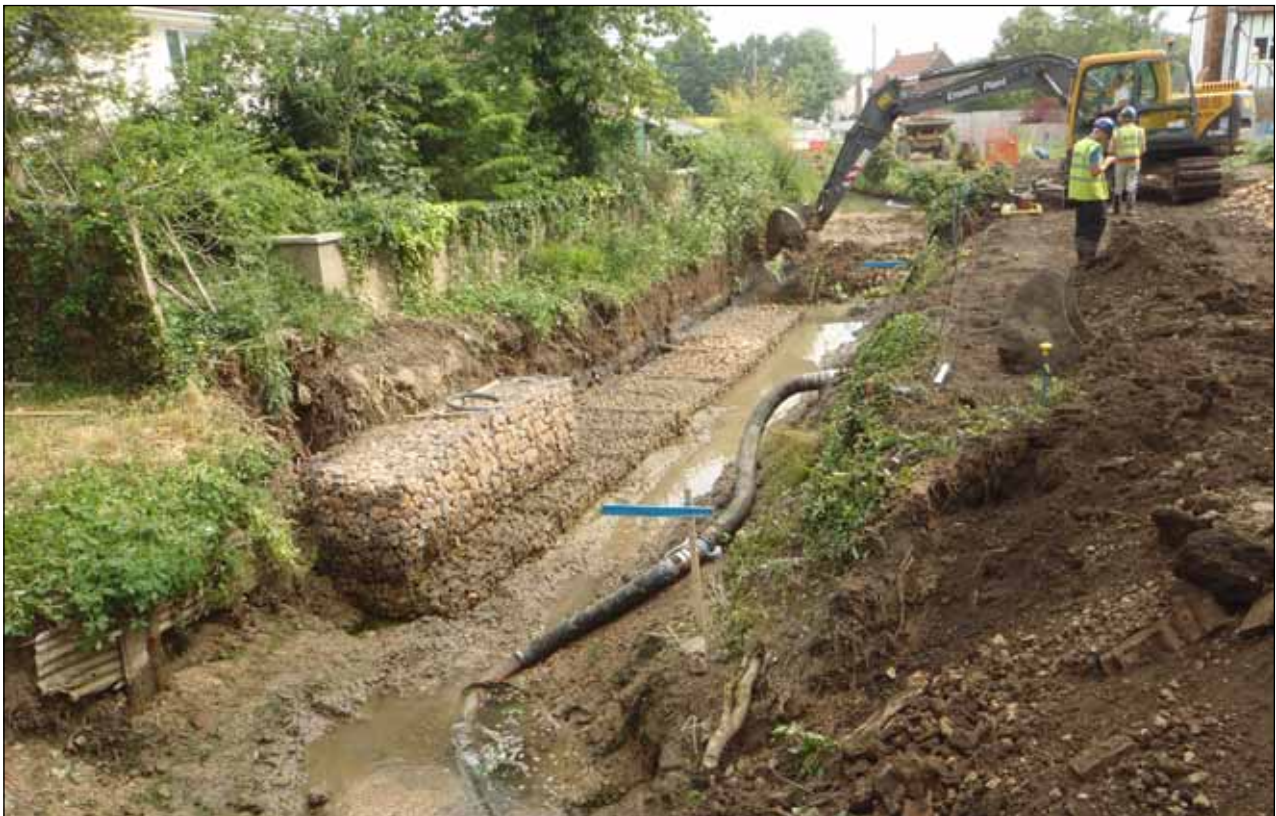
Plate 4: Bumpstead Brook widening adjacent to the Old Tanyard

3.9.1 Works to widen the brook were observed on the stretch between Crescent Bridge and Church Street Ford on 3rd May 2013 (Plate 4). Additional fragments of cow horn and bone were recovered from the dark grey sandy silt (context 2). Further widening works were observed on the southern bank between Church Street Ford and the private access footbridge on 4th July 2013 and to the south of the Water Lane culvert on 5th July 2013. Only dark grey river silts (context 2) and recent made ground (context 1) extending along the banks were observed.

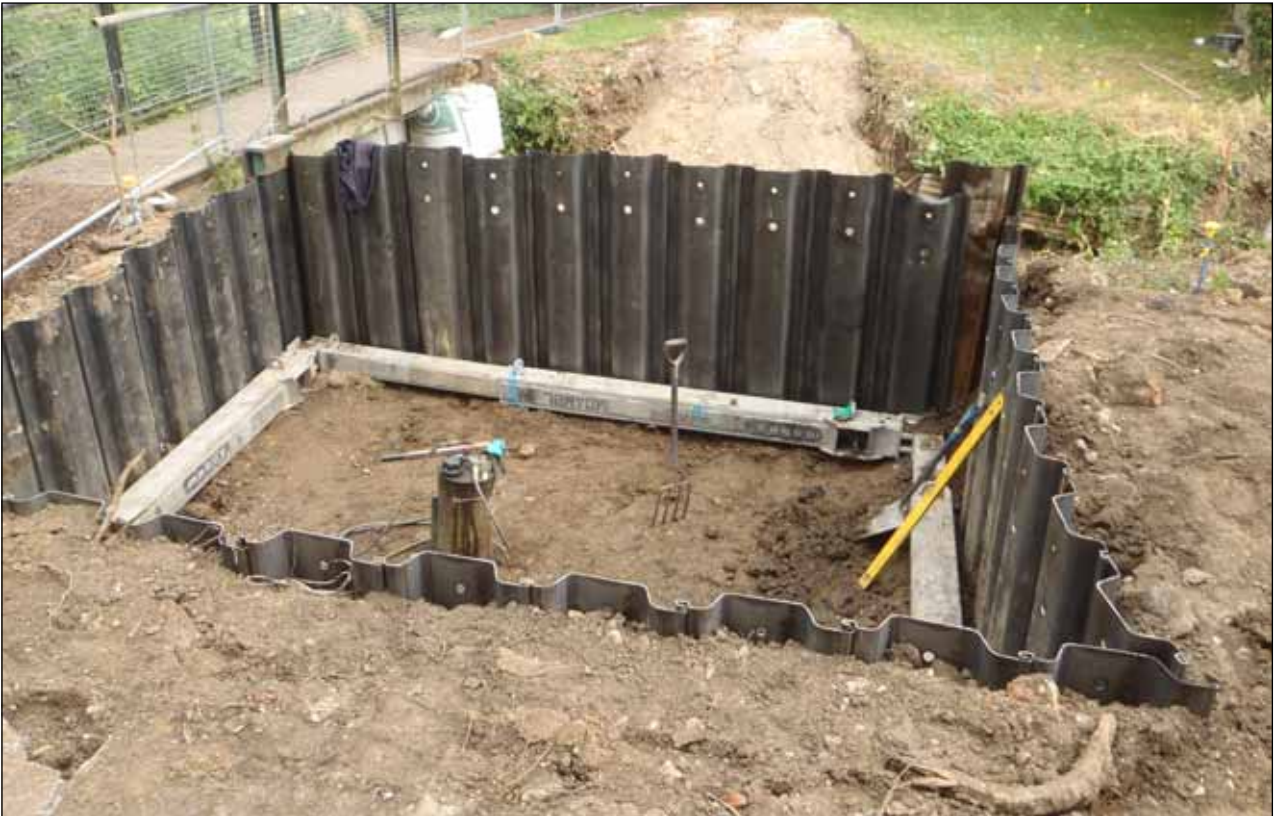
Plate 5: Excavations at the private access footbridge

3.5.1 Excavations associated with these works were observed on the 19th, 20th and 26th June 2013 (Plate 5). On the north side of the brook the base of the deposit sequence observed comprised orange brown gravels (context 5) up to a height of 60.70m OD. Overlying this was a 1.6m-thick dark silt layer (context 2) to a height of 62.3m OD. Made ground (context 1), 1.3m thick, was observed on the south side of the bank of the brook. A former revetment was observed on the southern bank consisting of wooden piles driven into the underlying gravels.

- 3.5.2 No surviving palaeoenvironmental deposits that might have contained macro-botanical remains, or lacustrine (lake) deposits, were observed and no finds were recovered.

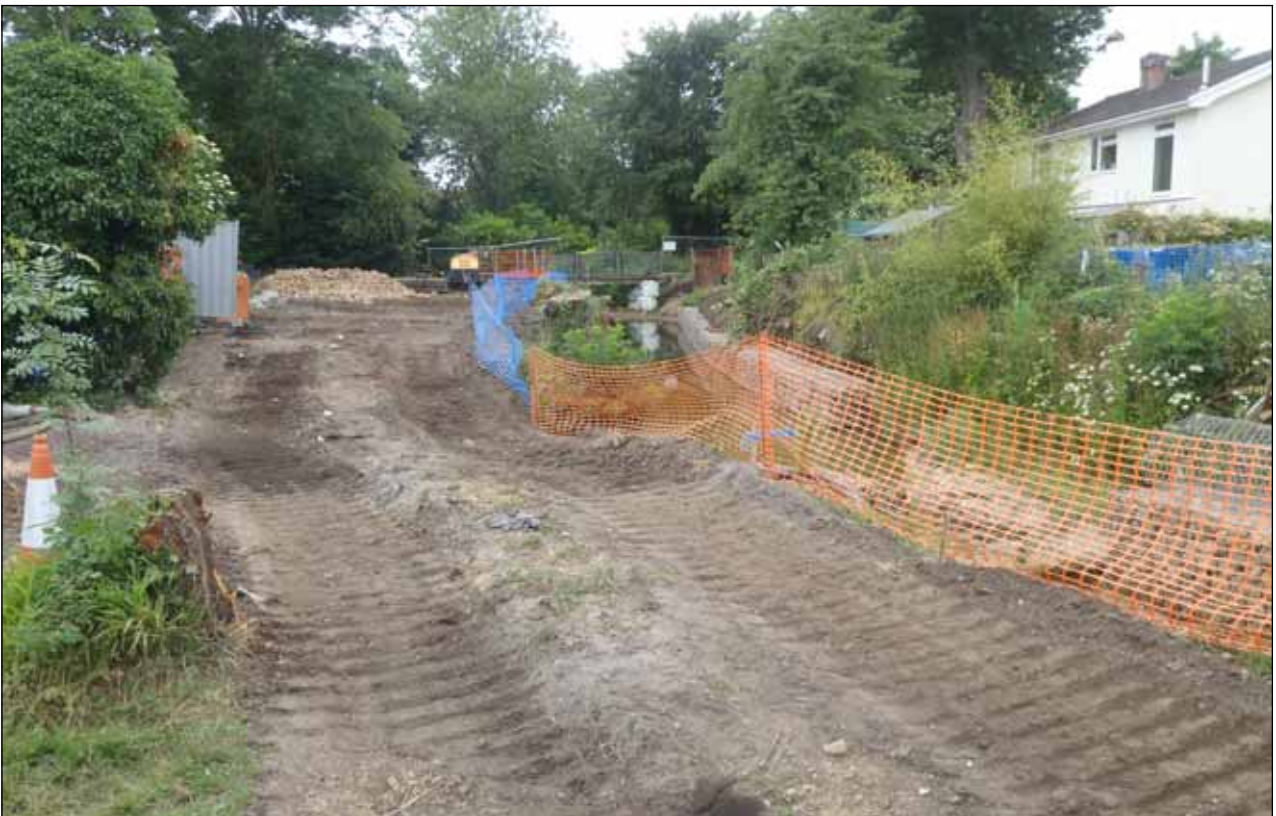
Plate 6: Churchfield footbridge excavations

3.6.1 Excavations associated with these works were observed on 5th July 2013 (Plate 6). Clean gravels (context 5) were recorded. No surviving palaeoenvironmental deposits that might have contained macro-botanical remains, or lacustrine (lake) deposits, were observed and no finds were recovered.

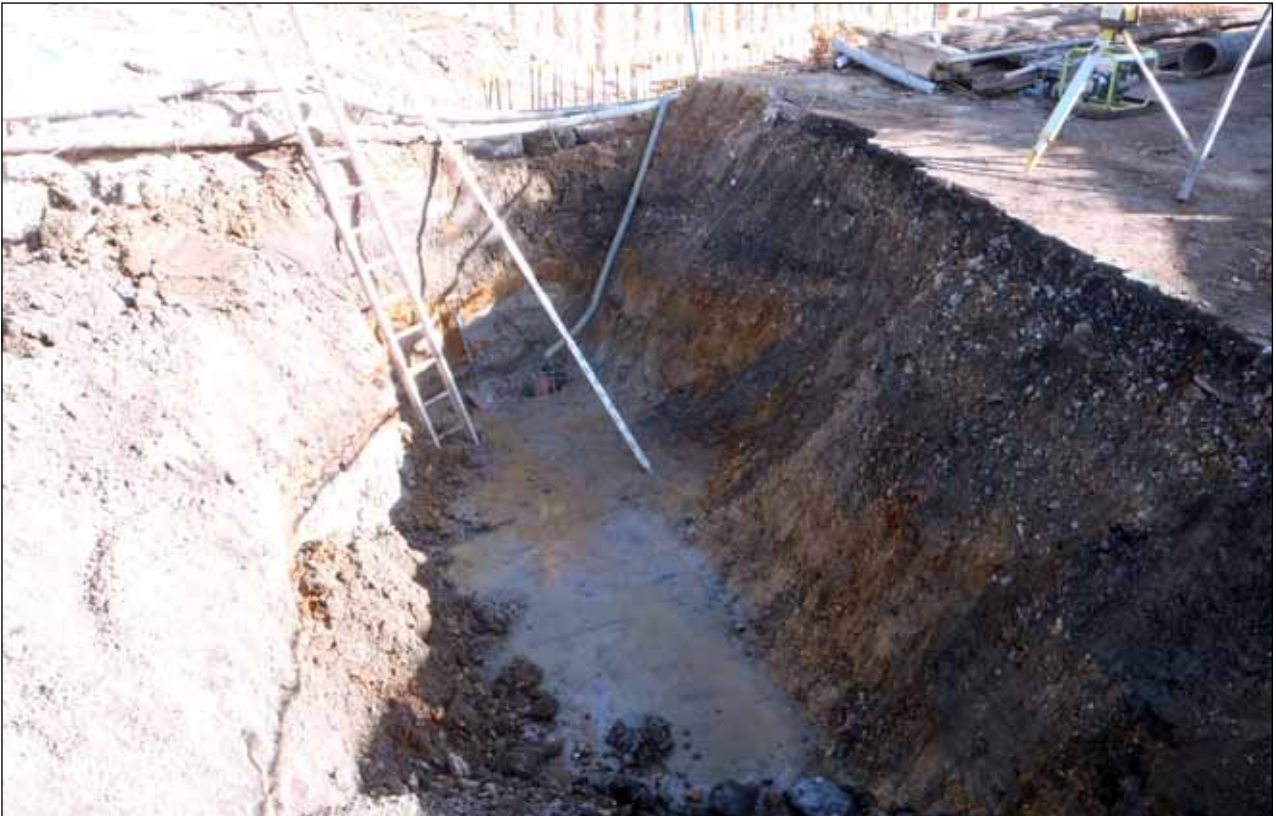
Plate 7: Water Lane culvert excavations

3.7.1 Excavations associated with these works were observed on 9th October 2013 (Plate 7). Clean gravels (context 5) were recorded. No surviving palaeoenvironmental deposits that might have contained macro-botanical remains, or lacustrine (lake) deposits, were observed and no finds were recovered.

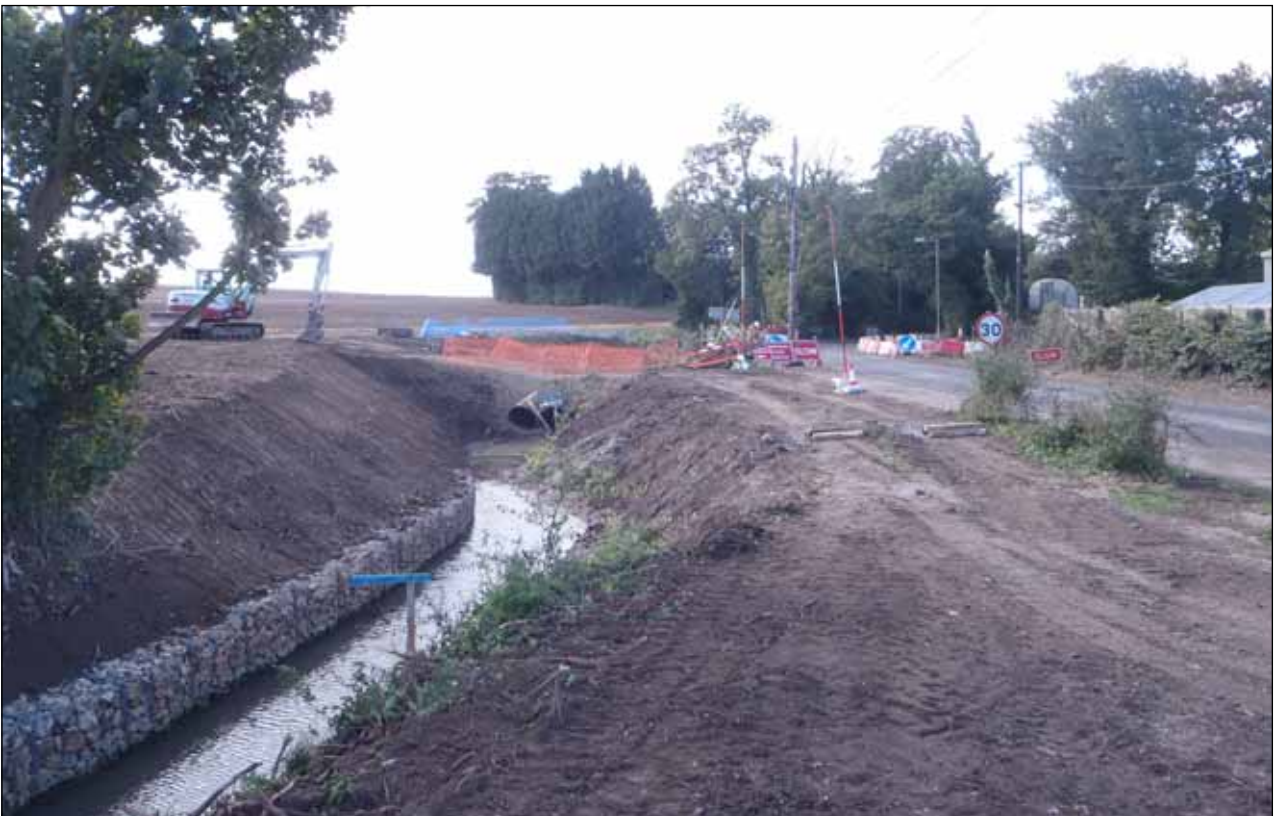
Plate 8: Helions Brook widening excavations

- 3.10.1 Excavations associated with these works were observed on 9th October 2013 (Plate 8). Clean yellow brown sandy gravels (context 5) were recorded.

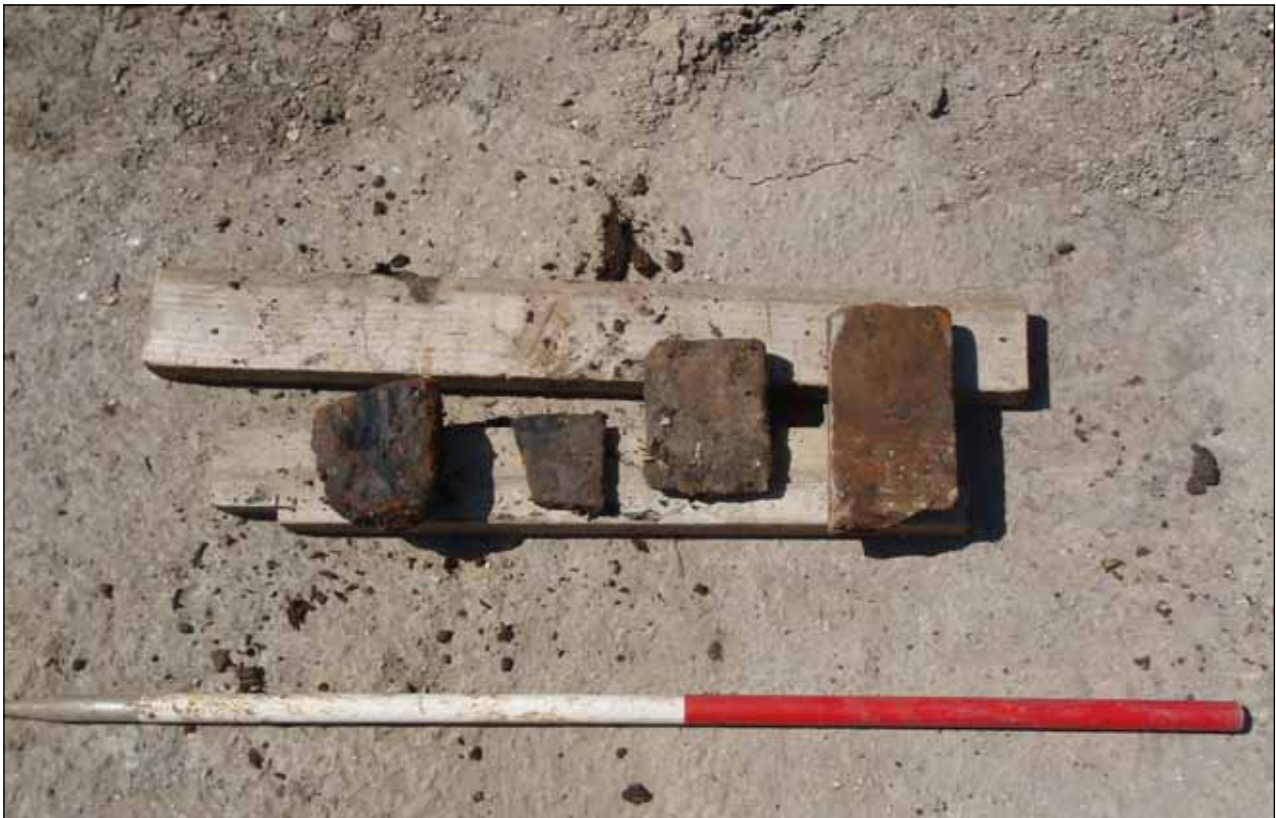
4.1.2 The split tree trunk and associated fragments of timber, brick and tile (Plates 9 and 10) in the recent river silts are considered to be part of an *ad-hoc* footbridge/ford across the Bumpstead brook, of later post-medieval to modern date, and do not appear to have been associated with the tannery.

Plate 9: 18th to 19th Century bricks and tile fragments associated with recent split-trunk 'ford'

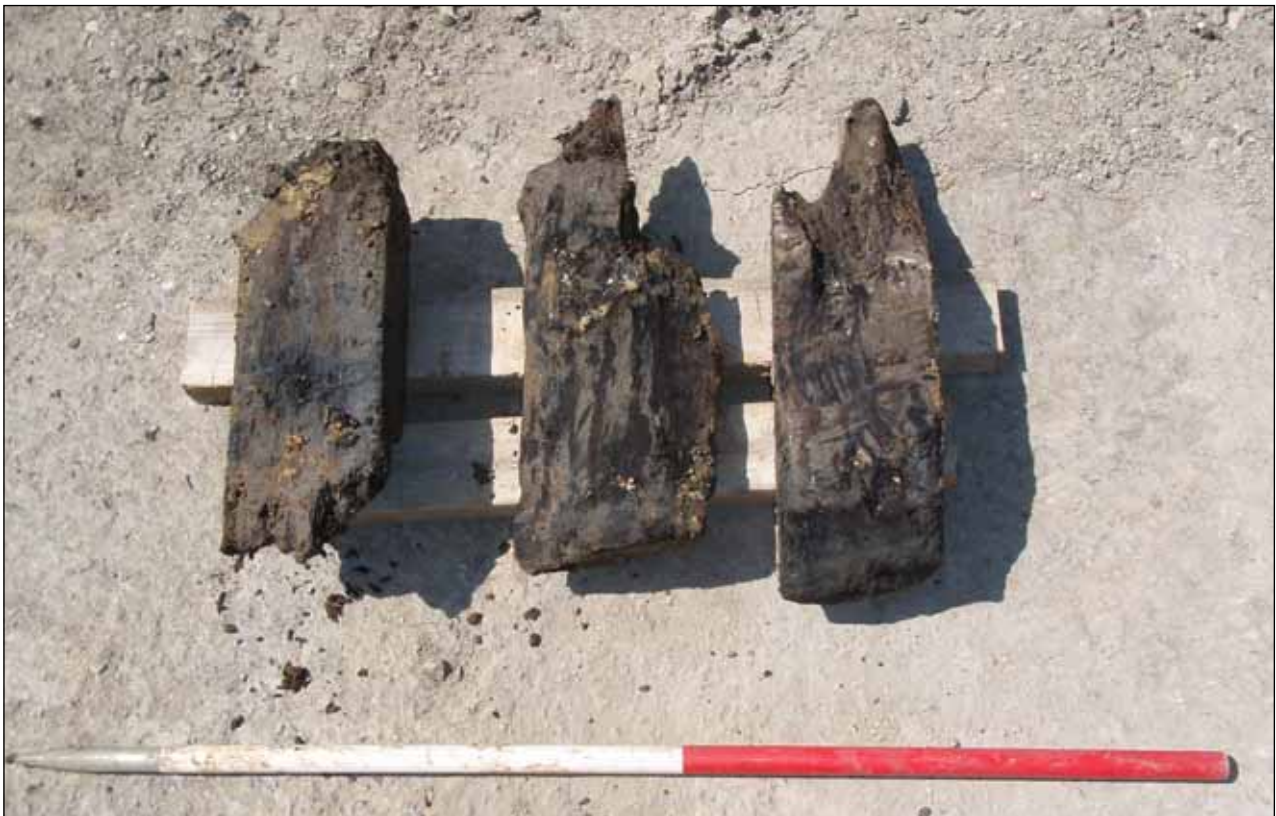
Plate 10: Three smaller timbers found adjacent to the recent split-trunk 'ford'
