KELD HEADS LEAD MINES AND SMELT MILL, WENSLEYDALE

Archaeological Survey Report

Revised June 2016

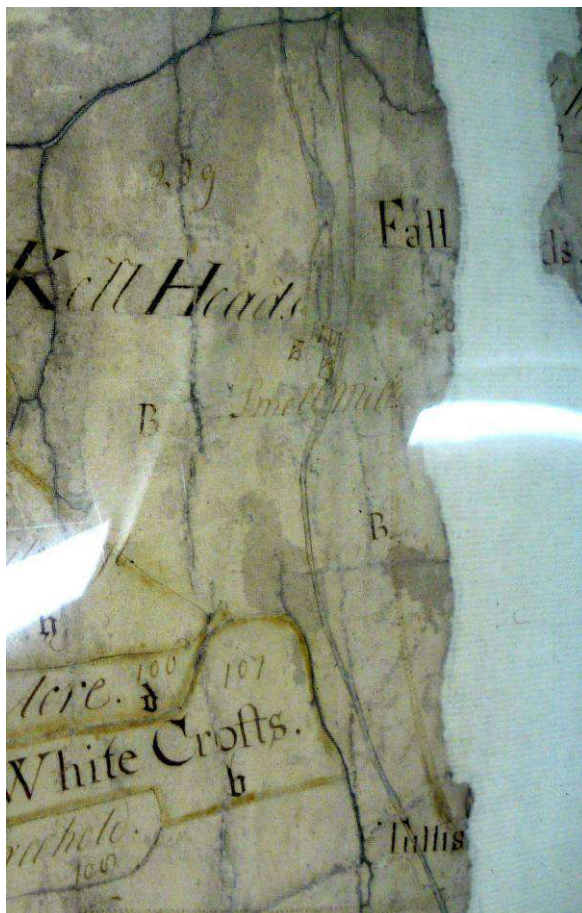
Plate 1: Wensley and Preston Estate Map - 1723 map (North)

- 3.3.1 *Plan of Wensley and Preston showing Preston, 1723* (ZBO (M) 1/1; Plate 1): this very early and detailed map shows the fields, closes, crofts and holmes with the place names Kell Heads, Tullis and Thocker (now Thowker Wood). At Kell Heads was marked the Smelt Mill with three buildings. From the dam to the north and flowing southwards were two leats; one of which entered into the small square building to the west and the second entered the larger northern east/west orientated building. The small square building to the west (Site **117**) is of interest as it is a building marked on the later eighteenth century maps and there appears to be also a building on this location on the maps of 1856 and 1866 indicating continuity of the structure. Numerous suggestions for the detailed location of the Old Smelt Mill (Site **144**) have been proposed and Mike Gill, for example has suggested that it is *c* 50m to the south of the Condenser House wheelpit at NGR 407777 491143 (Gill 1992, 115; Gill pers comm February 2015; Smith 1998, 59-61; www.nmrs.org.uk). However, in the light of the present survey, and by comparison with eighteenth and early nineteenth century estate maps, it would appear that it was beneath the later condensing house (Site **102**).

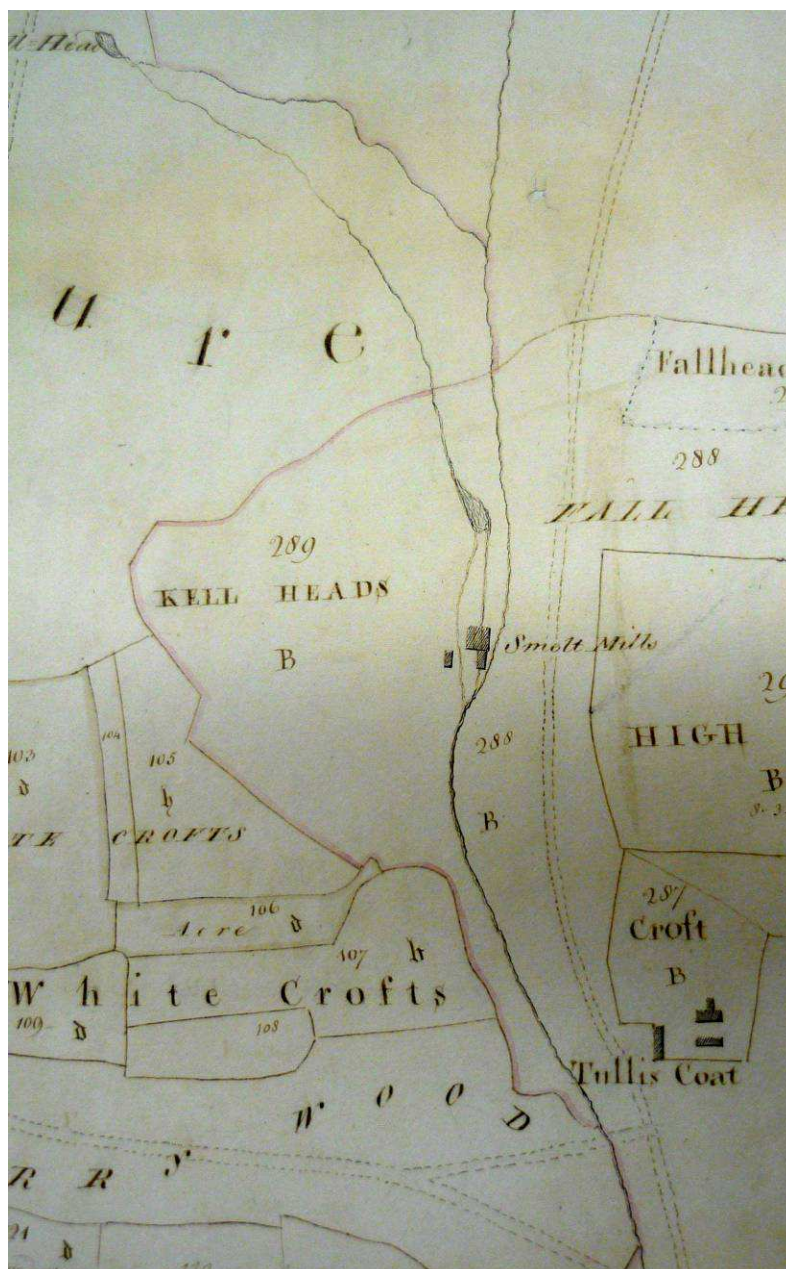
Plate 2: A Plan of the Manor of Wensley and Preston - 1778

- 3.3.2 ***A Plan of the Manor of Wensley and Preston, 1778*** (ZBO (M) 5/1; Plate 2): the map showed, a similar configuration of the three buildings of the Smelt Mill (Site 144), the building to the west (Site 117), the dam and the leats, as was found on the 1723 map. The field to the west was marked Kell Heads, and the beck flowing through the Smelt Mill was what is now known as Keldheads Gill; Tullis Cote farm and Croft were denoted to the south. Access to the Smelt Mill was along a track going northwards and east of Keldheads Gill from the east/west road to Wensley; this track continued up to Preston Moor and Leyburn Common. To the south of Tullis Cote no mining or lead mine entrances were indicated.

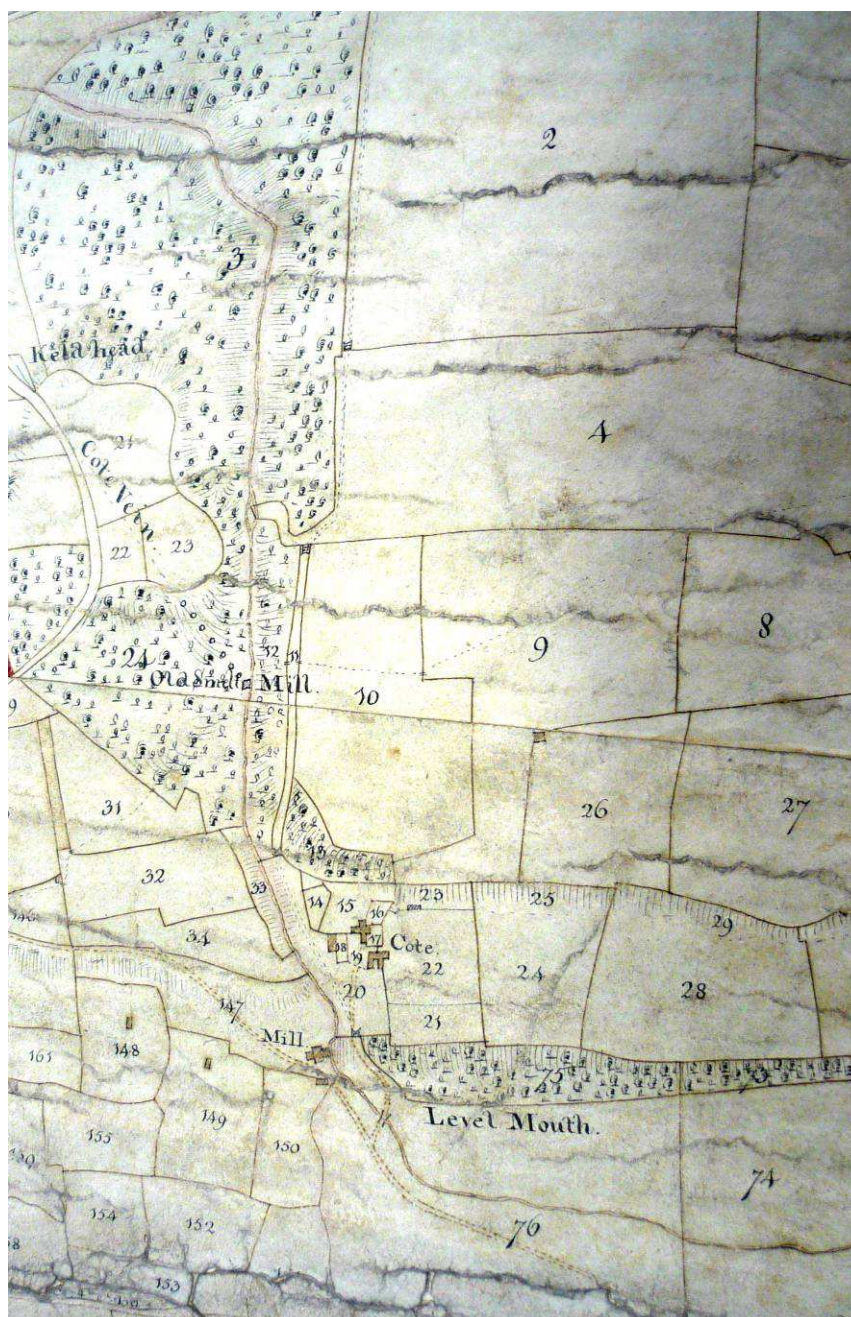
Plate 4: A plan of Lord Bolton's Mines in Wensleydale, 1828

- 3.3.4 ***A plan of Lord Bolton's Mines in Wensleydale, 1828 (Plate 4)***: this map denoted the 'Old Smelt Mill' as one small square building on the west side of a very straight Keldheads Gill. Tullis Cote farm had been developed with buildings remodelled and to the south was an area of woodland (presumably Thowker Wood) with Level Mouth marked underneath. The Cote Vein is marked as a dashed line (very faint) going very close to the Smelt Mill and then to the south-south-east to Tullis Cote and towards the name 'Level Mouth'. On this line was marked what were possible shaft mounds; six to the north-west of the Old Smelt Mill and three to the east of the gill and to the south-east of the Old Smelt Mill. No mine buildings are marked. The piece of woodland comprising Area C of the Study Area (*Appendix 1, Fig 2* (to the east of Keld Heads Lane) was shown only as mixed woodland. The road to the east of the Old Smelt Mill was shown as a walled trackway with a gate at each end (ZBO (M) 13/6).

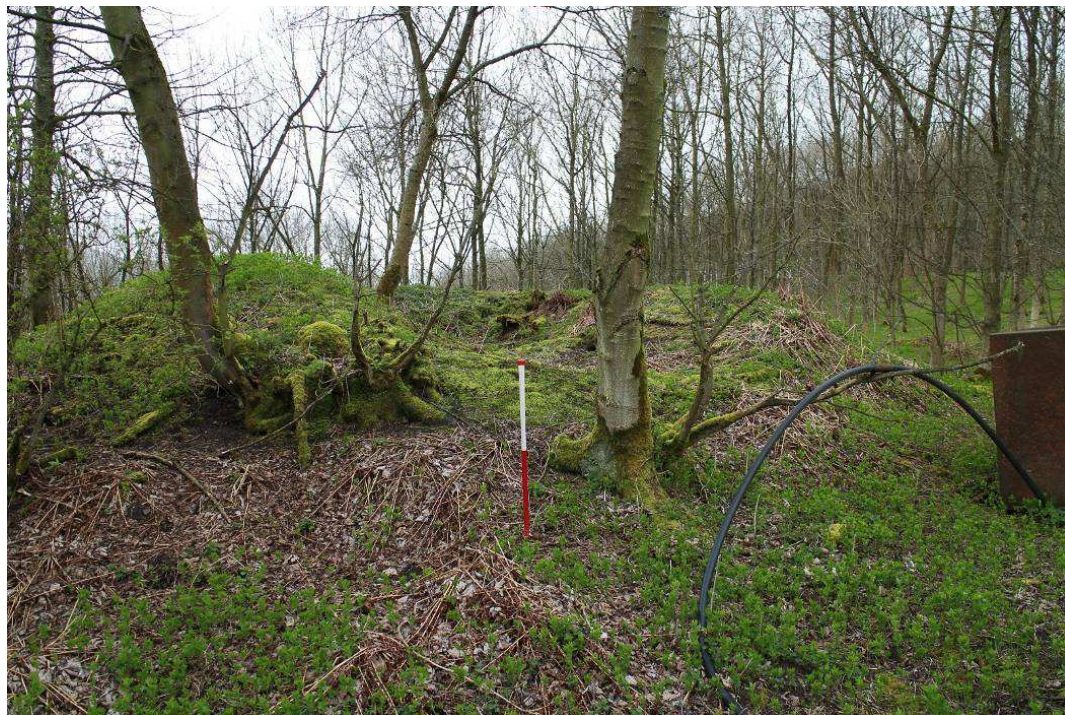
Plate 7: Shaft Mound (Site **8**)

and **8** may have been open and worked in 1856 and 1878 as they are marked as *Shafts* on these maps (but not denoted as *Old Shafts*, which they were on the 1891-4 OS map). Perhaps during the second half of the nineteenth century they were kept open as airshafts. Site **18** had two shaft mounds in an area measuring 29.5m x 19m; Site **111** had four shaft mounds in an area of 31m x 22m.

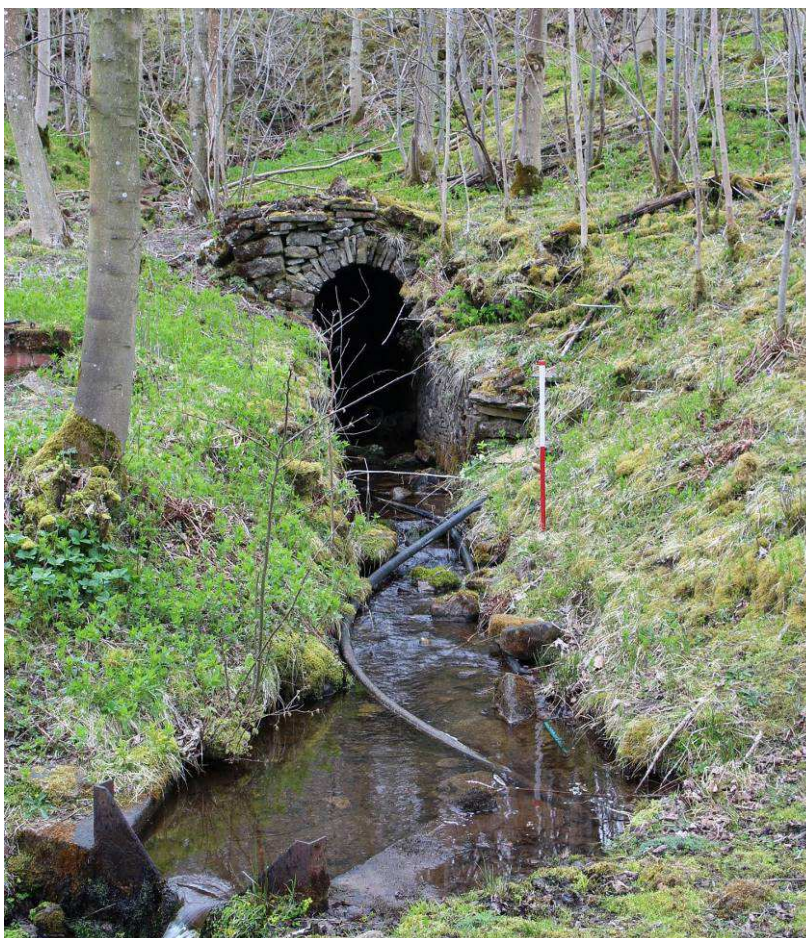
Plate 10: Adit entrance - Site 16

wall foundations enveloping the adit mouth except downslope to the south. A wooden screen was placed on top of the adit mouth and a bypass channel had been cut above it to redirect a stream away from the opening. There were fittings for a metal sluice in the channel to the south of the adit.

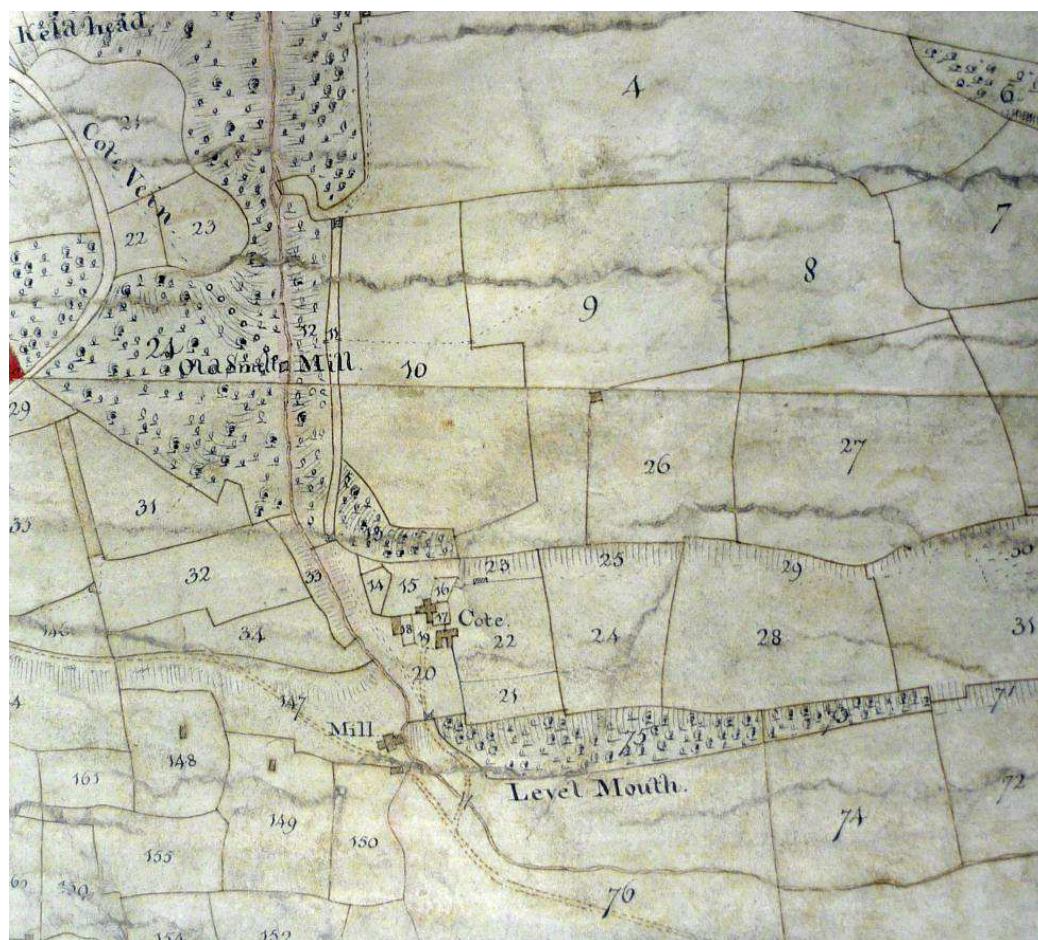
Plate 12: Extract of *Plan of Lord Bolton's Mines in Wensleydale, 1828* showing the Level Mouth south of the woodland below Tullis Cote

- 5.1.2 *The Plan of Lord Bolton's Mines in Wensleydale, 1828*: this is the earliest cartographic evidence found for mining activity in the area of the main adit (Site **55**) (Plate 12) which was later exploited by the Keld Heads Mining Company. The actual location is not clear but the *Level Mouth* is marked south of the woodlands (known as Thowker Wood on the plan of 1723 and the OS map of 1856). The adit entrance may have been on the southern edge of the woodlands and east of the track (Keldheads Lane) which goes north past Tullis Cote and on to the Old Smelt Mill.

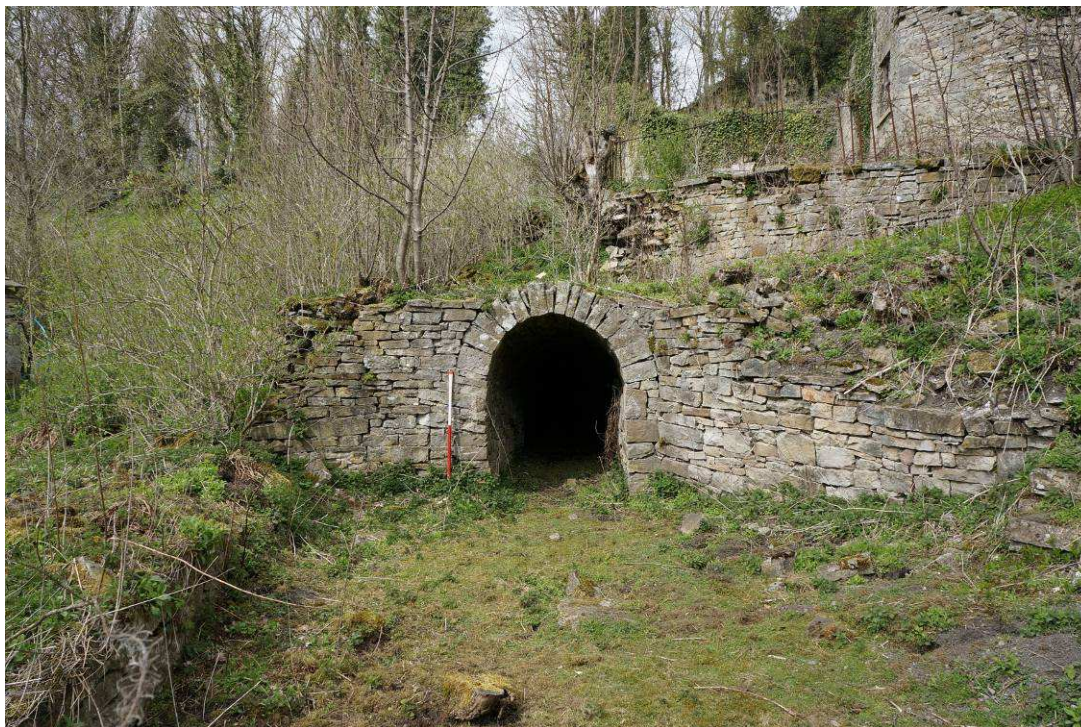
Plate 14: The entrance to the main adit (Site 55)

- 5.2 THE EXTANT BUILDINGS AND ASSOCIATED FEATURES (FIGS 9, 11, 21, 26, 28 AND 35)**
- 5.2.1 ***The Main Mine Adit:*** the mine entrance (Site 55) was marked as a small rectangular building on the 1856 map (slightly inaccurately) and then as *Level* on the 1866 map; to the west were the workshops (Site 56-9). The adit can presently be seen set into the slope of the hillside going back at least 30m (Plate 14). It is stone lined, barrel-vaulted and has a stone arch at the entrance standing at approximately 2m tall, and 1.3m wide. A retaining wall is present to the west of the arch heading across the front of the adit, which stands up to 2m high. There were also retaining walls to the east and the west. All the walls have been constructed using angular stones and the adit has also been lime mortared.

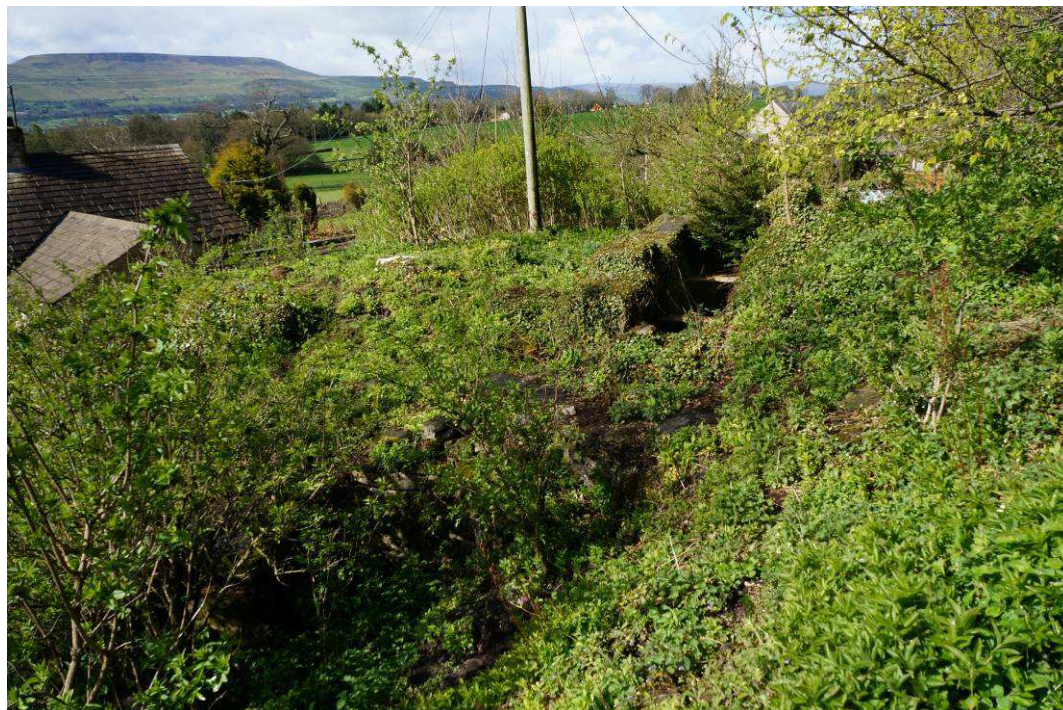
Plate 15: The wheel-pit (Site **65**) looking west

- 5.2.4 **The Wheel-pit:** a water wheel would have controlled the winding and pumping mechanisms at the mine before the engine was installed c 1878-9 (Gill 2000, 84). The extant wheel-pit (Site 65) is a stone-revetted rectangular pit, aligned east/west, partly cut into the hillside and partly above-ground; it is 13m in length by 2.7m wide. There are socket holes for various fixings include two opposing axle pads in the centre of the structure. The coursed stonework is obscured and overgrown; however, very large blocks of cut stone can be observed. Squared slots were also noted in a section of north/south walling at the eastern end of the wheel-pit (Plates 15 and 16); a row of three slots served perhaps for connecting rods linking it to the mine shaft (Site 127).

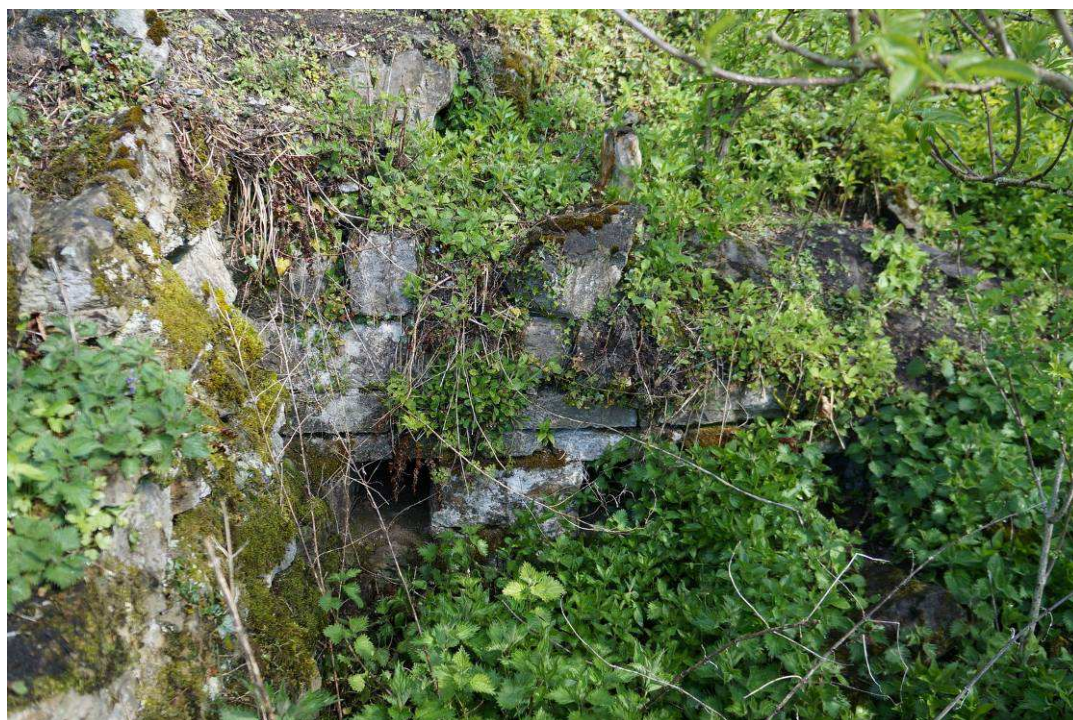
Plates 16: One of a series of square slots set into the walling at the east end of the wheel-pit (Site **65**)

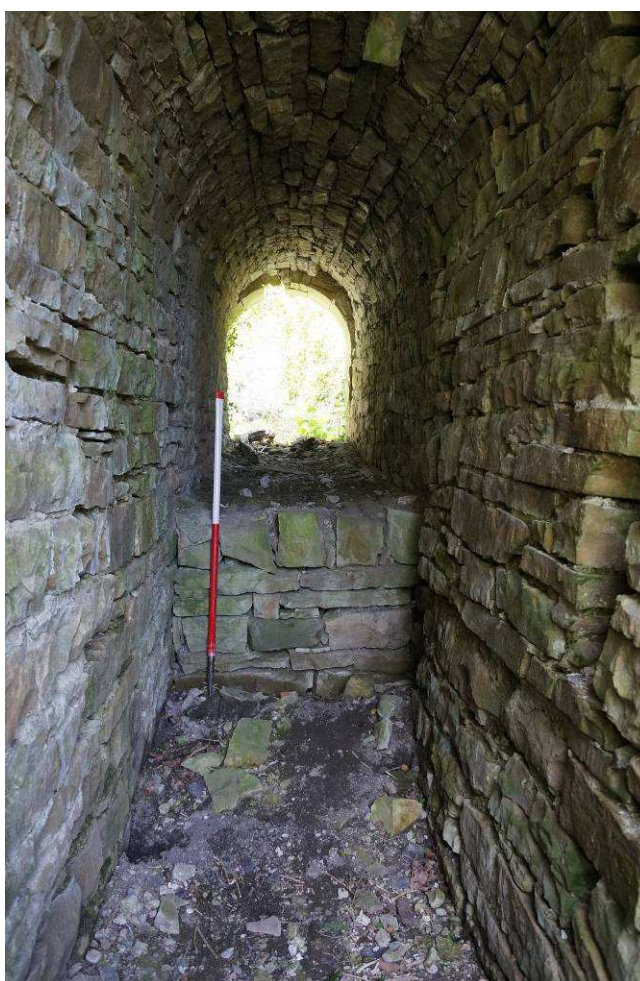
- 5.2.6 The barrel-vaulted, stone-lined tunnel (Site 67) was inserted into the revetted walls for the north/south track (going from the dressing floors, up to the Smelt Mill further up the hill) in order to create a sub-way connection between the wheel-pit and Engine House. The tunnel would have accommodated the drive shaft connecting the engine, the pumps and machinery to the mine shaft to the west (Atkins 2012, 6). It was *c* 7m in length, 1m in width and 1.5m in height. Inside was a stepped change in the floor level (to allow for the slope of the hillside).

Plate17: The barrel-vaulted tunnel (Site 67) for drive shafts/connecting rods between the Engine House and mine shaft.

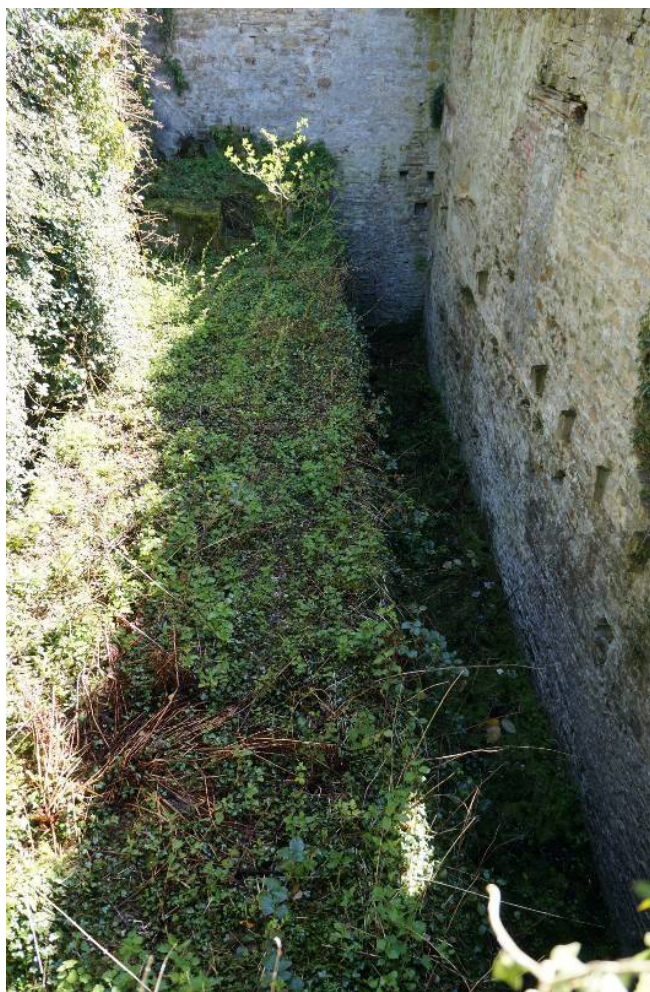
Plate 18: Interior of the Engine House (Site **66**), looking east

(Plate 18); drive shafts from the engines would have gone through the arched tunnel (Site **67**) to reach the mine shaft mechanisms. The engine bed comprised a large stone platform running the entire length of the north side of the structure and elements for securing the engine survive on the eastern end of the platform. To the south of the platform is a deep pit, which descended below ground level on the south wall adjacent to the Boiler House (Site **53**) and which probably housed the main drive wheel. The south wall between the Boiler House (to the south) and the Engine House provided apertures for points of access for machinery and connecting links between the boiler and the engine.

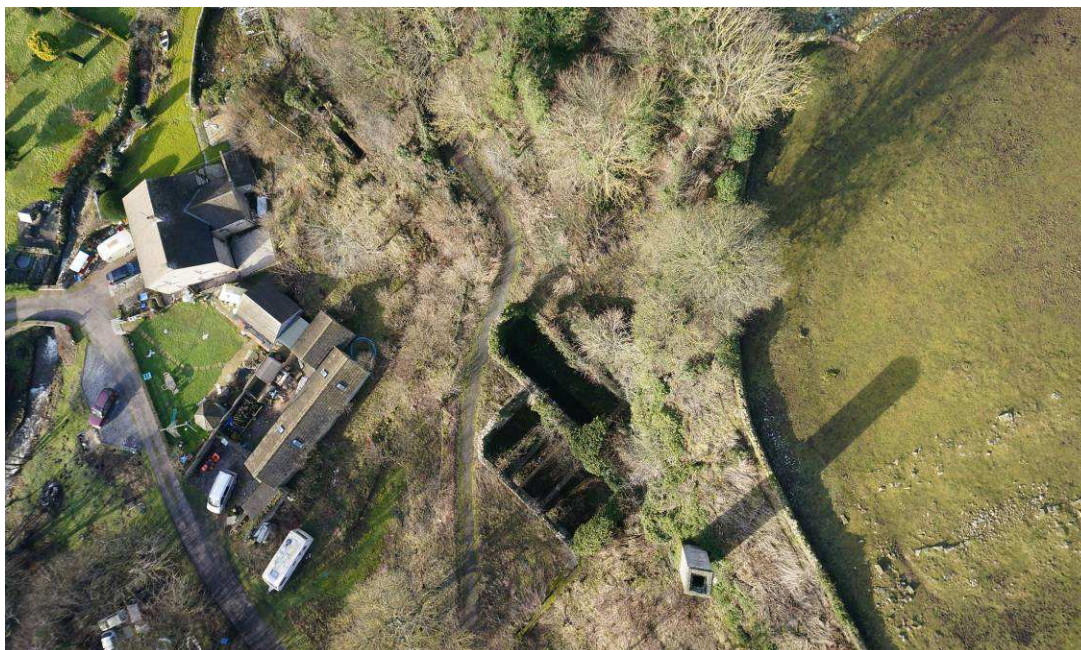
Plate 19: Aerial view of the main adit and Engine House area

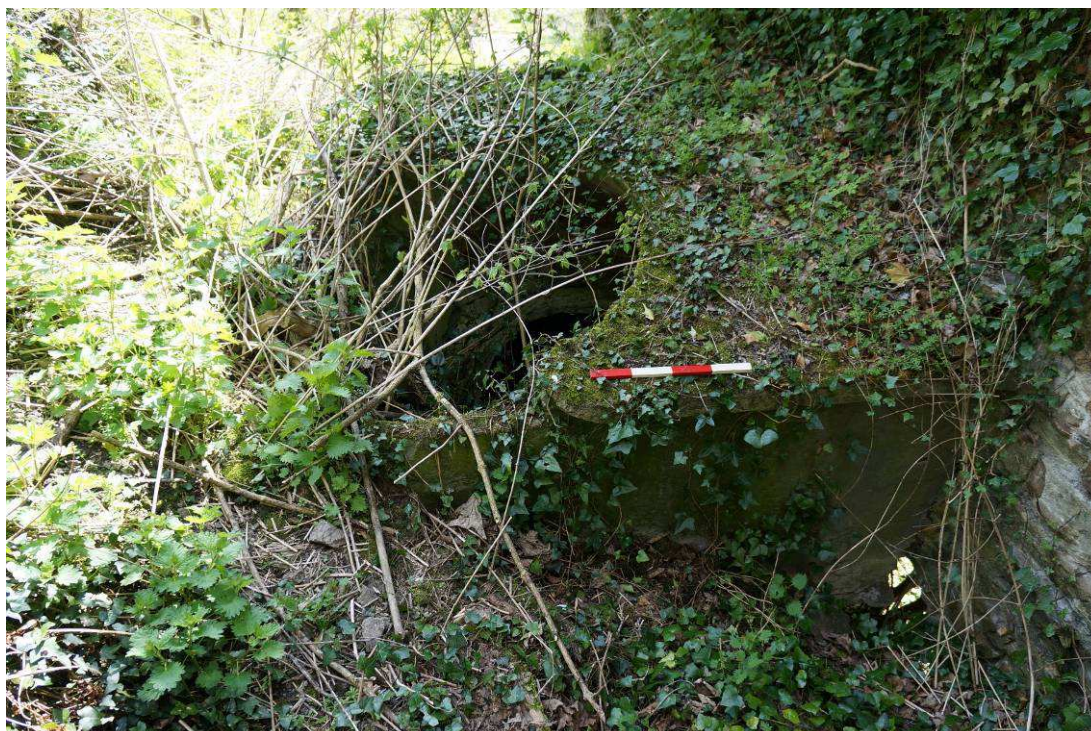
5.2.9 **The Boiler House:** the early steam engine would have required a boiler, water supply and heating; the offset rectangular building (Site 53) to the south of the engine comprised the Boiler House (Spensley 2014, 62). This is confirmed by the presence of the flue (Site 51) and the chimney (Site 52). The north end of the flue (Site 51b) abuts the Boiler House and has an entry point set into the building. The chimney (Site 52) lies 20m to the north-east of the Boiler House and has a circular opening at the south-west side of the base of the chimney, where a flue joined (Site 51b) (Atkins 2012, 7) (Plate 20).

Plate 20: The circular opening leading into the side flue (Site 51b)

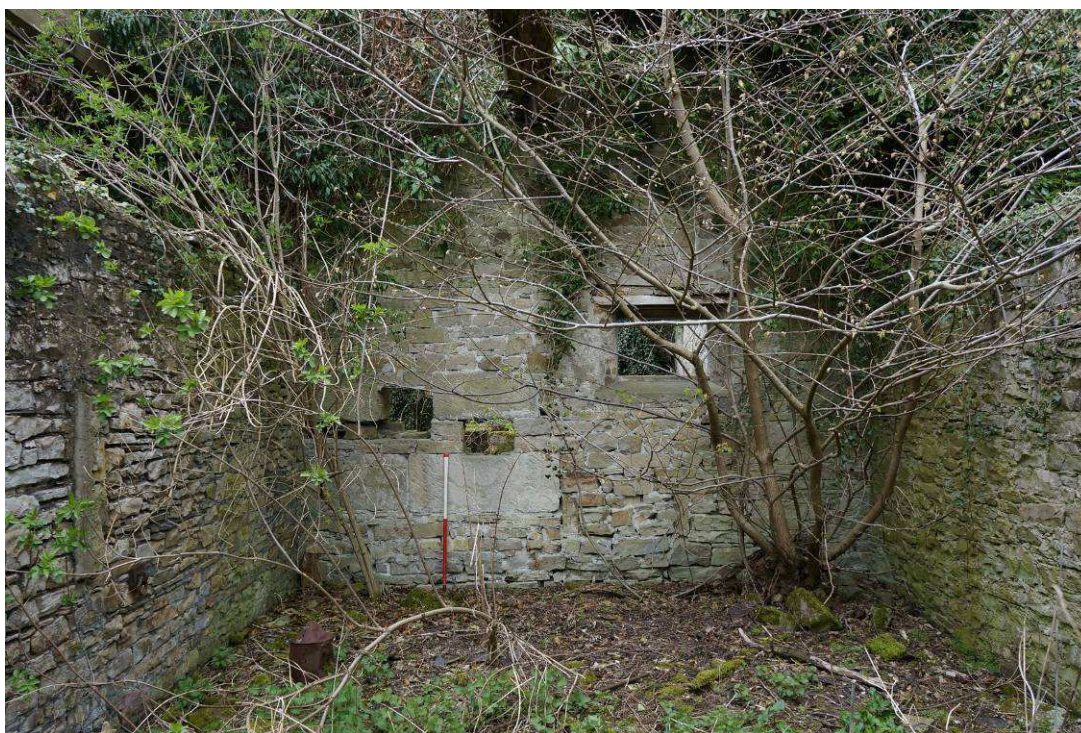
- 5.2.12 The internal walls butted against the external walls suggesting that the space was divided at a later date, and may have been when the Engine / Boiler House was converted for use as 'adjacent stables and stores..... a building with timber roof structure' (Listed Building Entry). The gable of the western cell abutted the Engine House.

Plate 21: The interior of the central cell of the Boiler House (Site **53**), looking north

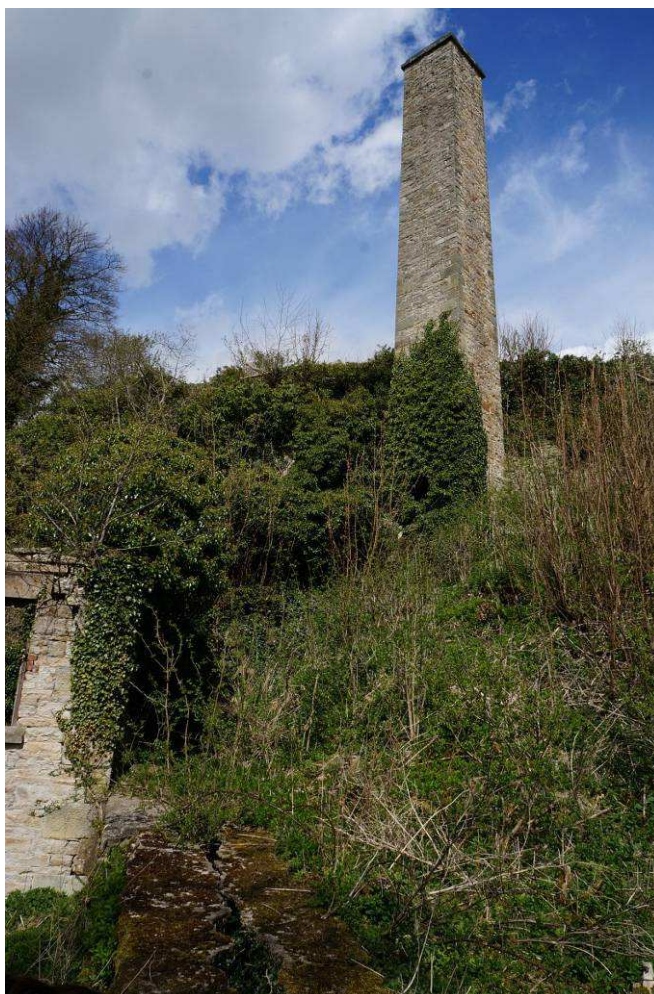
2.5m in plan and 16.5m in height (Atkins 2012, 7) (Plate 24; Fig 27)). It is well constructed with quoin stones up to half way from the base. It had a circular opening at the south-west side of the base of the chimney, where a flue (Site **51b**) once joined, from the Boiler House (Site **53**).

Plate 24: The chimney (Site **52**) and flue (Site **51a**) looking north

A building survey should be undertaken of the Grade II Listed Engine House, Boiler House, wheel-pit, and adjacent chimney (Sites **52**, **53**, **65** and **68**) to provide a mitigative record and a structural survey report would be needed to advise on any consolidation work to the structures. Stabilisation of the wheelpit (Site **65**) should include half filling it with rubble to support it from future collapse. The concrete flue (Site **51a**) leading up to the chimney is fractured and is also a hazard, and it may need capping with concrete. There is little surface evidence surviving for the mine shaft (Site **127**) between the wheelpit and Engine House, and probing may be required to identify the structure/nature of any capping over the infilled shaft.

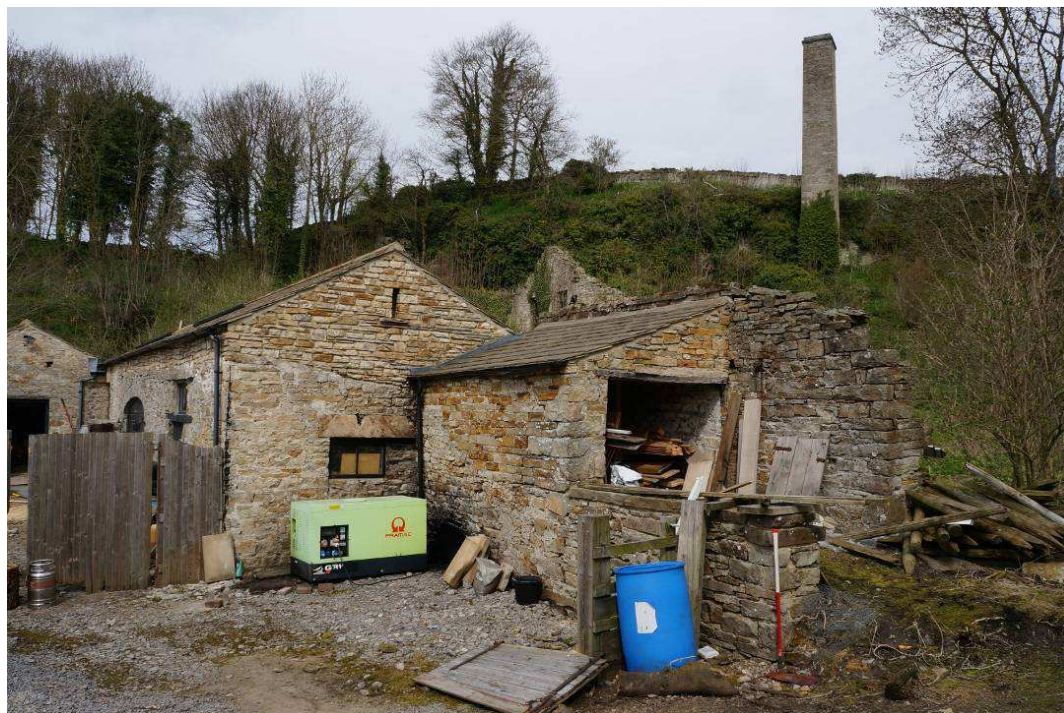
Plate 25: The workshops looking north-east (Sites **56-9**)

- 5.2.14 **The Workshops:** the workshops (Sites **56**, **57**, **58** and **59** (Plate 25)) comprised a series of buildings immediately to the west of the main mine adit (Site **55**) and south and east of the drainage adit (Site **63**) and are clearly depicted on the 1866 plan as separate buildings, lean-tos or extensions (Fig 37). In addition, there is a photograph showing the workshops that was probably taken around the start of the twentieth century (Section 3.3.24: Plate 6).

- 5.2.15 A small building (Site **59**) on the west was, in the 1866 plan, directly linked, via a retaining wall, to a walled area Site **64**. The building is now a small lean-to abutting the west side of a larger rectangular workshop building (Site **58**) to the east. The two larger buildings were orientated north/south and shared a long wall. The western building (Site **58**) was offset with respect to the eastern buildings (Site **56a** and **56b**), and was depicted as a long building on the 1866 plan; it is still extant as a long rectangular barn with a large, arched, entrance on the western side with three windows. The buildings to the east were depicted as three separate 'cells' on the 1866 plan, with two to the north (Site **56b**) and one to the south (Site **56a**). The sunken area to the north of the building (Site **56b**) was possibly the remains of two small yards or bins, although on the 1866 map it was depicted as part of the 'workshops' buildings. The southern element (Site **56a**) was originally depicted on the 1866 map in a historic photo (Plate 6) as having a large chimney attached to the north end, but now largely gone. In the angle between these two buildings was a small square building (Site **57**) which was a single story lean-to, butting against the western gable end of Site **56a**, and its northern end abuts Site **58**.

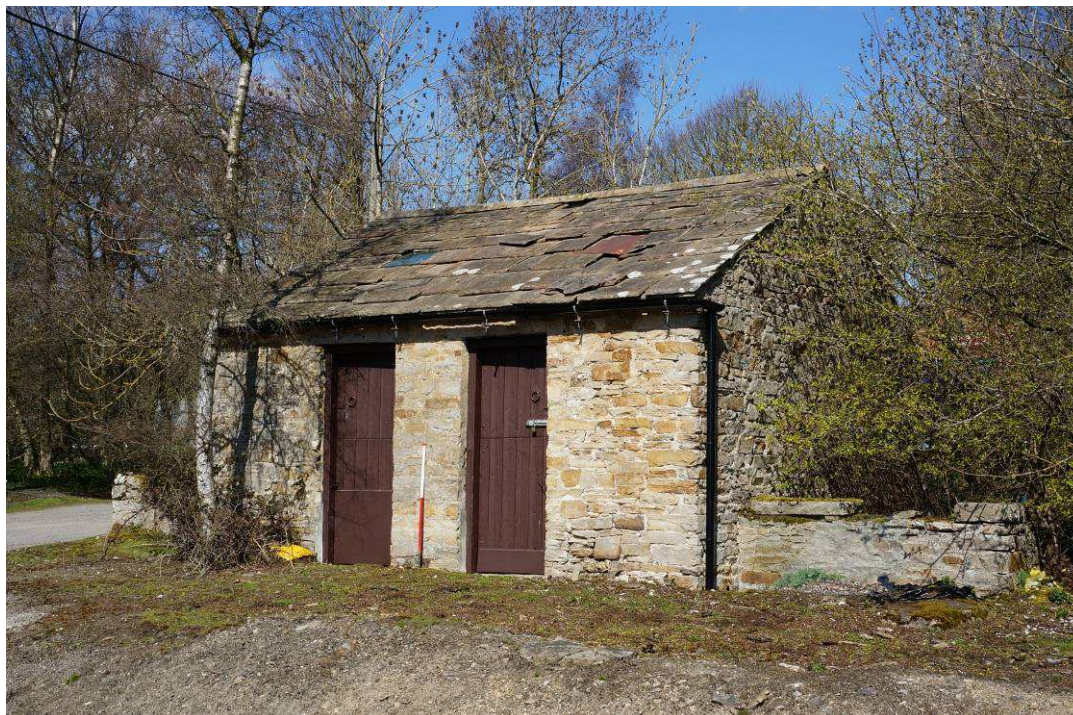
Plate 26: Early dressing floor building (Site 43)

- 6.1.2 The earliest features on the site were a pair of buildings (Sites **43** and **125**) shown on the 1856 OS map, of which one (Site **125**) is no longer extant, and indeed had gone by the time of the 1866 mine map (ZBO (L) 19). The other building (Site **43**) is still extant (Plate 26) and is the earliest surviving feature within the complex. It is a small (5m by 4.5m) square, stone-built, single-storey building, constructed using rough angular stones and lime mortar, and presently has a slate roof and two doors on the south side. The remains of two walls flank either side of the building, and butt against the standing structure. The function of the building is uncertain, but it can be conjectured that it related to ore dressing. It is immediately north of the later dressing floor (Site **33**) that was first depicted on the 1866 mine map, and its southern wall is parallel to the walled enclosure around the dressing floor (Fig 37). It is possible, however, that there was an earlier dressing floor in the area, and although there was not one specifically represented on the 1856 map, tracks and probable spoil heaps seem to extend around the area containing the two buildings, suggesting that this was the site of a small-scale manual dressing operation. Only a year later than the OS map, in 1857, the Ripon and Richmond Chronicle detailed an account, entitled 'Improvements at the Keld Head Mines' (Spensley 2014, 63-4), which describes an intensive mechanical dressing operation and the description corresponds with the features shown on the 1866 mine map. The implication is that this was an improvement of an earlier dressing operation. By the time of the 1866 map there was a further small building depicted extending out from a wall that was shown to extend between an area of bouse teams and the dressing floor. There are fragmentary remains of a curvilinear retaining wall (Site **44**) which corresponds to the historic boundary wall; it stands up to 0.5m high and is 0.4m wide. There is at least one wall stub surviving for a further building, which was shown on the historic OS mapping.

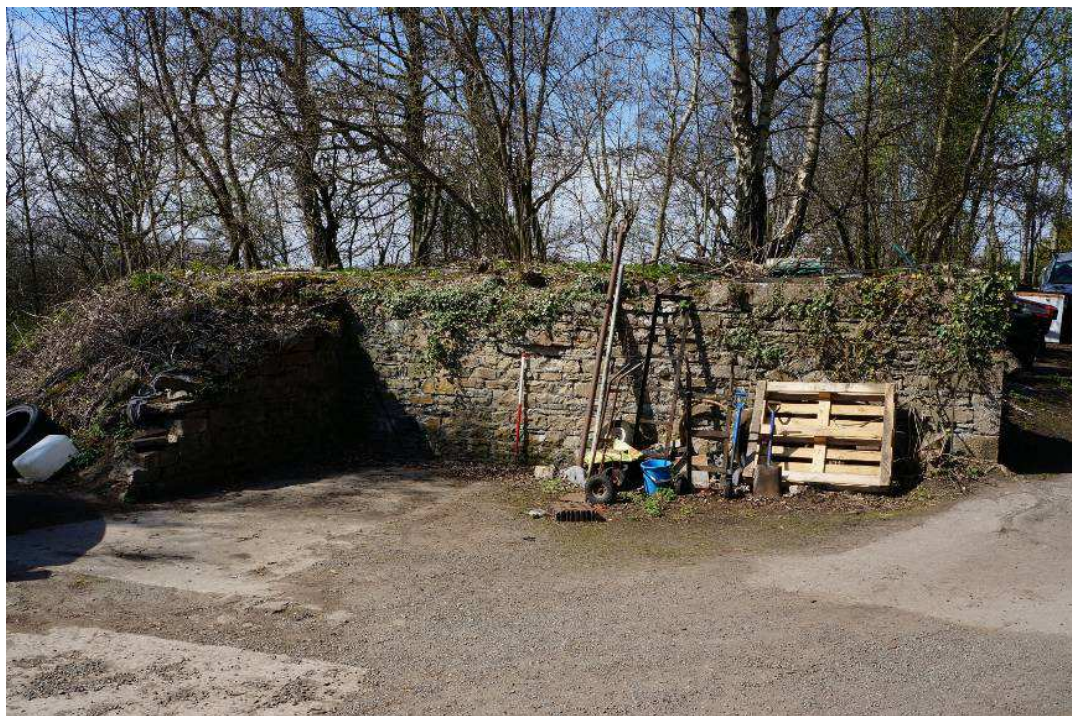
- 6.2.2 The 1866 map (ZBO (L) 19) showed two adjoining small rectangular buildings, south of the bouse teams and set into the corner of a rectangular compound. These approximately correspond to two parallel concrete pads (Site 46a) observed during the survey and are possibly the remains of the floors of the two buildings shown on the 1866 map (Plate 27). The east pad measures 3m by 4m and the west pad is slightly larger at 4.5m by 3m; both pads are flush with the current ground surface. The level foundation of a north/south dividing wall, measuring 0.5m wide, is present

between the two pads, and a partially extant L-shaped retaining wall (Site **46b**) forms the south-west corner of the building. The wall is made from rough, angular stones with lime mortar and it stands to 1.3m high and is 0.4m thick. These pads have a slightly different orientation to that of the buildings shown on the 1866 map and it is therefore possible that they were later structures that related to the later power house (Site **48**) rather than to the bouse team complex.

Plate 27: Southern area of bouse teams and the site of a former building (Site **46**)

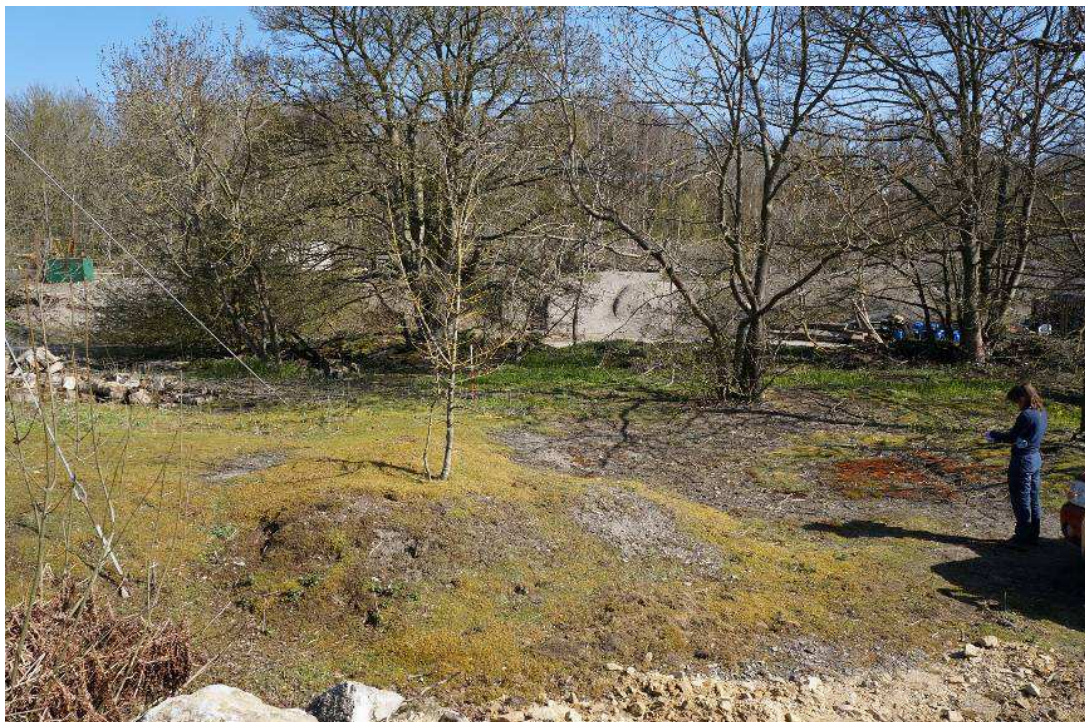
Plate 28: Lower dressing floor, showing the surviving earthworks (Site 33)

6.2.3 **Dressing Floor:** a further tramway was shown on the 1866 mine map (ZBO (L) 19), which extended south-east from the base of the bouse teams, taking the stored gangue, onto a rectangular dressing floor platform and directly to a crushing plant adjacent to a large wheel-pit. The water supply for the pit was shown as a probable launder extending from the area of the bouse teams (Site **50**) but there was no tail race depicted; however, it is probable that the water was then re-used for the hotching tubs and buddles. There are presently slight earthworks consisting of fine silt waste overlying the wheel-pit and crushing plant (Site **33**; Plate 28) and there is a mound with three large retaining bolts, which stand upright (1.25m high) and are 0.95m apart (Site **33d**); they approximately coincide with the southern edge of the crusher.

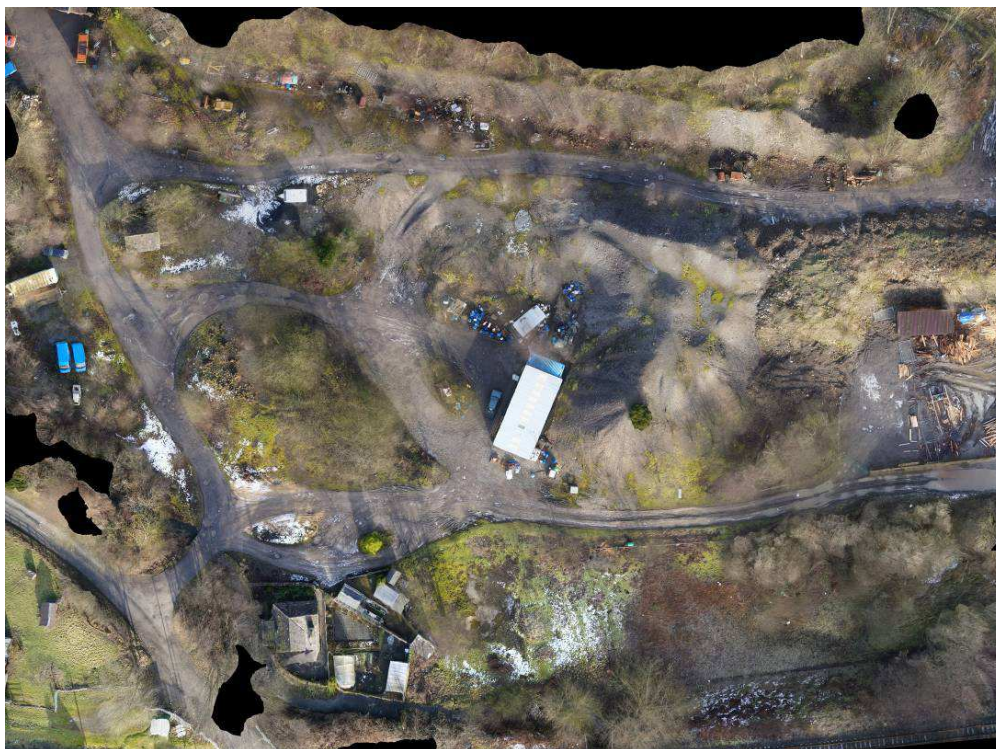
Plate 30: Aerial view of the southern spoil heaps and dressing floor

6.3.1 **Spoil Heaps:** the 1895 map indicates that by this date the spoil heaps had reached their present extent (Fig 6; Plate 30); however, at that date spoil mounds (Sites 40 and 42) were a single spoil mound and the tramways of that date showed that they had been feeding spoil to the southern part of the large spoil mound (Site 40). At some date, between the 1919 OS map and the 1953 OS map, an east/west railway siding (Site 41) had been established, in order to carry stone, via the aerial ropeway (Site 141), from the Preston-under-Scar limestone quarry. This extended east/west, terminating at a point just to the north of building 43. This had entailed the excavation of a large cutting through the spoil heap, and now gives the false impression that there had originally been two spoil heaps (Sites 40 and 42), when the reality that it was originally one (Plate 31). Some wooden sleepers survive along the alignment of the railway line (Site 41a) as well as a single mine wagon (Site 41b). The overall spoil heap (comprising both elements Sites 40 and 42) was over 165m in length and had fanned out to a width of 80m near its eastern end. At its highest it was up to 10m in height, again at its eastern end. The layout of the southern element of the spoil heap (Site 40) had been deliberately designed to avoid the area of the dressing floor, indicating that the dressing floor was still being used up until the final years of the operational life of the mine.

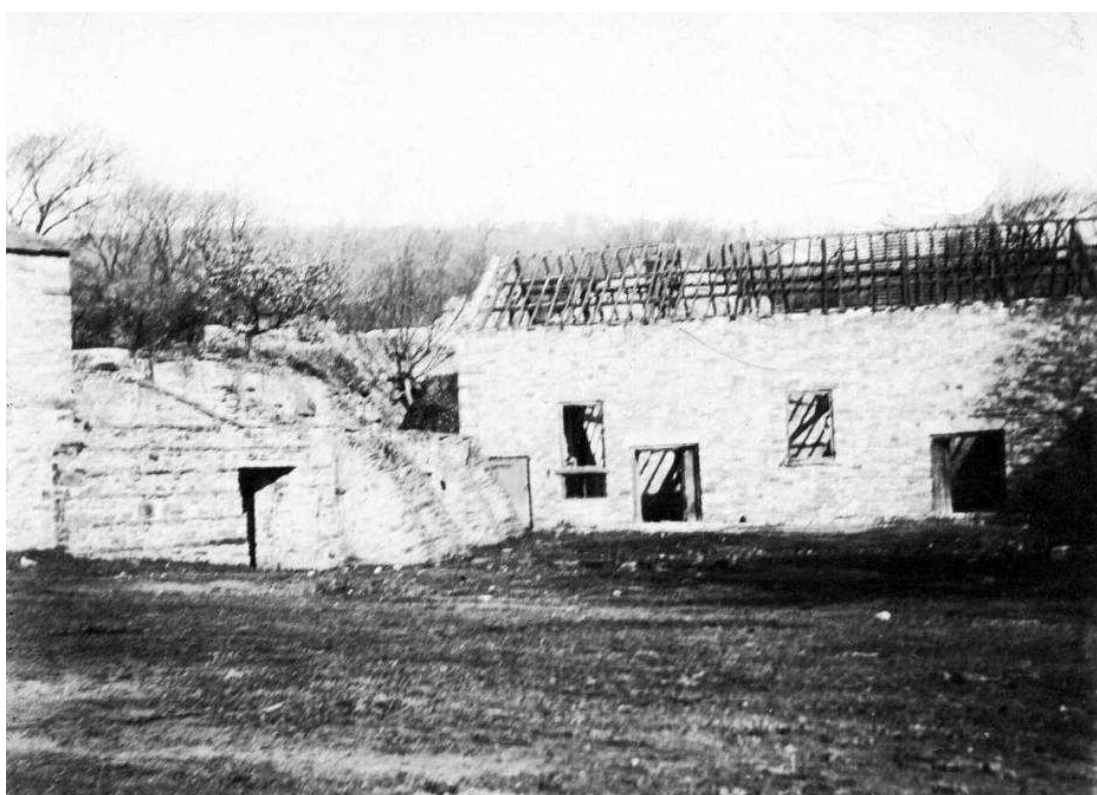
Plate 32: Photograph of the south elevation of the Smelt Mill (NMRS *RT Clough Collection*). The photograph is taken from grid reference 40781 49102 and is looking south-west.

- 7.1.6 ***The Photograph of the Smelt Mill (undated) (Plate 32):*** this showed the south elevation with storage bins to the west. The south wall had at least two large, wide doorways with windows or openings above and to the west of these. The storage bins had curved or buttressed side walls with, probably, two side walls and a back wall with the fourth side or front remaining open for uninhibited access; however the southernmost outbuilding or store on the photograph had a wide doorway (NMRS, *RT Clough Collection*).

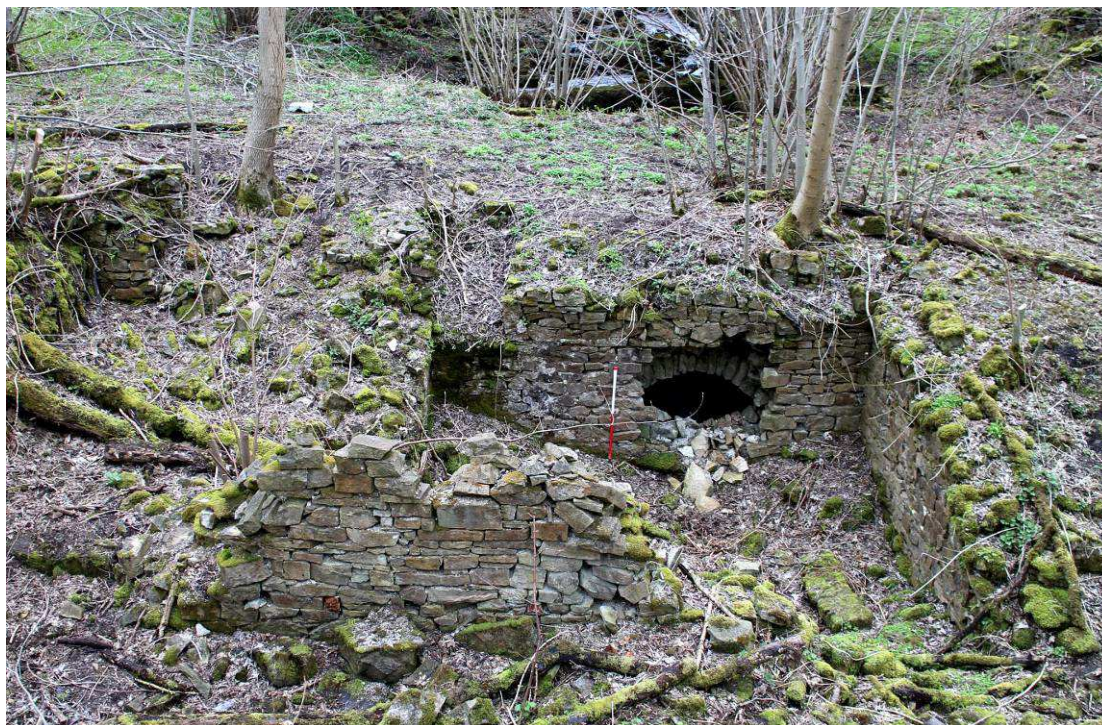
Plate 36: The Smelt Mill ore bins (Site **75a**) looking north

The structural integrity of the culverted tunnel (Site **134**), carrying Keldheads Gill beneath the Smelt Mill, needs to be ascertained. Visible damage is limited to part of an ore bin wall (Site **75a**), which has collapsed into the tunnel; any future collapse of this tunnel may lead to a backflow of water that may cause flooding and erosion of the site. Some consolidation works will be required of the north elevation wall of the ore bin. Unstable capping stones and side walls of some of the Condenser Flues channels (Sites **6f** and **6g**) will need removing or consolidating as they are a clear health and safety hazard.
