KELD HEADS LEAD MINES AND SMELT MILL, WENSLEYDALE

Archaeological Survey Report

Revised June 2016

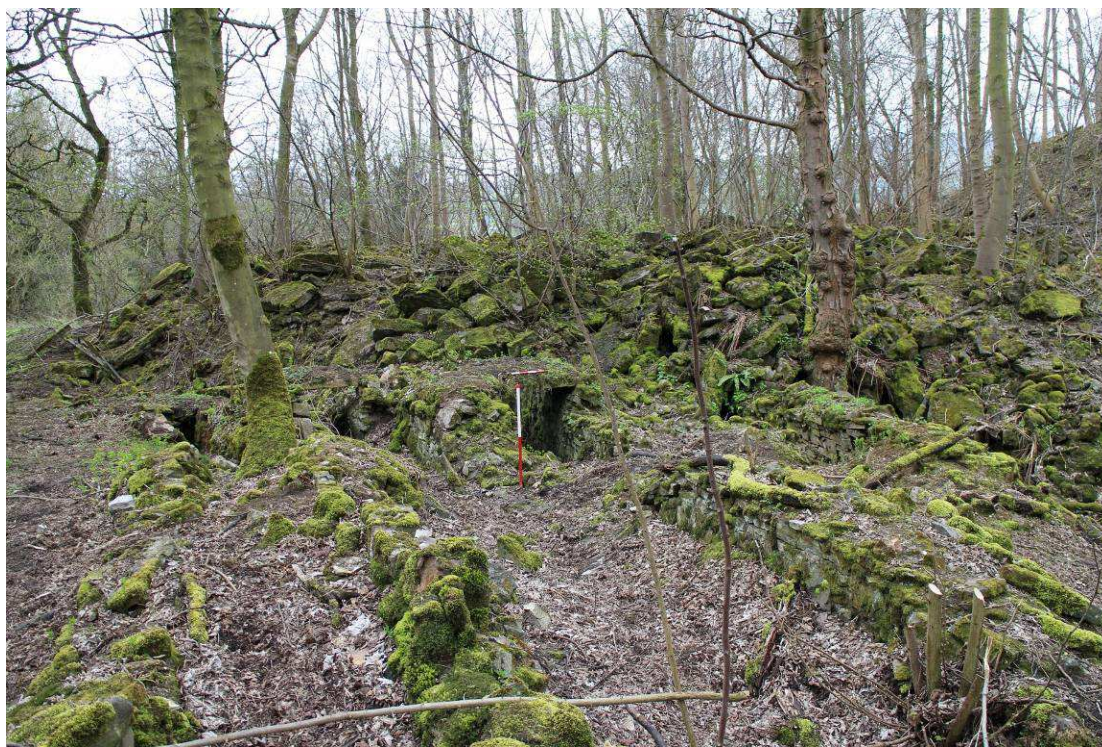
Plate 37: Flue-terminals **6g.1**, **6g.2** and **6g.3** looking south

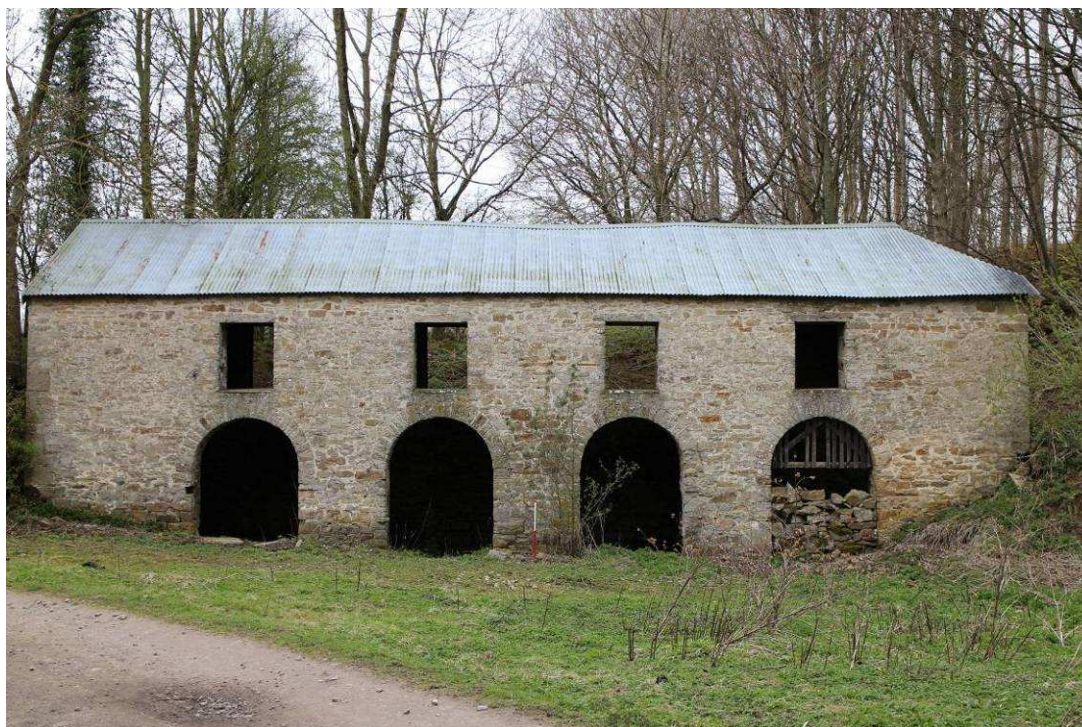
- 7.3.12 **Peat House:** the Peat House (Site **73**; Plate 38; Fig 18) survived in its entirety (except for the roof): it was a building *c* 17.4m by 6.1m of rubble stonework. It is trapezoidal in shape, of double height with no second storey and is open to the roof. It was supported on seven tie-beam trusses of wood (Clough 1962, 101) and has four bays; at ground level with four cart openings and plain rectangular openings above. The gables are both blind; the west elevation has four square windows above to match those at the front of the building. Photographs are included in Clough 1962 and Raistrick 1975 showing that it previously had stone slate roofing, but the roof has now been replaced with modern corrugated iron.

Plate 38: The Peat House (Site **73**) looking west

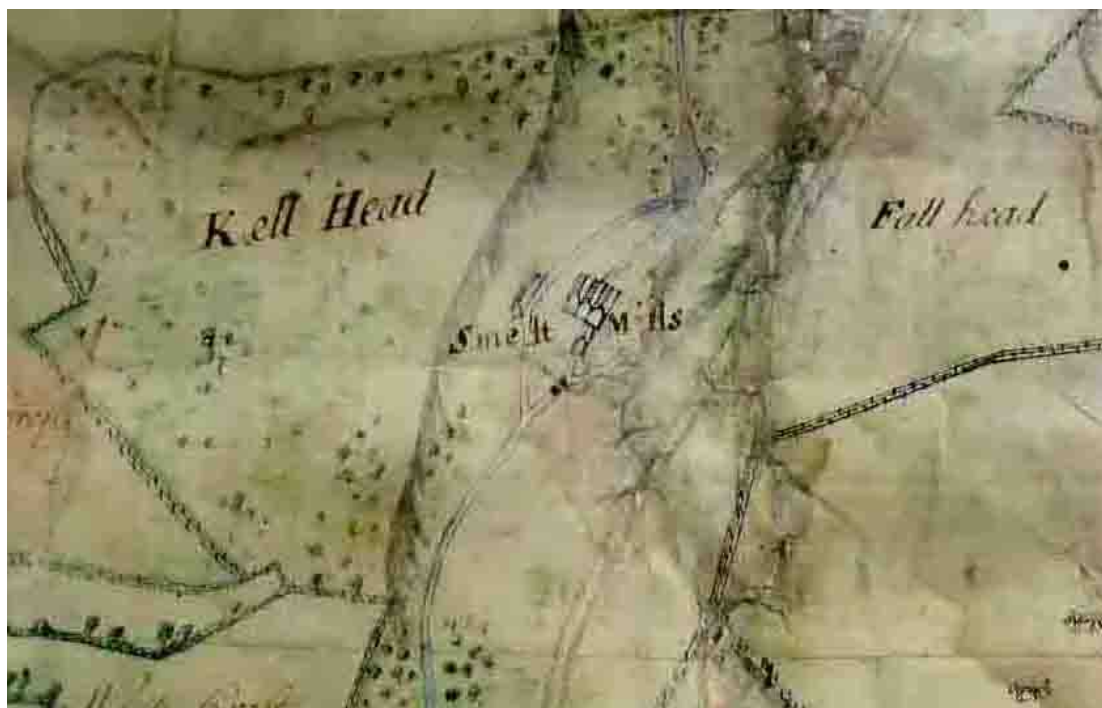
- 8.1.4 The site of the L-shaped Old Smelt Mill buildings shown on both the 1778 map and early eighteenth century map (Figs 15 and 23; Plates 39 and 40) closely resemble the footprint of the stone section of the Condenser House with the wheel-pit (Site **102a**),

Plate 40: Extract from *The Eighteenth century map from the Bolton Estate* showing the Old Smelt Mill

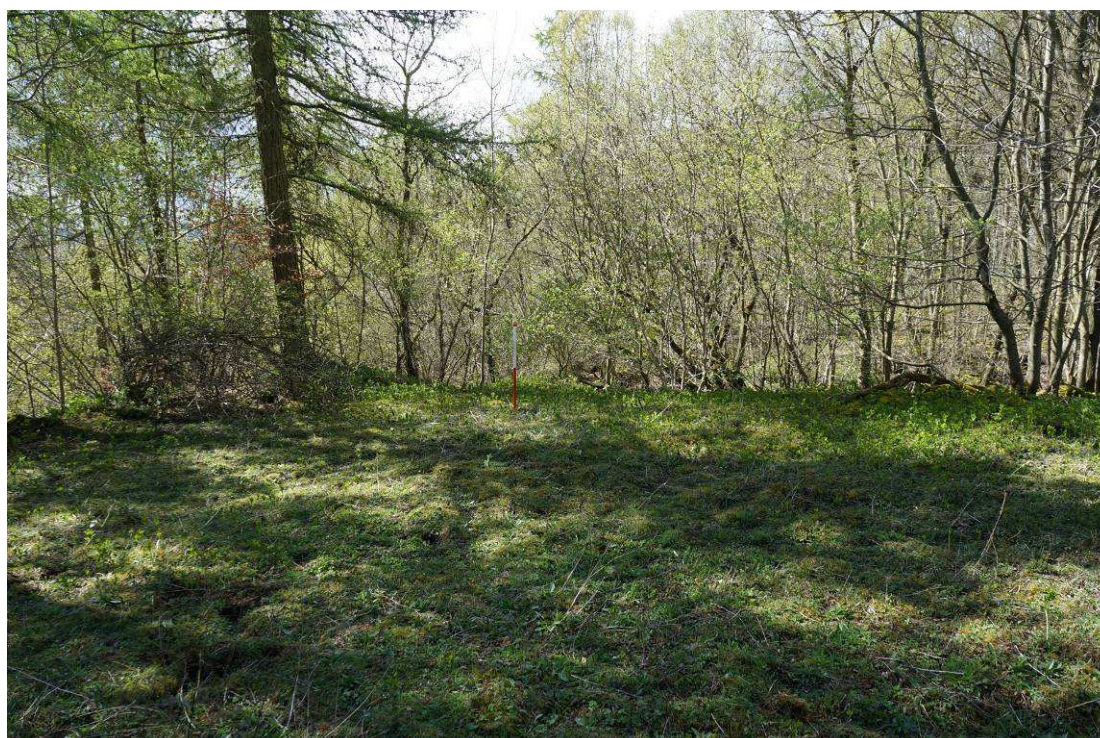
- 8.1.3 The present fieldwork and contour survey of 2015 has located the modern quarry (Site **5**) and potentially the remains of the earlier reservoir (Site **145**) (Figs 13, 15 and 23). South of the quarry a north-east/south-west leat (Site **108b**) was identified which fed water to the Condenser House and which was depicted on the 1778 map as supplying the Old Smelt Mill (Site **144**). The southern end of the leat survived as a well-defined embanked feature (Site **108b**), which crossed the large platform (Site **102f**) north-east of where the Condenser Flue emerged from the Condenser House. On the north side of the stone condenser building there was a small rectangular annex (Site **102e**; Plate 41), which measured 7.6m by 5.25m, it had short wall stubs on the south end, and was slightly levelled suggesting extant flooring close to the ground surface. This small levelled annex was either a part of the Condenser House, or was part of the earlier Old Smelt Mill.

Plate 41: The small annex (Site **102e**) at the southern edge of the large platform (Site **102f**)

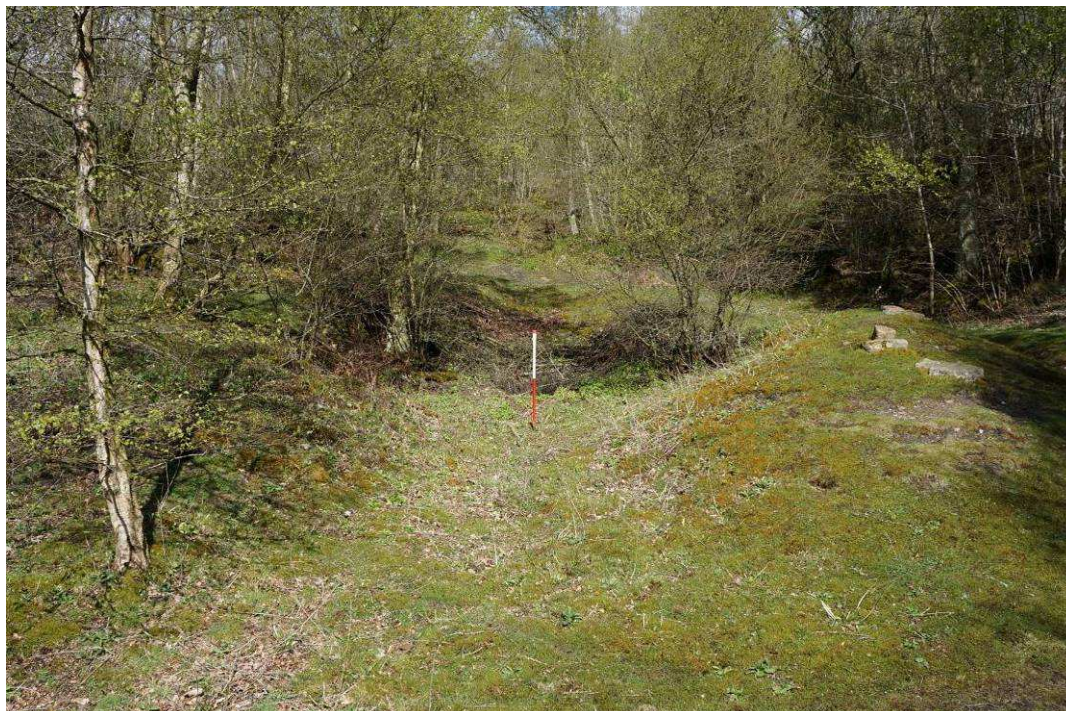
Plate 42: The sunken building Site **117** looking north

8.1.8 This building (Site **117**) does appear as a constant on all the historic maps back to that of 1723; it may have been a building with an underground stone-lined storage facility for lead; firstly from the Old Smelt Mill of the eighteenth century and then later, from the Condenser House of the mid-nineteenth century. Its consistent location is significant as it provides a locational reference which can be used to define the location of the Old Smelt Mill, which no longer survives as a clearly identifiable feature. On this basis it can be fairly reliably inferred, by comparison between the 1778 map and the present survey (Figs 15 and 23), that the northernmost element of the Old Smelt Mill (divided into three partitioned entities) was on the site of the Condenser House and wheel-pit (Site **102a**), and that the southernmost part of the 'L' shaped building extended over the area of the tail race and adjacent platform (Site **102b/c**).

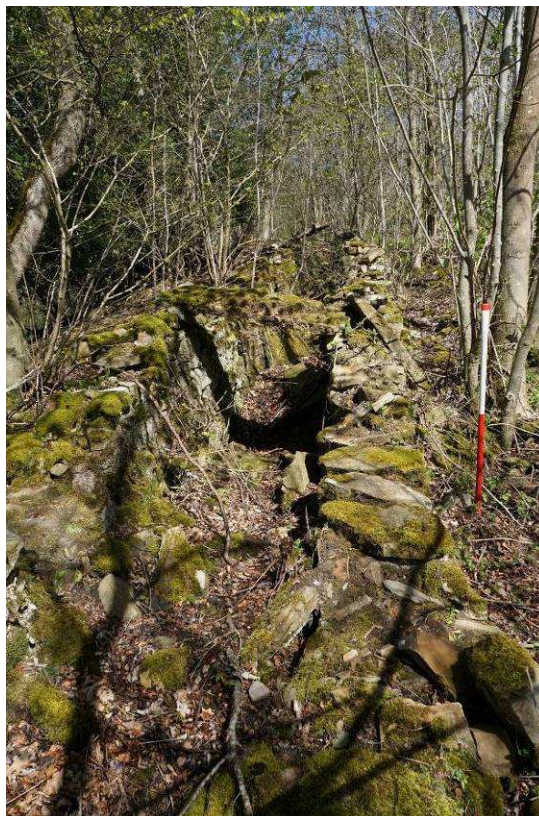
- 8.2.2 At the southern end of the flue the first of the two main Condenser Flues was associated with the early phase of the New Smelt Mill comprising the east/west orientated building (as seen on the 1856 OS map) with the small extension on the east of this being the roasting house (Site **128**) (*Section 7.3.6*). Within this was thought to be the roasting hearth and flue (Site **6g.1**), which was the initial part of the smelting process, and its gases and fumes were diverted into the easternmost Condenser Flue (Site **6f**) (*Sections 7.3.6; 7.2.7; Smith 1998, 44-8, 54; Martell and Gill 1990, 29-30; Raistrick 1975, Vol 2, 14*). Two other hearth flues (Sites **6g.2** and **6g.3**) also led from the original smelt building to conjoin into the easternmost Condenser Flue (Site **6f**; Plate 43) (*Section 7.3.7*).

Plate 43: The earlier eastern Condenser Flue (Site **6f**)

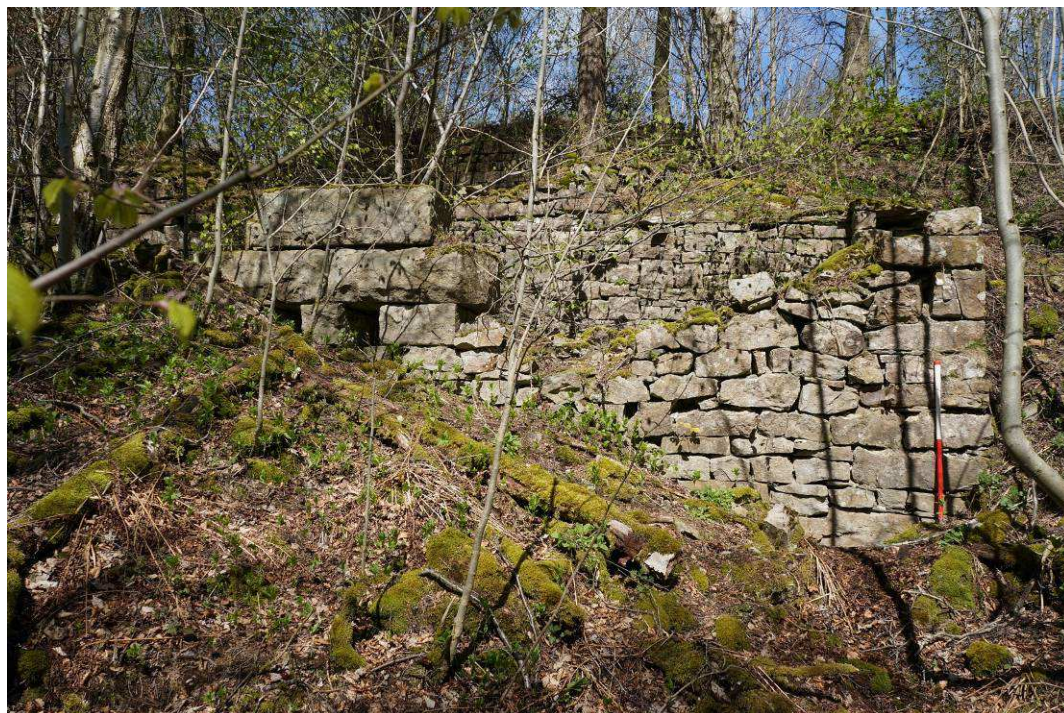
- 8.3.6 The surviving rectangular stone structure (Site **102a**) is set into a steep south-facing slope south of the little annex (Site **102e**) and below the large platformed area (Site **102f**). It consisted of dressed stone wall foundations for a single rectangular room (5.7m by 3.7m internally). To the south was a large wheel-pit orientated east/west and set into the slope (Plates 46 and 47), and would have been supplied by the lead **108b**, taking water from Keldheads Gill, and at a later date the supply was augmented by launder **113**, taking water from the large reservoir **28**. The water wheel was intended to drive the fans of the 'fan house', which was housed in the stone half of the Condenser House and over the main Condenser Flues (Smith 1998, 55), and were intended to force the smelt gases into the Stokoe Condensers (Raistrick 1975, 102-3).

Plate 46: The southern side of the Condenser House wheel-pit (Site 102a)

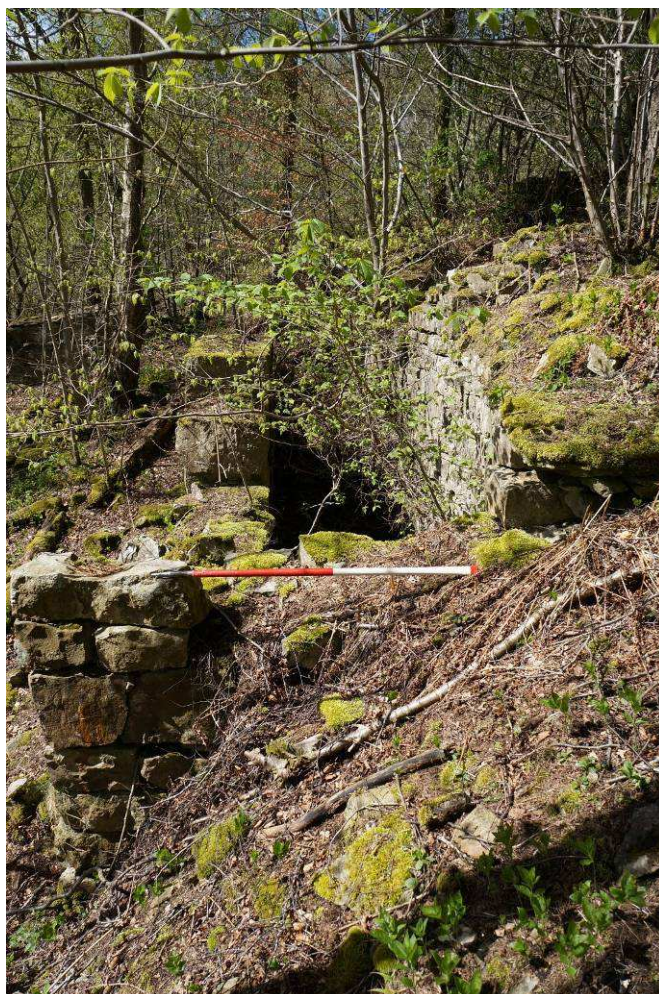
Plate 47: The Condenser House wheel-pit looking west (Site 102a)

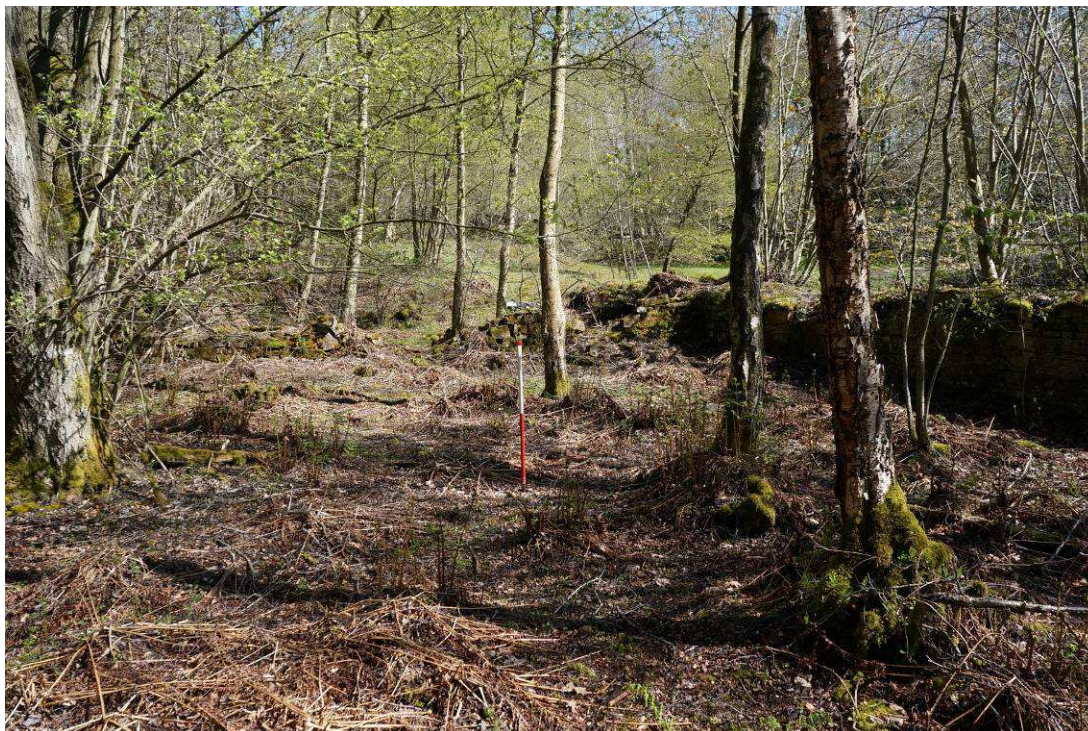
- 8.3.8 *The Settling Pits (Figs 15, 17 and 24)*: the suspension of lead fumes in water was then channelled out to the large settling pits (installed by the time of the 1866 plan) which are to the south-west of the Condenser House (Sites **100**) (Plate 49). On the 1866 plan these are depicted as two large trapezoidal features, and Clough reported them as ‘two large open stone flagged settling pits’ (Clough 1962, 101). The settling pit to the south (Site **100**) had well-constructed drystone, internal retaining walls visible with an aperture in the centre of the southern retaining wall; the settling pit to the north survives only as a sub-square sunken feature with one wall at the eastern side. The NMRS photograph of the Condensing House (Plate 50) showed that the northern settling pit was connected by a channel from the Condenser House (Smith 1998, 58).

Plate 49: The settling pits (Site **100**) looking south-west

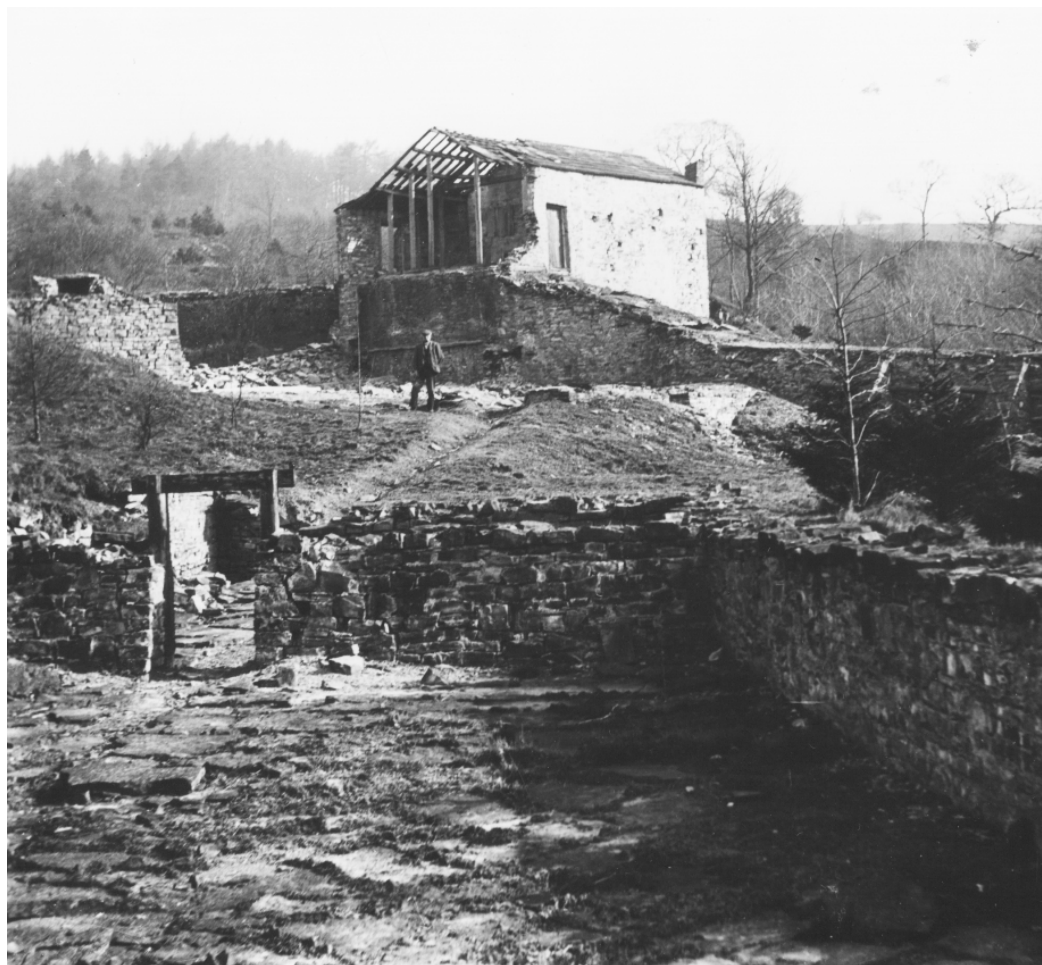
- 8.3.10 *Photograph from the Clough Collection, NMRS* (Plate 50) (c 1908): this photograph recorded the stone-built half of the Condenser House **102a**, with a door on the west side of the windowless southern elevation (and another door opposite it on the northern elevation). The south wall also had a chimney on the southern corner eastern gable. West of this were the considerable remains of the Condensing Flue **6f**, which was built of regular well-constructed stone work. Behind this was the wheel-pit for the water wheel, which had evidently been dismantled.

Plate 50: The Condenser House c 1908 (Photo of J Backhouse, from the Clough Collection, NMRS). The photograph is taken from approximate grid reference 40774 49113, and was orientated north-east

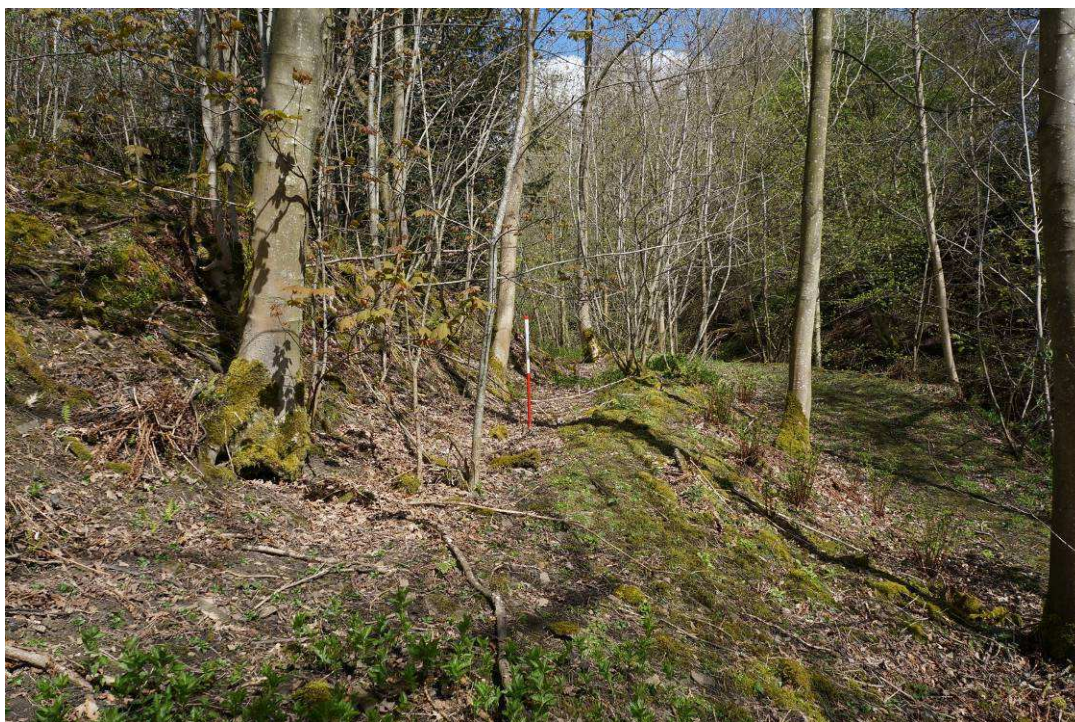
- 9.1.5 The water supply for the Condenser House (Site **102**) used the same embankment (Site **108b**) (supporting a launder) as the earlier Smelt Mill suggesting that the condenser wheel-pit was in the same location as that of the underlying Old Smelt Mill. However, instead the water was drawn from Keldheads Gill rather than the small reservoir (Site **145**), and necessitated the construction of a leat (Site **108a**; Plate 51) that was terraced into the slope. A very substantial tail race extended south from the eastern end of the wheel-pit and led into a stone-revetted canalised section of Keldheads Gill.

Plate 51: The headrace leat (Site **108a**) extending between Keldheads Gill and the Condenser House

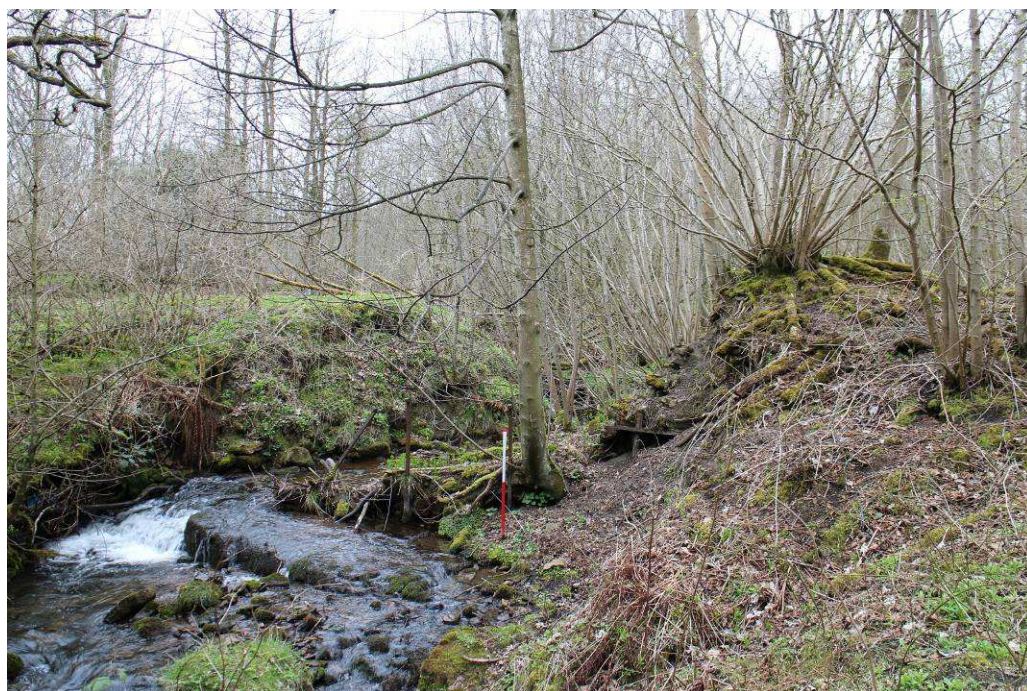
Plate 52: The extant section of the dam (Site **90**) which has been breached

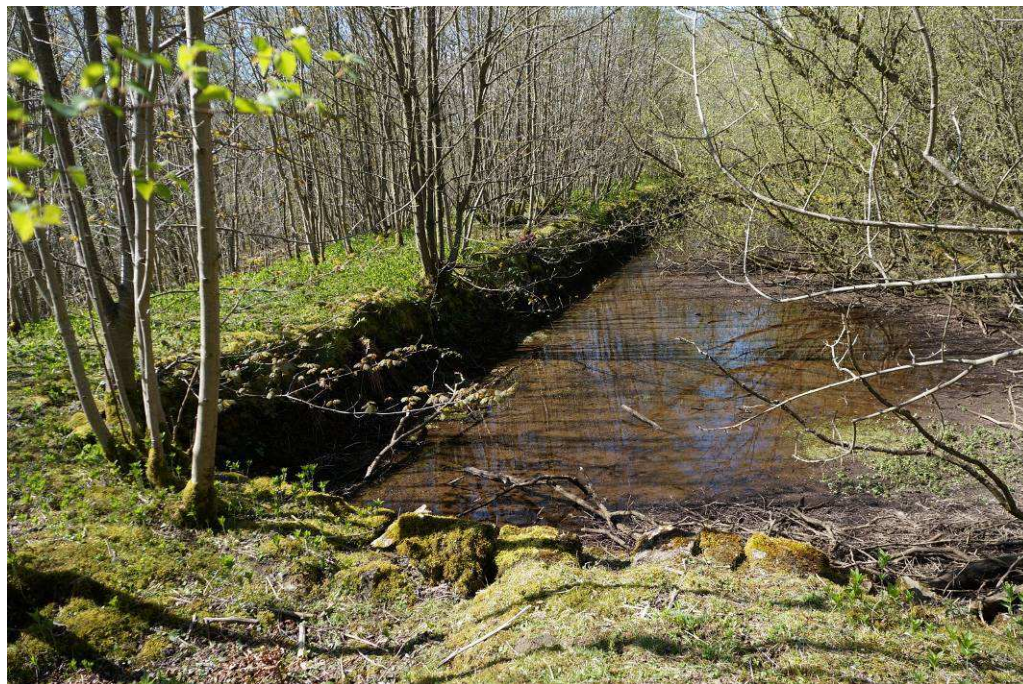
9.2.1 **1866 Mine Map:** by the time of the 1866 map, some 10 years after the OS first edition map, there had been some notable changes, principally the construction of a number of reservoirs which would have provided a more reliable water supply. The most substantial of these was the large reservoir (Site **28**; Plate 53) in the northern/central part of the area of upper workings, and which would have powered both the New Smelt Mill and the Condenser House. This is a large, sub-rectangular reservoir cut into the hillside, which measures approximately 82m long by 41m wide and has a large, well-defined dam surrounding all except the upslope side. The dam had battered stone walls on both sides and a flat top and was a very substantial earthwork; its proximity to adits **16**, **19** and **20**, suggesting that it used spoil from these adits in its construction. It was fed by a canalised stream (Site **14**) and by drains leading from three drainage adits **16**, **19** and **20**. There are outflows on both the western and eastern sides (the latter being via a now-collapsed culvert). The westernmost of these (Site **24**) is a canalised channel and at the time of the 1866 map merged with that from the springs to the north-west, and then bypassed the lower reservoir (Site **90**) before feeding the New Smelt Mill water wheel via a launder. The easternmost outfall re-used the channel (Site **26**) that had formerly led directly between Adit **19** and the lower reservoir (Site **90**). Extending from the eastern outfall of the reservoir was a line of five, small rectangular stone-constructed bases (Site **113**) running for approximately 15m west-north-west/east-south-east (Plate 54). These are the surviving remains of a foundation for a wooden launder that led downslope to launder base **108b**, and which fed the Condenser House. The 1866 map shows this launder, but no longer shows a direct connection between launder **108b** and Keldheads Gill, which may suggest that the supply from Reservoir **28** had completely replaced the supply from the gill. However, the 1891 OS map shows the leat (Site **107**) to Keldheads Gill in place, and it is possible, therefore, that its omission on the 1866 map was a cartographic error rather than an indication that it was no longer in use.

Plate 53: The dam of the large reservoir (Site 28) looking south-west

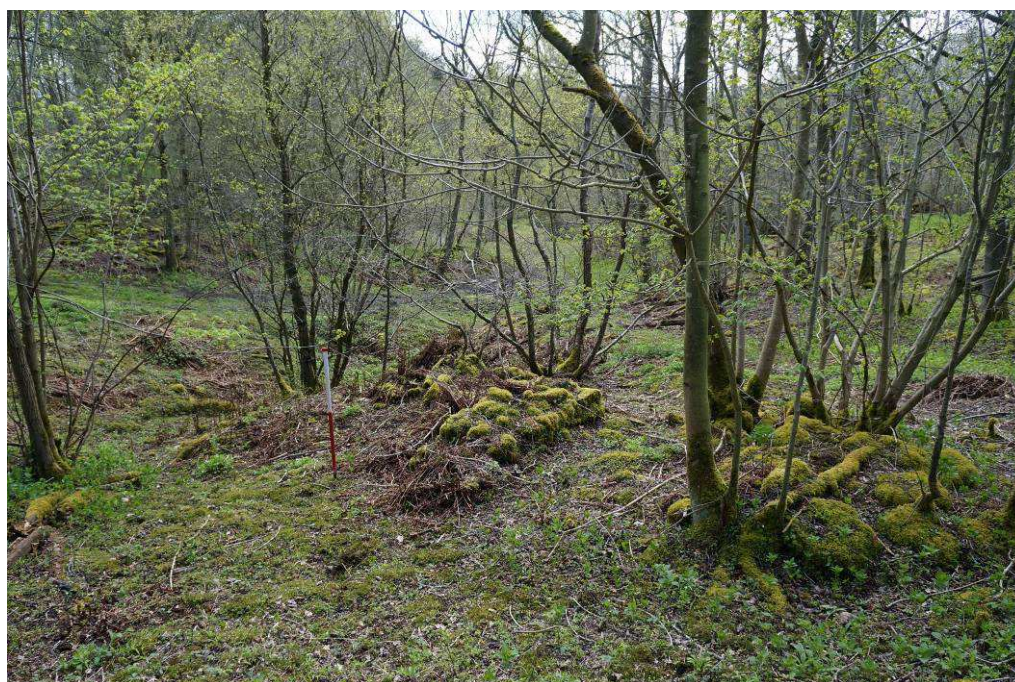
Plate 54: Two of the rectangular stone bases (Site 113) supporting a launder that would have taken water from the large reservoir (Site 28) to the Condenser House (Site 102)

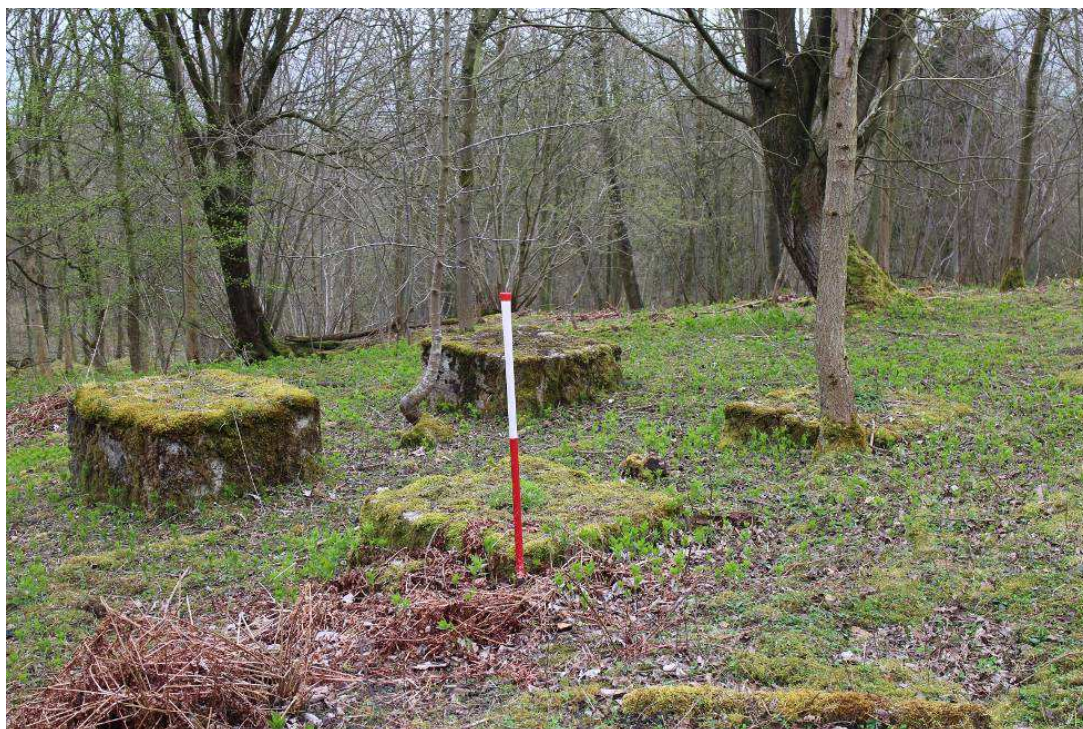
10.1.2 **Aerial Ropeway:** the alignment of the aerial ropeway (Site **141**), first depicted upon the 1953-58 OS mapping, runs diagonally downslope through the study area. The extant sites include three concrete bases, each consisting of four square concrete supports, for the foundations of the aerial ropeway towers (Sites **1**, **4** and **103**; Plate 55). In addition, broken sections of twisted metal rope litter the floor along the alignment of the ropeway. The aerial ropeway was originally a single rope system that carried 52 buckets (Johnson 2002, 155).

Plate 55: Concrete Aerial Ropeway Base (Site **4**)

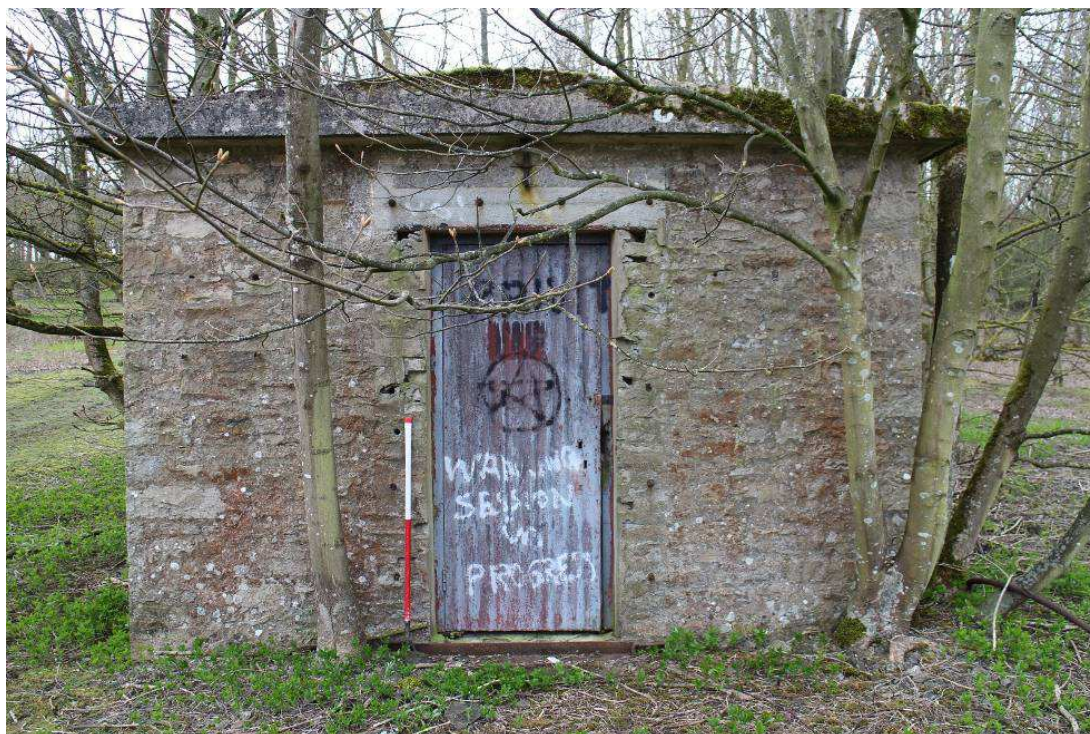
- 10.1.3 **Explosives Store (Site 2):** this is a single-storey, two-celled rectangular building (Plate 56). It is 9m long by 4m wide with mortared stone construction and has a slightly pitched concrete slab roof. There is a doorway in the south gable end and a window/hole in north gable.

Plate 56: Preston-under-Scar Quarry Explosives Store (Site 2)

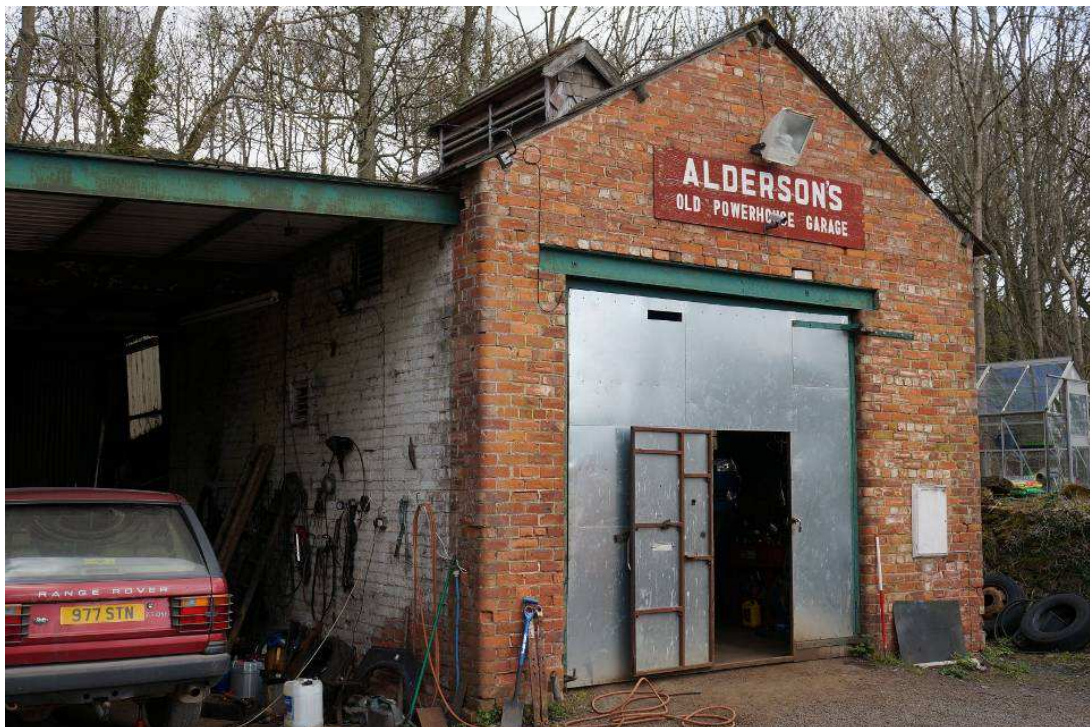
- 10.2.1 In the early twentieth century the mine buildings at Keld Heads were remodelled, and a red brick power house was built (Spensley 2014, 147). This is what is now the Old Powerhouse Garage located in the area of the earlier bouse teams (Site 48; Plate 57). The structure is rectangular, single-celled and is open to the roof. The red brick constructed walls are very thick, and it has an internal concrete floor. There is an RSJ on the door in the south elevation and above it a pitched slate roof. A wooden louvered ventilation system is present on the apex of the roof. Three large windows are present

on the eastern wall elevation. Local knowledge states that the original engine base was present before the concrete floor was laid down for the garage in the 1980s. A concrete flue heads north from the structure and is attached to the chimney adjacent to the Boiler House (Site 53).

10.2.2 A modern RSJ-framed lean-to with corrugated walls is located on the west of the power house (Site 49). Local knowledge states that it once housed two boilers to power the engine for the aerial ropeway and would have provided electrical power for the limestone quarry. The structure has an inspection pit for the garage, but there is no surviving evidence of footings for the boilers.

Plate 57: Electricity generating house (Site 48)
