Land south of
Fletton Parkway,
Hampton,
Peterborough

Archaeological
Watching Brief Report

December 2017

Client: Anglian Water

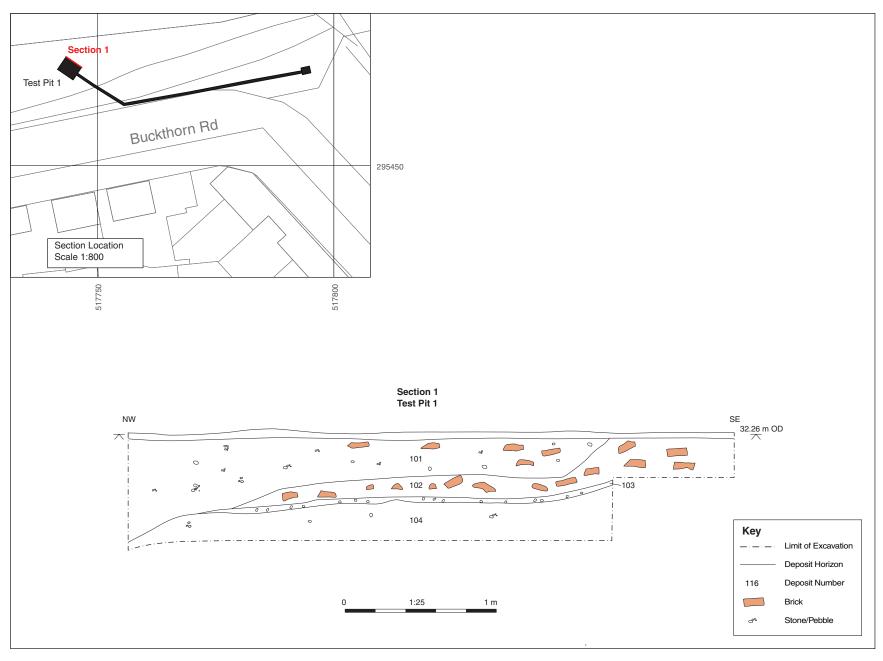
Figure 2: Section of Test Pit 1. Scale 1:25

- 2.1.7 The test pit had a maximum depth of 2m. The earliest excavated layer comprised natural geology of sand and gravel (104), measuring 0.6m thick (Fig. 2, section 1 and Plate 3).

- 2.1.8 Sealing layer 104 was a thin layer of redeposited grey clay (103). This had a maximum thickness of 0.1m. The material located above the clay consisted of a 0.8m thick redeposited brick and soil mixture (102), which had been used to build up a bank adjacent to the footpath. Sealing this was another layer of silty soil and brick (101), which had again been deposited as a layer of made ground, although there was less brick rubble than in the layer below.

- 2.1.9 The area of Test Pit 1 was sealed by a silty clay topsoil and turf.

3.1.1 No archaeological finds or features were present within the area of the Watching Brief. The soil sequence across the two test pits was fairly uniform, comprising redeposited or disturbed soils. The sequence could be due to landscaping, back fill or levelling at the time the houses were constructed to the south. The only natural geology encountered was layer 104 in Test Pit 1 (Fig. 2, section 1 and Plate 3).

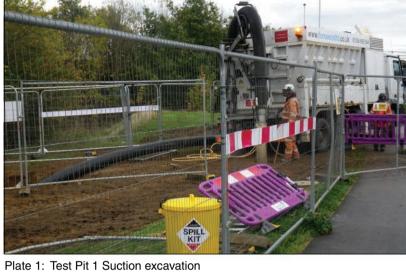
- 2.1.6 A test pit measuring 3m x 4m was excavated at the western end of the excavation area to locate an existing pipe line (Fig. 1 and Plate 1). This work was undertaken entirely using suction excavation and the loose material was stock piled close to the site. The spoil consisted of whole and crushed modern bricks along with sand, gravel and topsoil (Plate 2).

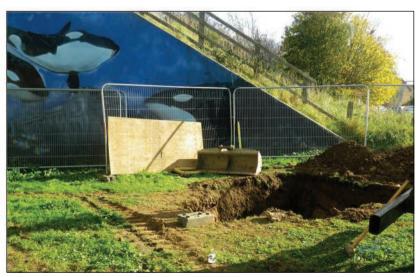
Plate 4: Position of Drill Pit 1. Viewed from the west

2.1.10 Drill Pit 1 was located at the eastern end of the pipeline (Fig. 1 and Plate 4). It measured 3m long, 2.5m wide and had a maximum depth of 1.2m. The whole of the area had previously been excavated to accommodate an existing pipeline (Plate 5). The deposits examined related to the back fill of the previous pit and consisted of layers of sand, gravel, re-deposited soil and rubble, sealed by turf. Nothing of archaeological interest was noted in Drill Pit 1.

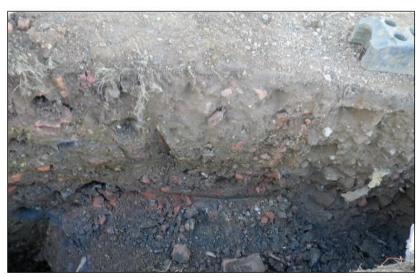
Plate 6: Disturbed material seen in Trench 1. Viewed from the south

- 2.1.11 Trench 1 (Fig. 1) linked Test Pit 1 and Drill Pit 1. It was orientated east-north-east to west-south-west, turning south-east to north-west for 10m at the western end. The trench measured approximately 65m long, 0.5m wide and up to 1.65m deep.
- 2.1.12 Excavation of the trench revealed a single, mixed layer of redeposited brick, rubble and soil (Plate 6 and 7), indicating severe truncation of the original ground level.
- 2.1.13 Weather conditions on site were bright and sunny.
