# Snowdown Colliery Kent

## Historic Building Assessment and Recording

**Document Title:** Snowdown Colliery, Kent, Historic Building Assessment and Recording

**Document Type:** Building Survey, Client Report  
**Issue Number:** 1

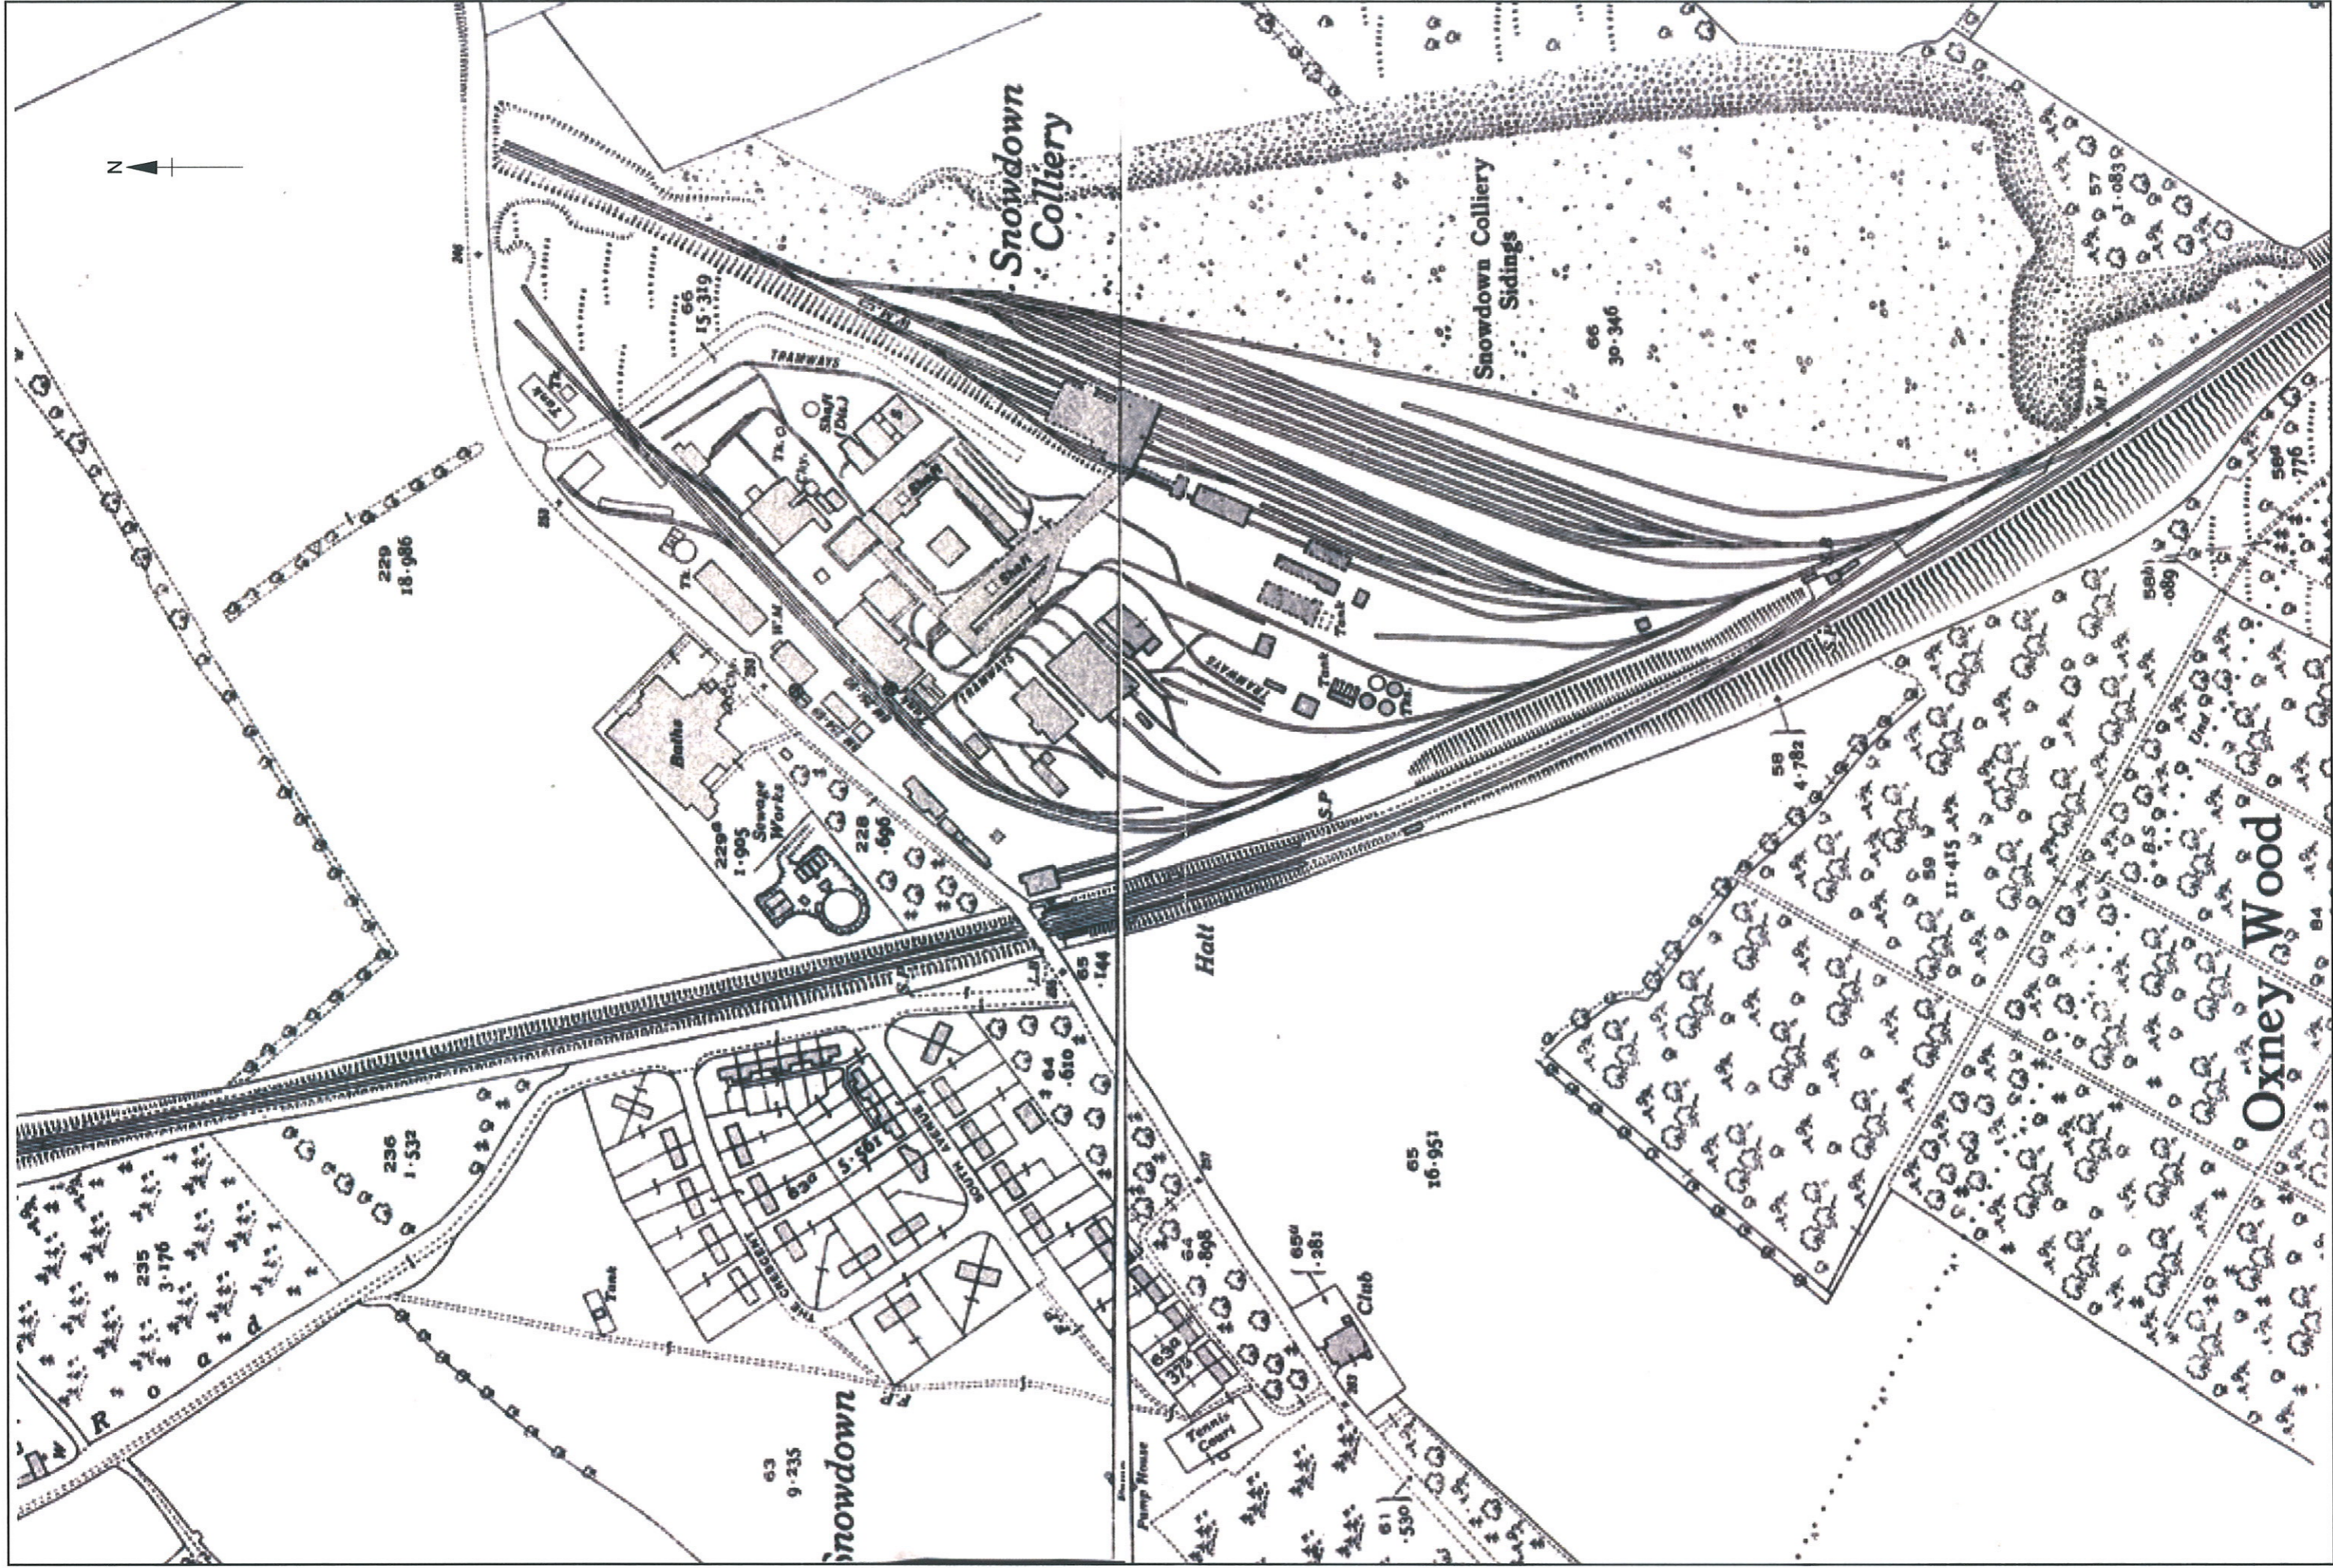
Figure 3: OS 25" Map, 1937

2.2.2 The next OS edition in Kent was 1929 but this was partial and did not cover Snowdown. So the first OS map showing the colliery buildings is the 1937 edition. The 1937 map (Figure 3) shows most of the major buildings that still survive were constructed by that date excepting building 2 the No. 2 Winder House. The pit head baths on the other side of the road from the main site were in existence by 1937 but have been demolished since the closure of the pit. The site of building 2 was occupied by an earlier building probably a smaller winder house. North-west of this was a large building with chimney which possibly produced power for the colliery via coal fired steam.

This is the only building in the modern style on the site and probably dates from around the early 1950s and may represent new investment in the site after nationalisation in 1947. It replaces an earlier building (see 1937 map, fig. 3) which may have housed a steam powered winder.

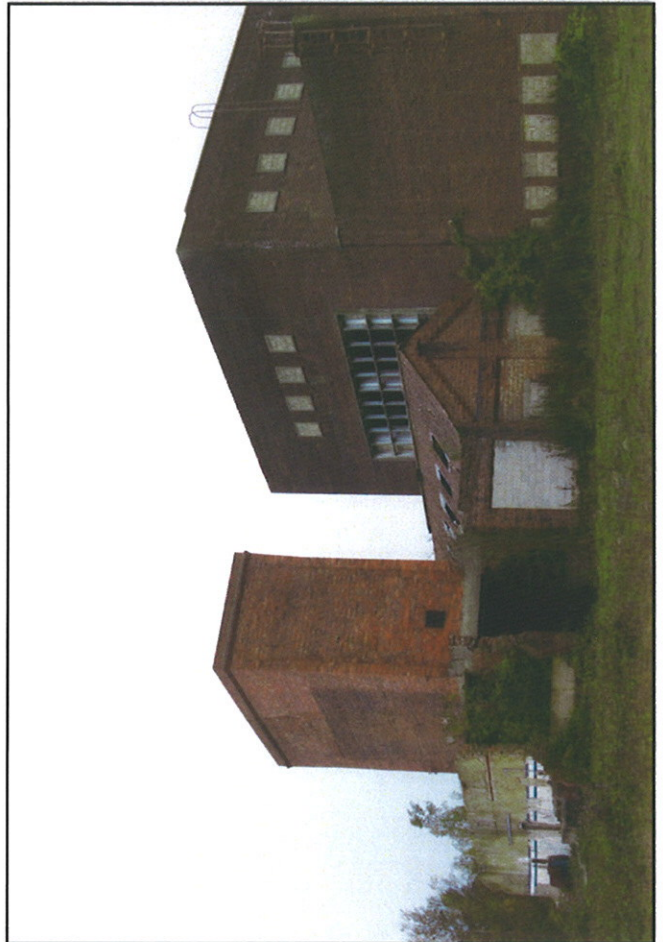
Plate 7: Fan House with No. 2 Winder House to right

*Description:* Built of red brick in english bond. Central rectangular plan tower with flat topped side chambers and gabled north-west wing, south-east wing demolished (plate. 7). The entrances have been blocked. Corbelled stepped detail to the base of the gable cornice. There are large circular openings about 3.0m in diameter, voussoired in brick, leading from either side chamber to both sides of the base of the tower (plate 8). There are remnants of iron ducts or housings between the circular openings particularly on the south-west side (plate 9). The lower part of the remaining wall of the demolished section has glazed blue and white tiles (plate 10) and there are two large concrete bases for fixing some plant or machinery against the wall (plate 11). The end walls of the tower are supported on concrete lintels the ends of which rest on the tops of the circular brick arches. Some of the brickwork adjoining the north-east arch is has been demolished and in time further deterioration of this

would render the tower unstable. The tower appears to be divided down the centre and is presumably either a vent for expelling foul air from the mine or drawing clean air in or both. The function of the fan house was to circulate the air around a mine to remove foul air and gasses and bring in clean air and there would be special doors and flaps in the mine shafts and tunnels to control the flow. The fan machinery has presumably all been removed unless some survives within the gabled wing; it may have been powered by steam originally and later by electricity.

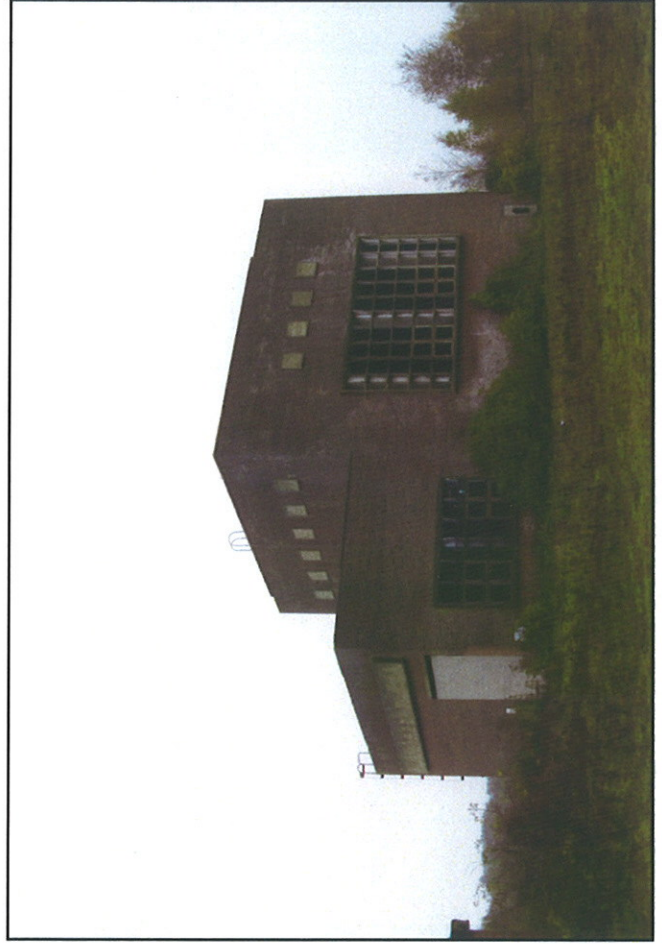
Plate 12: No. 2 (Koepe) Winder House looking south

*Description:* Huge functional modern flat roofed rectangular plan brick block with higher square section to the south-west (plate 12). Built against the north-east wall of the Fan House. The walls are of darkish brick laid in stretcher bond with huge concrete framed windows and a row of four square higher blocked openings in the north-west and south-east walls, a small blocked door in the north-west wall gives a sense of the enormous scale of the building. There are also six high square blocked openings in the north-east wall of the main room. The lower north-east section also has a huge window in the north-west wall and a large blocked entrance in the north-east wall with a long raised concrete panel above.

The building has a massive frame of reinforced concrete uprights and beams, which can be seen behind the windows. The frame supports a huge gantry hoist which spans the high square room and runs on wheels on the top of a concrete beam (plate 13), the frame then continues up to support the roof. The lower parts of the walls in the large room are covered in blue glazed tiles and the hoist chain runs into a rectangular aperture in the floor.

This building would have housed the winding engine for No 2 shaft which is to the south-west. There is a blocked rectangular opening halfway up the south-west wall which is otherwise blank (plate 14), this was probably for the winder cable to pass through as it is positioned in line with No. 2 shaft. There is possibly only one opening because this building housed a Koepe winder in which both cages are connected to the same cable which is driven by the frictional resistance of the cable to the wheel or sheave instead of being wound onto a winding drum as in conventional winders.

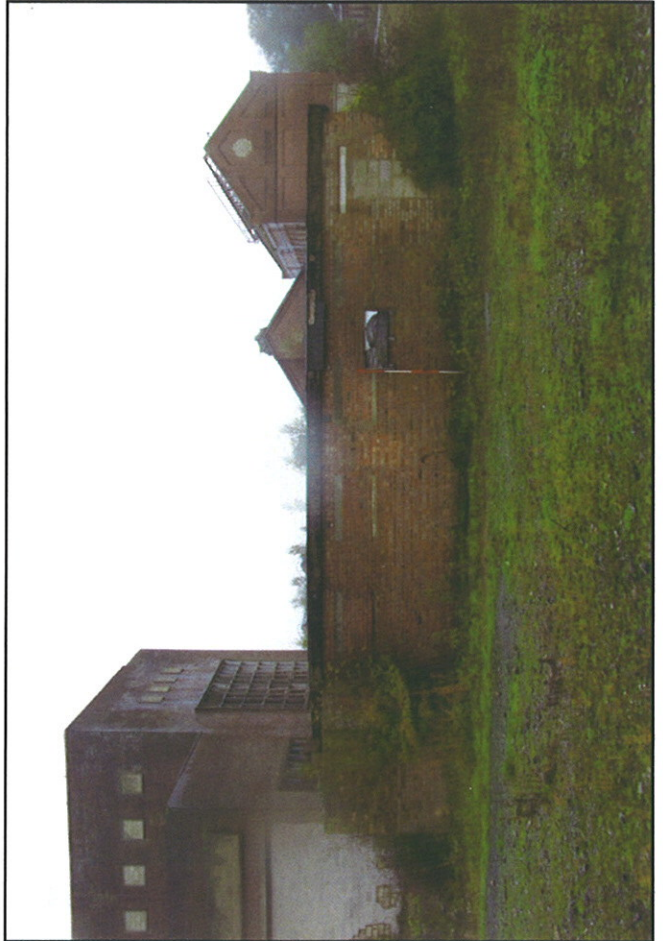
Plate 15: Explosives Store looking south-west

*Description:* Low plain rectangular flat roofed brick building (plate 15). Built in brick laid in english bond with two blocked door openings on the north-east side, probably mid twentieth century in date.

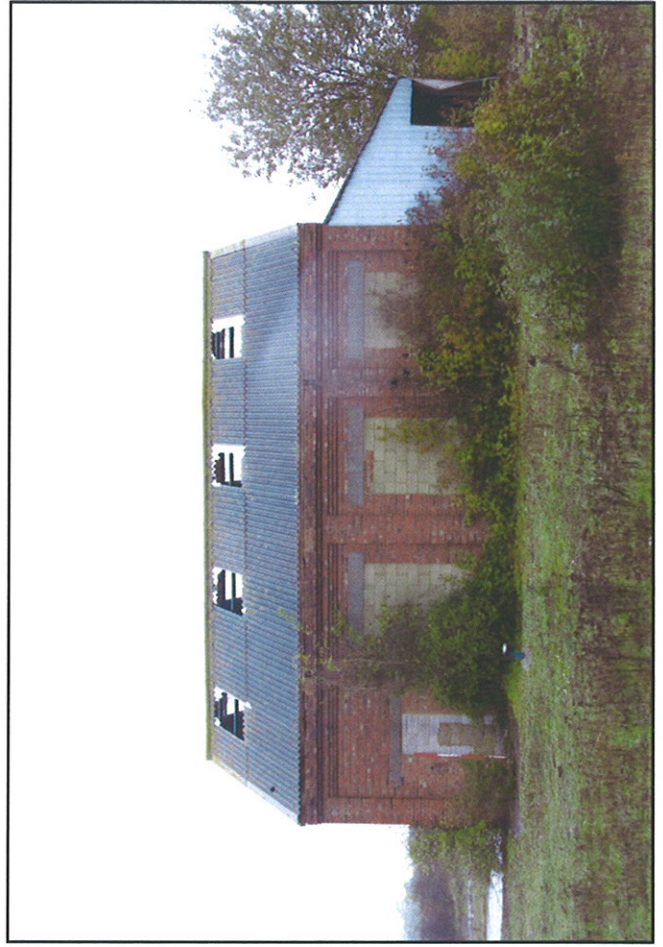
Plate 16: Building 4, south-east elevation

*Description:* Rectangular building of four bays built in brick in english bond with gabled roof clad in corrugated asbestos with later lean-to extensions in brick and metal panels at north-east end (plate 16). The bays are divided by flat piers in the brickwork and contain window openings with concrete sills and lintels, which have been infilled with concrete blocks. The north-east gable has two shallow piers and a corbelled crow-step detail to its lower edge as on building 1 and some others. The south-west gable end has been rebuilt in plain brick with a large opening that has been infilled with concrete blocks.

The large later opening in the south-west end would have been for vehicles to enter the building for repair. This suggests either that the building had a different function when first constructed or that it was necessary to make access for larger vehicles than those originally used.

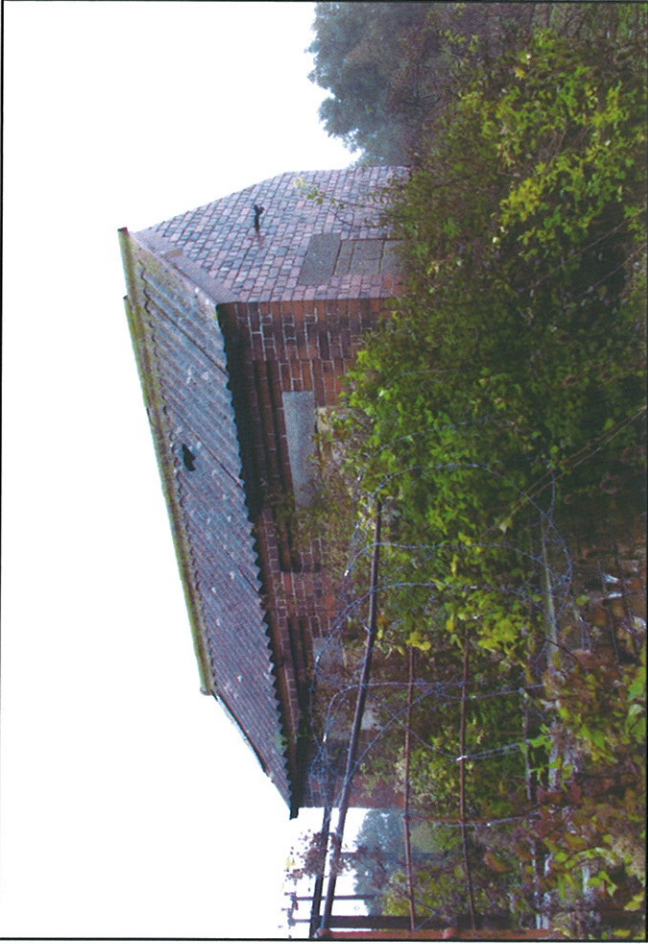
Plate 17: Building 5, looking east

*Description:* Small rectangular two bay gabled brick building (plate 17) adjacent to large rectangular sunken brick lined tank (plate 18). The building is of brick laid in english bond. It has a blocked window opening in each bay on both sides of the building and a blocked door at either end.

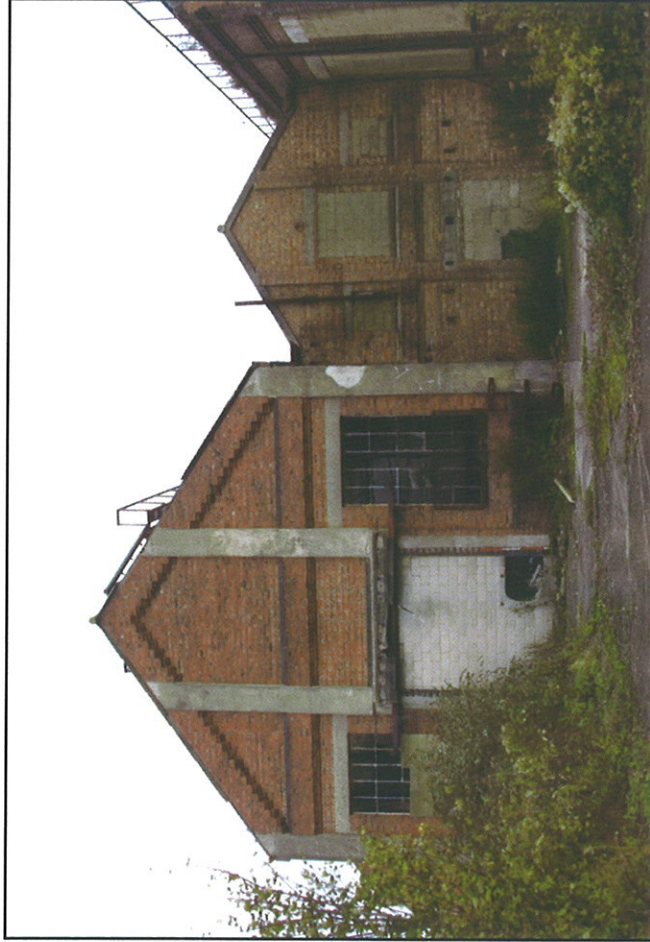
Plate 42: Building 17, South-west gable with building 18 on right

The south-west end wall has a large blocked entrance in the central bay and two large crittal windows in the side bays (plate 42). The pilasters at this end have been rendered or rebuilt/refaced in concrete probably due to cracking as is seen in the pilasters of some of the other large buildings.

The end walls are built in brick in three bays with flat pilasters, there are three blocked openings in the lower north-east end and three upper and one central lower blocked opening in the south-west end wall (see plate 42). A narrow gauge rail ran into the building through the central south-west opening for the coal tubs to be brought in for repair.
