Maldon Road Roundabout Scheme, Colchester, Essex

Archaeological Monitoring and Recording Report

February 2017

Client: Anglian Water

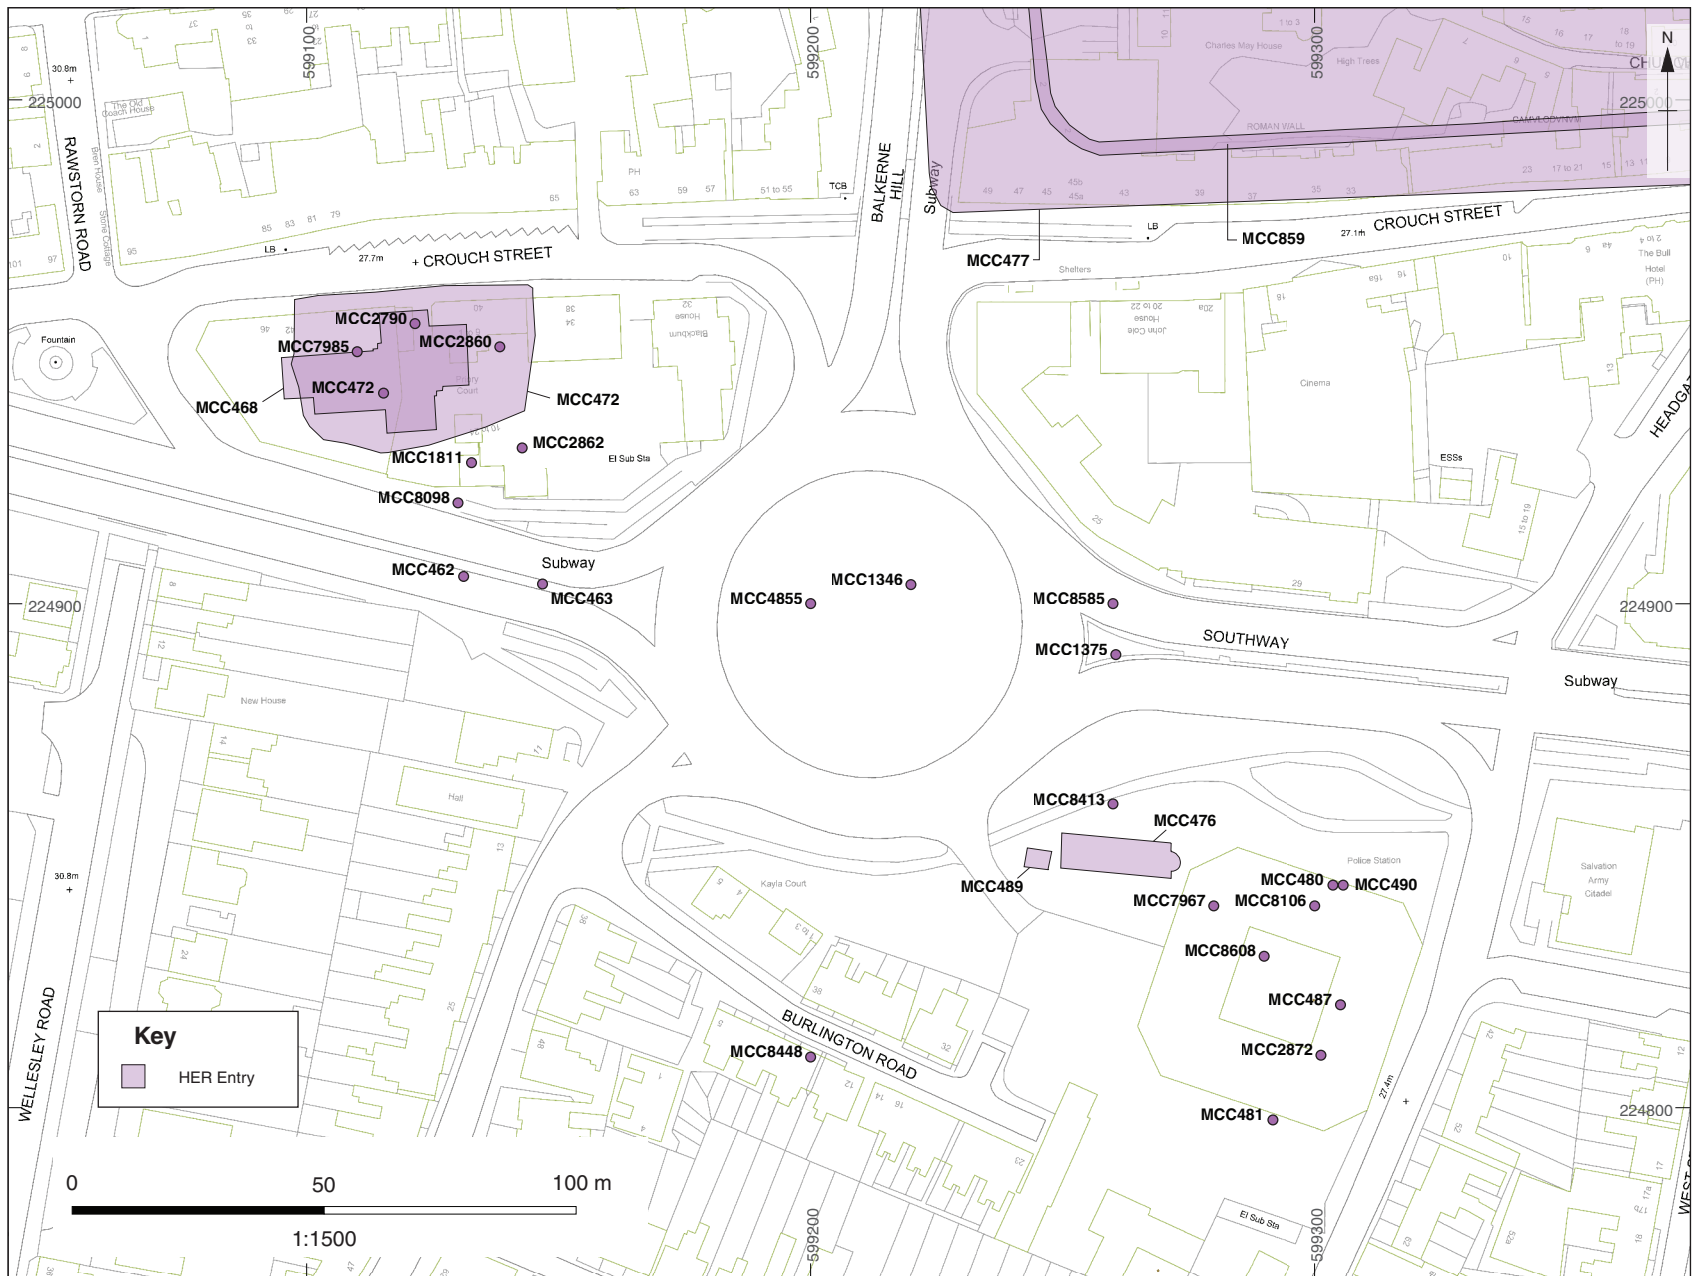
Figure 2: Main heritage assets immediately surrounding Maldon Road roundabout

- 1.3.1 The following provides a brief summary of the relevant archaeological and historical assets within the immediate proximity of the roundabout. The account given here is taken from the WSI (Brudenell, 2017), drawing on data from the Colchester Historic Environment Record (CHER), the location of selected sites, findspots and other heritage assets discussed here are plotted on Fig. 2.

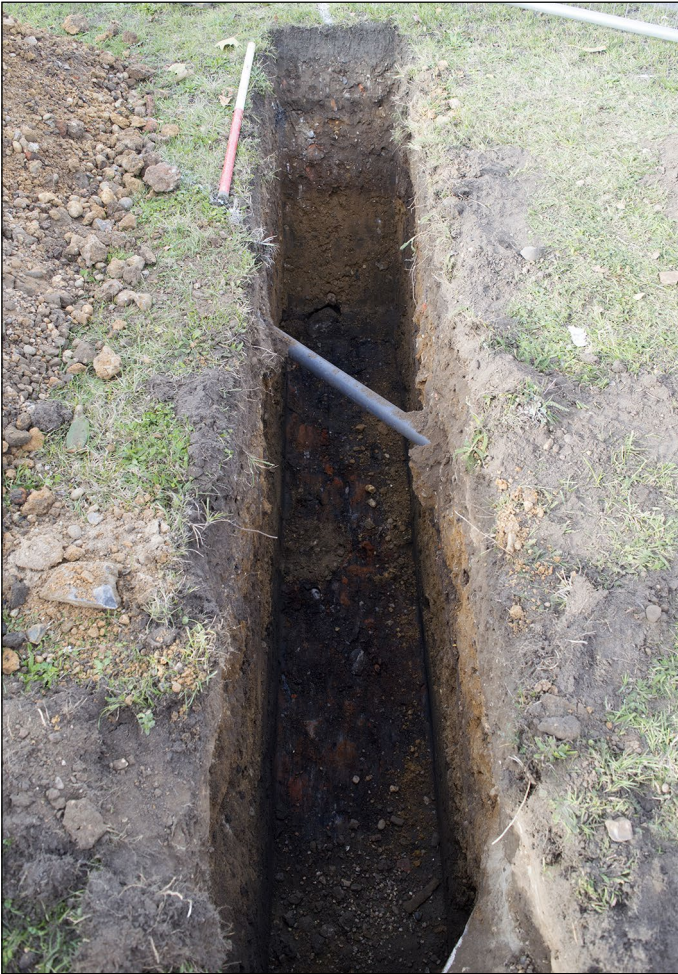
3.4.1 PT 1 (Plate 1) was 55.4m long, 0.5m wide and cut to a maximum depth of 1.2m. The trench ran from the north-west side of Maldon Road and ran across the road to the south-east parallel to the route of the roundabout.

3.4.2 The trench contained three deposits. A layer of turf (1) measuring 0.15m overlay a thick deposit of made ground (2), measuring 0.45m and comprising mid grey brown silt, with patches of redeposited natural gravel and sand, and frequent CBM inclusions. A single animal bone (26g) was recovered from this deposit. Underlying this was a similar made ground deposit (3), comprising a yellowish brown silty sand with moderate gravel inclusions and common CBM inclusions, and measuring 0.35m thick. The lowest deposit (4) comprised a dark black sandy silt, with very frequent modern brick and redeposited natural gravel throughout. This deposit is highly likely to be contaminated, due to the strong smell of fuel that was noted during excavation. The natural geology was not observed.

Plate 1: PT 1 looking south-east

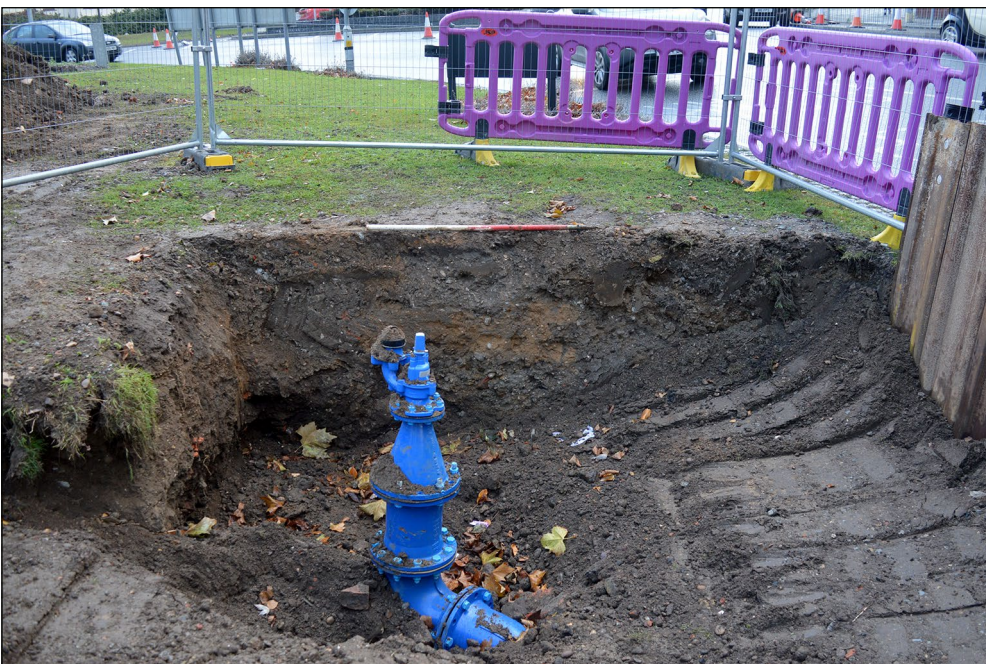
- 3.6.1 CP 1 (Plate 2) was located inside the roundabout, facing the A134. It measured 3.3m x 3.3m and it was excavated to a total depth of 1.30m. It contained a single deposit. A layer of turf (5) measuring 0.15m thick overlay a thick homogenised deposit of dark yellowish brown made ground (6), comprising redeposited natural gravel and sands and frequent modern brick inclusions throughout. It measured 1.05m thick.

Plate 2: CP 1 looking north-west

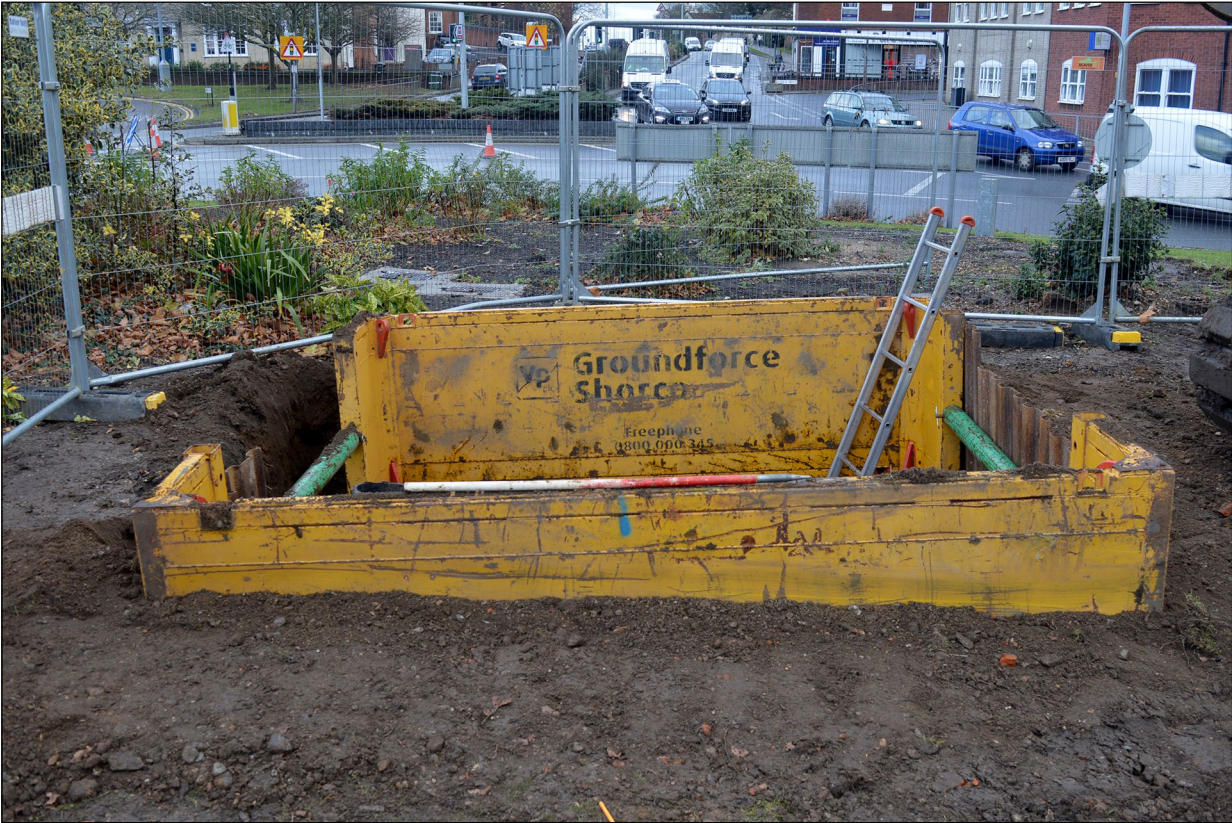
- 3.7.1 CP 2 (Plate 3) was located inside the roundabout, to the north-west facing the A134. It measured 3.3 x 3.3m and was excavated to a depth of 3.7m. It contained two deposits; a layer of turf (5), measuring 0.20m thick, overlying a thick deposit of made ground (8), measuring 1.7m thick made up of a dark blackish brown sandy gravel, with frequent large concrete slabs, modern brick and pieces of iron wire (Plate 4). A single animal bone (5g) and an oyster shell was recovered from the made ground. This overlay the natural geology of sandy gravel (9), encountered at a depth of 1.90m.

Plate 3: CP 2 looking north-west

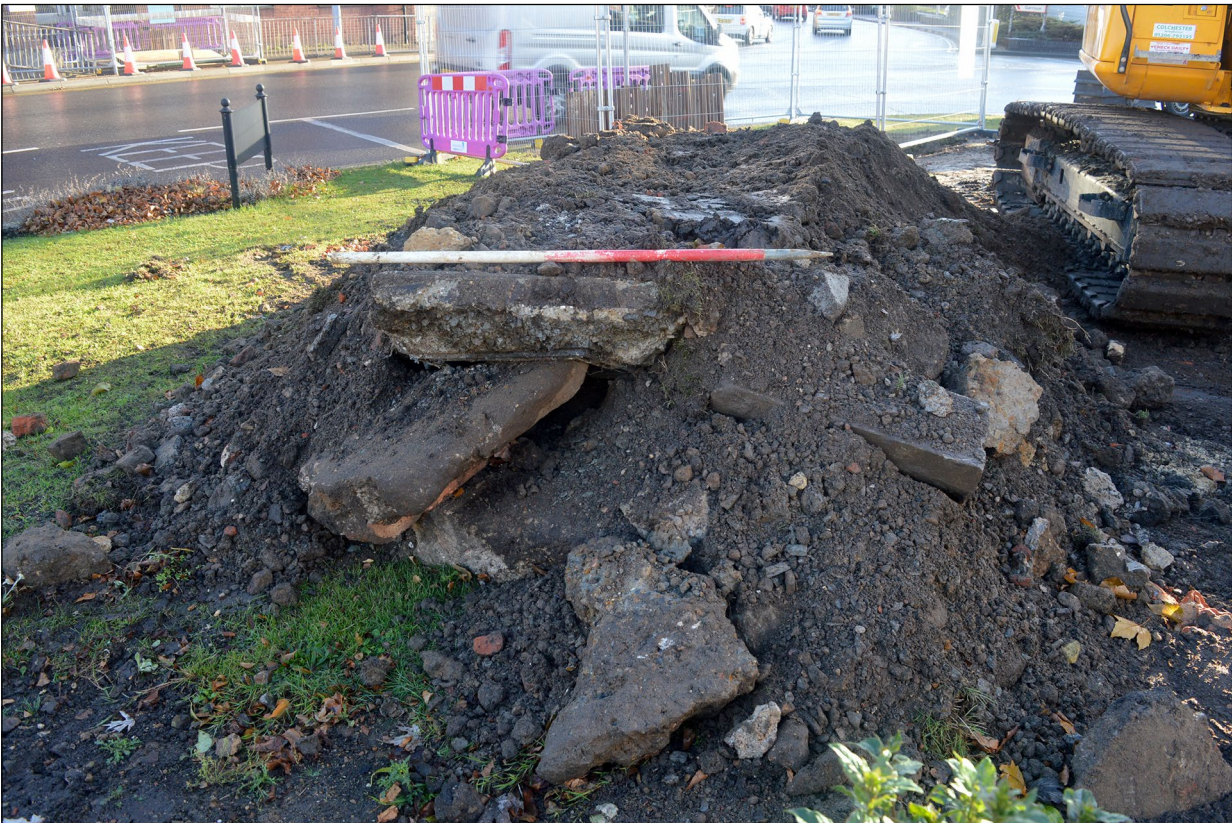
- 3.5.1 To the north-west of PT 1, PT 2 stretched from the northern half of the roundabout across the road to the pavement around Priory Court. It measured 10.3m long and 0.5m wide and was excavated to a depth of 1.0m.
- 3.5.2 The deposits were closely comparable to those recorded in PT 1, with only minor differences noted in the frequency of the CBM inclusions. The same context numbers have been ascribed to these deposits.

Plate 4: Made ground spoil from Pipe Trenches 2 and 3
