# Old Cloisters Building Brasenose College Oxford

## Report on an Archaeological Investigation

December 2013

## *Archaeological Evaluation Report*

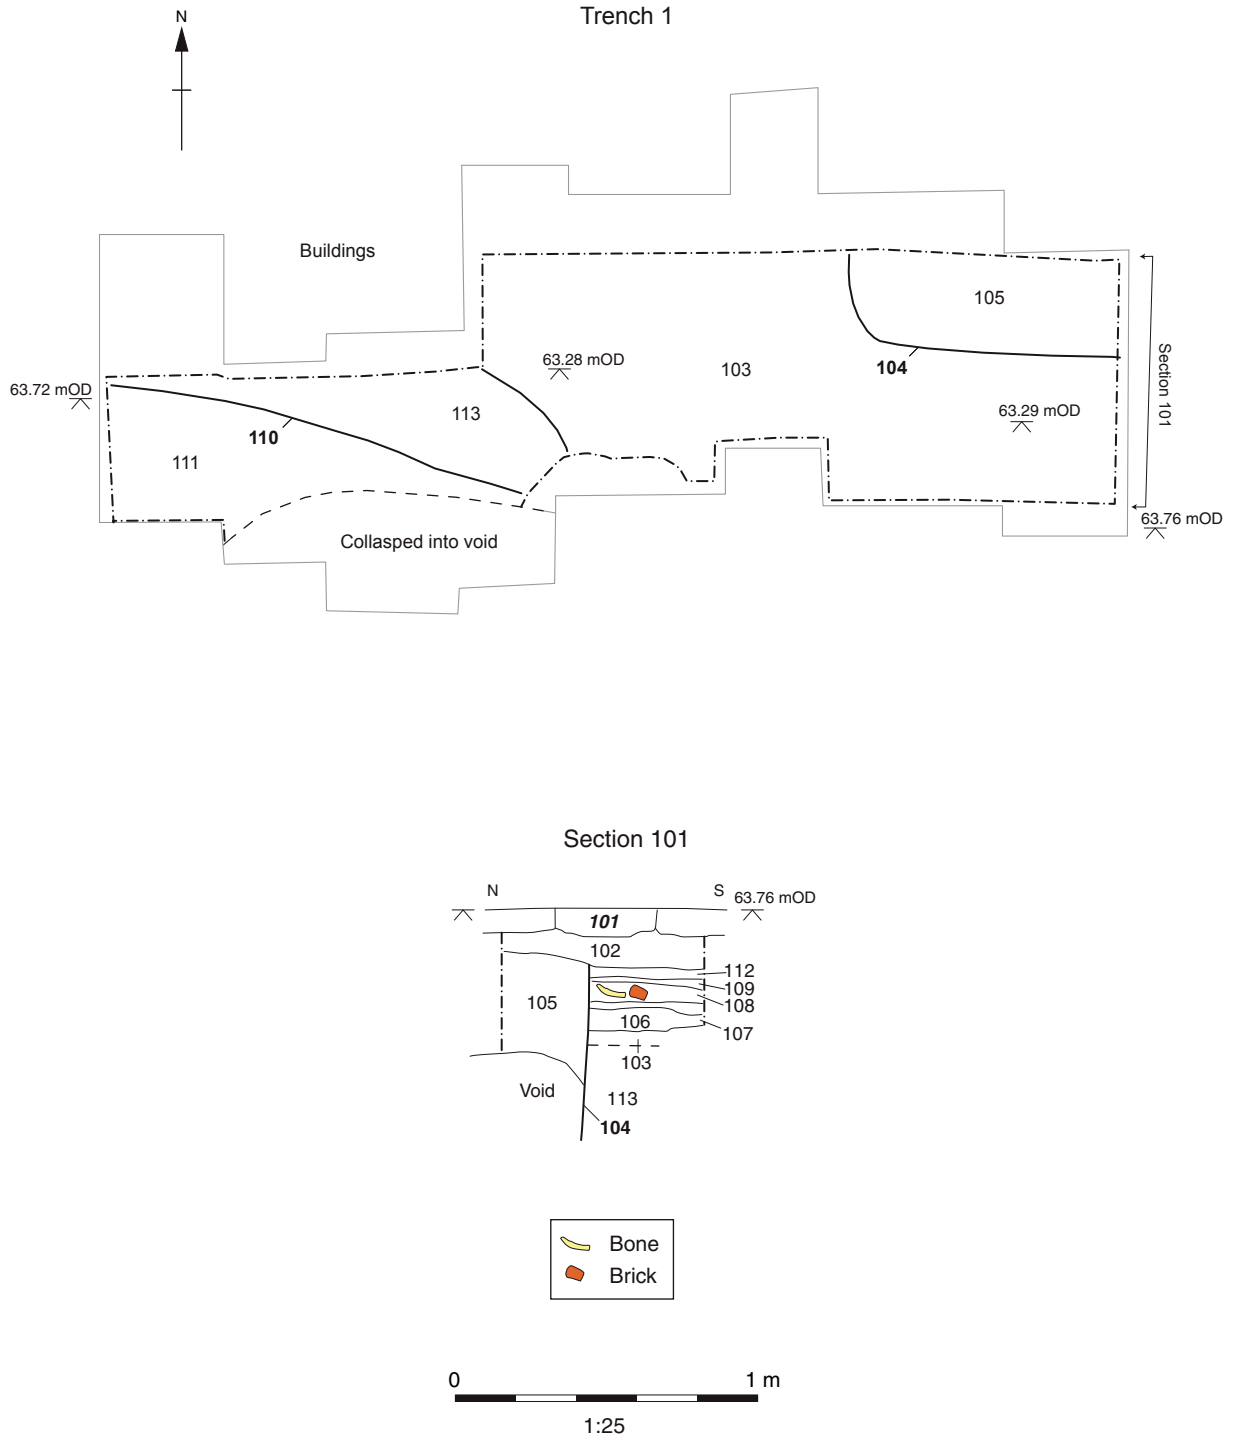
Figure 5: Trench 1, plan and section

- 3.2.1 Trench 1 was located in the centre of the Old Cloisters building and was positioned to investigate beneath a grave marker on the eastern side of the room, inscribed J B 1700, which corresponds to James Buerdsell on the list of burials. On the western side of the room the trench was placed over a grave indicated by a marker stone on the burial plan which is difficult to read but may be GP 1741 relating to George Polley on the burial list. The marker stone on the west side of the trench was not revealed as it

was beneath cables and service pipes. The trench was aligned east-west, it measured 3.34m x 0.7m and was at least 0.8m in depth. The trench was located in the central part of the investigation area.

- 3.2.2 The earliest deposit revealed in Trench 1 was context 113; a friable dark greyish brown loam (probable garden soil) with occasional inclusions of stones and charcoal flecks. This was overlain by a possible floor deposit 103, of compacted firm white lime mortar. The sequence of floors and deposits continued with 106 as a deposit, 107 as a floor, 108 as a deposit, 109 as a floor and at the top of the sequence was deposit 112 which contained animal bone and oyster shell fragments.

- 3.2.3 Deposit 112 (and the previous underlying sequence, Plate 2) was truncated by two visible east-west aligned grave cuts 104 and 110.
- 3.2.4 Grave cut 104 was visible in plan (at 63.58m OD) and partially in section. There was evidence for the decay and decomposition of the wooden coffin, with a void exposed at one end (Plate 1). The western end of the cut was seen and the grave extended to the east and north. The grave fill 105 was partially excavated to a depth of 63.08m OD but no human remains were encountered.

- 3.2.5 Grave cut 110 was visible in plan and partially in section as there was evidence for the decay and decomposition of the wooden coffin, with a resulting void at the western end. The cut appeared oval in plan and only the eastern end of the grave cut was seen. The cut extended west and south. The grave fill 111 was partially excavated to a depth of 63.08m OD but no human remains were encountered.

- 3.2.6 The graves were sealed by the bedding 102, for the flagstone floor 101, which lay beneath the brick supported present wooden floor, at an average depth of 63.74m OD.

- 3.2.7 Each grave was beneath a grave marker stone, although it is clear from Cut 104 that the marker stones do not necessarily indicate the head of the burial.
