Former Masons Cement Works Great Blakenham Suffolk

Archaeological Evaluation Report

OA East Report No: 1179 OASIS No: oxfordar3-75464 NGR: TM 1215 5020

By Louise Bush BA MA PIfA

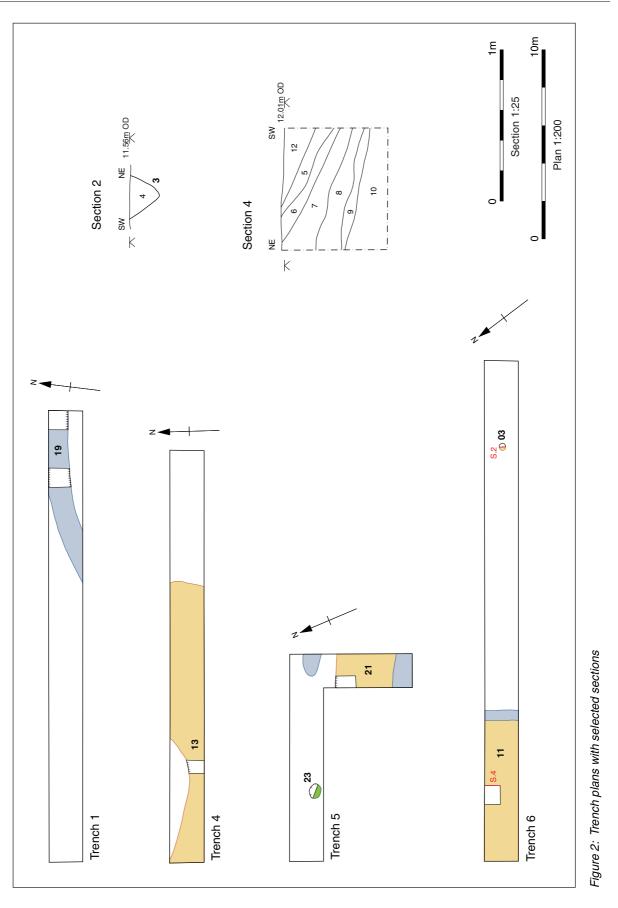
- Fig. 1 Site location map
- Fig. 2 Trench plans with associated sections
