# Brasenose College Radcliffe Square Oxford

## Historic Building Recording and Archaeological Investigations Report

*Historic Building and Archaeological Investigation Report*

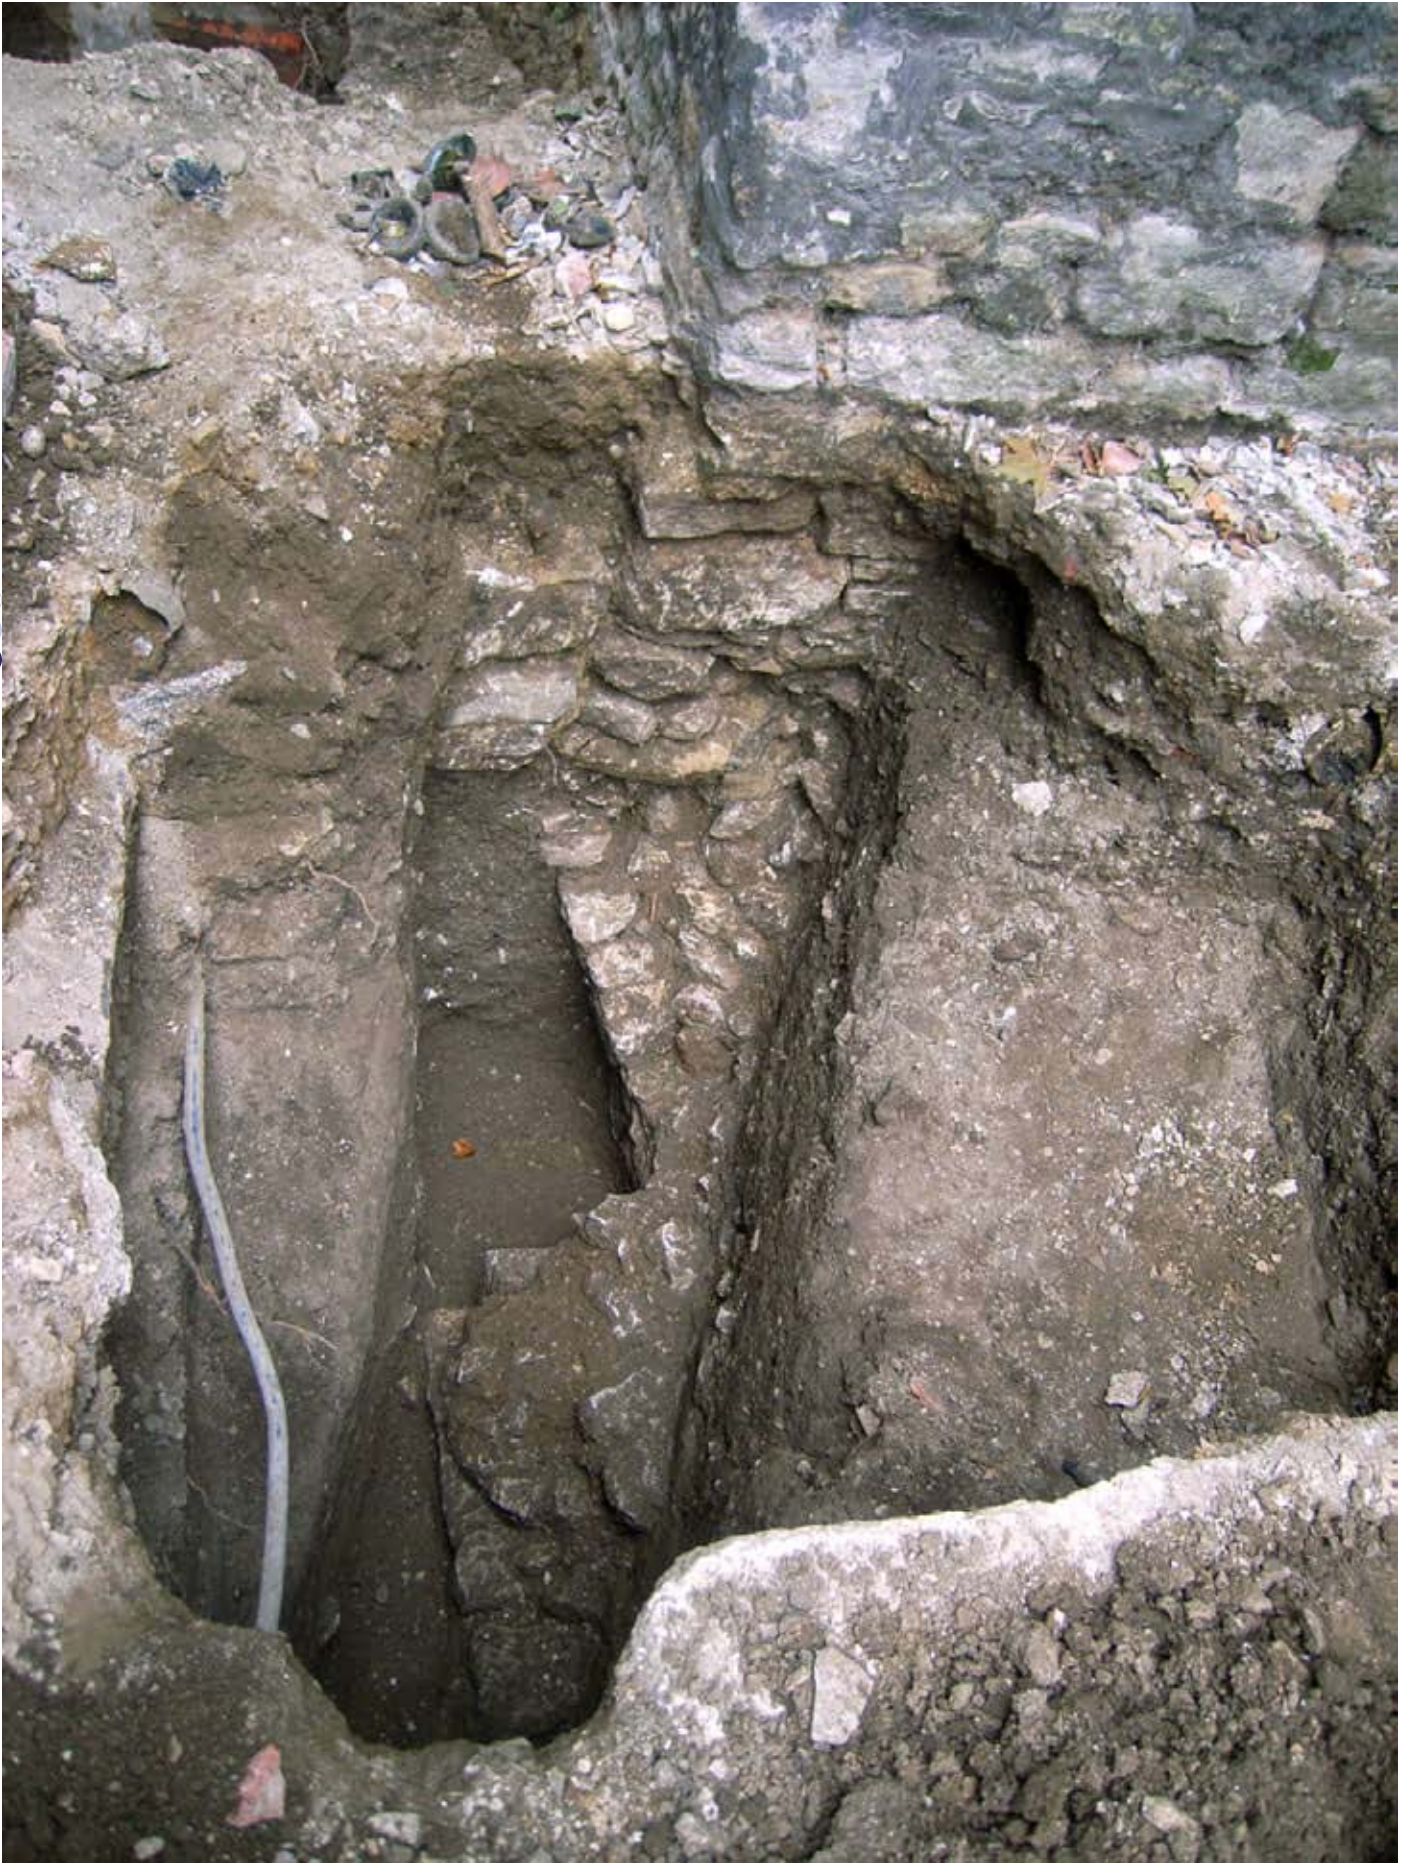
Plate 1: Test Pit 5, wall 22 - looking west

- 5.2.5 If the southern return of the earliest structure (Wall 22) found in Test Pit 5 is the remains of a buttress, it would suggest that this structure formed the southern wall of a building which once lay on the site of the Eckersley Room (Fig. 12). However, if instead the observed terminus of the wall's return represents an interruption for a threshold, it

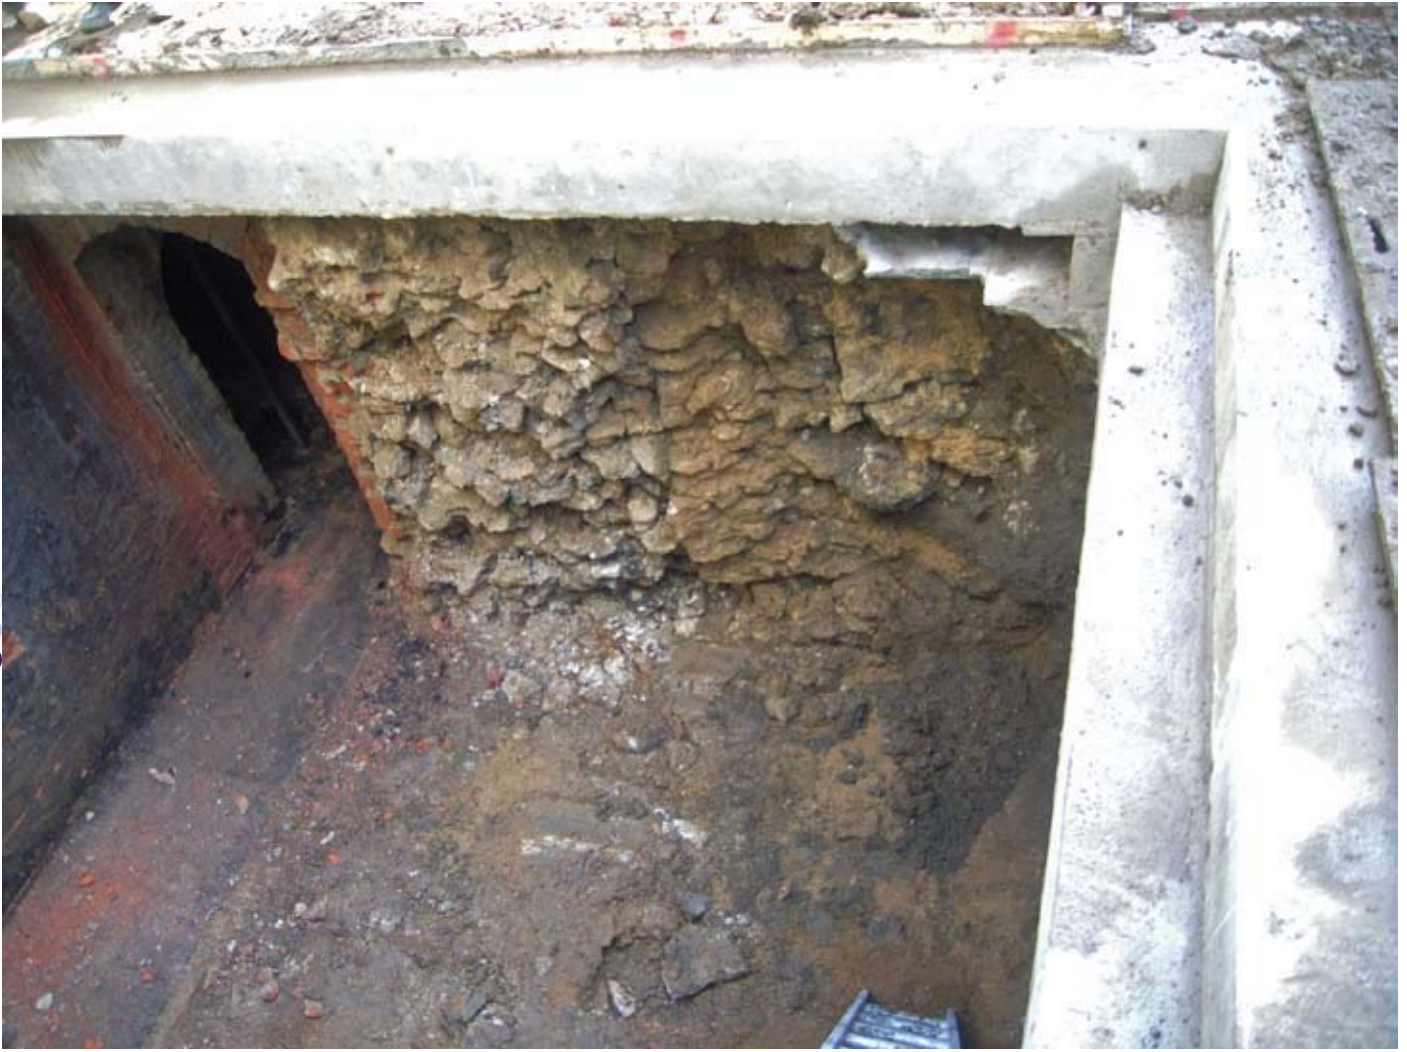
- 4.3.21 The earlier pits (89 and 91) and their fills were truncated by the construction cut (99) for an 18th- or 19th-century cellar, which was observed to be 5 m long and at least 2.8 m deep (Plate 2).

Plate 2: Test Pit 7, cellar remains - looking north

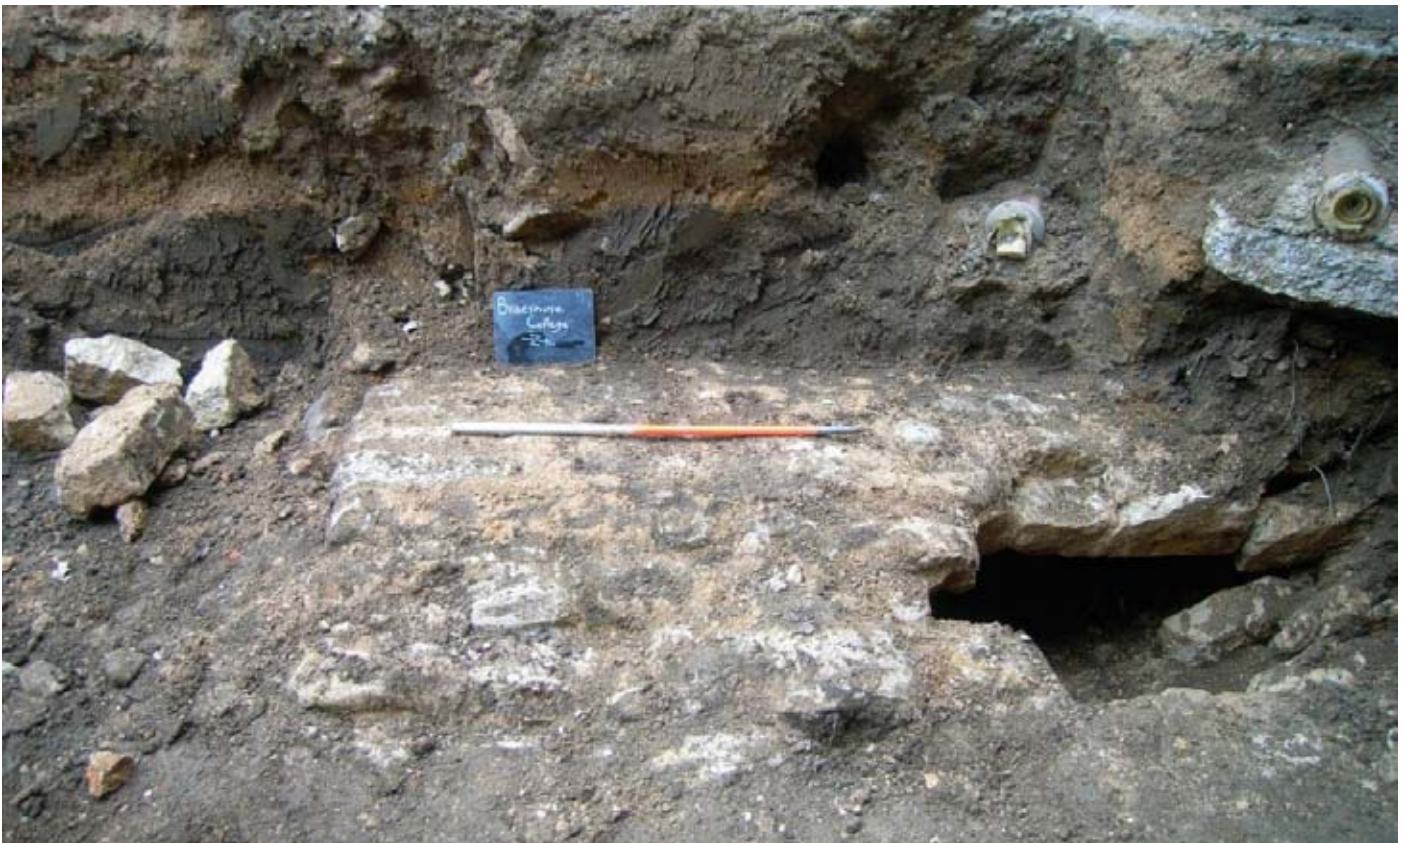
Plate 3: Test Pit 10, barrel vaulted structure

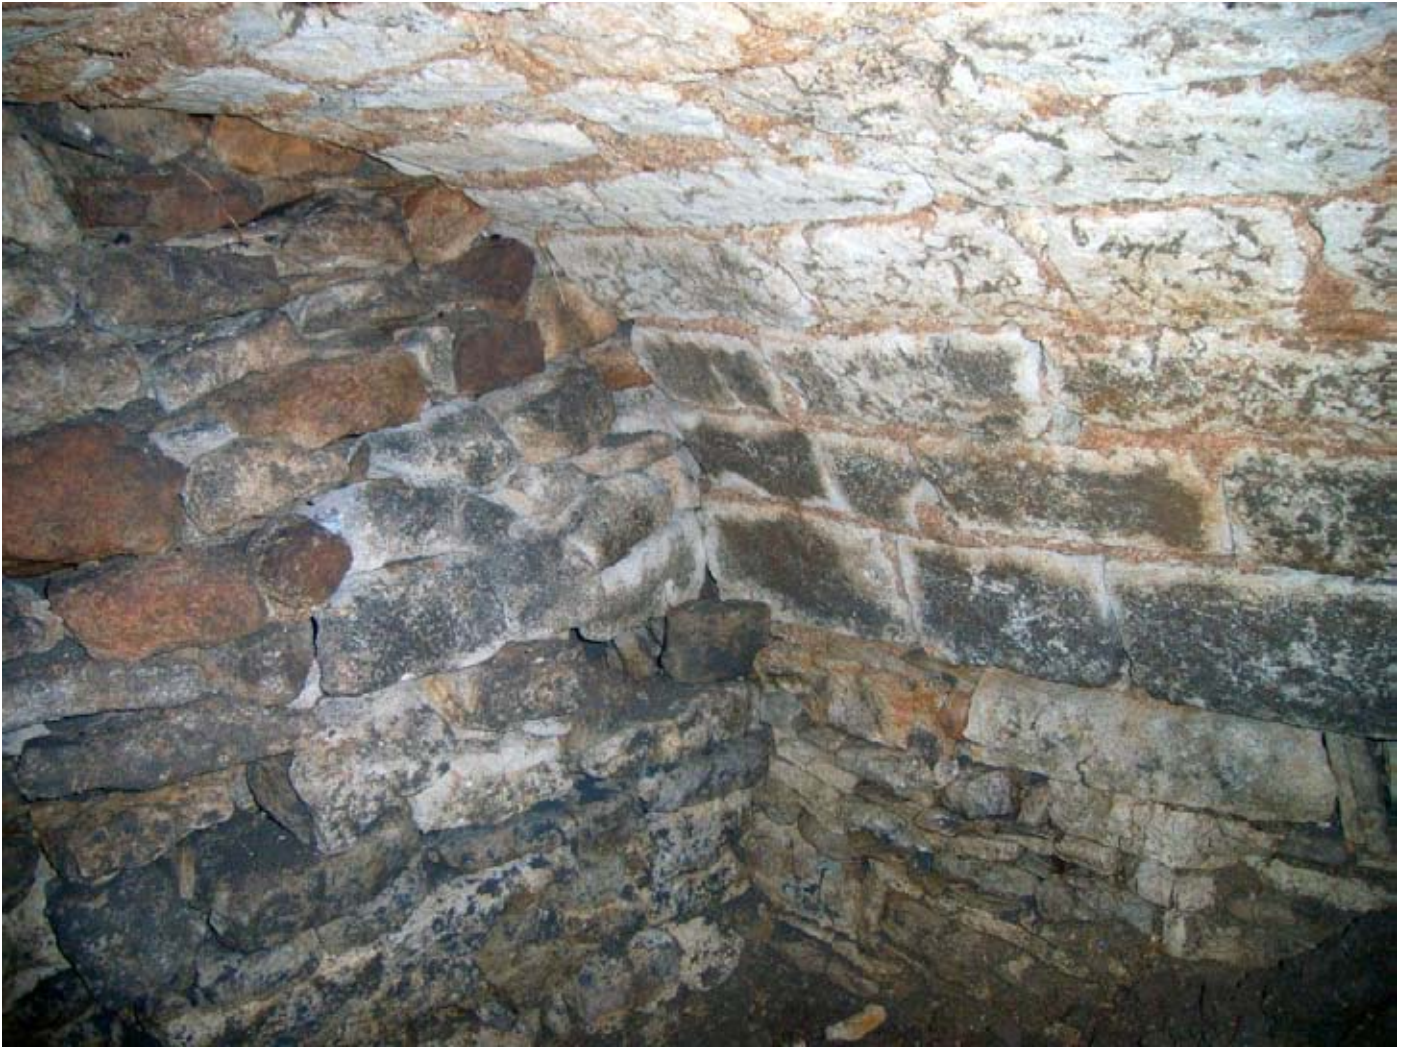
Plate 4: Test Pit 10, interior of barrel vaulted structure

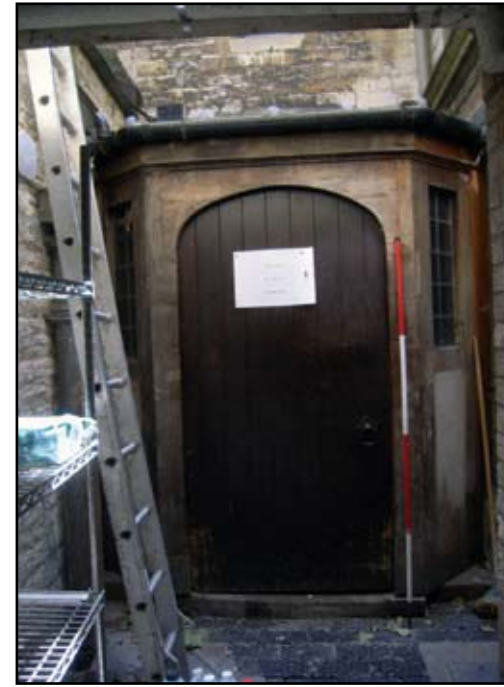
- 4.1.18 A single storey wooden porch with flat leaded roof is adjacent to the stair extension. Internally, this space contains stainless steel sinks and a large opening in the south wall leads through to the kitchen. A doorway in the east wall leads out into another small courtyard (Plates 6 and 9).

Plate 6: Entrance porch to kitchen area

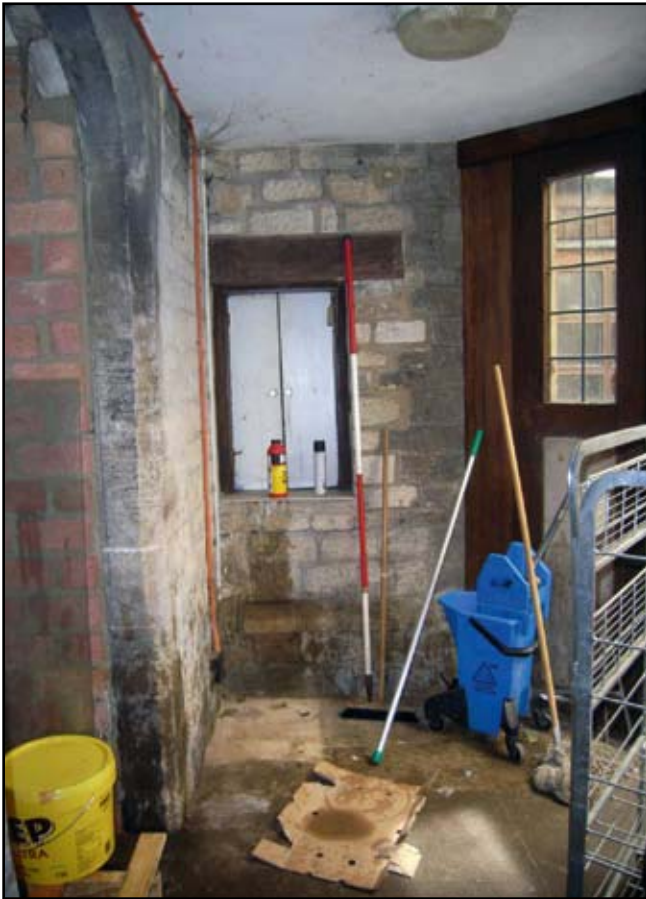
Plate 9: Internal view of porch (viewed east)

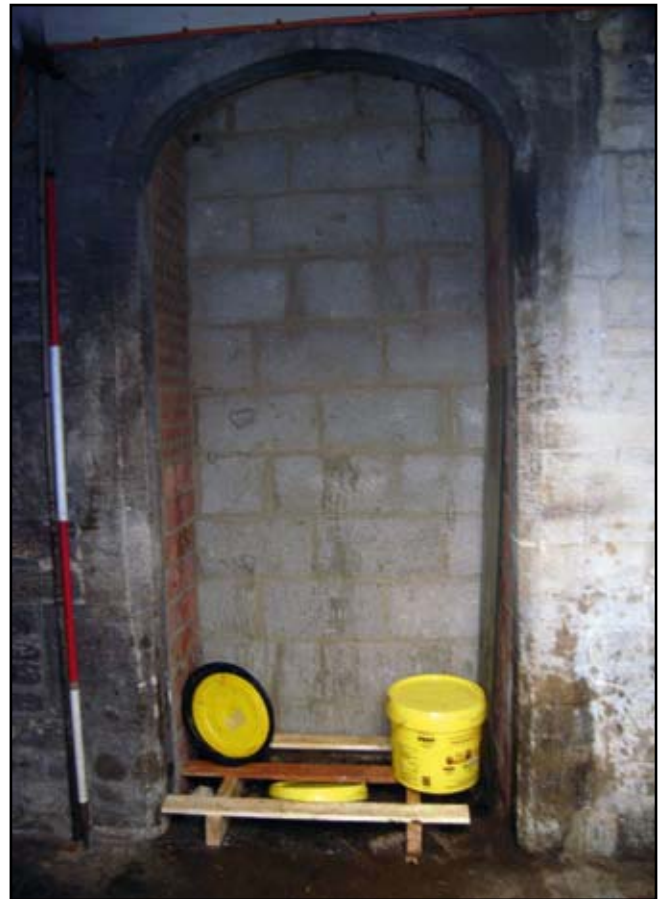
Plate 10: Detail of blocked doorway to kitchen

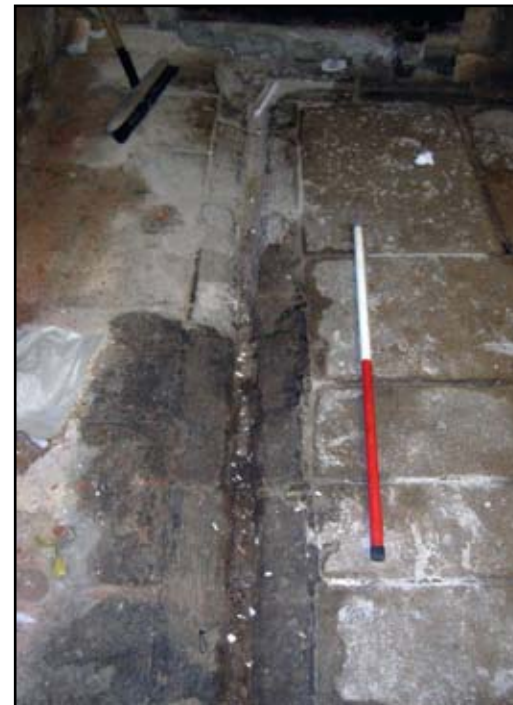
Plate 16: Detail of drainage channel on floor, Buttery Cellar

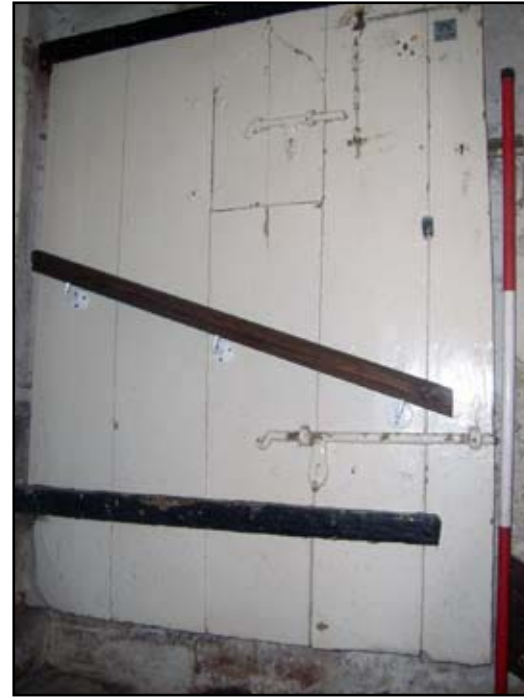
- 4.2.13 The wood door is truncated at the top to allow for a low ceiling within the entrance. The door itself is a simple plank and batten timber door with two large metal hinge straps, the upper one being a later replacement. There is a bolt fixed to the lower section of the door and another fixed to a small opening in the upper section of the door. Beyond the doorway there are two pieces of roughly worked stone which are supported on a modern inserted steel 'I' beam. Voids to each side of this suggest the steel beam replaced an earlier lintel which was probably of timber. A section of modern ceiling was adjacent to the steel 'I' beam, and the brick vaulted ceiling begins beyond it, to the east (Plates 14 and 19). Stone stairs lead down into the cellar with most of the steps worn in the centre (Plates 13 and 19). There has been some replacement of sections, most likely of 18th or 19th-century date.

Plate 18: Detail of Buttery Cellar door

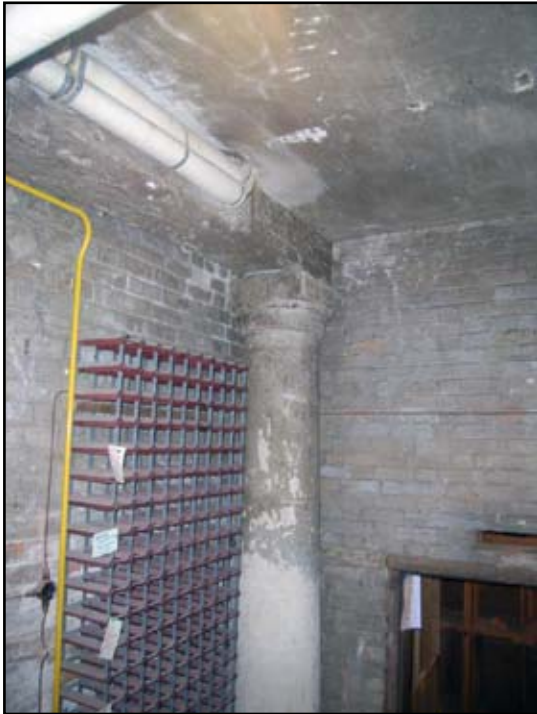
- 4.2.19 A further stone column can be seen within the brick wall in the centre of the cellar space, its upper section observed above the brick vaulting. Adjacent to this column is a wide opening with a moulded stone frame that has rebates within the jamb, suggesting there was once a door hung here; the western jamb has brick infill within one rebate.

Plate 25: Detail of stone column within main Wine Cellar

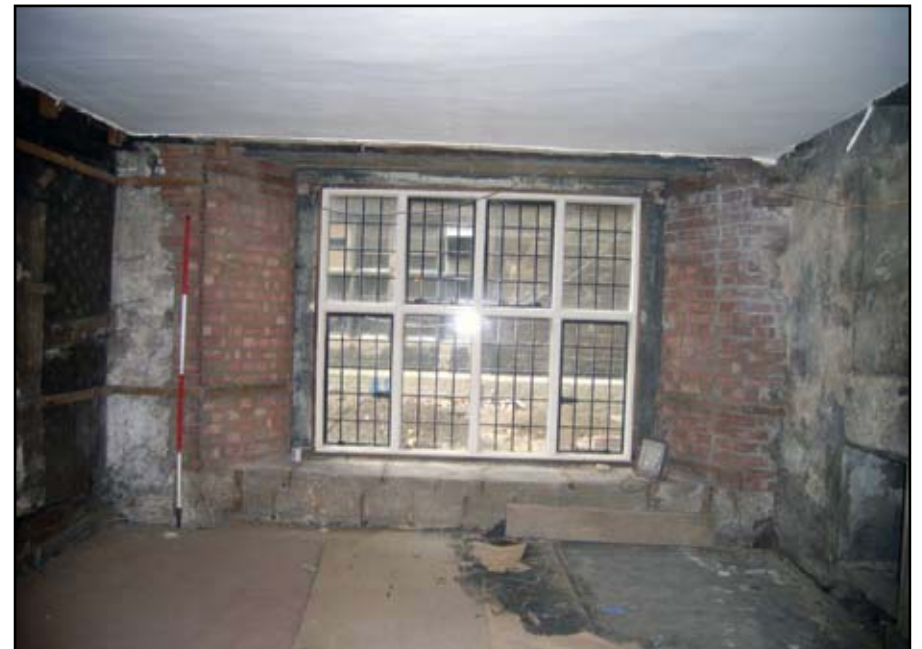
- 4.2.10 The south elevation consists of a large window dating to the early 20th-century that replaced two earlier small windows. The window almost reaches ground level and has a deep concreted sill. The reveals are of modern pink coloured brick laid in a varying bond. The window itself has a timber frame set within a stone surround and consists of 'four over four' multi-light windows with casement openings. The window has scrolled latches, and turnbuckle catches. To the window's east, there is a section of rubble stone walling with render covering which is possibly contemporary with the 16th-century fabric of the east elevation.

Plate 28: South elevation of Eckersley room

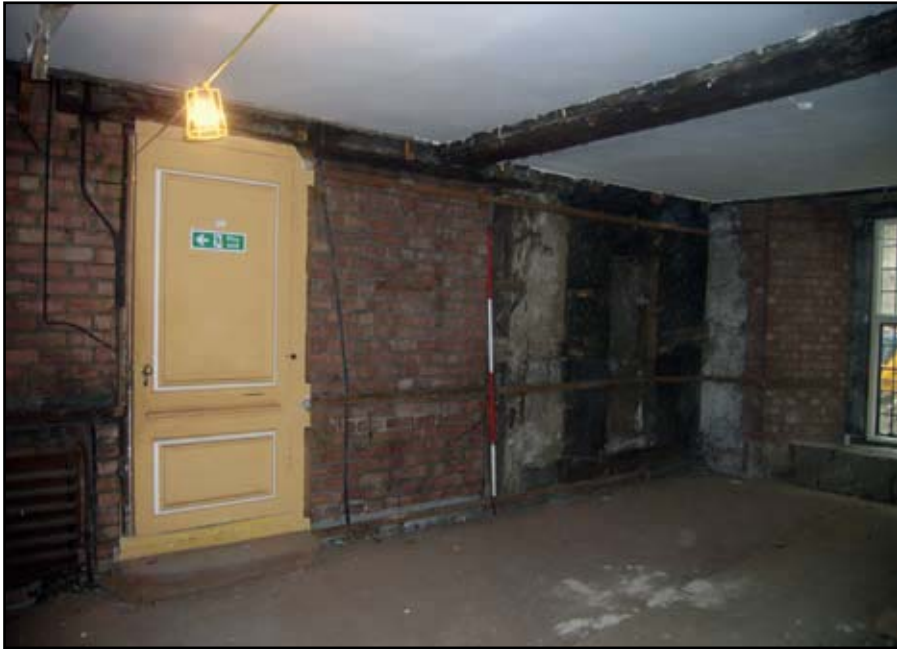
Plate 29: East elevation of Eckersley room

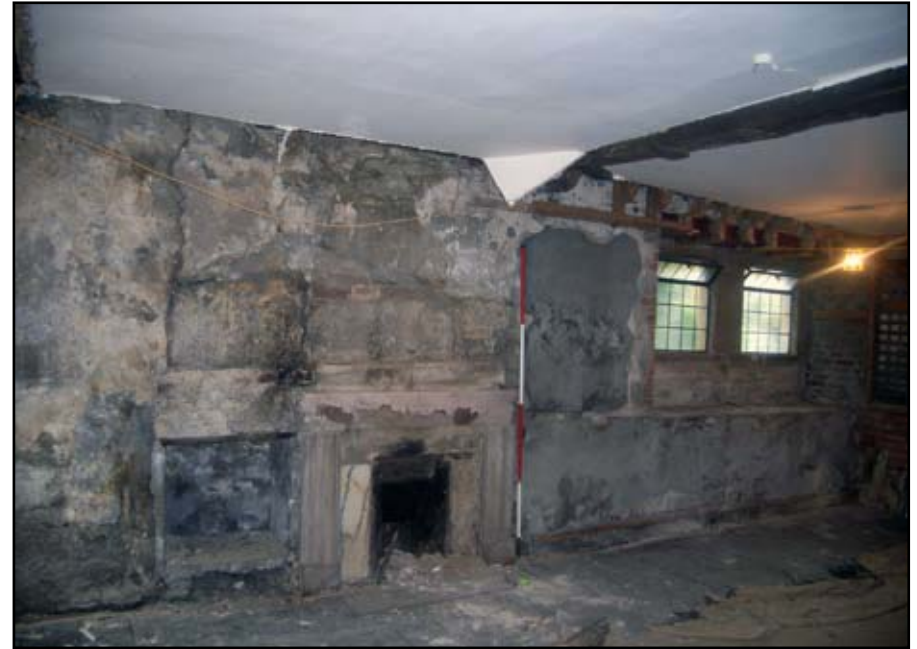
- 4.2.1 Removal of the 20th-century panelling revealed the fabric of the walls. The west elevation was drawn and this is included as Figure 10. The wall is predominantly constructed of roughly coursed stone with a friable cream coloured render over. The south end of the wall has two hearth openings; the southernmost was clearly disused. This consists of a recess 560mm deep with all surfaces covered in a grey coloured render and a timber board lintel. Beneath the recess is a void covered with loose fill, and the raised height of the recess suggests an early floor level; no other evidence was observed.

Plate 30: West elevation of Eckersley room

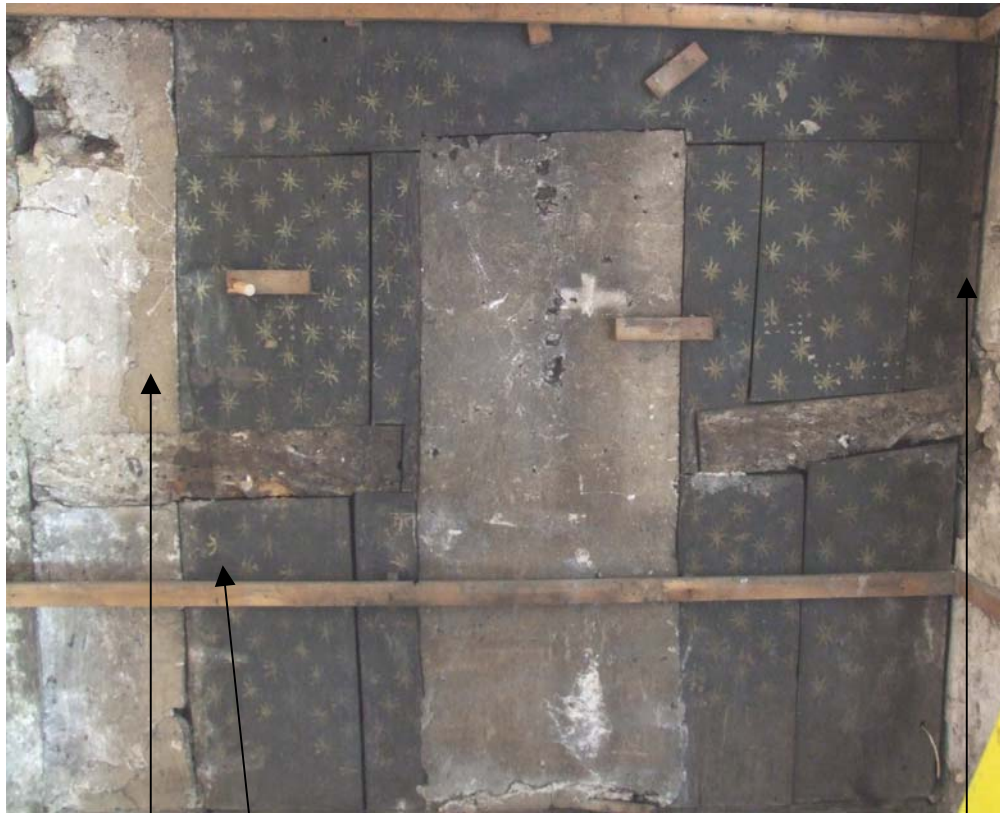
The historic finish of the exterior stone wall to the right of the painting is lost. The paint on the adjoining wooded boards is stopped just short of the edge, leaving an unpainted margin which must have been covered by a wood or plaster finish to the exterior wall. This may well have been painted. On the left side of the decoration the boards are painted right up to the edge. They abut a plaster repair which runs from floor to ceiling. It is possible that there was a returning wooden partition, running parallel to the exterior wall, inserted here. There is a mortise in the upright timber to the left of the plaster panels, which may have formed part of a support for this. The painted area would thus span the width of a small chamber or passageway, the painting continuing onto surfaces now lost.

plaster repair

unpainted margin

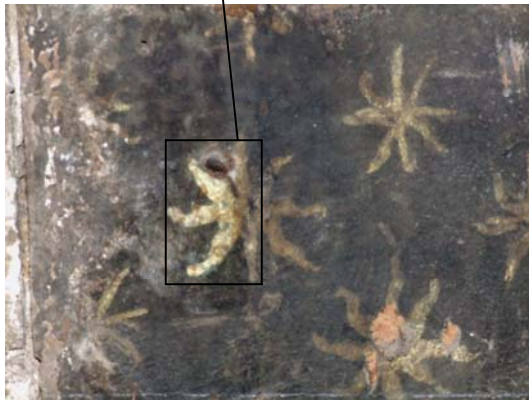
The original techniques are sound, and there are no signs of ongoing deterioration. In a few places there is a need for paint-fixing, for example, where mechanical damage has caused paint loss and exposed edges need catching and. The painting is extremely dirty with loose surface deposits which are easily removed with water. A small cleaning test revealed the original intensity of the yellow.

Cleaning test
