# Corpus Christi College, Oxford, New Sub Main Works

## Archaeological Watching Brief Report

**Client: Corpus Christi College,  
Oxford**

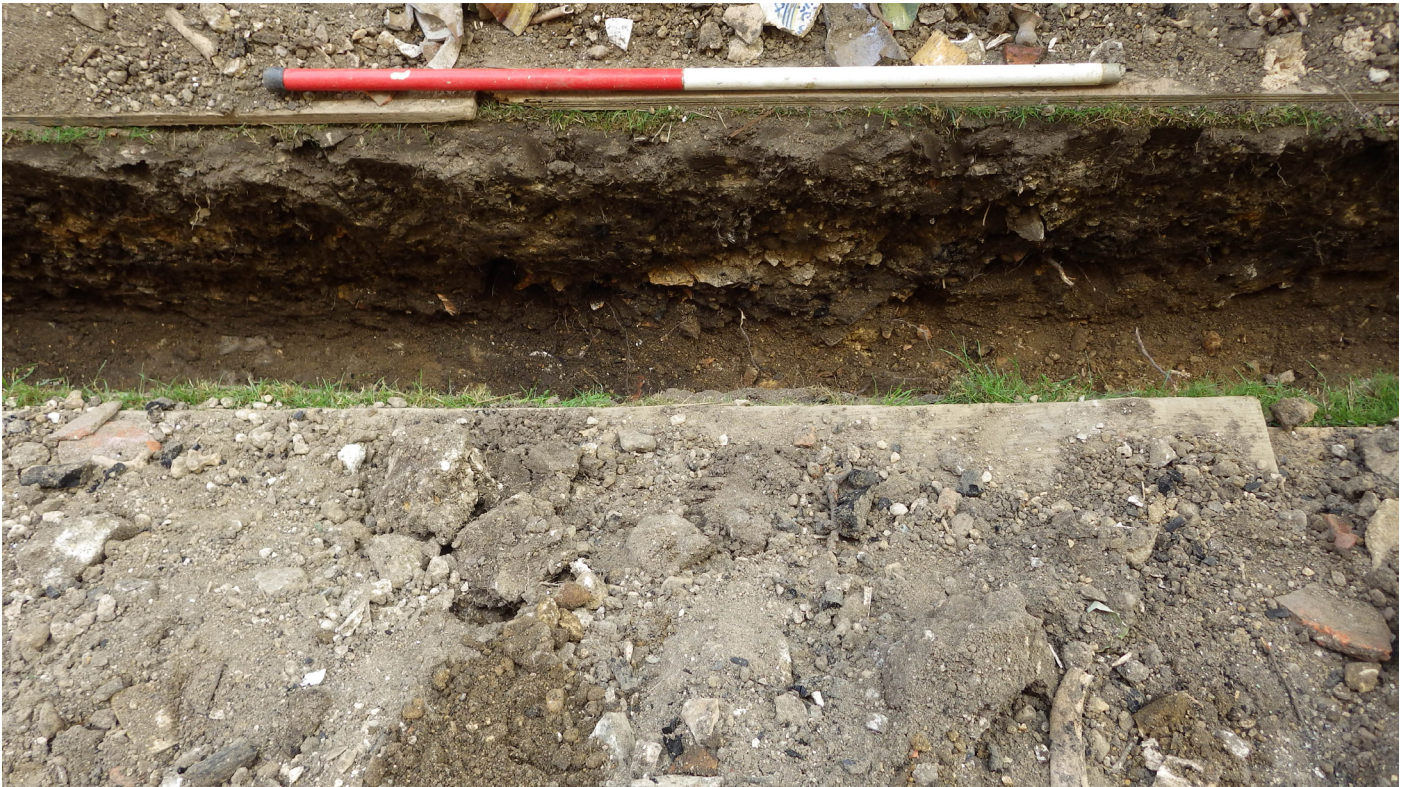
Plate 3: Trench 3, rubbish pit 6, east facing section 1

- 3.1.4 The trench was located in a grassed area (Figs 2 and 3; Plate 2). The earliest deposit encountered was 2, described as a subsoil deposit, which contained pottery dating to 1600-1675, and clay pipe dating to 1650-1700 (Fig. 5, Sections 1 and 2). A pit, 6, was identified, but not fully investigated as the base was below the impact depth of 500mm below the ground surface. The pit cut layer 2, and had steep sloped and slightly concave sides (Fig. 5, Section 1; Plate 3). The earliest pit fill encountered, 5, was a firm, light yellowish-brown silty clay with no inclusions. This was overlain by 4, a loose, mid yellowish white silty clay with degraded mortar inclusions. The upper fill, 3, was a dark brownish-grey clay silt with charcoal, degraded animal bone including a rare (for

this date) turkey bone (see Appendix C. 6), and oyster shell inclusions. Fill 3 also contained pottery dating to 1650-1700 (see Appendix C.1). The upper fill of the pit was sealed by topsoil 1 (Fig. 5, Sections 1 and 2).

- 4.1.3 A fill from a pit (6) in Trench 3 produced some interesting evidence for the diet of the inhabitants of the college in the second half of the 17th century, and was located in the Merton Grove area of the site where previous midden deposits have been located. In addition to the cattle and sheep bones recovered, the pit also contained bones from guinea fowl or pheasant, a woodcock, a pigeon and a turkey. Both the domestic fowl and the pigeon specimens were tarsometatarsi from juvenile individuals, perhaps suggesting that they were bred specifically for the table. The most significant of these finds though is undoubtedly the turkey bone, a tibiotarsus.

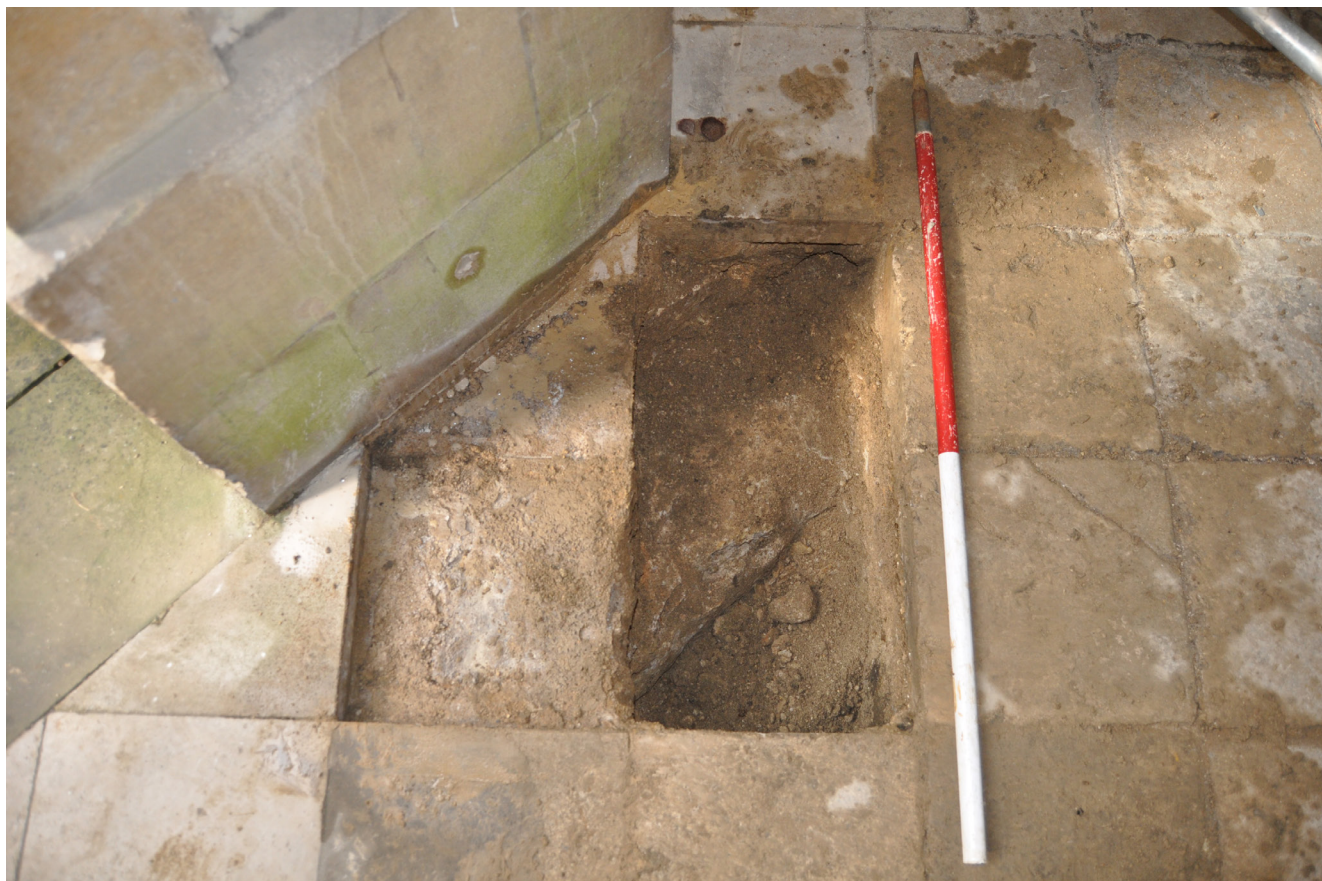
Plate 4: Test Pit1, view to south east

- 3.1.10 The earliest deposit uncovered a firm dark greyish-brown garden type soil, 19, with occasional charcoal fleck inclusions. It was cut by the construction cut 16, for wall 15. (Fig. 5, Section 5.). The construction cut which was backfilled with deposit 18, which had spread over the remnant of the wall when the upper courses were removed, and was a light greyish-yellow sandy silt with mortar and occasional angular limestone inclusions. The wall, 15, was constructed from roughly hewn limestone blocks each measuring around 0.2m by 0.1m by 0.05m. The bonding material was a coarse light

grey sandy mortar. At least 3 courses of the wall survived, and it was not investigated below impact depth. Sitting on the upper remaining course of wall 15 was a stone footing, (12), probably the foundation of a pillar. It was constructed from roughly hewn limestone blocks, at least one course deep. It measured 0.2m wide by 0.2m long and up to 0.2m high and continued beyond the limits of the test pit. A layer of mid yellow-brown sandy silt with mortar and occasional charcoal flecks (17) overlay deposit 18, and abutted 12. Layer 17 was sealed by 20, 0.05m thick bedding layer for the current stone tile floor (14) that runs the length of the cloister. (Plate 4).

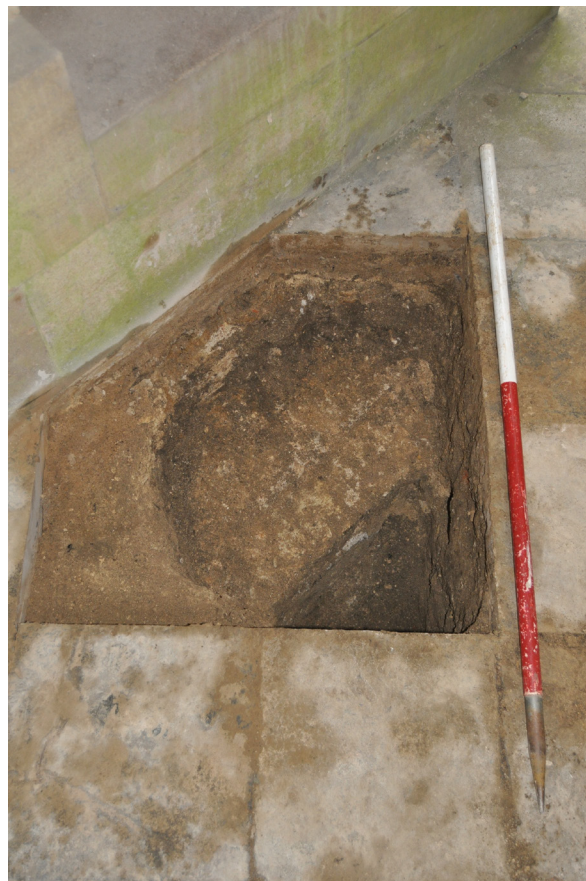
Plate 5: Test Pit 2, view to south west

- 3.1.11 The earliest feature in Test Pit 2 was a west-east aligned wall, 21, constructed from limestone blocks which measured around 0.14m by 0.33m by 0.13m. They were possibly faced on the north side but this was obscured by later deposit 23. The wall survived to two courses high and was bonded with pale greyish-pink sandy mortar. The exposed area of wall measured 0.35m wide by 0.75m long and 0.24m thick (Fig. 5, Section 6; Plate 6). Butting against the wall was deposit, 23, a firm dark greyish brown mixed mortar and sandy silt with frequent pale pinkish mortar flecks. Constructed directly above wall 21 was a probable pillar foundation, 24, made from limestone blocks measuring 0.25m by 0.2m and faced on the north side. A single course survived with a thin layer of pale pinkish-grey mortar on the north face. Wall 21 was sealed by a levelling deposit, 22, which also abutted 24. Layer 22 was a firm dark greyish-brown mixed sandy silt with frequent degraded mortar fragments and occasional small red brick and limestone fragments. This was overlain by a levelling layer, 25, a firm very dark grey- brown sandy silt with frequent pale greyish brown mortar, occasional brick and charcoal fleck inclusions. Layer 20 which appeared to post-date 25, was 0.12m thick and extended beyond the limits of the test pit. Layers 20 and 25 supported tile floor 14 (see above).

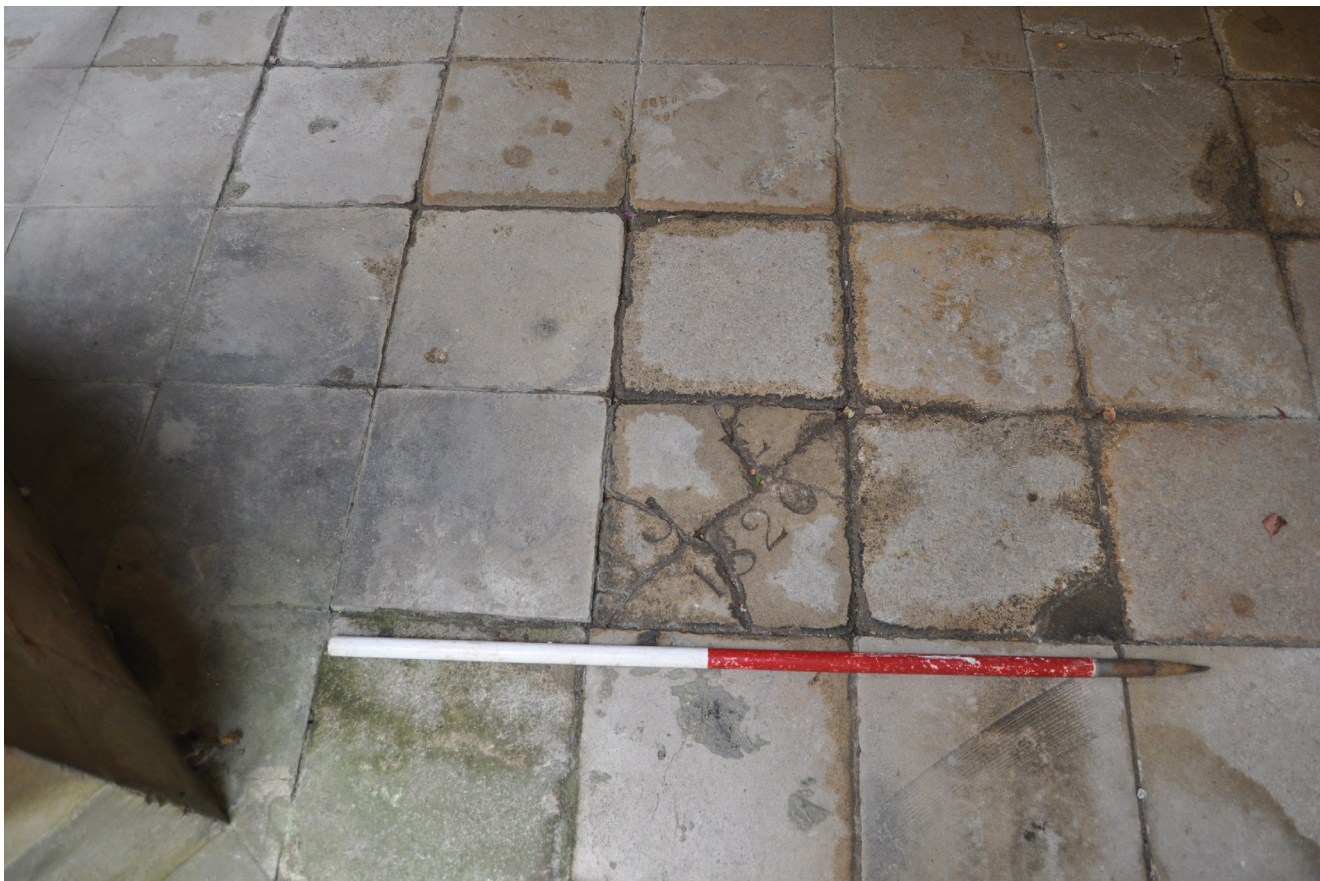
Plate 7: Initialled stone floor tile by Test Pit 3, view to west

- 3.1.15 One of the tiles forming surface 14, and adjacent to Test Pit 3 had an inscription reading "J. L. 1820". The initial 'L' may be an 'E' but the surface was worn (Plate 8). The tile was photographed and recorded but could not be reinstated or retained as it was cracked and fragmented upon removal.
