# Rye Environmental Centre, High Wycombe, Bucks

## Archaeological Watching Brief

**THE RYE ENVIRONMENT CENTRE, HIGH WYCOMBE,  
BUCKINGHAMSHIRE**

***ARCHAEOLOGICAL WATCHING BRIEF REPORT***

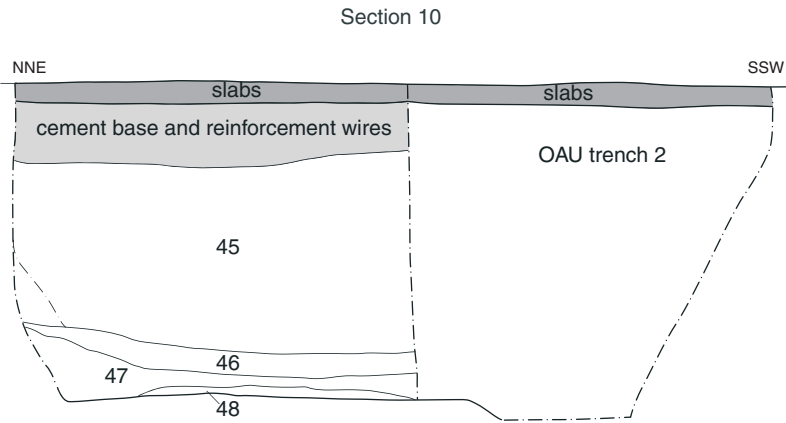
Figure 5: Section 10 ( between piles 9 and 10), Section 16 and Section 14

- 3.1.3 A trench approximately 2.5 m in length by 0.6 m wide by 1.1 m deep was excavated between piles 9 and 10 in order to remove an obstruction encountered during the augering of the pile holes. The southern half of this trench was excavated through the backfill of OAU evaluation Trench 2. The northern extent revealed the following stratigraphic sequence (Fig. 5).
- 3.1.4 A 0.3 m+ thick, compact, light grey silty sand (48) with chalk flecks, charcoal, flecks of mortar and lenses of reddish brown staining was observed in the base of the trench. This deposit probably represents a make up deposit for a removed floor surface noted by the Hartley excavations in 1954. Overlying this deposit was a mixed layer of compact, light grey silty sand (47) with inclusions of flint, charcoal, chalk and mortar, which was approximately 0.2 m thick. These inclusions were similar to those

observed within the deposit recorded in pile hole 3. Deposit 47 was in turn overlain by a 0.08 m thick, red- brown silty clay (46) which included brick fragments, flints, mortar flecks, iron mesh and other construction debris, all probably part of the construction horizon for the swimming pool complex. This horizon was overlain by 0.6 m of the made ground observed across the rest of the site (45) which was in turn overlain by 0.2 m of re-enforced concrete underlying the paving.
