Cornbury Park Near Charlbury Oxfordshire

Archaeological Watching Brief Report

Cornbury Park, near Charlbury, Oxfordshire

ARCHAEOLOGICAL WATCHING BRIEF REPORT

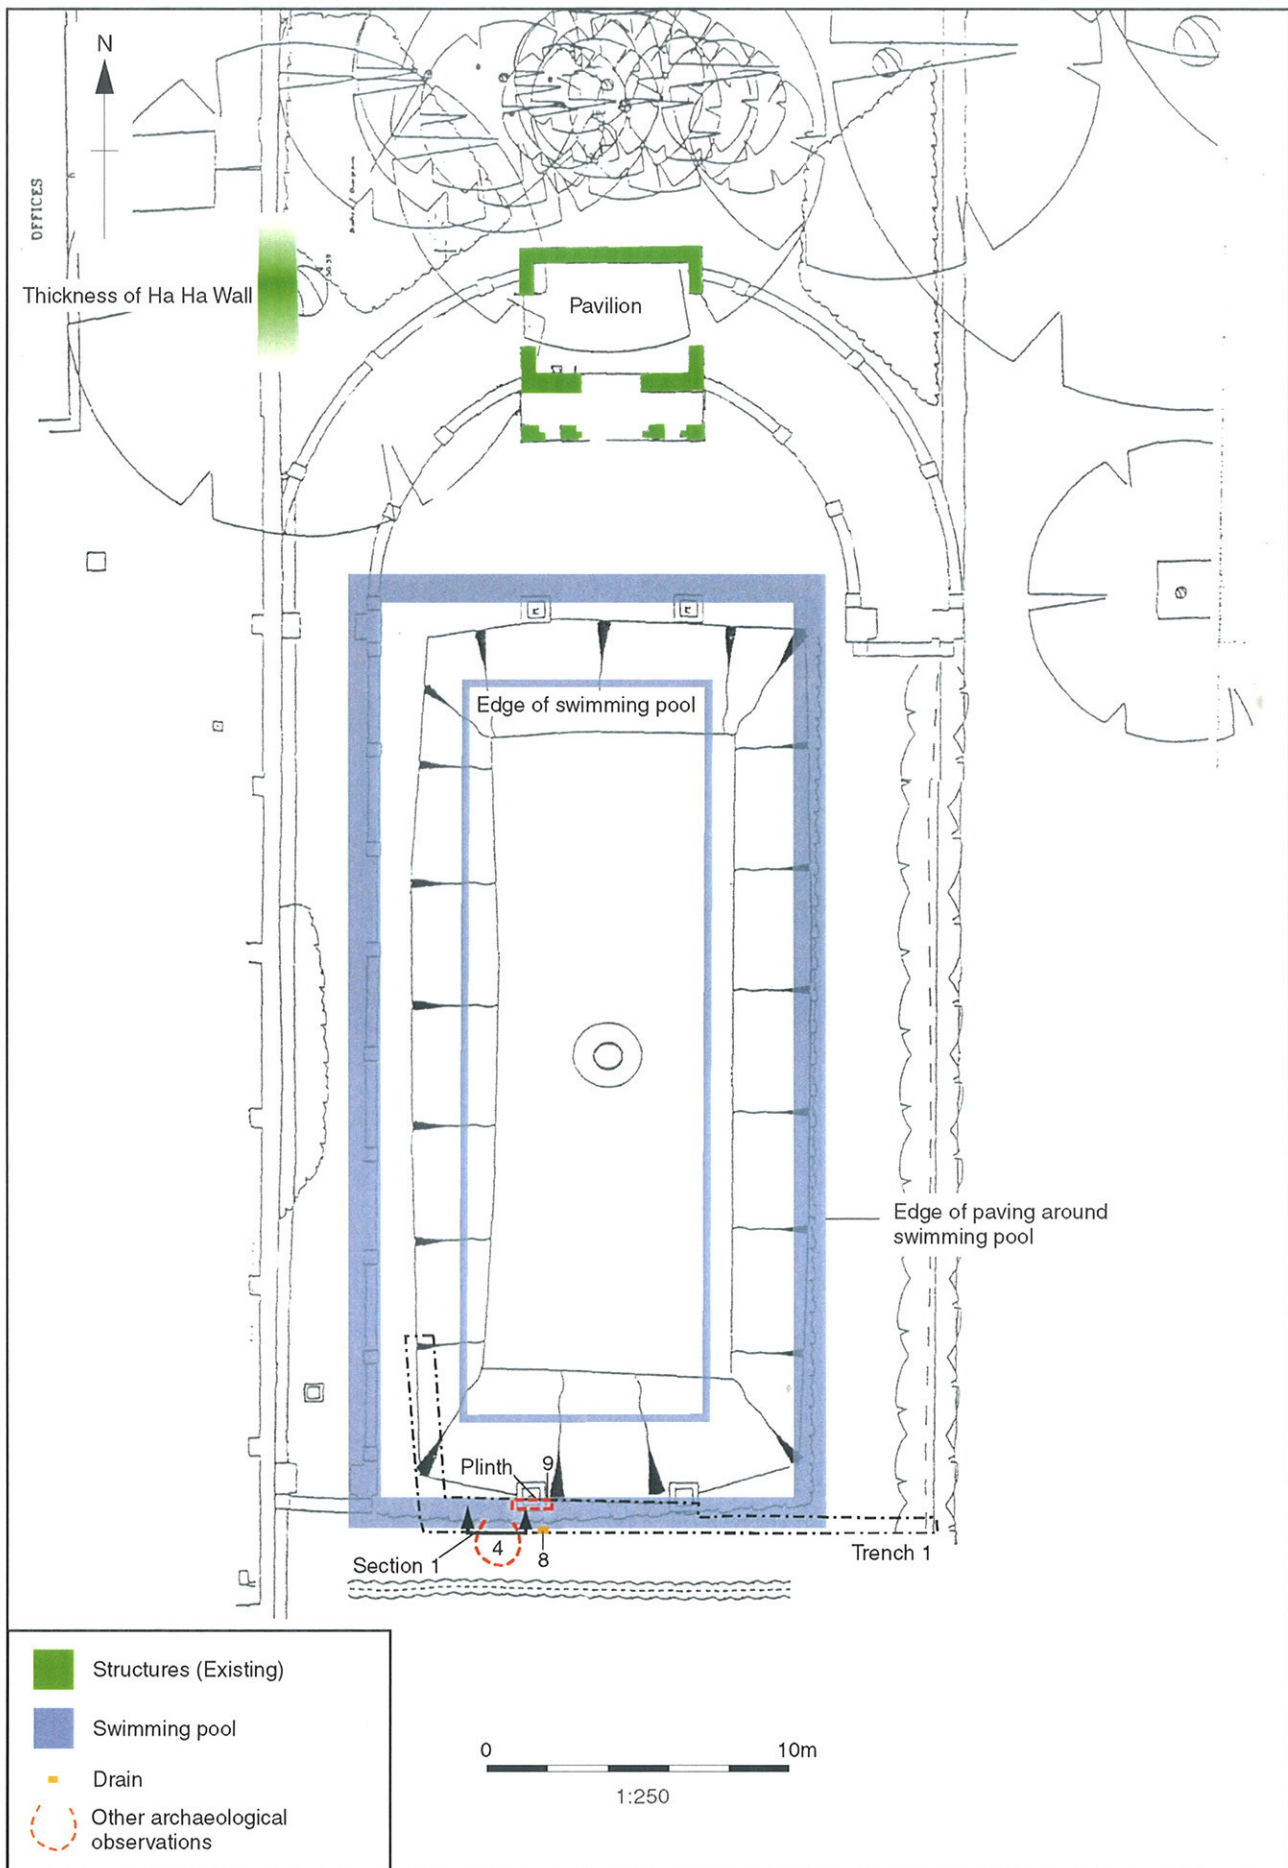
Figure 2: Site Plan

- 3.1.2 Two other features were observed, comprising a 20th century brick drain (8) and a 1.2 x 1.2 x 1m plinth of concrete and brick rubble (9) for a garden ornament (Figs 2). These were all sealed under a 0.4 m thick layer of dark brown silty clay loam topsoil (1).

3.1.4 The Yew tree next to the Ha Ha wall was removed because of the root damage to the base of the wall. This revealed a 1.5 m wide wall constructed of rough limestone blocks bonded with a lime mortar and rubble core. This formed the solid base for the present tall west garden wall (Fig. 2).

- 2.2.1 First a trench was excavated around the south end of the proposed swimming pool to re-route a water pipe around the house. Then the area of the swimming pool was excavated with a 360⁰ machine (Fig. 2). The area was piled and then the concrete was poured. The drive in front of the east front of the house was graded for new drive.
- 2.2.2 All archaeological features were planned at a scale of 1:100 and where excavated their sections drawn at scales of 1:20. All excavated features were photographed using colour slide and black and white print film. A general photographic record of the work was made. Recording followed procedures detailed in the *OAU Fieldwork Manual* (ed D Wilkinson, 1992).

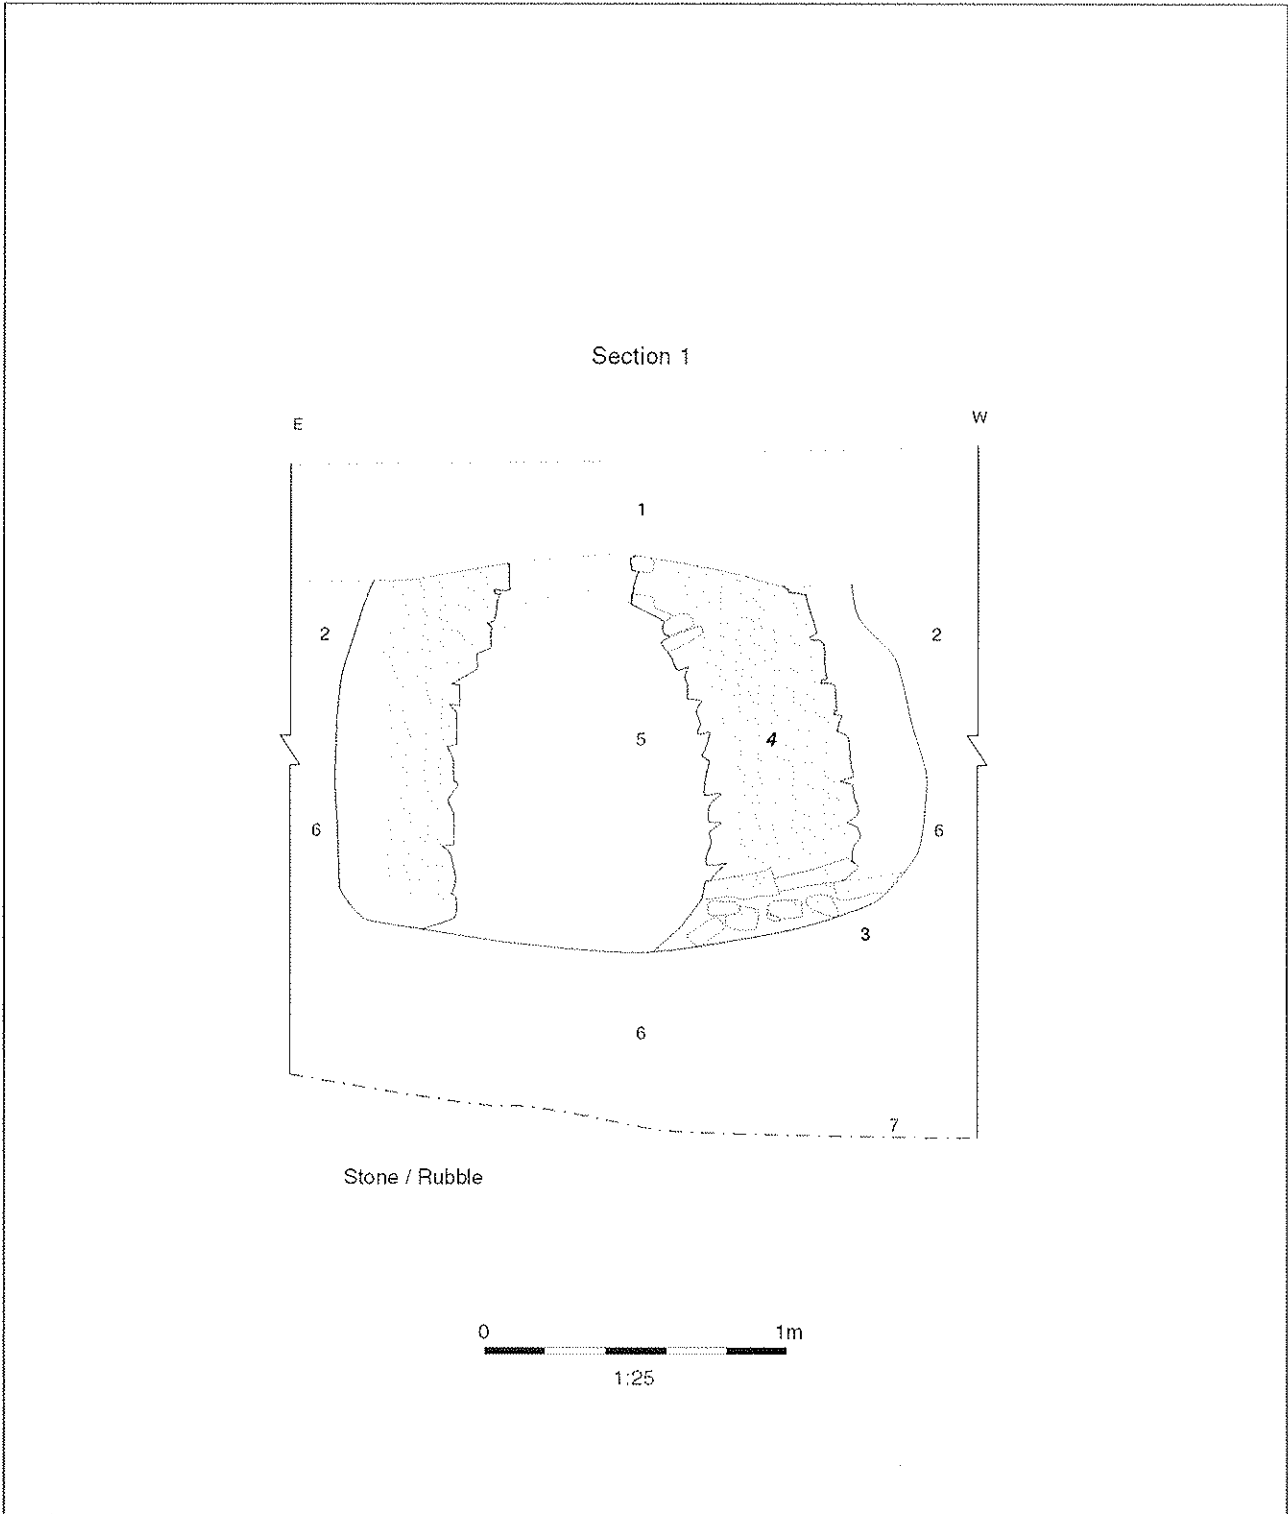
Figure 3: Section 1

- 3.1.1 The excavations for the swimming pool showed that the natural (7) was sealed below a 1 m thick layer (6) a series of thin dumps of silty clay loam over compacted layers of crushed stone and gravel. This was the remains of an earlier driveway to the house. Overlying this was a 0.7 m thick layer of yellowish brown silty clay (2) with lenses of limestone fragments and gravel. This was material used to build up the ground for the sunken garden. Cut into this was a large circular feature (3) with near vertical sides rounding to a flat base. It measured 2 m in diameter and 1.5 m in depth and contained a limestone soakaway (4) constructed in rough drystone courses on a compact rubble base. This had slowly silted up with dark greyish brown silty clay (5) (Fig. 3).
