High Street Oxford

Archaeological Watching Brief Report

April 2007

ARCHAEOLOGICAL WATCHING BRIEF REPORT

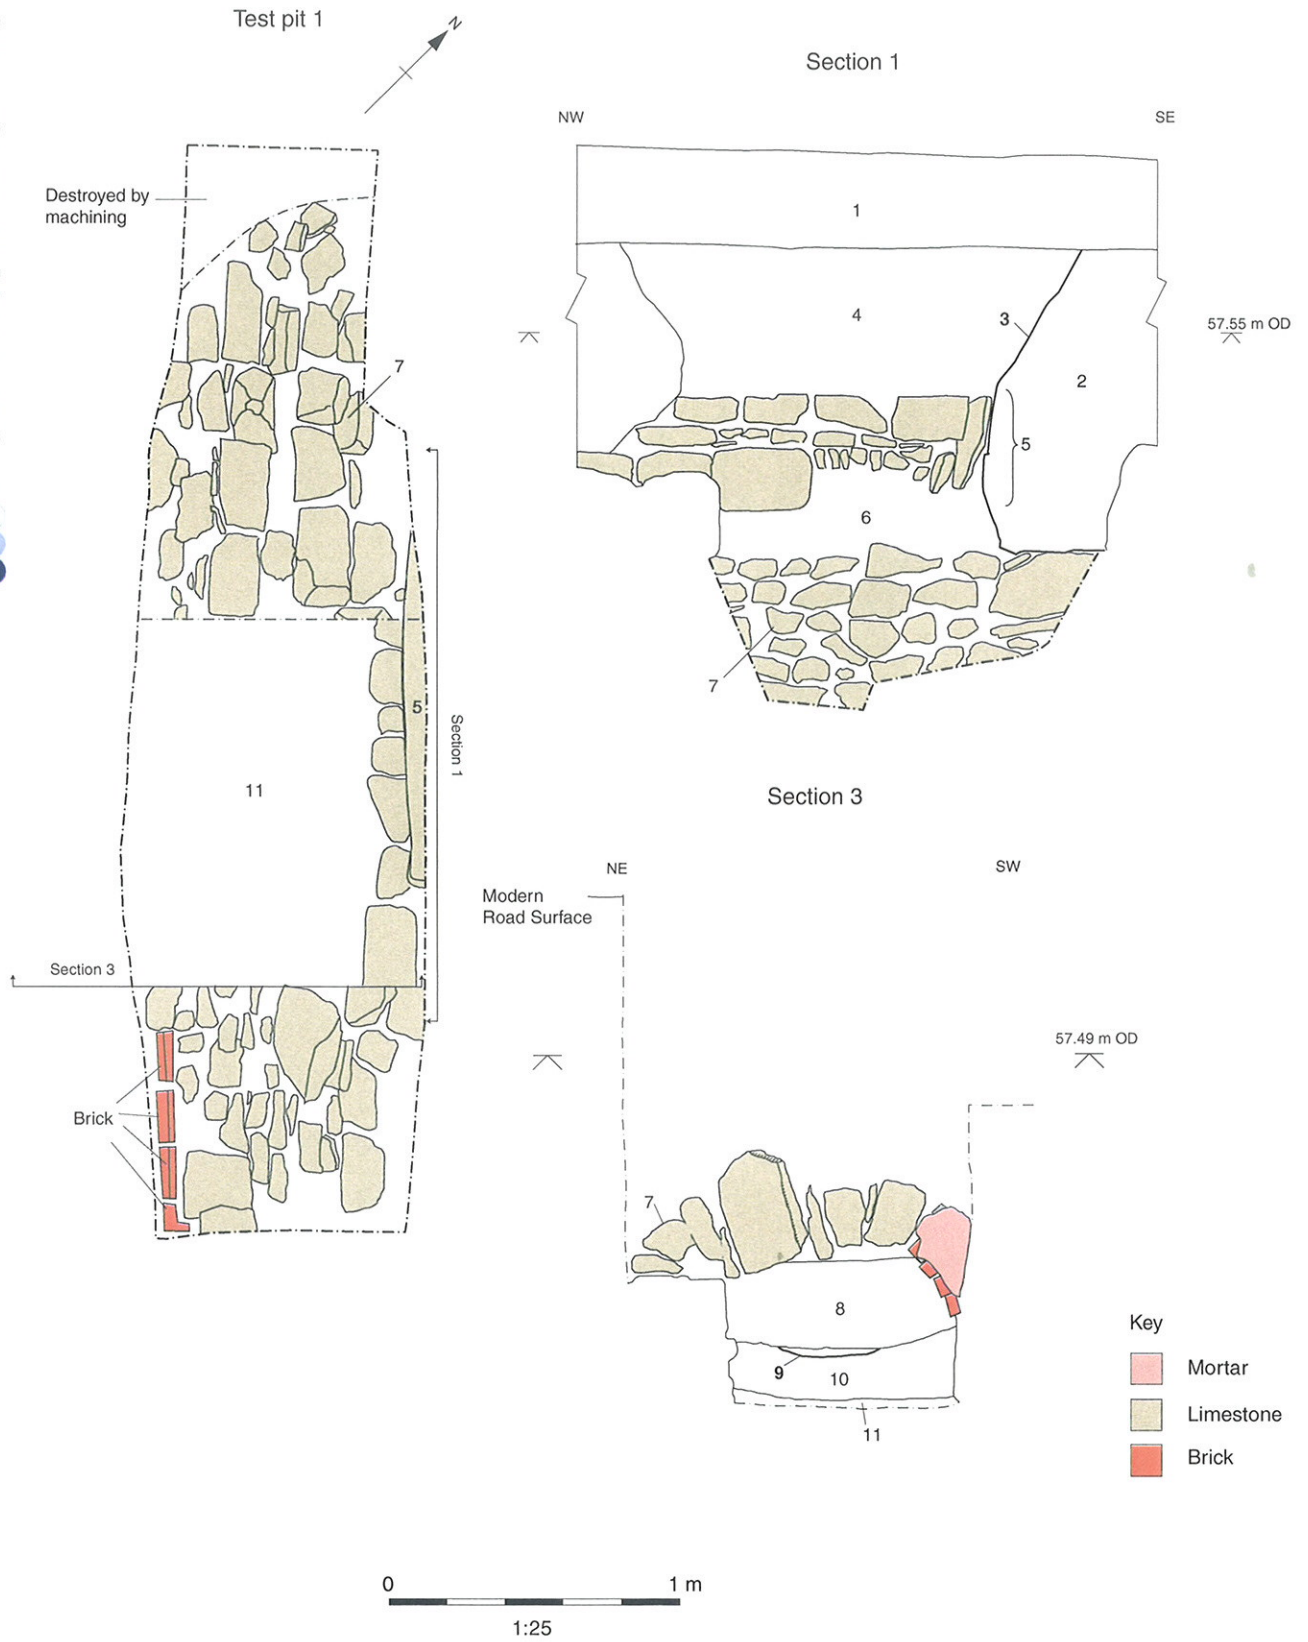
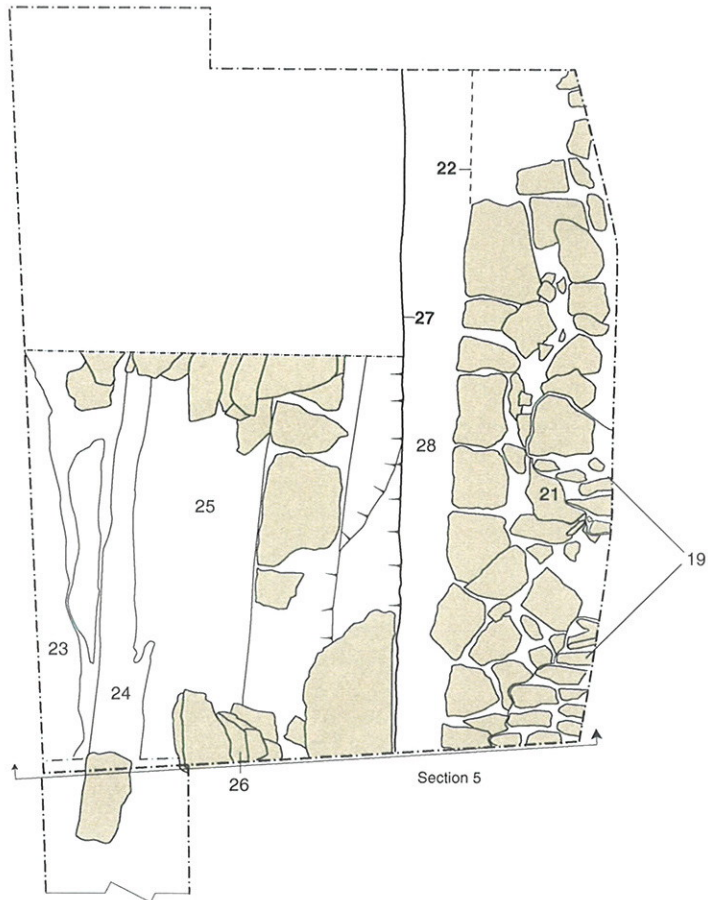
Figure 3: Plan and sections of Test pit 1

- 3.1.2 Test Pit 1 comprised a section of the pipe trench measuring 3.4 m x 1.0 m. Excavation terminated at formation level, at a depth of 1.8 m (56.24 m OD) without reaching the base of the culvert. The culvert (7) was of dry stone construction, made from roughly hewn blocks of limestone (Fig. 2, section). It consisted of two parallel side walls 0.70 m apart and at least 0.60 m high with a barrelled roof. The barrel was constructed of particularly large pieces of stone measuring up to 0.36 x 0.36 x 0.30 m, with smaller stone wedged between them. The lowest fill encountered during excavation of the culvert was a light grey sandy silt at least 0.12 m thick (11), which was overlain by a layer of more gritty material with red mottling and 0.30 m thick (10). Above this was a thin layer of dark grey silt (9) and an uppermost fill of gritty brownish grey sandy silt 0.30 m thick (8). Toward the south-eastern end of the test pit was a repair to the south-western side of the culvert, constructed from brick and a hard light grey mortar. A deposit of brick and stone rubble observed immediately to the south-west of the test pit may be the back-fill of a pit dug to access the culvert during this repair.

- 3.1.3 The culvert was overlain by a layer of light grey gravel and sand (6) that had been used as make up for a well-made road surface (5). A glass seal from a wine bottle from Magdalen College bearing the date 1763 (Plate 1) was recovered from layer 6. The road was only exposed in the north-eastern face of the test pit and comprised a layer of limestone blocks and smaller pitched stones, on which was a surface layer of flat limestone blocks.

- 3.1.4 Road surface 5 was overlain by a layer of gravelly sand made ground 0.50 m thick (4) associated with the current tarmac road surface (1). The made ground was cut by a modern feature of uncertain form and function (3), which truncated the road surface.

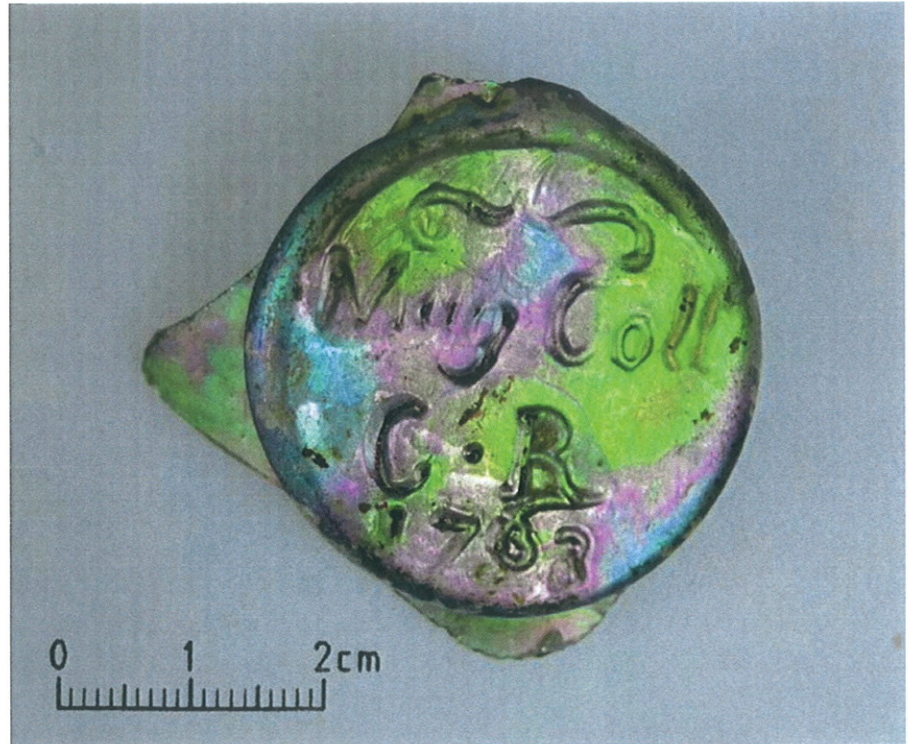
Plate 1: Glass seal from a wine bottle from Magdalen College common room, dated 1763

- 3.2.2 A circular glass seal from a wine bottle bearing the legend "Mag Col C R 1763" (Plate 1) was recovered from a layer of made ground in Test Pit 1. Mag Col C R refers to Magdalen College common room.

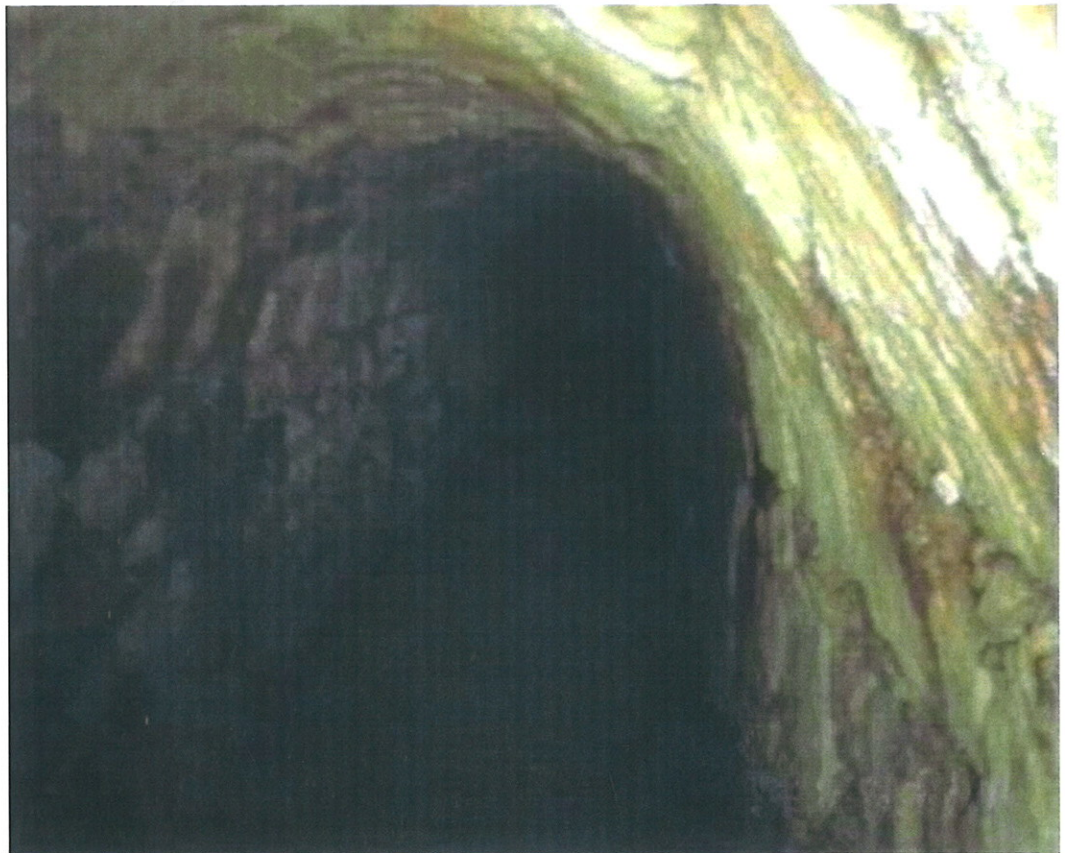
Plate 2: Interior of the culvert, facing south-east from manhole 32

- 3.1.11 On 30th March a CCTV survey of the manhole was carried out by DBI. This confirmed that the entrance shaft opened directly into the southern side of the barrelled roof of the culvert. This section of the culvert survived in good condition and was a further 1 m in depth from the base of the shaft. Immediately to the north-west of the manhole the culvert had been blocked off by the construction of a stone wall across its interior. In Test Pits 1 and 2, to the north-west of this, the culvert had completely silted up, but south-east of the wall it was open and unobstructed (Plate 2). A small opening was observed in the side wall forming the north-eastern side of the culvert. This appeared to slope downward from the culvert and is therefore likely to be an outlet rather than an inlet.
